CASCARA TREE CONSULTING

ARBORIST REPORT

REFERENCE: Tree Inventory & Assessment

SITE ADDRESS: 8636 N Mercer Way, Mercer Island, WA

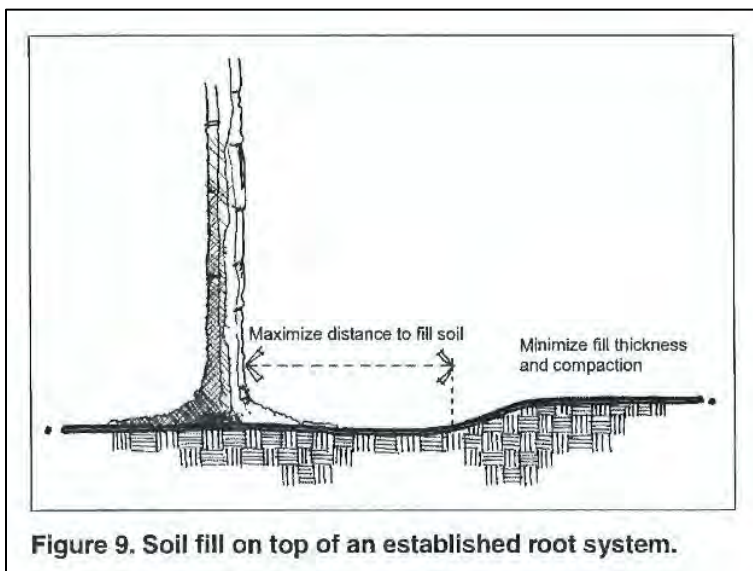
Figure 1. Expose root flare by removing soil around base of trees (Best Management Practices: Managing Trees During Construction, 2016).

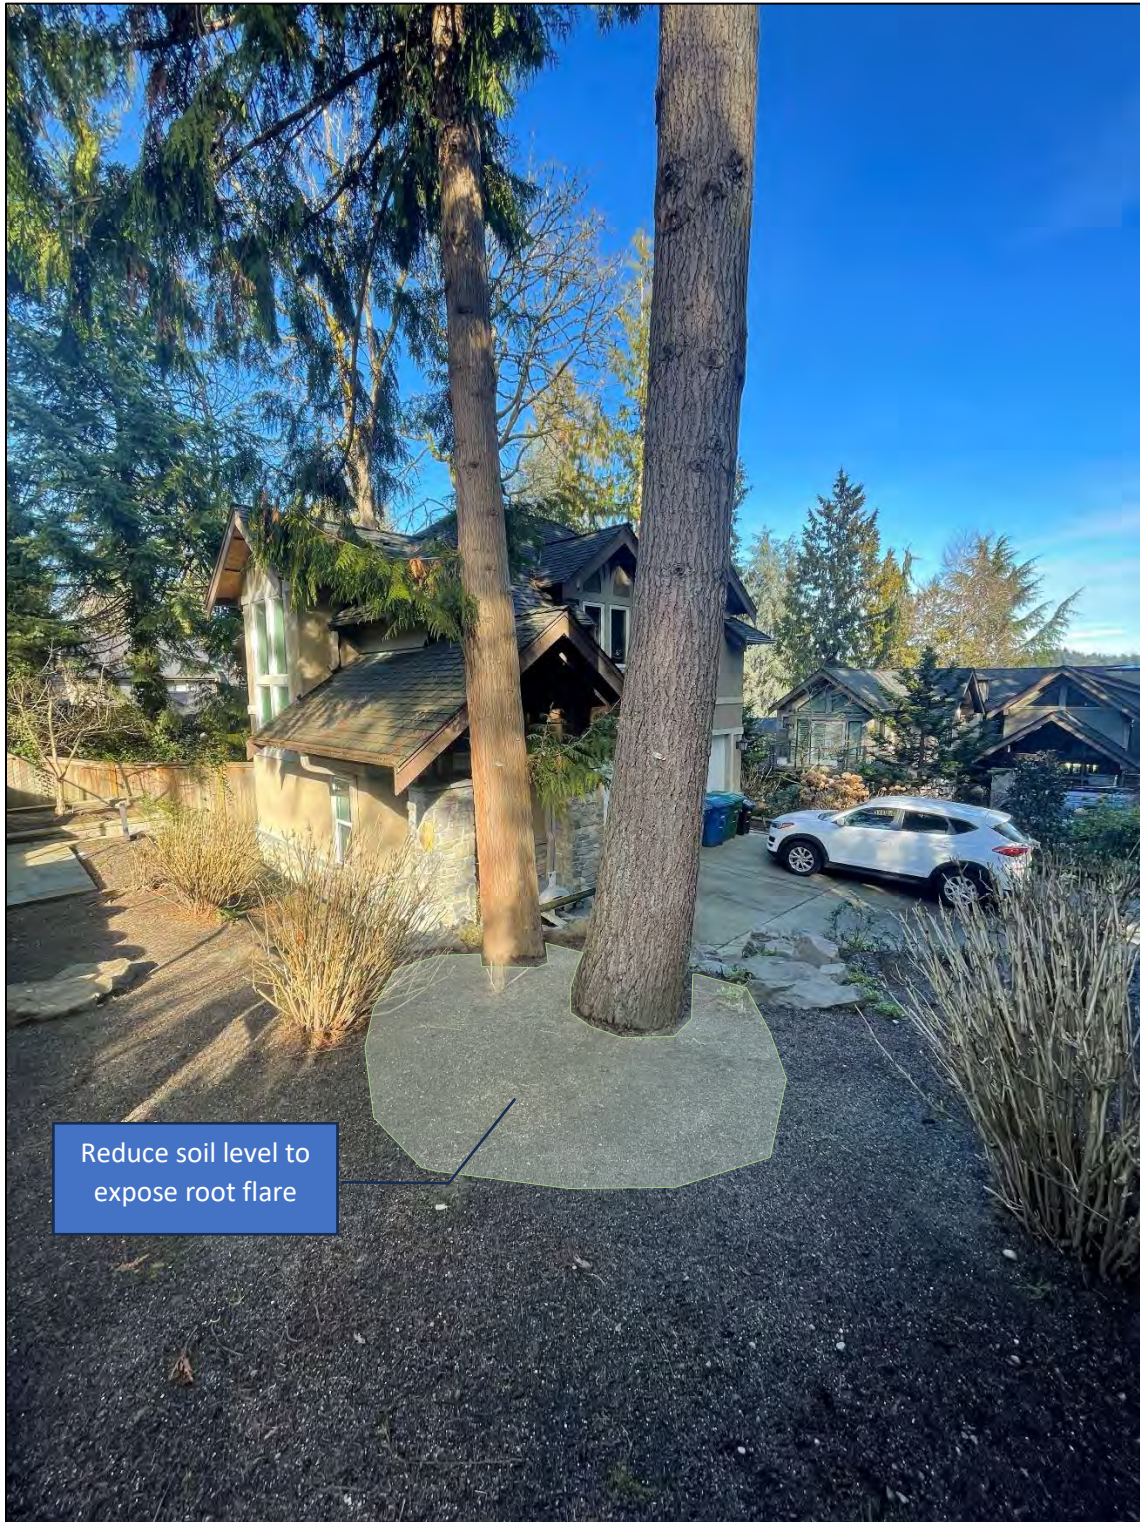
Tree #s 1924 and 1925 are located near the existing detached dwelling unit. These trees are a 16-inch DBH western redcedar (*Thuja plicata*) and 20.5-inch DBH Douglas-fir (*Pseudotsuga menziesii*), respectively. A rock retaining wall was installed east of the trees and fill soil was added to level the area. As a result of the fill, the trunks were slightly buried at the time of my assessment, which can lead to trunk rot and other moisture-related issues. **To mitigate potential issues, I recommend removing the soil around the base of the trees to expose the root flares.** This work should be done by hand using a shovel and mattock to carefully remove soil from around the base of the trees. Gradually expose the root flare without causing damage to the roots or trunk and avoid excessive disturbance to the root zone. Any adventitious roots growing above the root flare should be carefully trimmed with hand pruners. The area around the tree should be re-graded to encourage proper drainage away from the trunk (see Figure 1).

Photo 1. Base of Tree #s 1924 and 1925. Slight fill soil added at base. See specifications for mitigating.

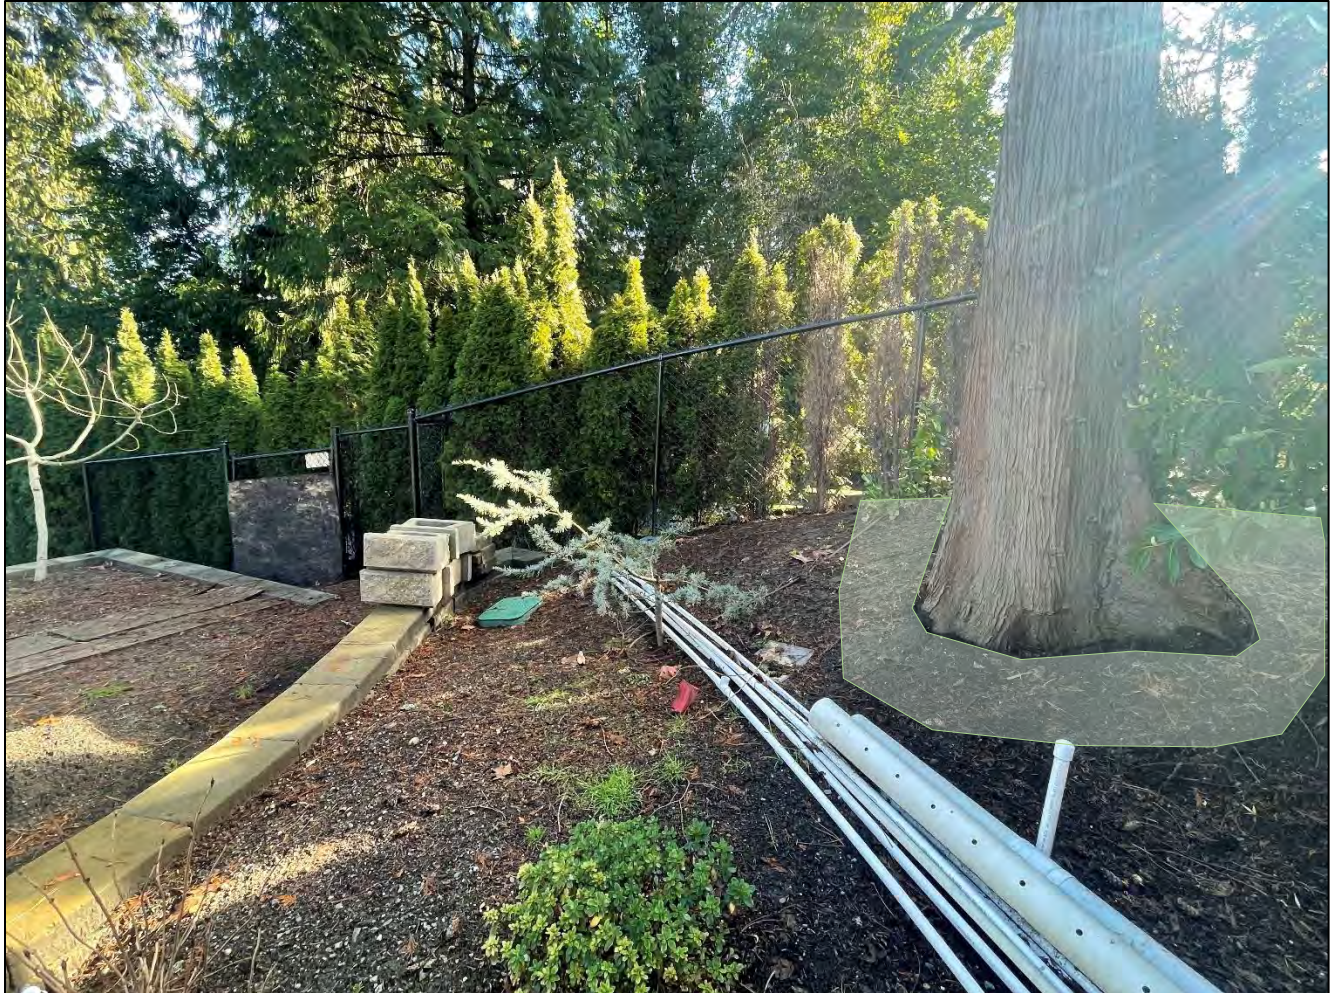
Tree #1929 is a 21.3-inch DBH western redcedar located along the western property line. A concrete block retaining wall was constructed about 8-9 feet from the base of the tree. Excavation required for the wall was minimal, and the grade was raised above the wall resulting in minimal tree impacts. **There were a few inches of fill soil around the tree base which should be removed per the specifications described above.** Overall impacts to this tree are likely to be negligible and should not impact long-term viability.

Photo 2. Base of Tree #1929. Slightly pull soil away from base of tree to ensure moisture is not accumulating at base.

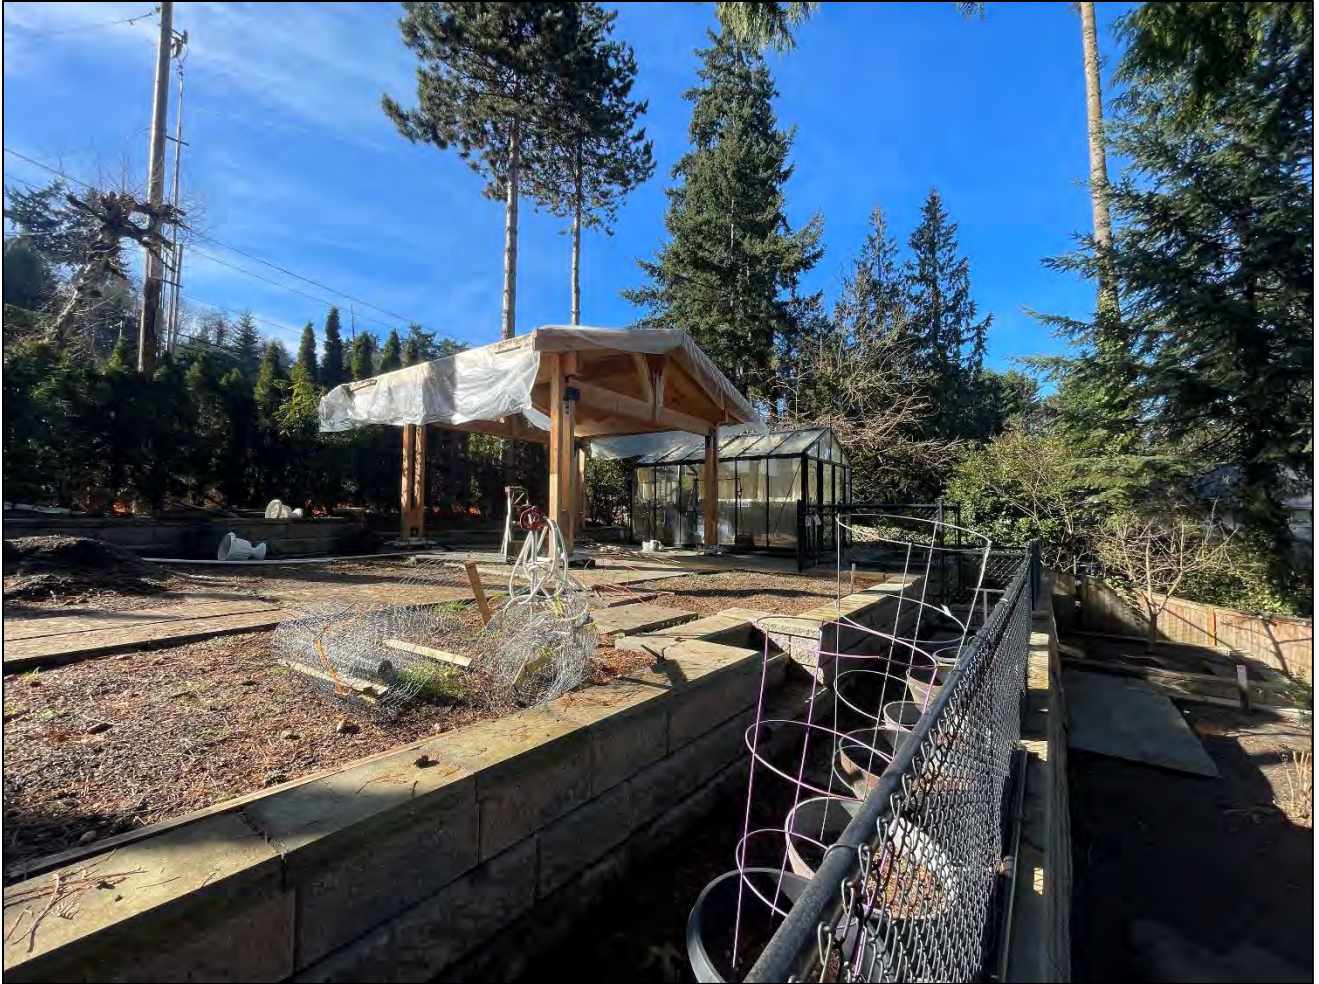
Photo 3. Looking southwest toward recent site work.
