**Arborist Report with addendum on pages 24-25 (1/22/25)
November 17th, 2023**

Rosen Trellis Project
David Taber

3009 60th Ave SE
Mercer Island, Wa

Arborist notes for the Rosen Trellis Replacement project at 3009 60th Ave. SE., Mercer Island Washington. Time of site visit: Wednesday, November 8, 2023. 2 PM.

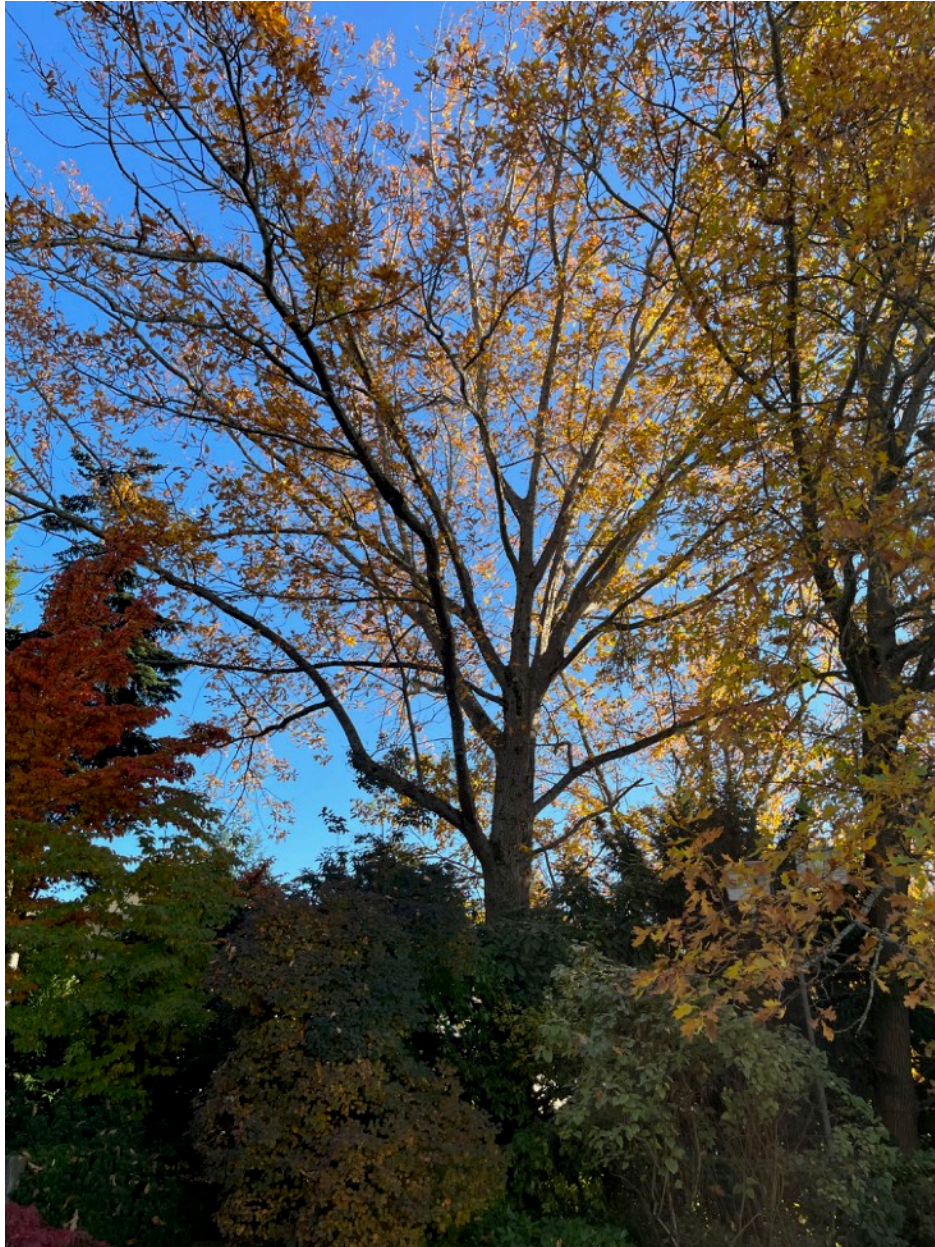
There is a Garry Oak (*Quercus garryana*) on the south property line with a diameter at standard height reading of 29 inches. During the site visit, I used a laser rangefinder to estimate the distance from the corner of the proposed improvements to the edge of this tree's trunk. I got a reading of approximately 18 feet but the exact geometry will need to be confirmed once the tree has been located on the site plan. This Garry Oak has natural structure and appears to be in excellent condition. The tree has better access to light to the northwest and its drip line extends approximately 30 to 35 foot in that direction. The southern and eastern drip lines are both closer to 20 foot. For the purposes of determining the size of the critical root zone of this tree, I am going to extrapolate 1 foot of critical root zone radius for every inch of diameter at standard height. This tree earns a critical root zone radius of 29 feet and how that critical root zone radius is interpreted and what the limits of disturbance are will be included further down in this report. This tree should have tree protection fencing installed as close to the drip line as possible or at the limit of disturbance for the excavation.

It is my professional opinion that there will be no adverse effects on the health or stability of the oak as long as the project is undertaken carefully.

Garry Oaks

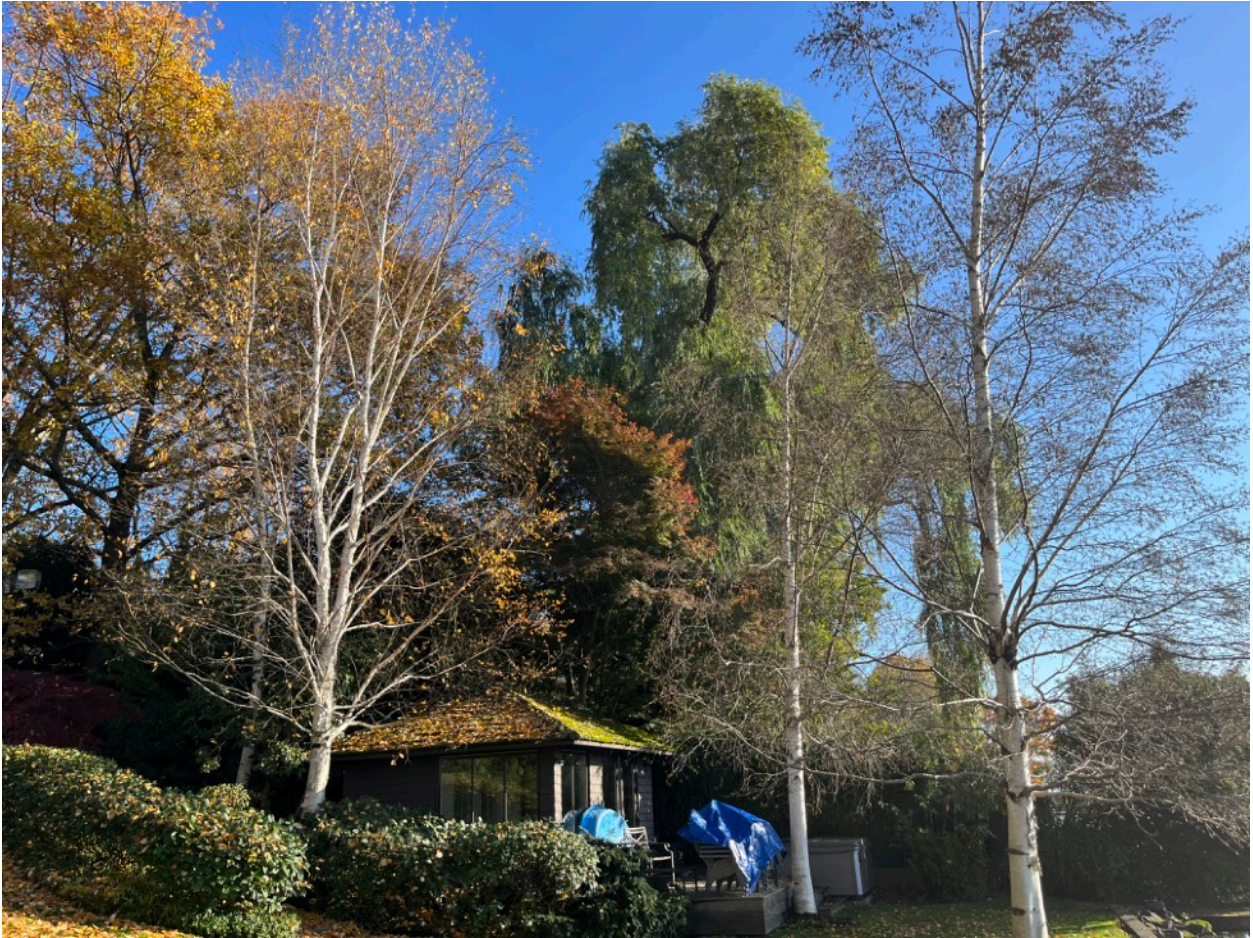
At the west end of the site, close to the water line, there are approximately six Paper Birches with diameter at standard height readings of between 8 and 16 inches. All of these trees have excurrent structure and are in excellent condition.

Paper Birches

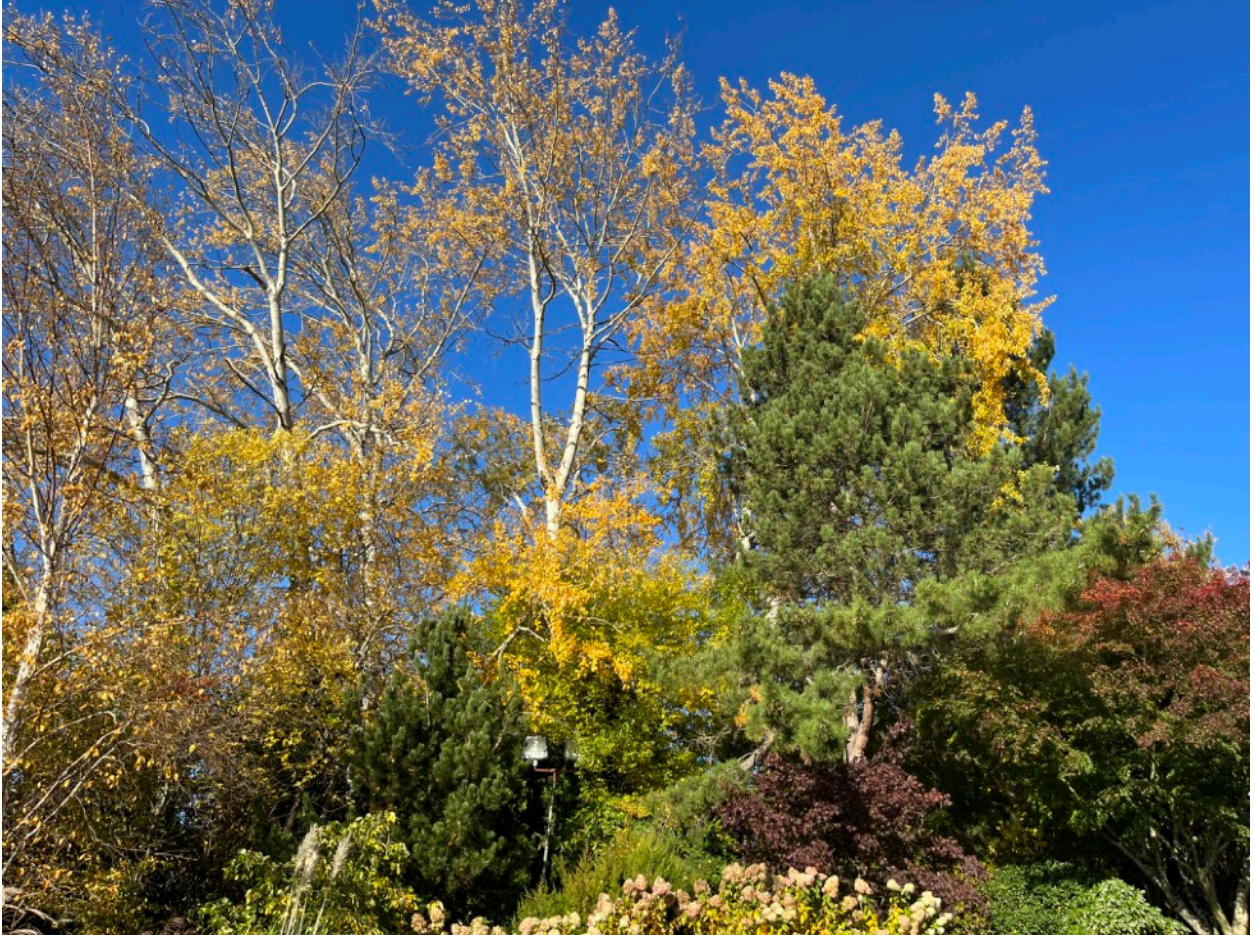
Several exotic varieties of pine, such as Japanese Black Pine and Ponderosa Pine, are growing on the north property line and all of these trees are thriving.

There is an impressive row of Quaking Aspen on the north neighbor's lot and while those trees are growing close to the property line with drip lines that extend over my client's site, none of the Aspen that are visible in the photographs are at my client's address.

The Pines and the neighbor's Aspens

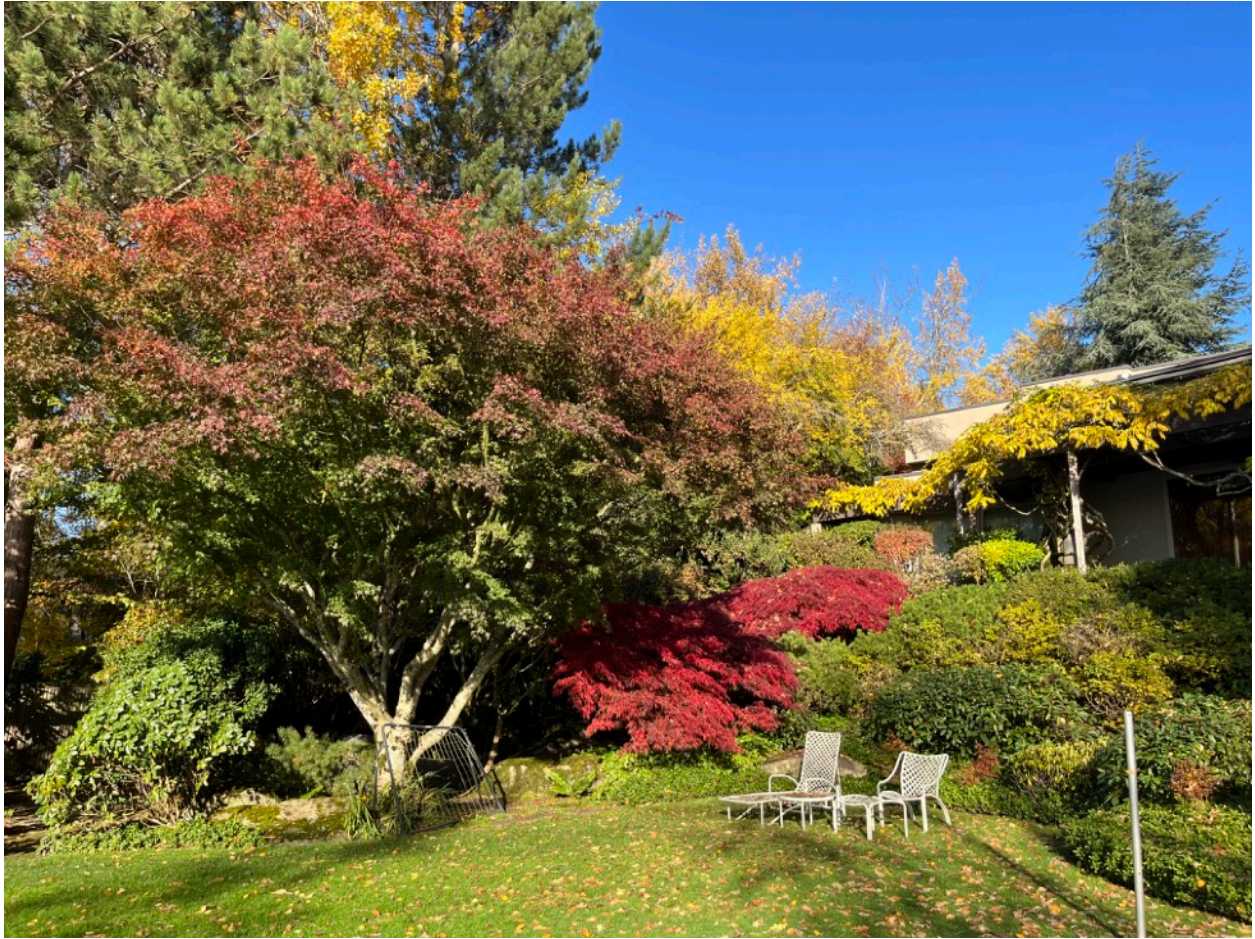
There is a very well established Japanese Maple that is growing adjacent to the north edge of the client's lawn in the backyard.

One of the large Japanese Maples in the backyard

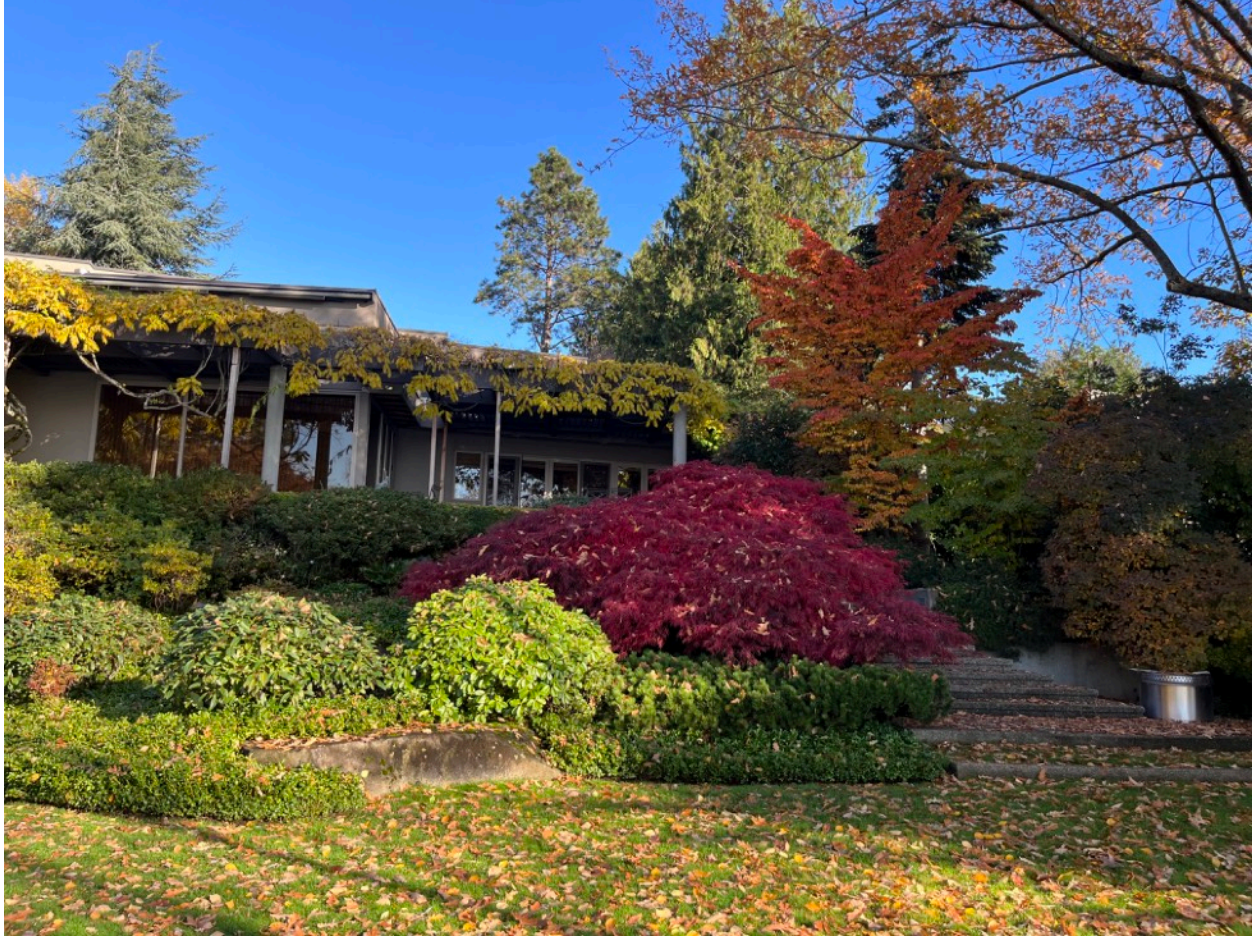
Looking east toward the existing trellis. The Noble Fir to be removed is behind the Stewartia in the right side of the frame.

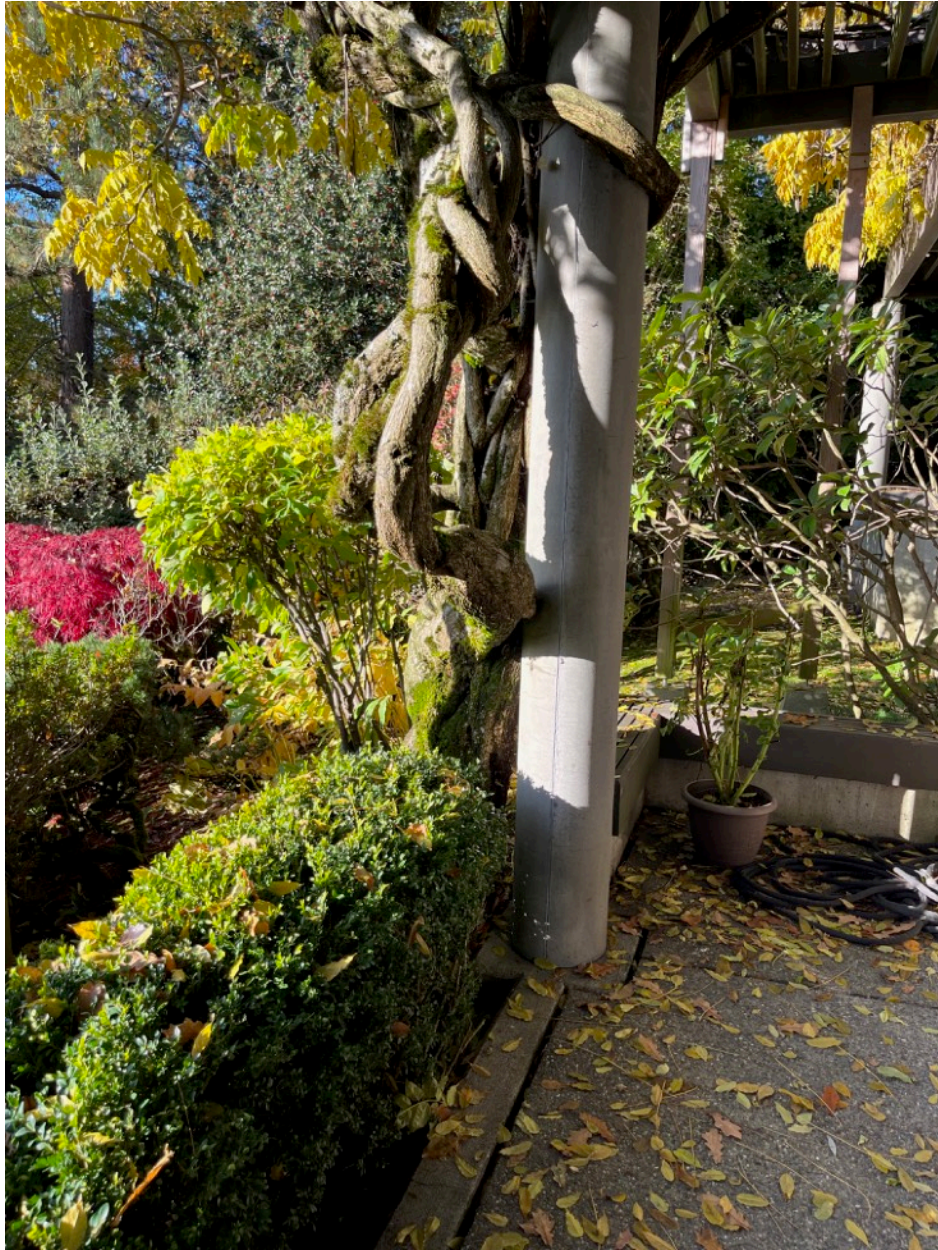
The trellis that is scheduled to be replaced is hosting a very well-established Wisteria vine that has its trunk located to the west of the existing patio behind the house. The vine is also anchored in some other locations around the structure and is being well managed and is in good condition.

One of the places where the Wisteria Vine originates

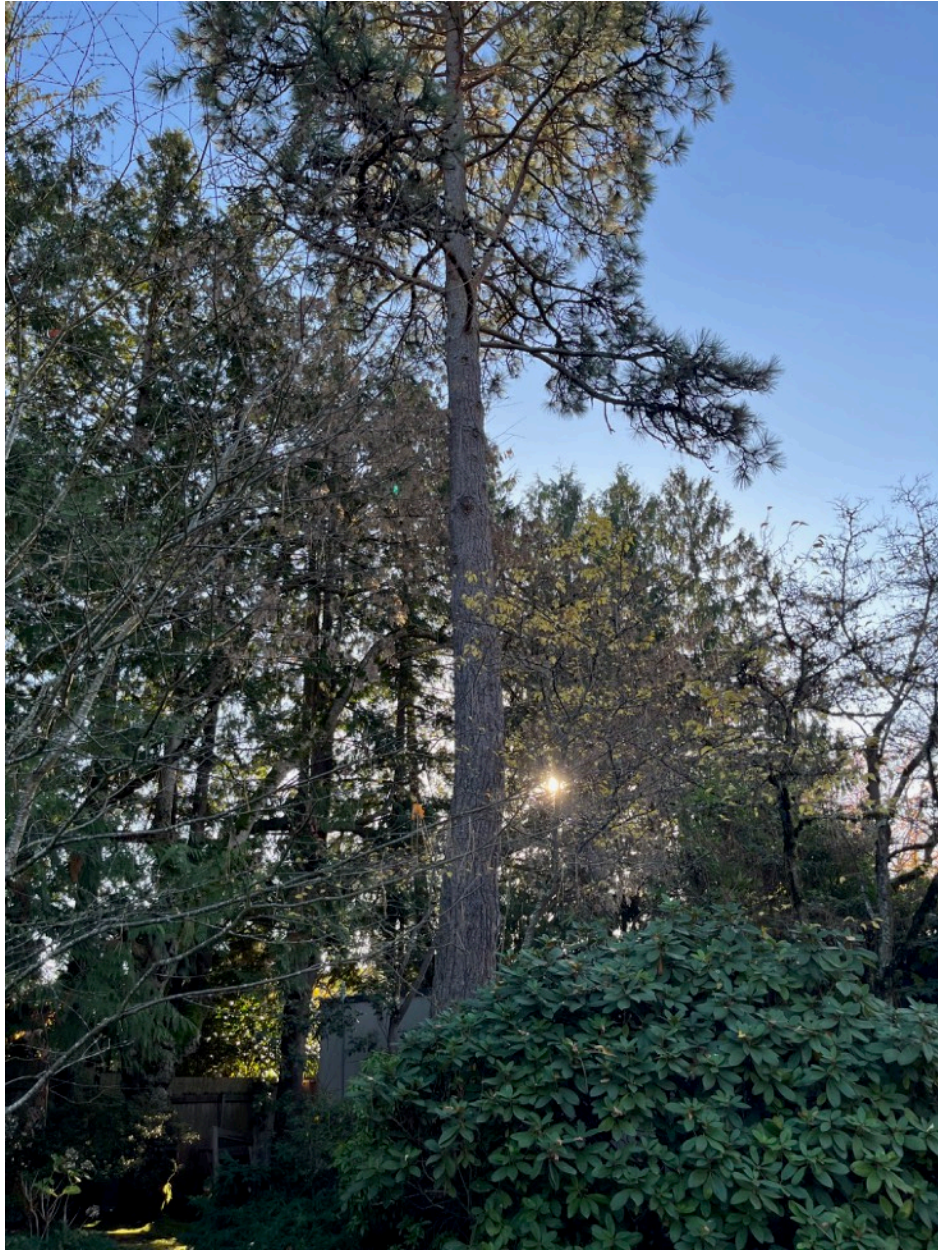
There is an excurrent Ponderosa Pine growing just to the east of the driveway with the diameter at standard height reading of 29 inches. This tree is in excellent condition.

Front yard Ponderosa Pine

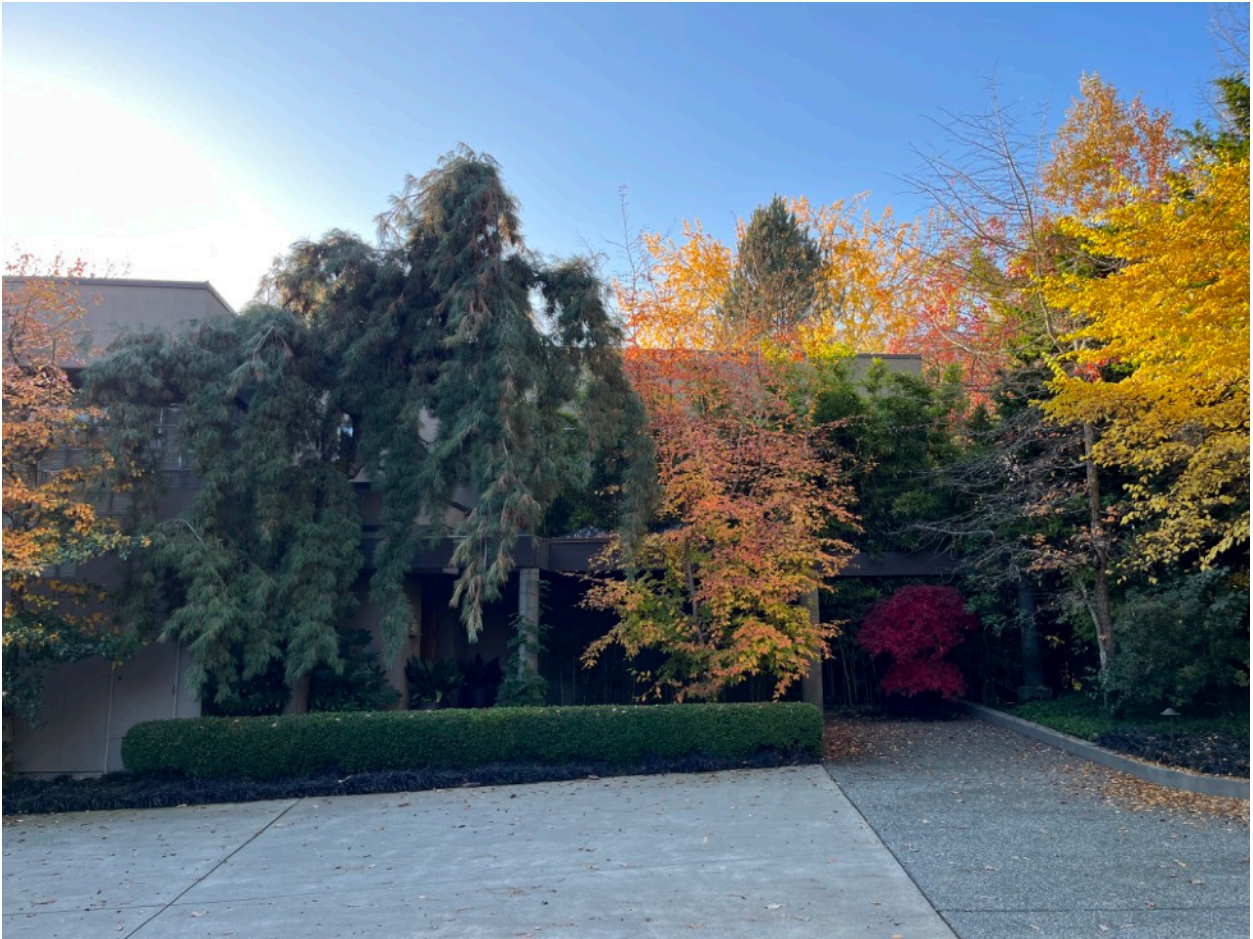
Just to the east of the entrance to the existing single-family residence are two fairly small Stewartia flanking a Weeping White Pine with an approximate diameter and standard height of 12 inches. To the north of the front door access is another Stewartia, a significant installation of Hinoki Cypress, most of which are still fairly small diameter at standard height, and a Japanese Snowdrop tree.

Main entrance. These trees are not near the project.

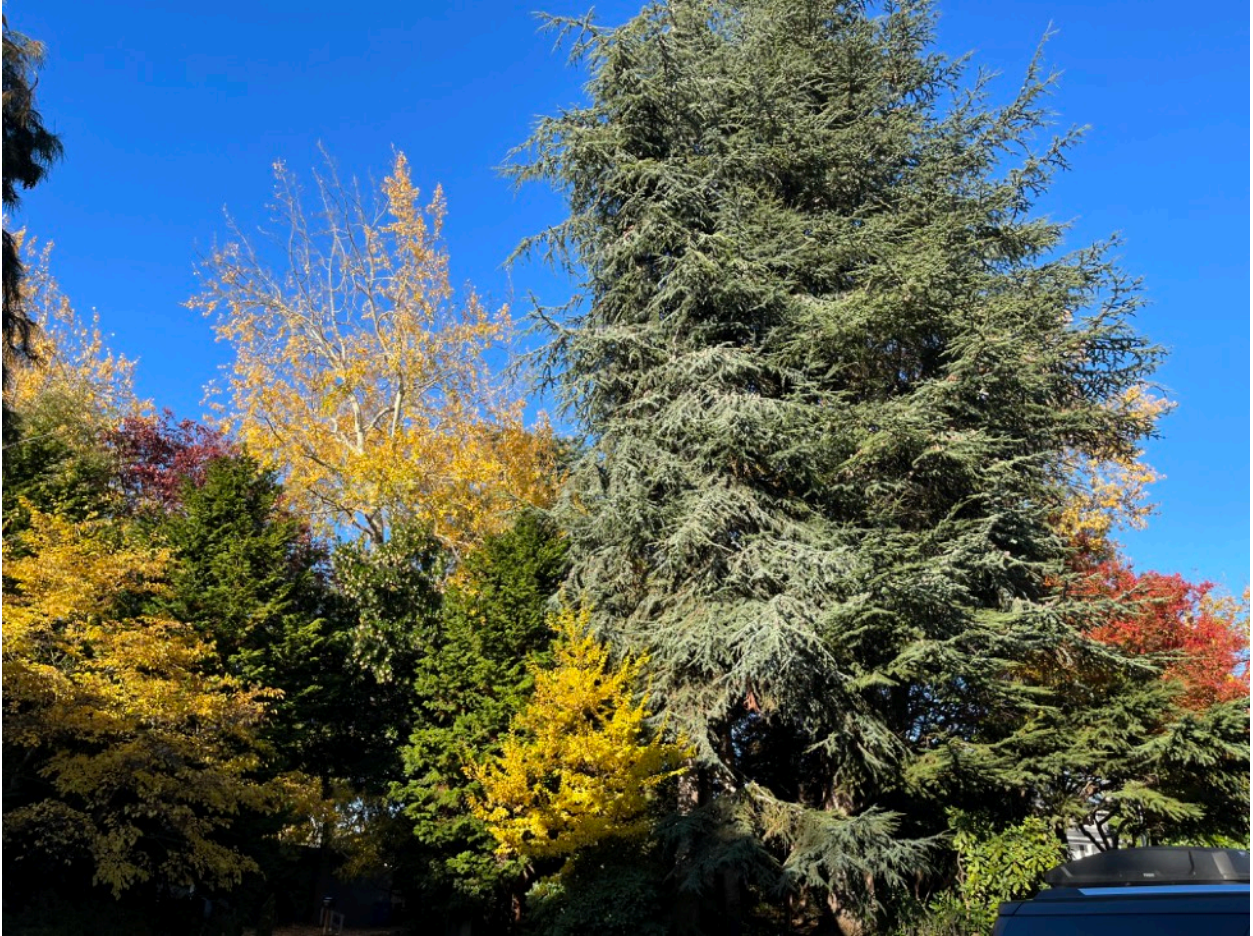
There is a driveway that connects this property to the adjacent property to the north. To the east of that access there are three very well established Blue Atlas Cedar, more Hinoki Cypress, and a variety of rhododendron, and Camellia in the understory. There is also another multi-stemmed Japanese Maple growing at the northeast corner of the front yard, along with a Flowering Cherry and a Deodar Cedar with two stems measuring 7 inches and 6 inches. None of these trees in the northern portion of the property will be affected by the proposed improvements and they are far enough away the tree protection fencing is not necessary in this region.

Blue Atlas Cedars in the NE corner of the lot.

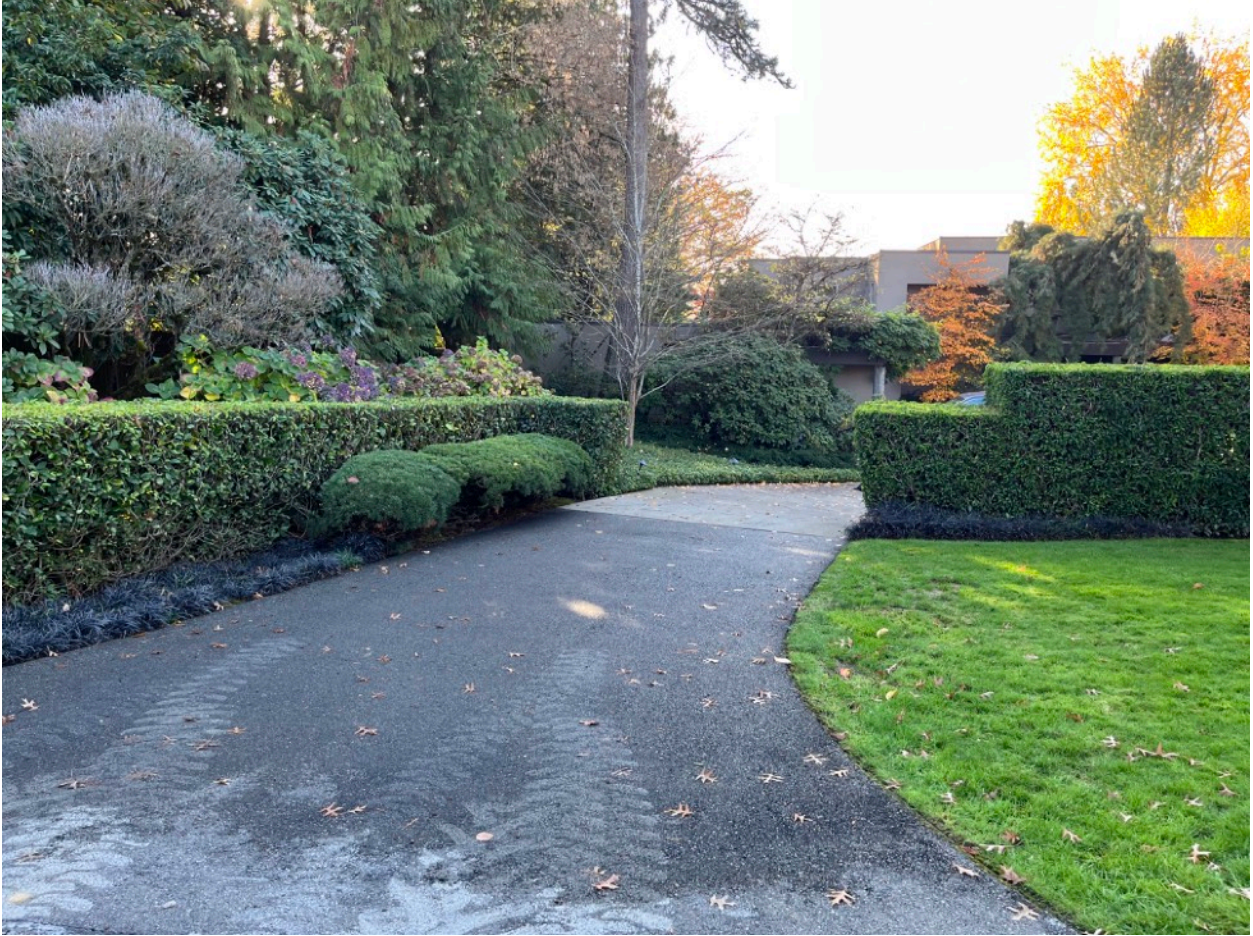
Another shot of the access around the north side.

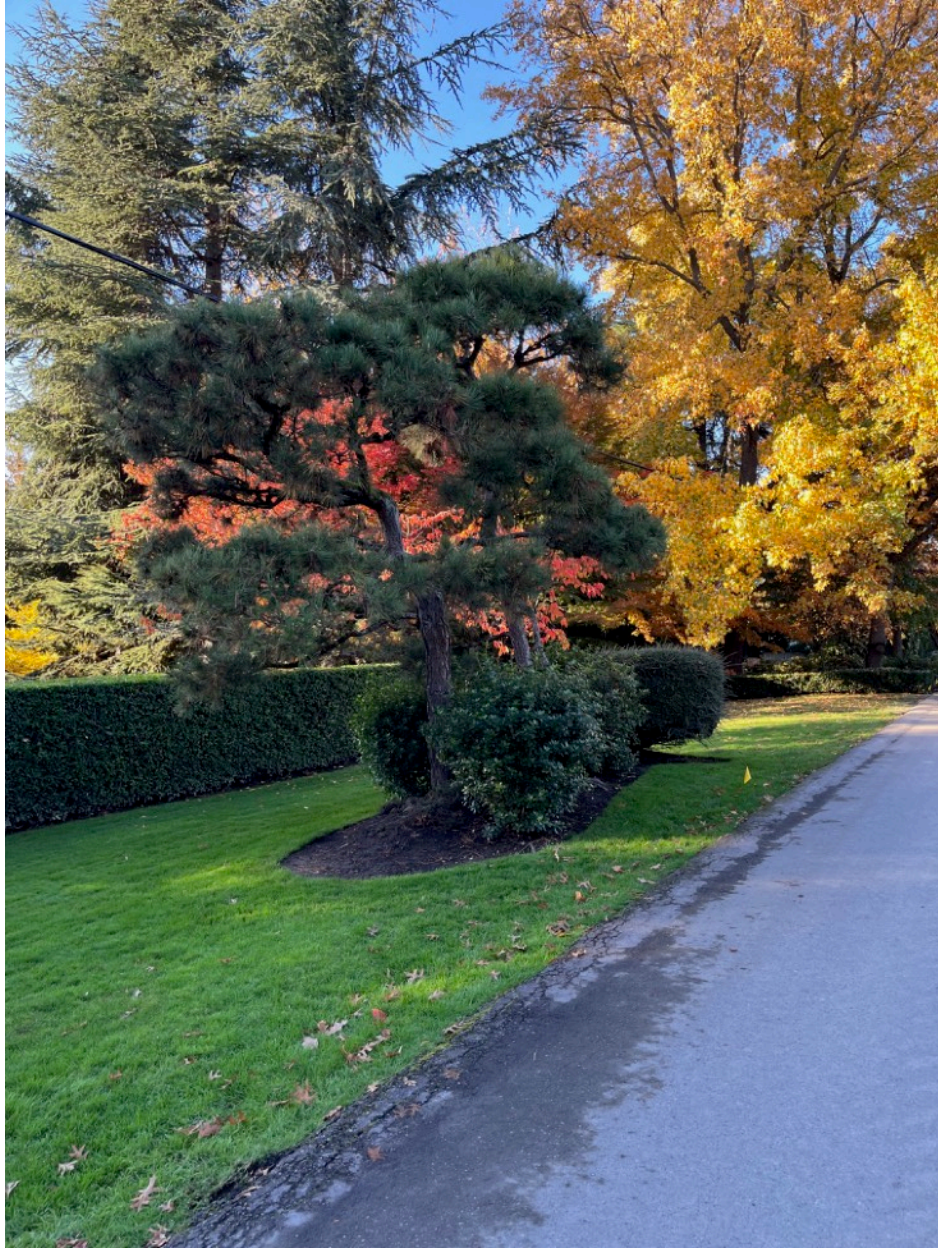
Mugo Pine close to the ROW.

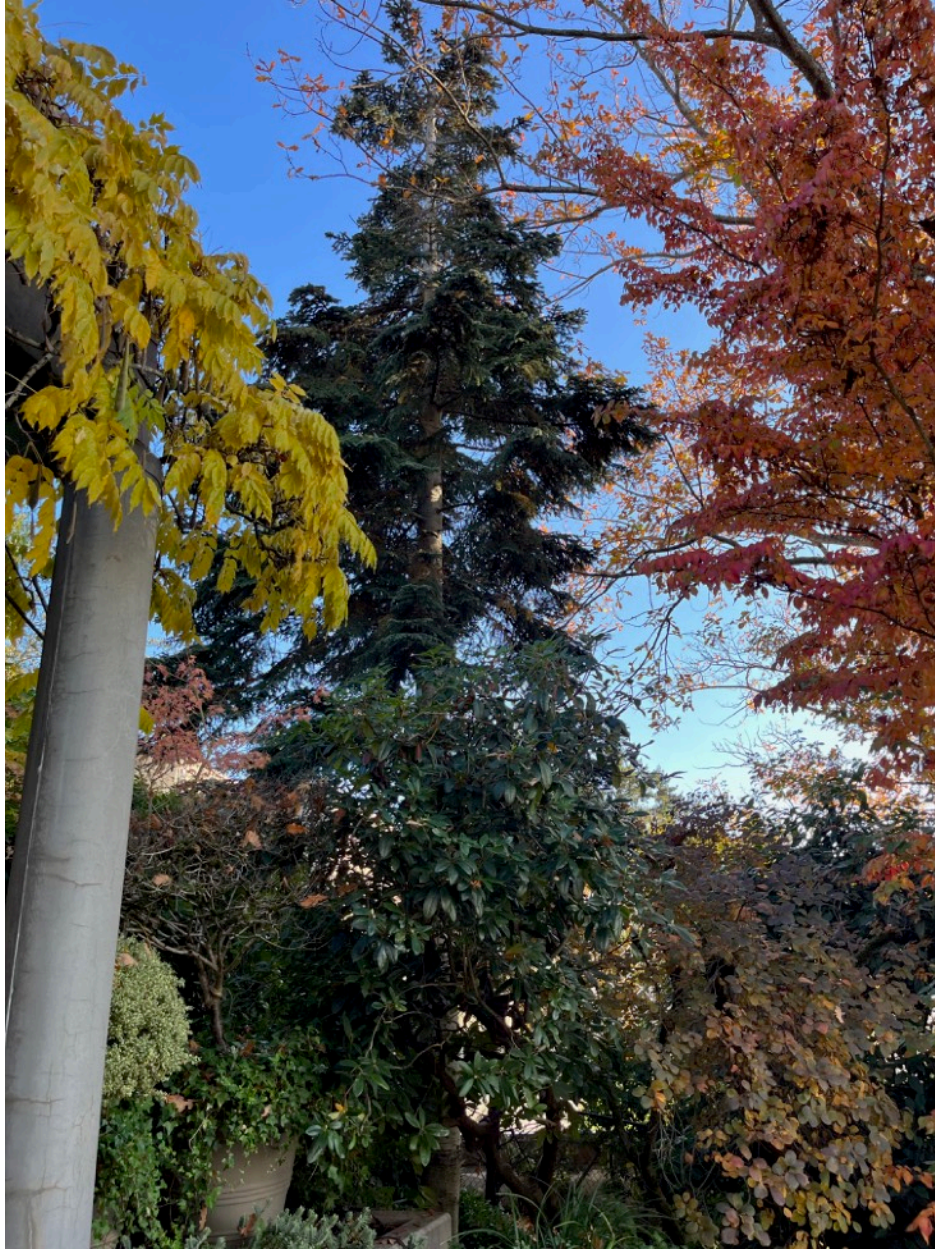
The tree that is in the way of the project is a Noble Fir (*Abies procera*) with a diameter a standard height of 14 inches. The tree is approximately 40 foot tall and in fine condition. The proposed eastern edge of the new retaining feature will be east of this tree and the area that the tree currently inhabits will have to be backfilled with new soil. There is no way to execute this project while simultaneously retaining the specimen. This tree should be removed and replaced according to the ratios published by The City of Mercer Island.

This is the fir that would need to be removed for the project to commence.

The client has received approval to remove the Noble Fir (pictured on page 20) to facilitate the project. The client has also informed me that they are intending to remove the two Crabapple (Mauls sp.) that are pictured on page 22. Both of those trees have DSH readings that are under 10” and do not qualify as regulated trees in the City of Mercer Island and no permits are required.

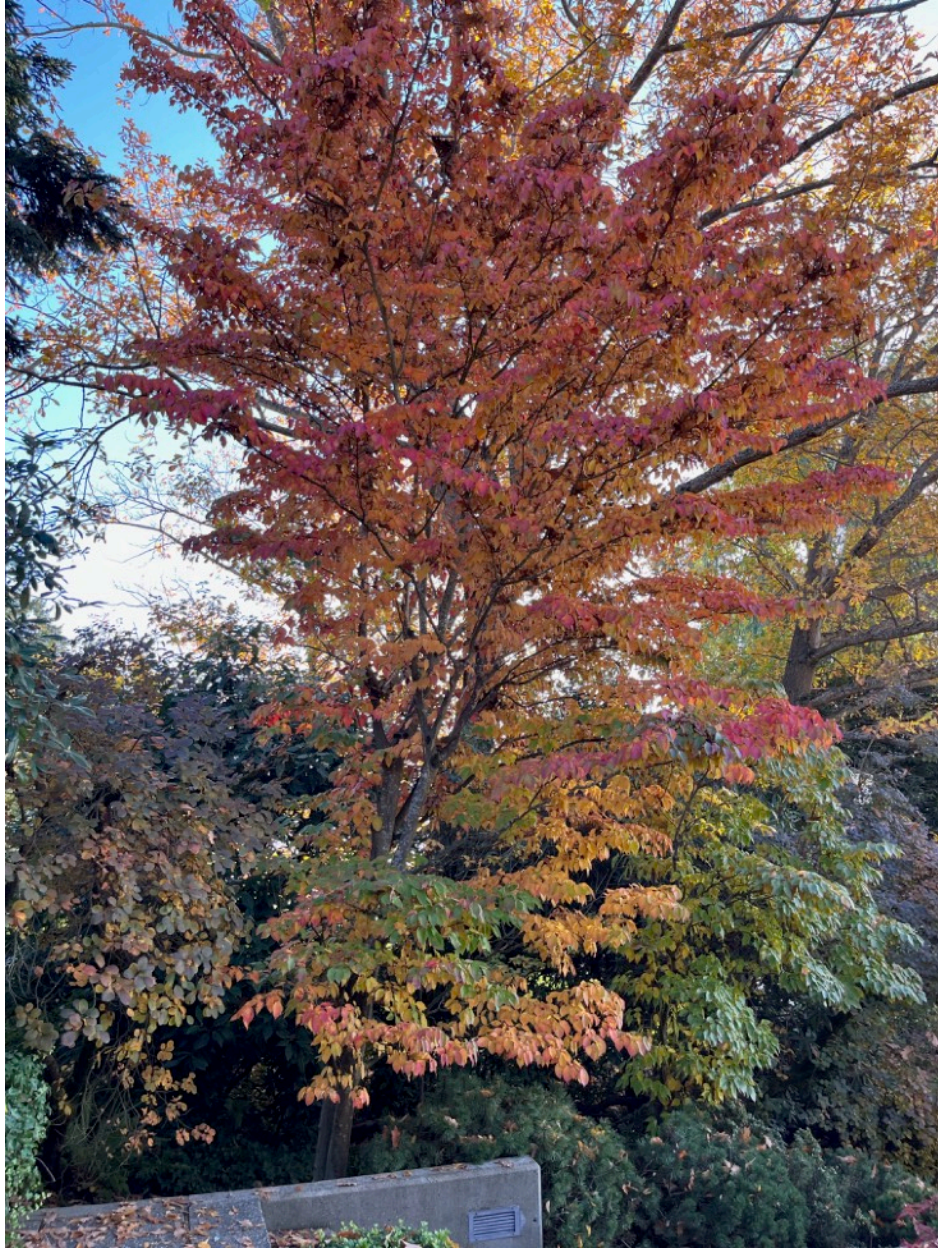
There is a Japanese Stewartia with an 8 inch diameter at standard height that is growing just to the south of the staircase that accesses the backyard and this tree appears to be a 10 foot away from the existing wall that is scheduled to be extended to the east. This tree's critical root zone will not be affected by the proposed improvements, but this tree is close enough that it should be accurately located on the site plan and it should have its drip line protected with tree protection fencing prior to construction activities commencing. The tree protection fencing ensures that the construction crew will not use the critical root zones of the trees that are being preserved to stage equipment, rinse tools, etc.

Stewartia that will need to be protected or moved.

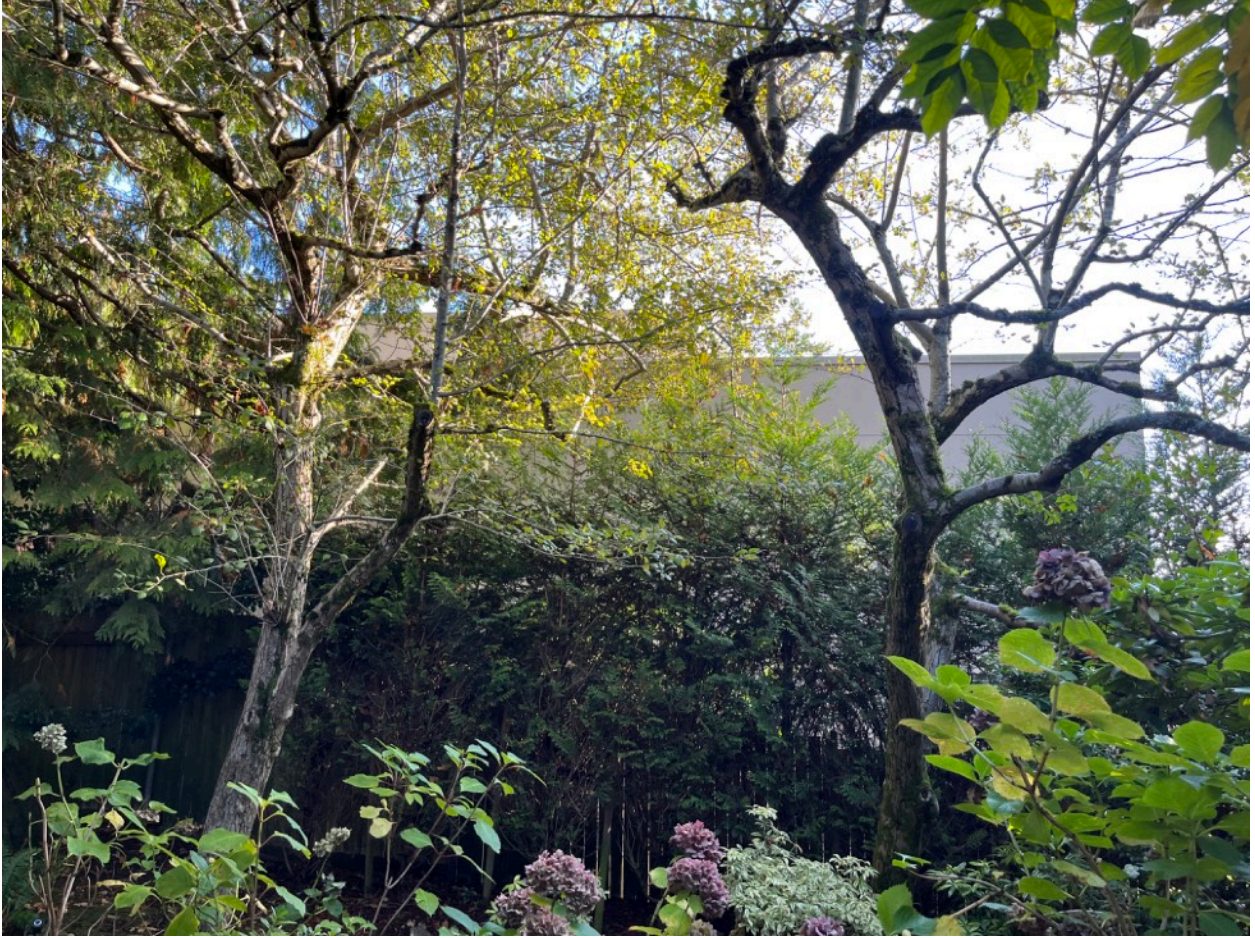
East of the proposed improvements are two Crabapple trees with approximate diameter and standard height readings of 8 to 10 inches. These trees are in good condition and will not be affected by the proposed improvements.

Crabapples that are also close to the project and should be protected.
