ARBOR INFO LLC

**Tree Assessment
For
Seascape Homes
At
Lot 1, 5222 Forest Ave SE
Mercer Island, Washington**

**Date
9/15/2024**

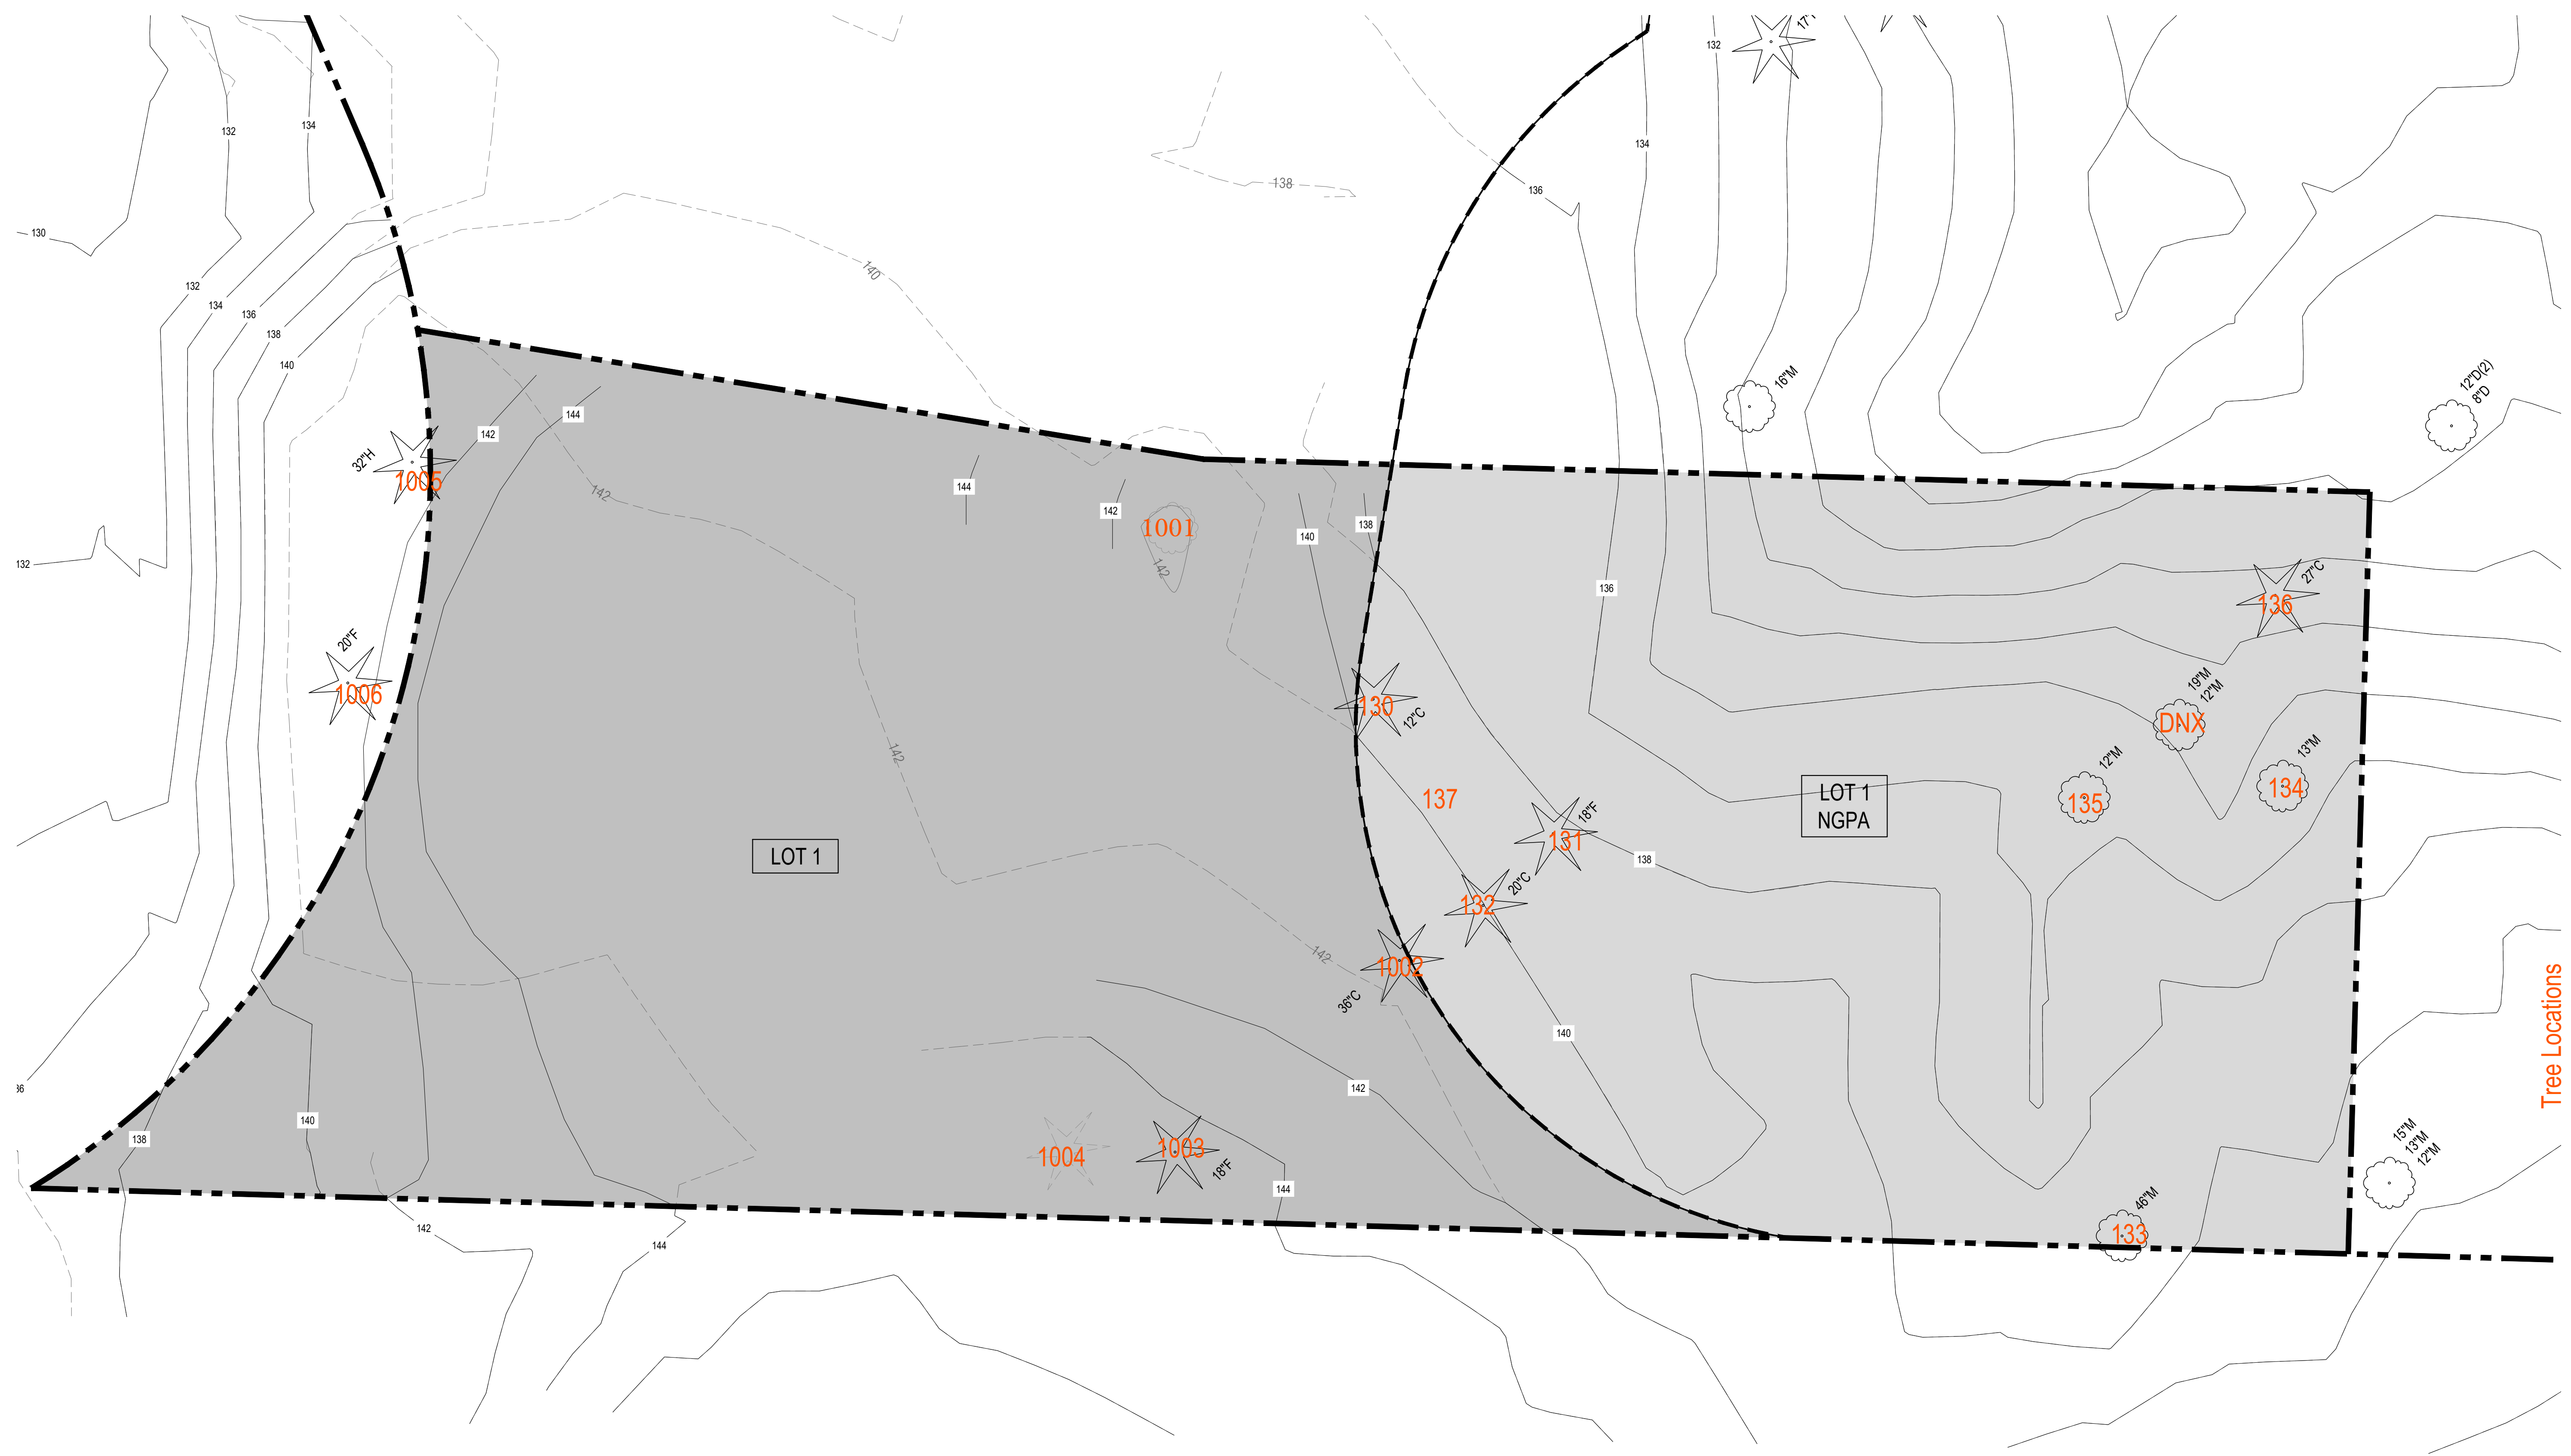
1 LOT 1 FULL TREE PLAN
SCALE: 1/8" = 1'-0"

Root zone impacts to the retained ROW trees are none or minor.

The tree removal plan will remove all viable trees, leaving no viable trees on site.

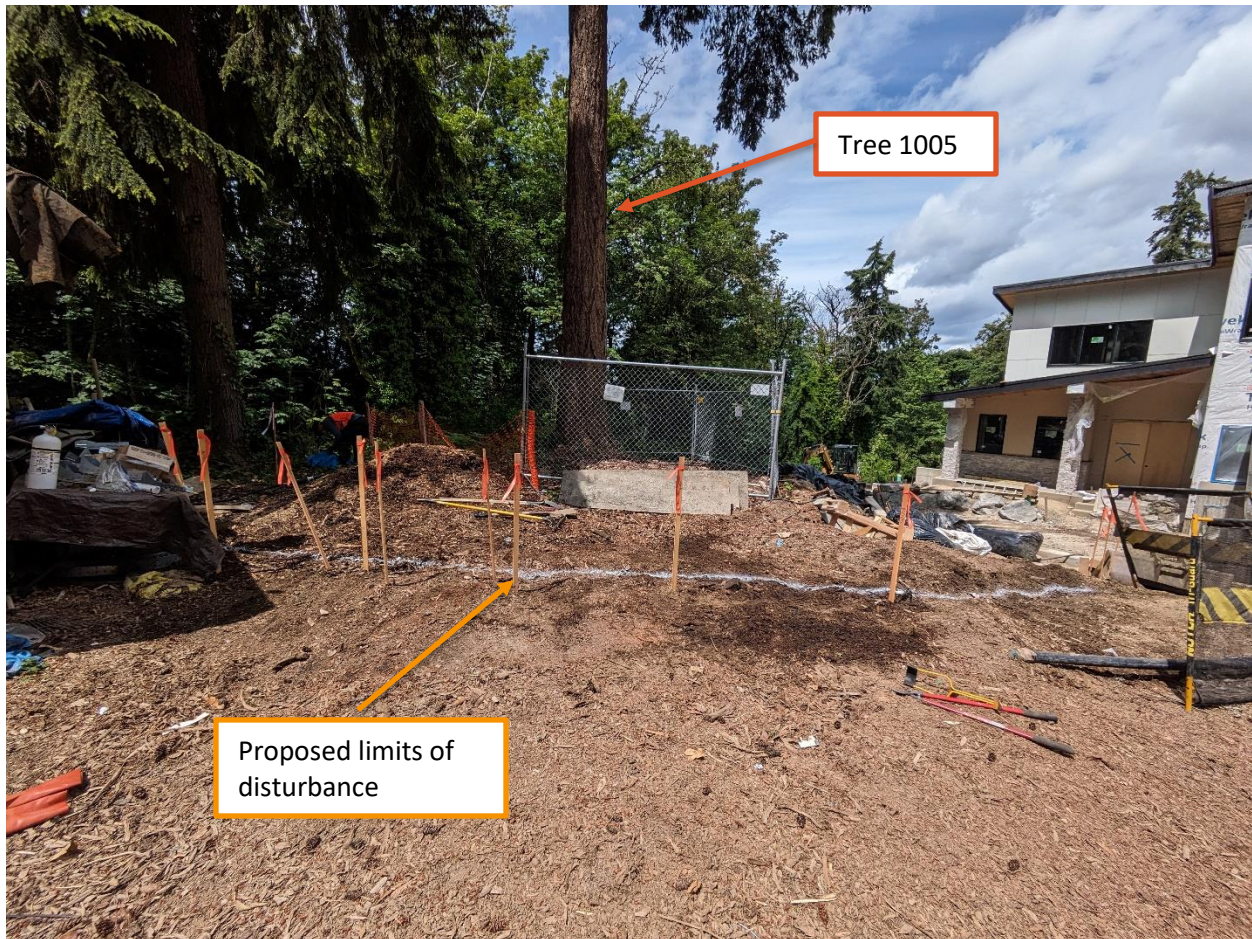
We utilized staking by the contractor, Jon Tellefson of Seascape Homes LLC, to determine the proposed limits of disturbance adjacent to the tree (Photo 1). We excavated an approximately 30 foot long trench 19 feet east of tree 1005 to a depth of 24 inches (Photo 2). We exposed no structural roots, roots over 2-inches diameter, during our excavation and exposed minimal fine roots (Photo 3). Photos documenting our excavation can be found in Appendix B.

Photo 1. Tree 1005 indicated above. The proposed limits of disturbance, and where we trenched, is indicated by the orange staking.

In our professional opinion, the proposed disturbance will have a minimal impact to the health and structural condition of the tree. We recommend tree protection measures in accordance to Mercer Island Municipal Code 19.10.080, including tree protection fencing, are set at the proposed limits of disturbance.

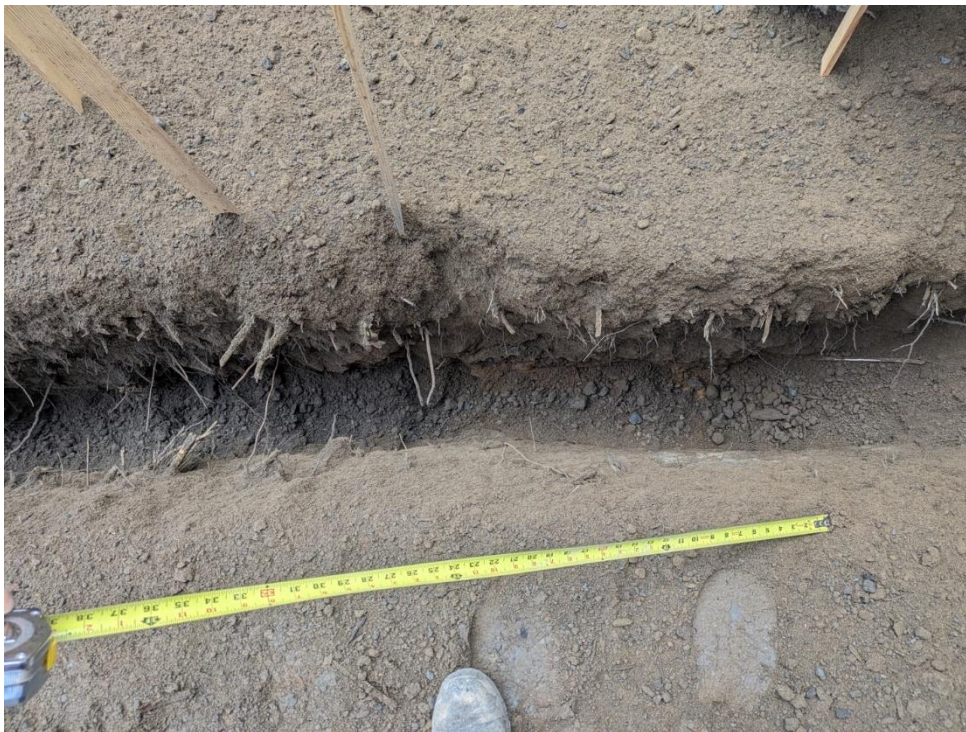
Photo 3. A typical section of trench with small feeder roots are exposed.
