## Memorandum

To: Seascope Homes LLC c/o Jon Tellefson  
CC: Sturman Architects c/o Kati Eitzman  
Site: 5222 Forest Ave SE, Mercer Island, WA 98040  
Re: Exploratory Pneumatic Excavation  
Date: June 20, 2024  
Project Arborist: Connor McDermott  
ISA Certified Arborist PN-8704A  
ISA Qualified Tree Risk Assessor  
John Wells  
Arborist Technician  
Referenced Documents: Site Plan A1.1 (Sturman Architects, 05/14/2024)

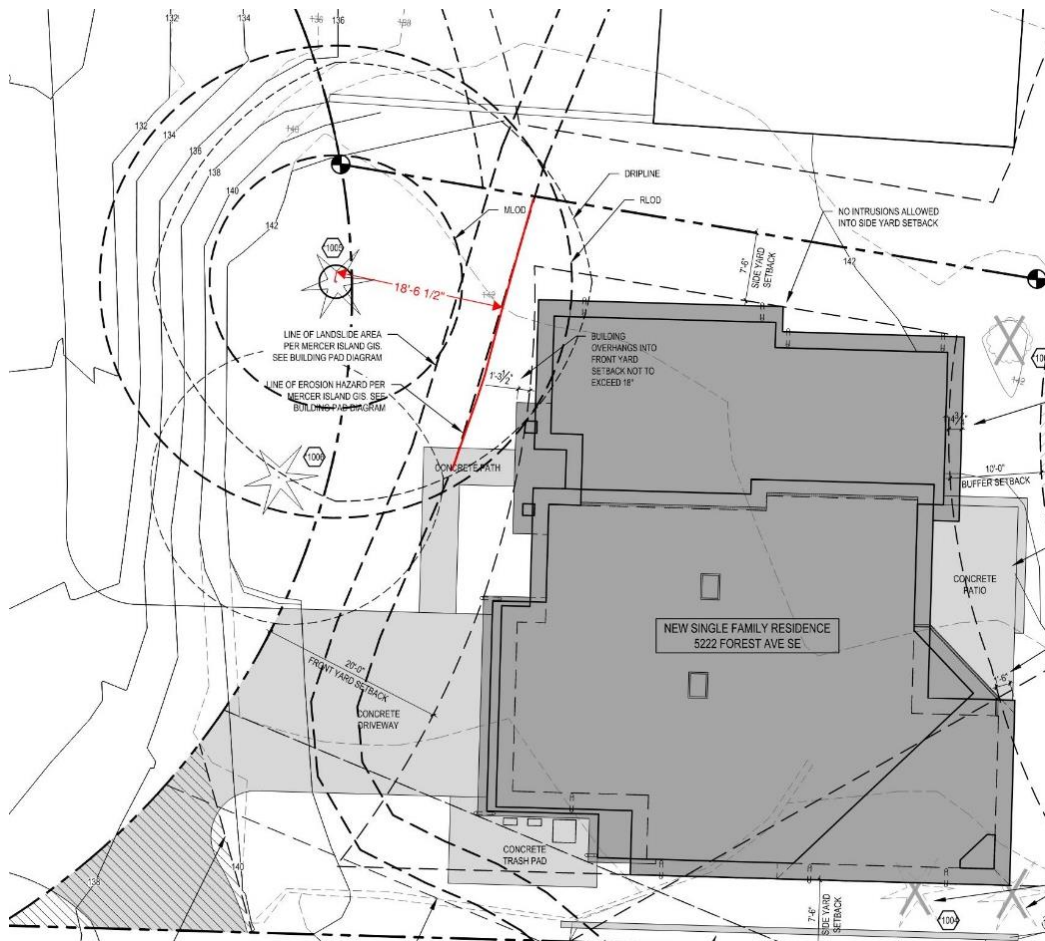
This memorandum documents the site visit of Connor McDermott and John Wells, of Tree Solutions Inc., to the above referenced site on June 14, 2024. We were asked to visit the site and perform exploratory pneumatic excavation at the proposed limits of disturbance for tree 1005 in preparation for a site development. We were asked to provide a memo with our findings and evaluation of proposed impacts. This memo only includes the tree within the immediate construction area as delineated on site plan specifically referenced in this memo (Figure 1).

Figure 1. Snip of the provided site plan (Site Plan A1.1, Sturman Architects, 05/14/2024). The approximate location of the excavation performed is indicated by the red line.

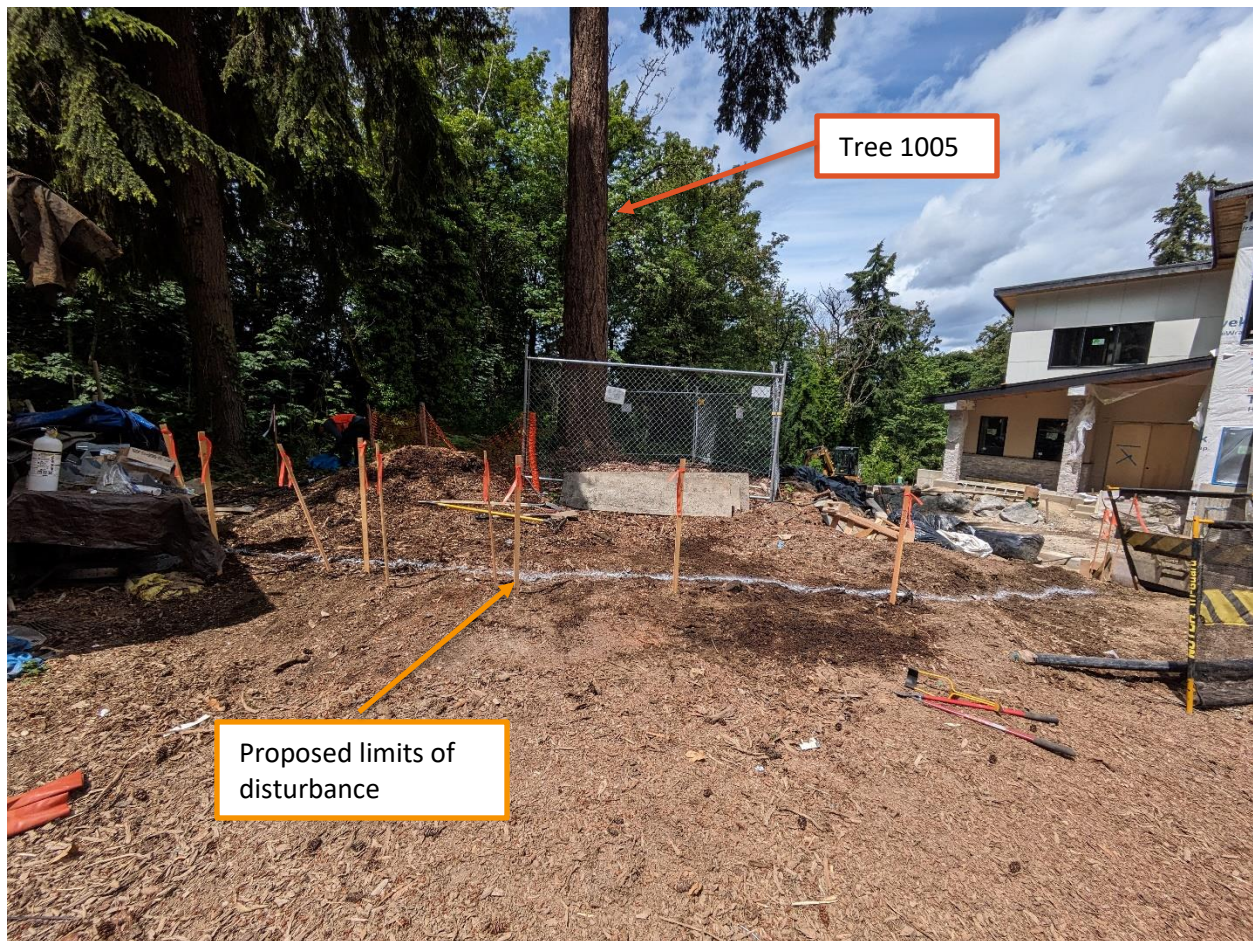
We utilized staking by the contractor, Jon Tellefson of Seascope Homes LLC, to determine the proposed limits of disturbance adjacent to the tree (Photo 1). We excavated an approximately 30 foot long trench 19 feet east of tree 1005 to a depth of 24 inches (Photo 2). We exposed no structural roots, roots over 2-inches diameter, during out excavation and exposed minimal fine roots (Photo 3). Photos documenting our excavation can be found in Appendix B.

Photo 1. Tree 1005 indicated above. The proposed limits of disturbance, and where we trenched, is indicated by the orange staking.

In our professional opinion, the proposed disturbance will have a minimal impact to the health and structural condition of the tree. We recommend tree protection measures in accordance to Mercer Island Municipal Code 19.10.080, including tree protection fencing, are set at the proposed limits of disturbance.

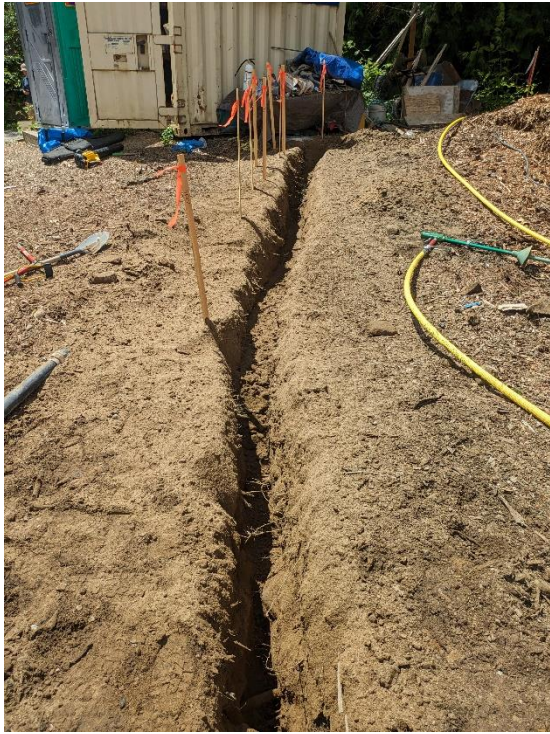
Photo 2. View of the trench from the north following pneumatic excavation.

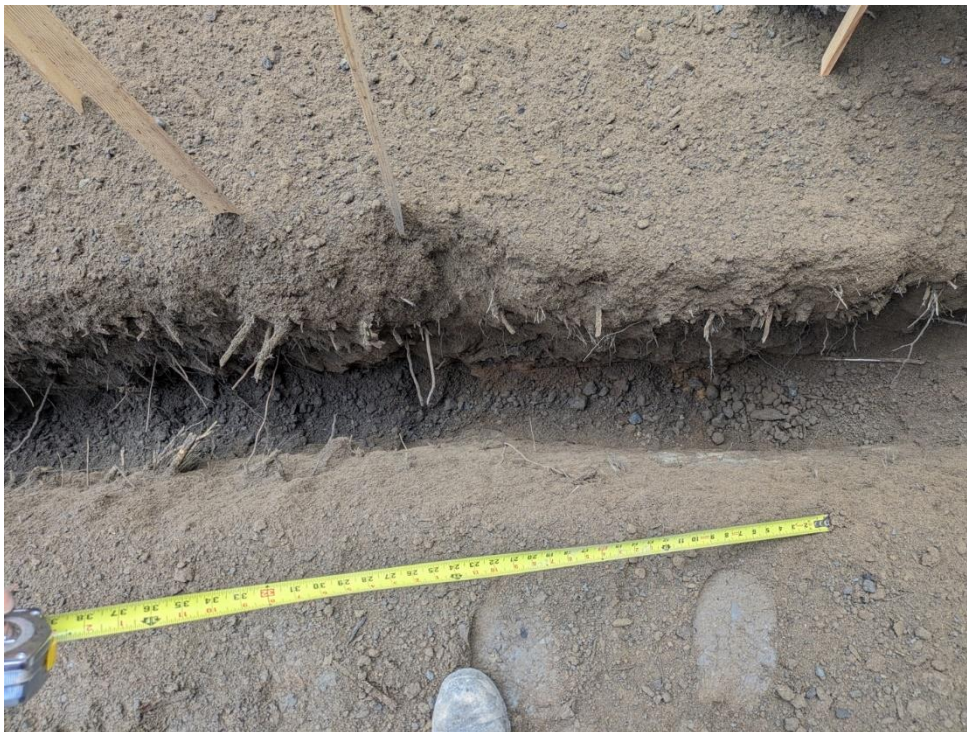
Photo 3. A typical section of trench with small feeder roots are exposed.
