JN 23150

Subject: **Geotechnical and Critical Areas Report**
Proposed Landscape Improvements
8636 North Mercer Way
Mercer Island, Washington

Subject: **Assessment of Recently-Constructed Modular Block Walls**
Cui Residence
8636 North Mercer Way
Mercer Island, Washington

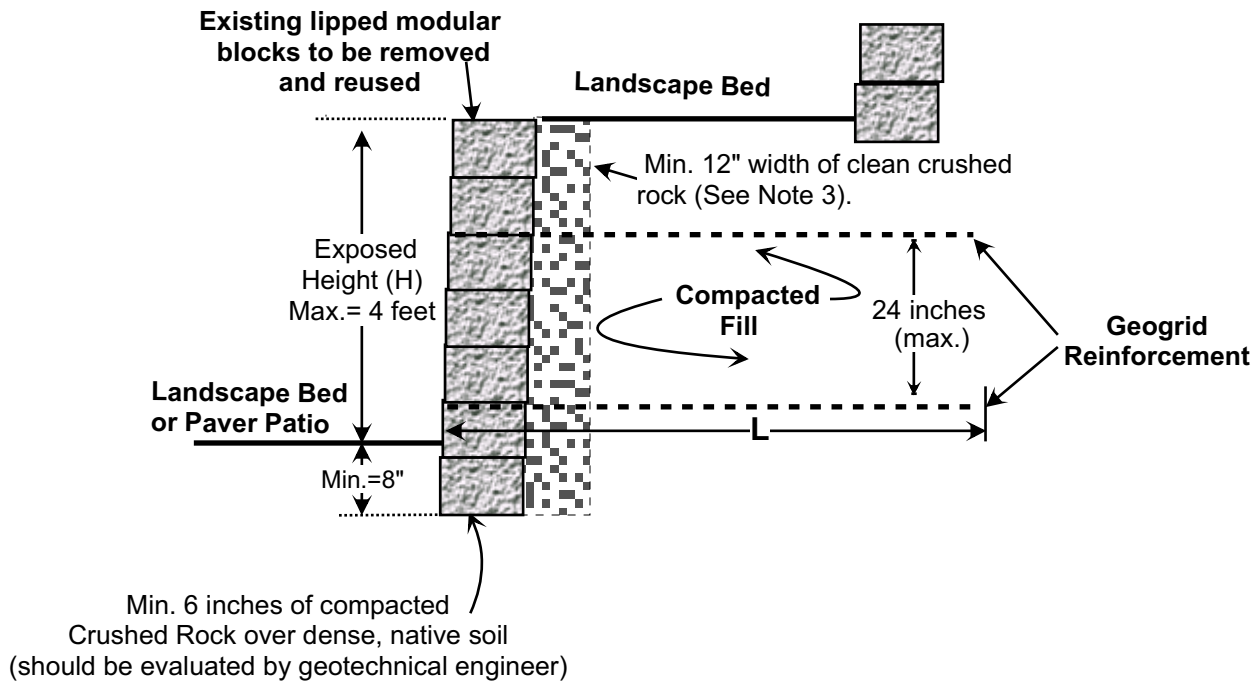
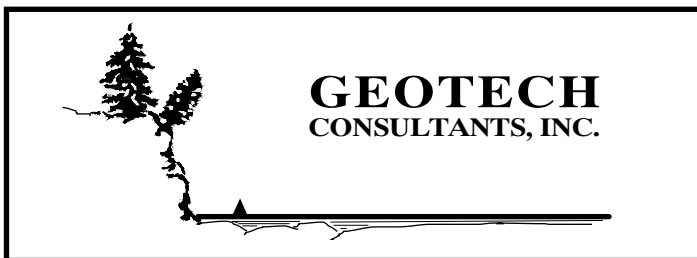
GEOGRID-REINFORCED WALL
 8636 North Mercer Way
 Mercer Island, Washington

1. This design for a typical retaining wall condition, and is not intended to support surcharges, such as those from vehicles or structures.
2. Geogrid reinforcement shall be Stratagrid 150, Miragrid 3XT, or equivalent, with a maximum separation of 24 inches between geogrid layers. Based on a 3- to 4-foot exposed height, geogrid reinforcement shall extend behind the block facing a minimum distance of $L = 6$ feet. This geogrid length accounts for the need to excavate approximately 3 feet below existing grade to reach dense, stable soil suitable for bearing.

3. A minimum of 12 inches of washed crushed rock shall be placed between the facing blocks and the Compacted Fill. If a 4-inch diameter perforated drain pipe is buried at the wall base, the perforated drain should connect to a suitable discharge point.

4. Compacted fill shall be free-draining, imported, coarse-grained granular soil, such as Seattle Type 17. A sample of which shall be submitted to the Geotechnical Engineer for approval prior to its use. The on-site soil is unacceptable for use as Compacted Fill in the geogrid-reinforced zone. The fill shall be compacted in a maximum of 10-inch lifts using a jumping jack..

Attached to this letter is a typical detail for the lower and middle reinforced walls. The short, upper wall does not require geogrid reinforcement.
