**ARBORIST REPORT**  
For:  
**WEAVER CONSTRUCTION CO.**  
**TODA Project**  
**2262 78<sup>th</sup> Ave. SE. Mercer Island, WA**

November 26<sup>th</sup>, 2024  
**UPDATED May 20, 2025**

Dates of Field Examination: November 19<sup>th</sup>, 2024 & May 9<sup>th</sup>, 2025

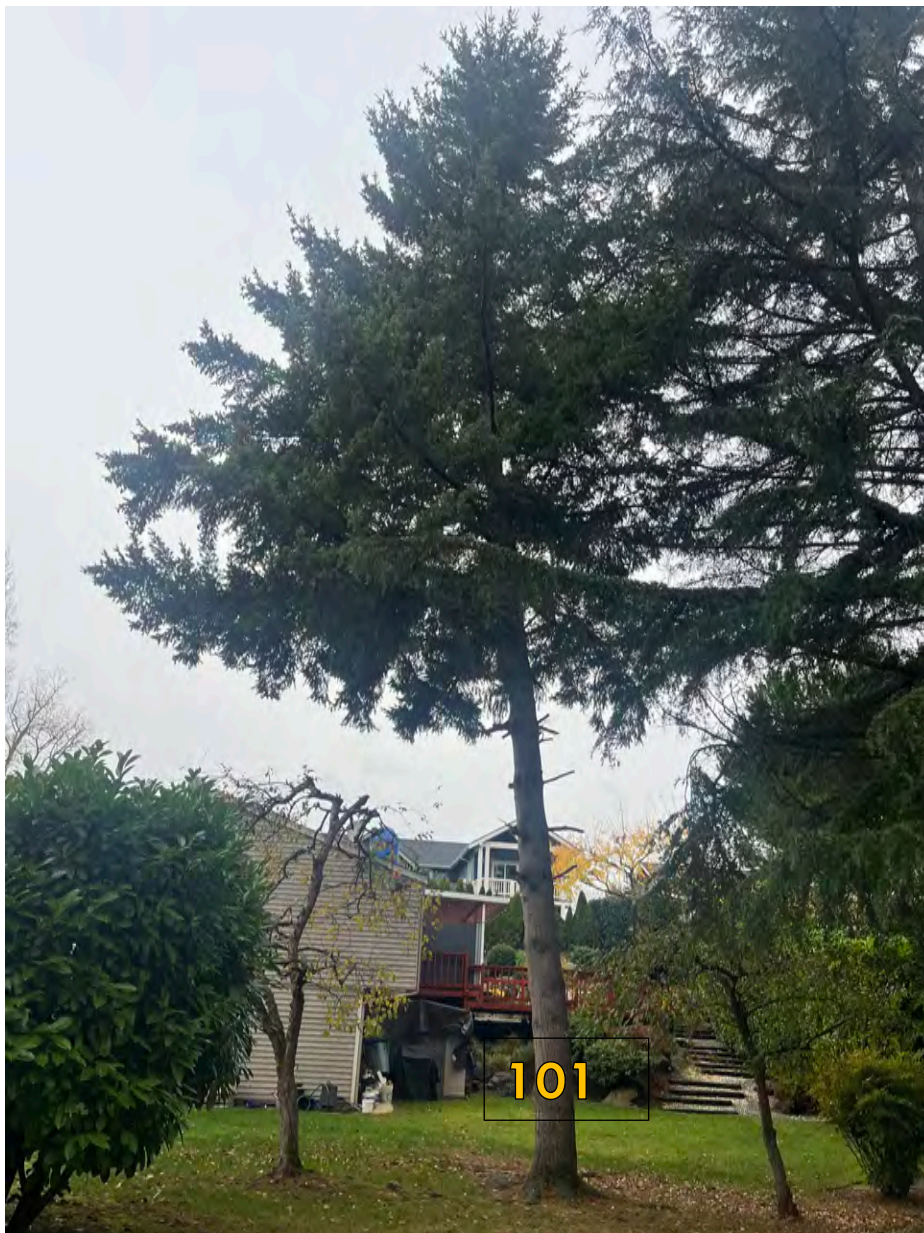
**Tree #101** is a Douglas-fir (*Pseudotsuga menziesii*) with a DBH of 21 inches and an average canopy radius of 17.5 feet. Its health and structural condition are good, and it is deemed viable. This tree was limbed up to 27 feet. Its lower trunk has a slight phototropic lean to the west which is corrected in the upper crown. Its canopy is full and shows good vigor. The corner of the proposed addition to the existing house is eight feet inside of its dripline.

PHOTO 1: Tree 101 viewed from the east. Note removed lower branches

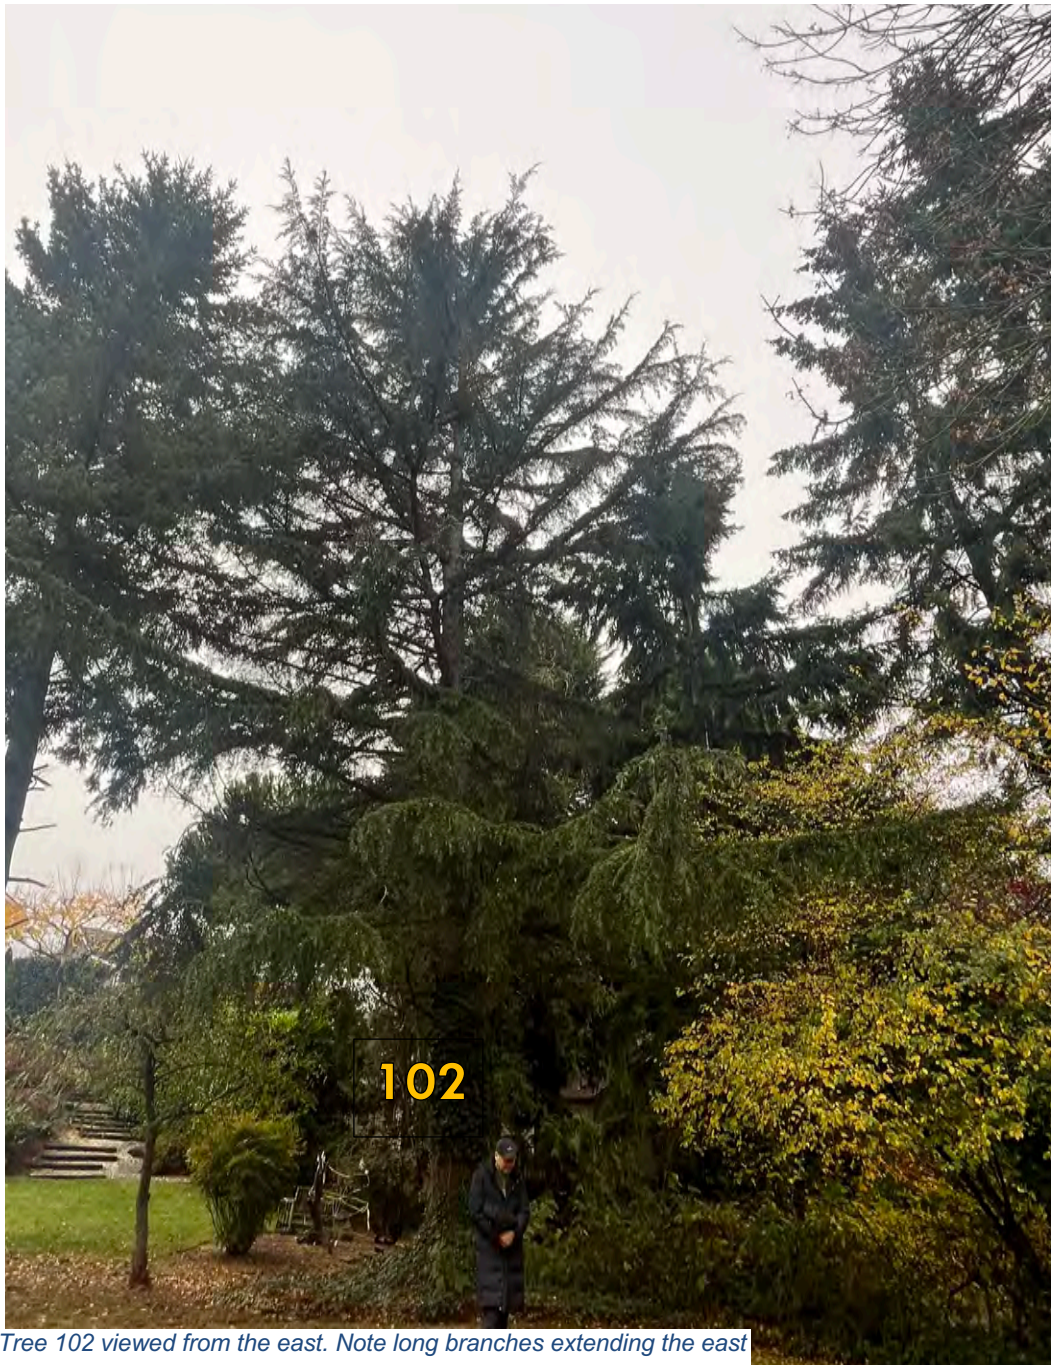
**Tree #102** is a Deodar cedar (*Cedrus deodara*) with a DBH of 31 inches and an average canopy radius of 22 feet. Its health and structural condition are good, and it is deemed viable. This tree is located within a critical area buffer. English ivy that was covering its lower trunk has been removed. Long over-extended branches are reaching 26 feet to the east. The canopy has been raised with stubbed branches remaining. When Tree #109 fell, it snapped several lower branches of this tree.

*PHOTO 2: Tree 102 viewed from the east. Note long branches extending the east over the lawn.*

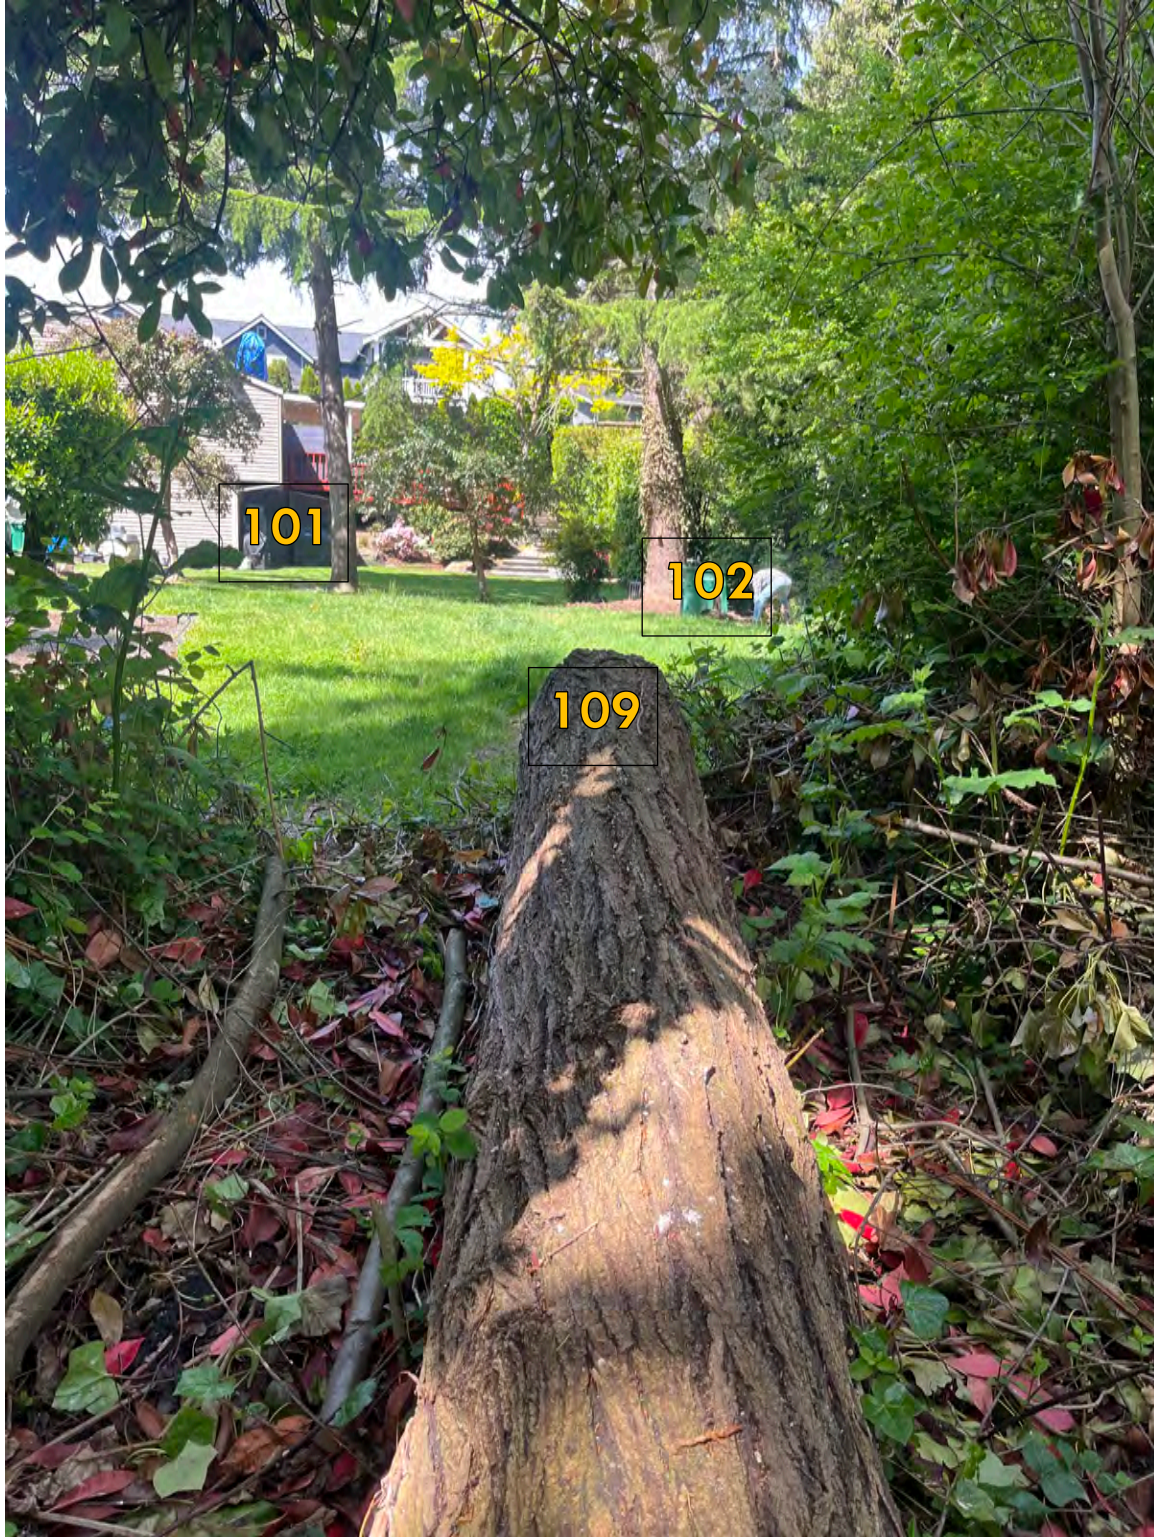
PHOTO 3: Tree #109 viewed on the ground in the orientation it fell post cleanup.

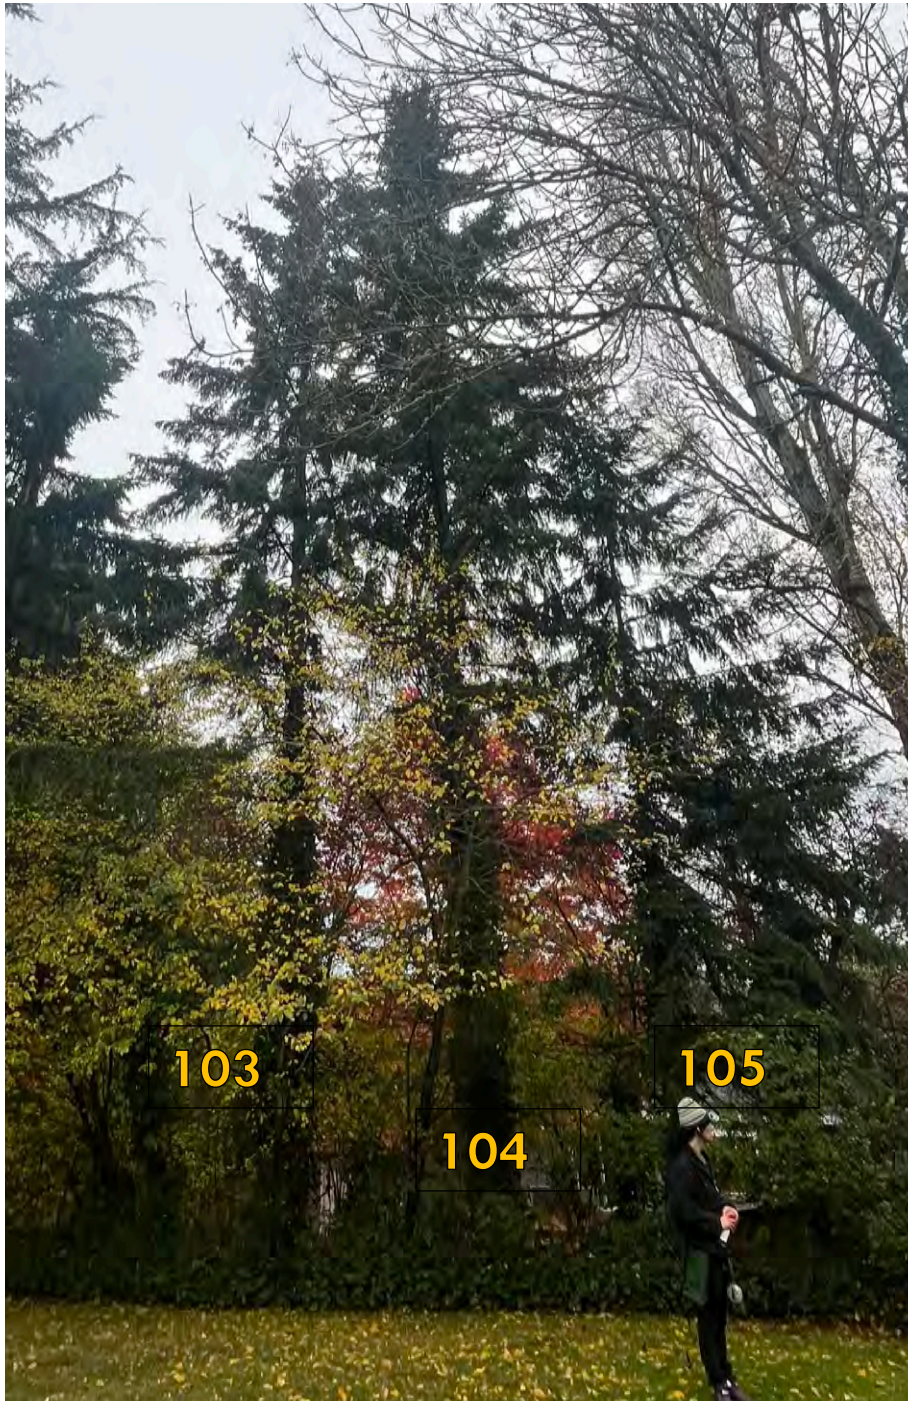
**Trees #103, 104, and 105** are Douglas-fir with DBH of 15, 16, and 17 inches and an average canopy radius of 14.5 feet. Each are viable with good health and structural condition. These trees are growing at the top of a slope and within a critical area buffer with ivy climbing into their lower canopies.

*PHOTO 4: Trees #103,104,105 viewed from the south*

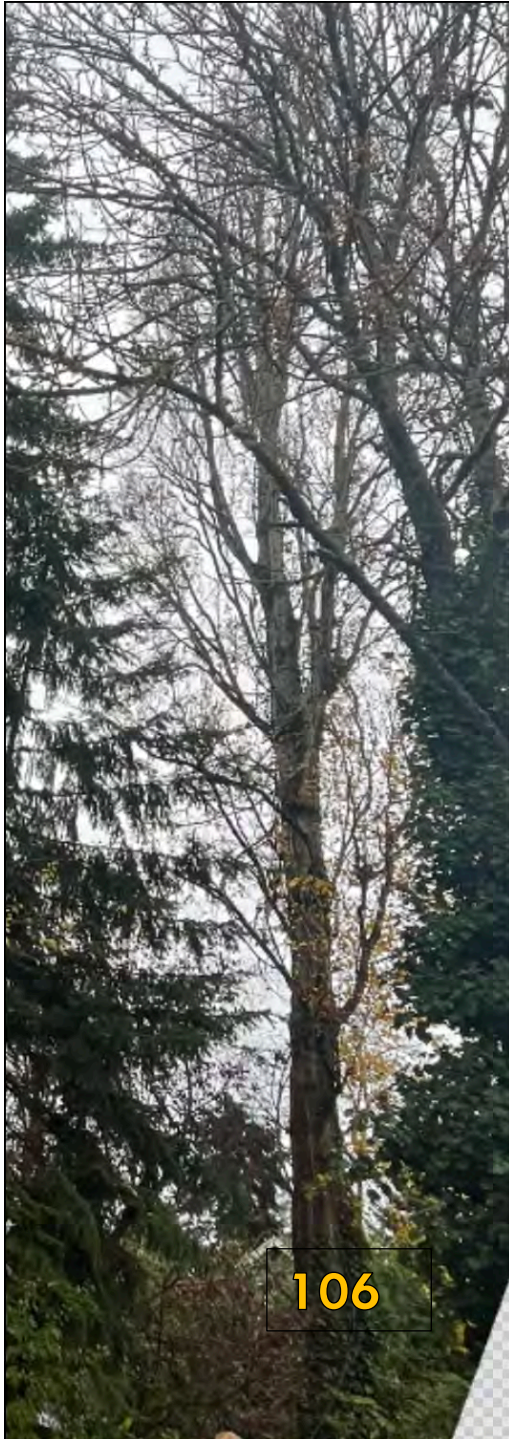
**Tree #106** is a Black cottonwood (*Populus trichocarpa*) with a DBH of 33 inches and an average canopy radius of 13.5 feet. Its health and structural condition are fair, and it is deemed viable. This tree is outside of the critical area buffer. It has a slight lean to the southwest, and English ivy on the trunk. Some dead branches were observed in its canopy.

*PHOTO 5: Tree #106 viewed from the southwest.*

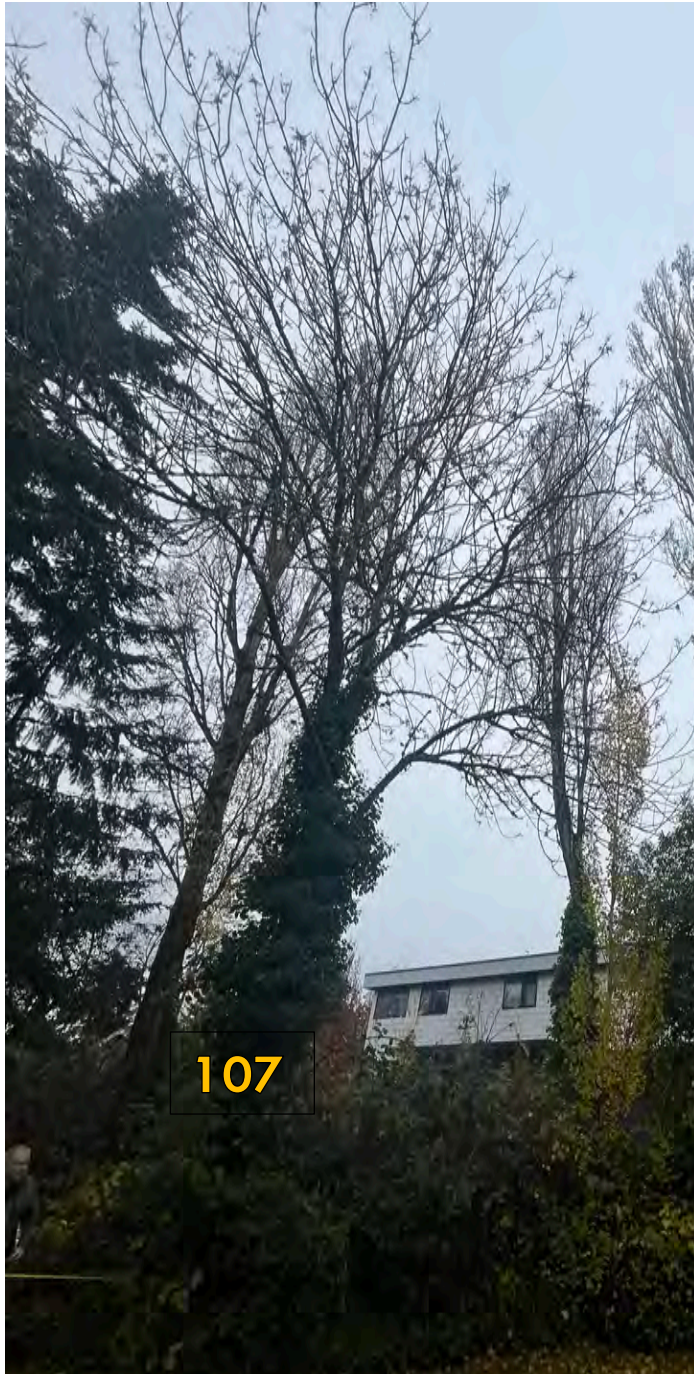
**Tree #107** is an Empress tree (*Paulownia tomentosa*) with a DBH of 13 inches and an average canopy radius of 19.5 feet. This viable tree is outside of the critical area buffer and its health and structural condition are fair. Its canopy is off-balance to the southwest, and ivy is climbing its trunk into lower canopy. The site plan shows this tree will need to be removed as it is within the clearing limits north of the proposed addition.

*PHOTO 6: Tree #107 viewed from the southwest. Note dense ivy on its lower trunk.*

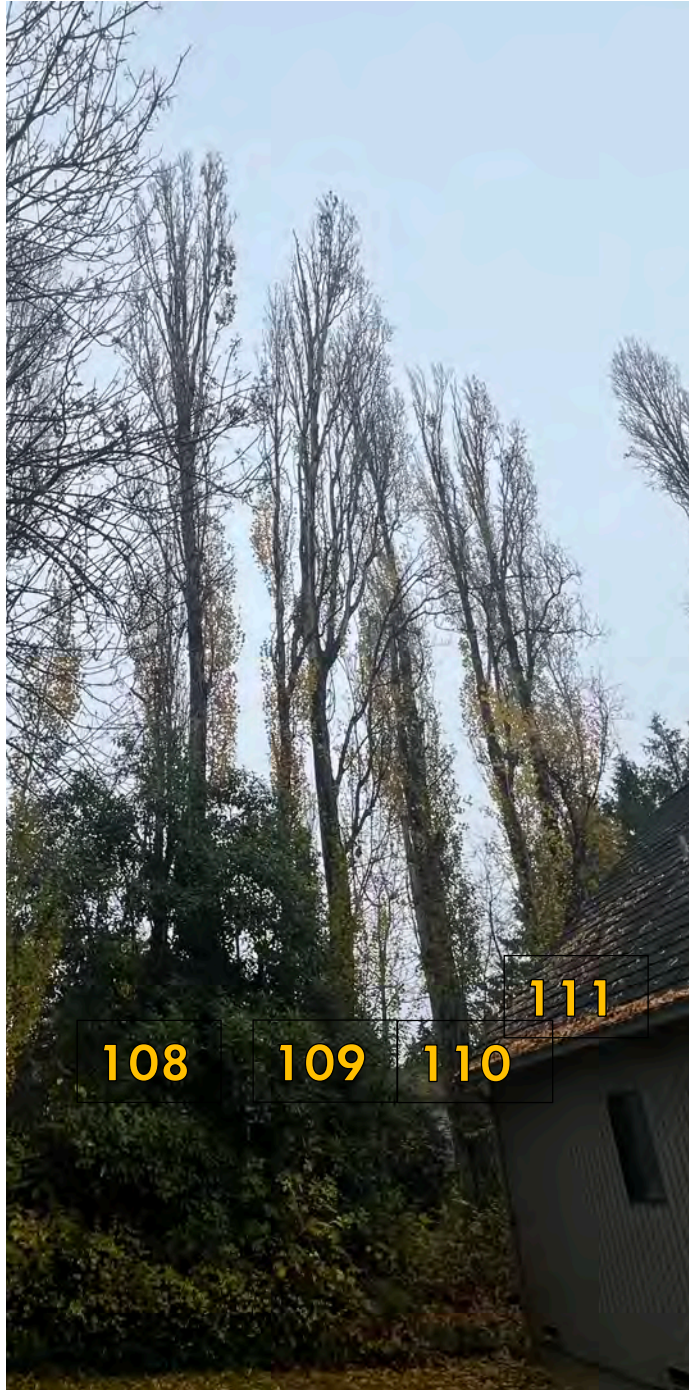
Trees #108-111 comprise a row of Lombardy poplar (*Populus nigra 'Italica'*) with DBH measurements of 12-23 inches. These have narrow crowns typical of the species with an average canopy radius of 10 feet. Their health and structural condition are poor. Many dead branches are collected in their crowns, and large roots extend to the east into an open drainage ditch. Several trees of the same species are growing on the adjacent property to the east.

PHOTO 7: Trees #108-111 viewed from the west in November 2024. Tree #109 has since fallen.

Trees #108, 110, 111, and 114 are in a state of decline. Flowing water in the drainage ditch to the east was observed undermining their root systems. These trees are not included in the tree retention calculation as they are in poor condition and unlikely to contribute to the site in the long term. Removal, or pollarding these four trees to retain as wildlife habitat snags is recommended.

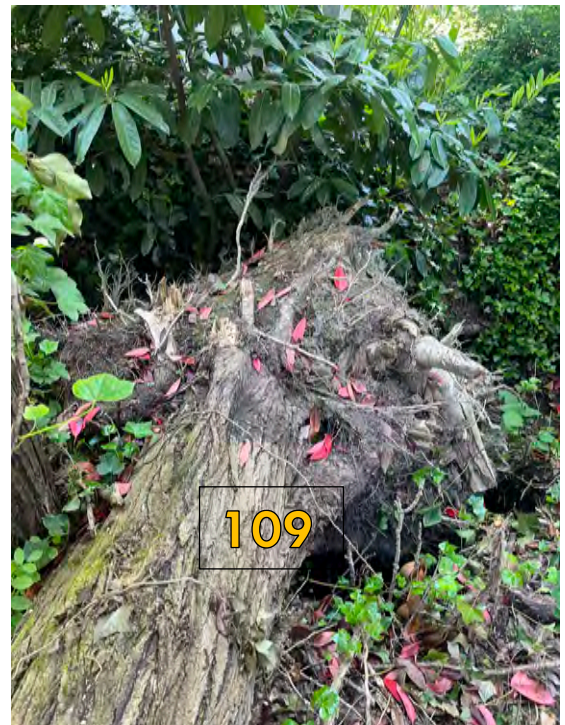
PHOTO 8: Fallen Tree #109 in May 2025. Note small root plate.

Tree #109 was uprooted in a severe windstorm in November 2024. When it fell, it damaged the grade along the drainage ditch and exposed more of the root systems of adjacent trees #108 and 110 to the flowing water. This is likely to further degrade their health and structural stability. These overmature trees are now functionally non-viable.

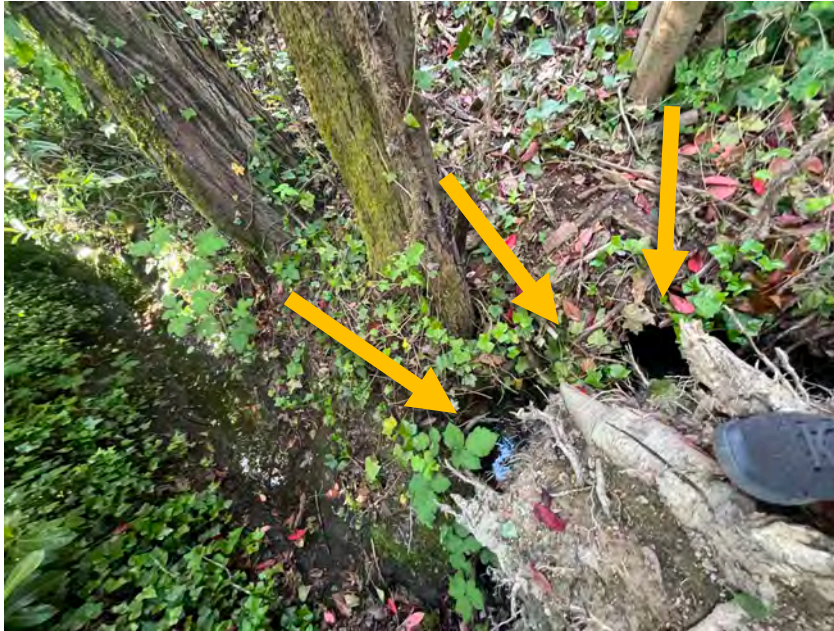
*PHOTO 9: Fallen Tree #109 in May 2025. Note flowing water undermining adjacent trees.*

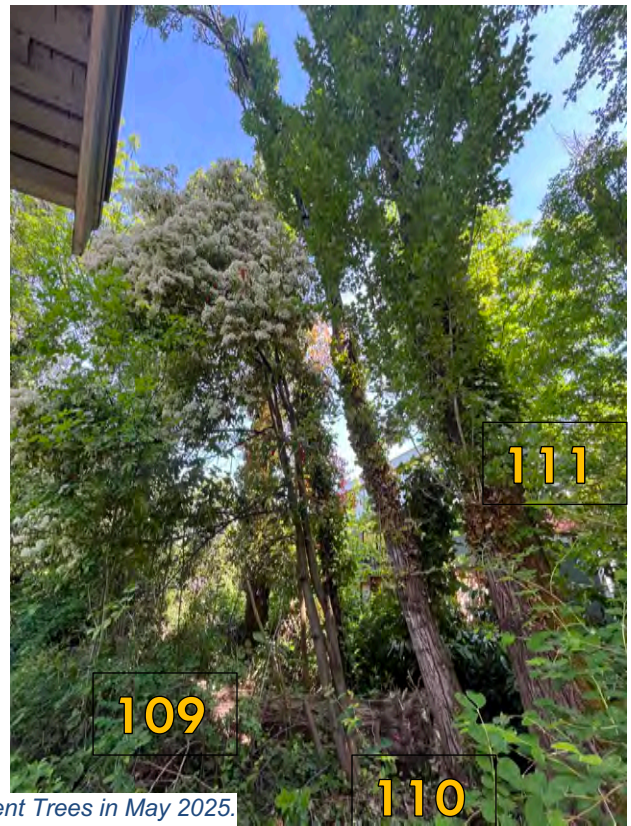
*PHOTO 10: Fallen Tree #109 and adjacent Trees in May 2025.*

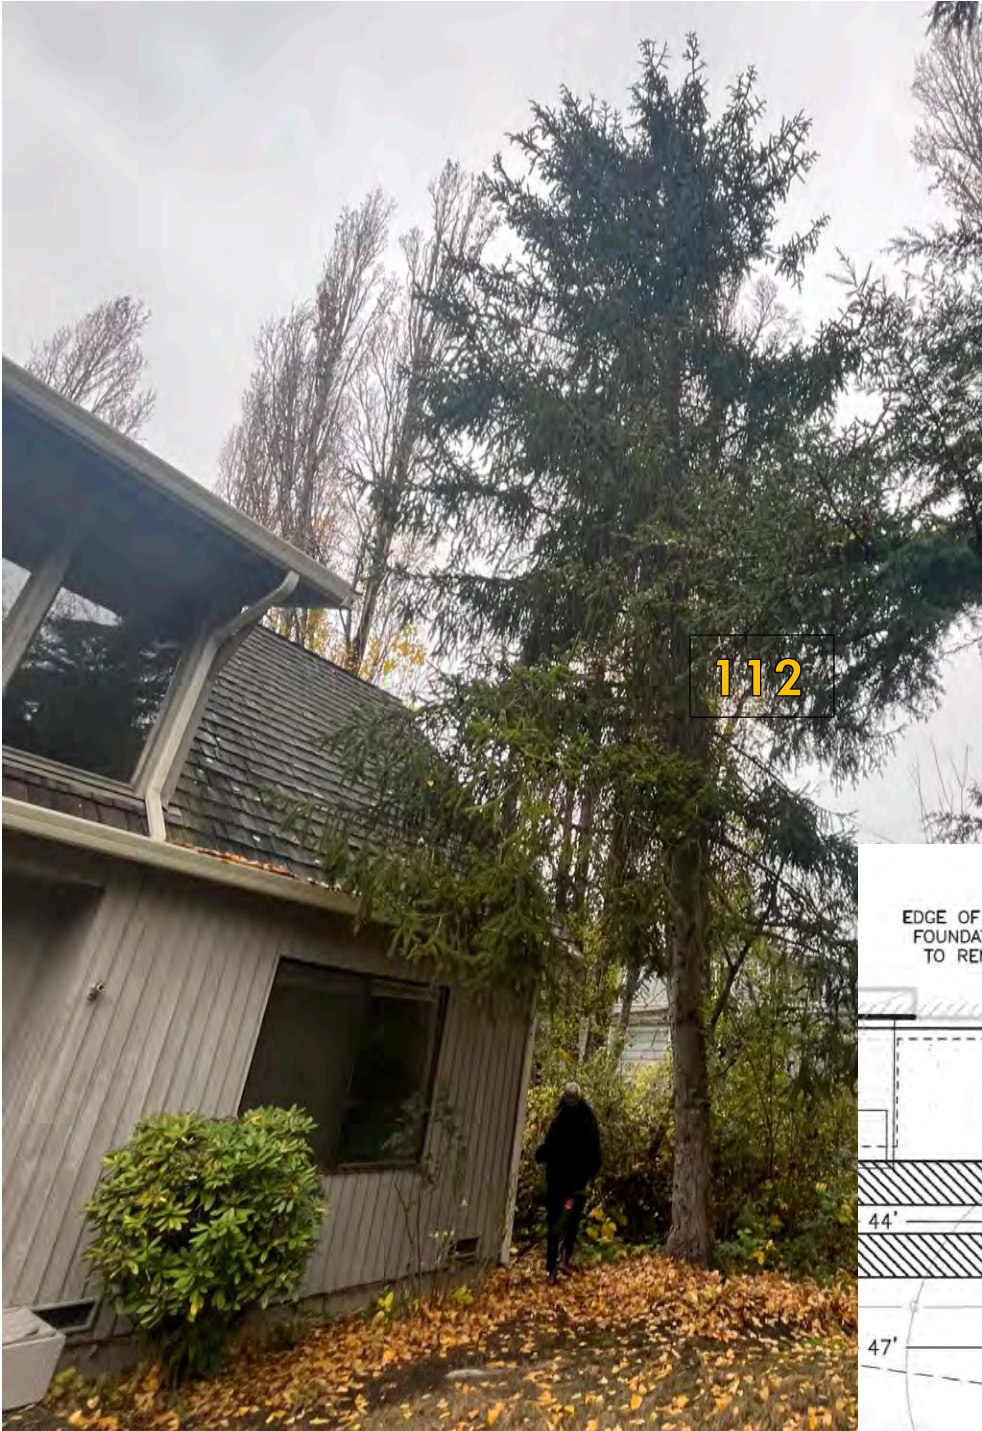
**Tree #112** is a Norway spruce (*Picea abies*) with a DBH of 13 inches. It has an average canopy radius of 14 feet and is in good health and structural condition. This tree is in the front yard and overhangs the southeast corner of the existing house. The drainage and grading plan shows a trench is to be excavated three feet south of its trunk for installation of a detention pipe. Large structural roots are likely to be severed in this area which would destabilize this tree.

PHOTO 11: Tree #112 viewed from the west. Note its proximity to the existing home.

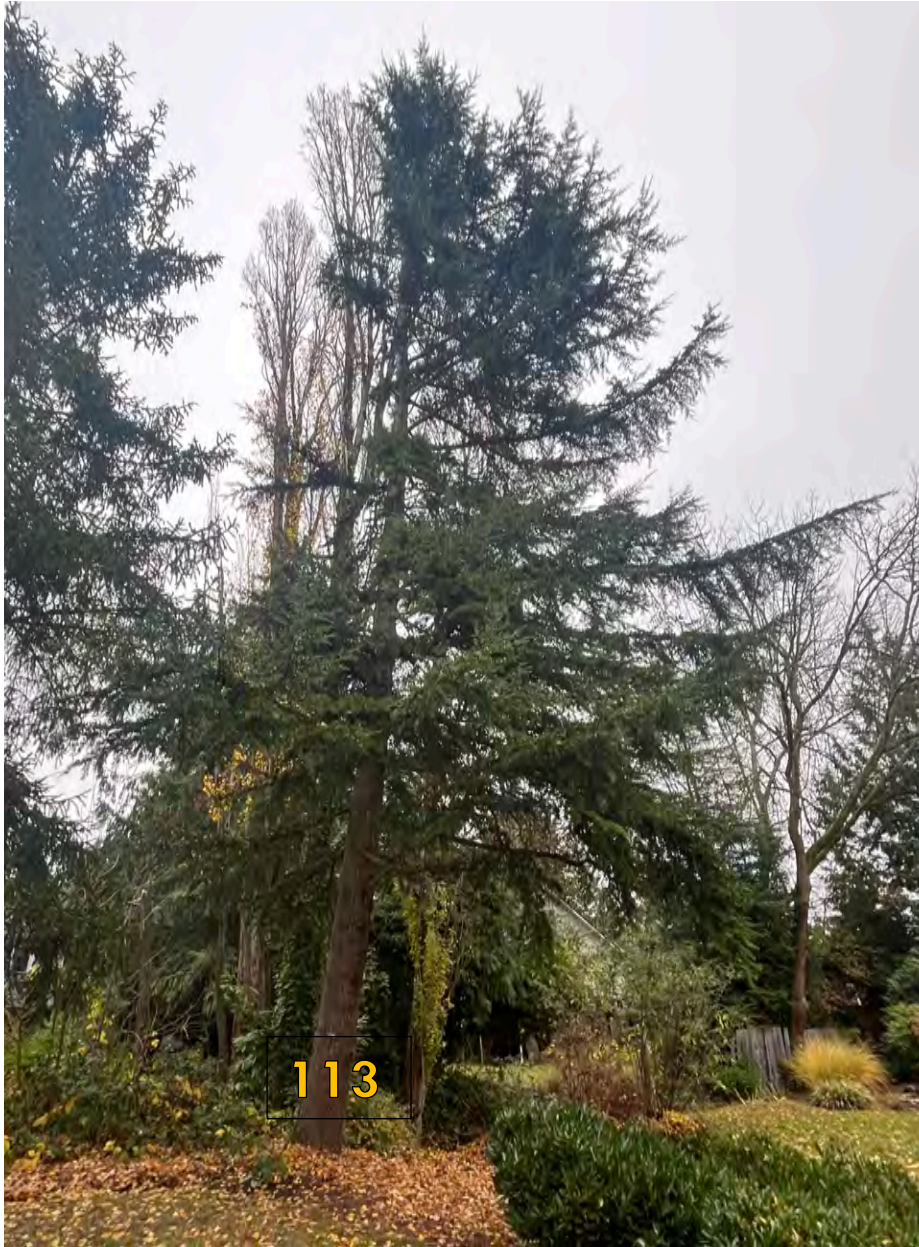
**Tree #113** is a deodar cedar (*Cedrus deodara*) with a DBH of 21 inches and an average canopy radius of 14.25 feet. Its health and structural condition are good, and it is deemed viable. This tree leans to the south with an off-balance canopy in the direction of the lean. The drainage and grading plan shows a trench is to be excavated five feet north of its trunk for installation of a detention pipe. Large structural roots are likely to be severed in this area which would destabilize this tree.

*PHOTO 11: Tree #113 viewed from the west. Note lean and off-balance canopy.*

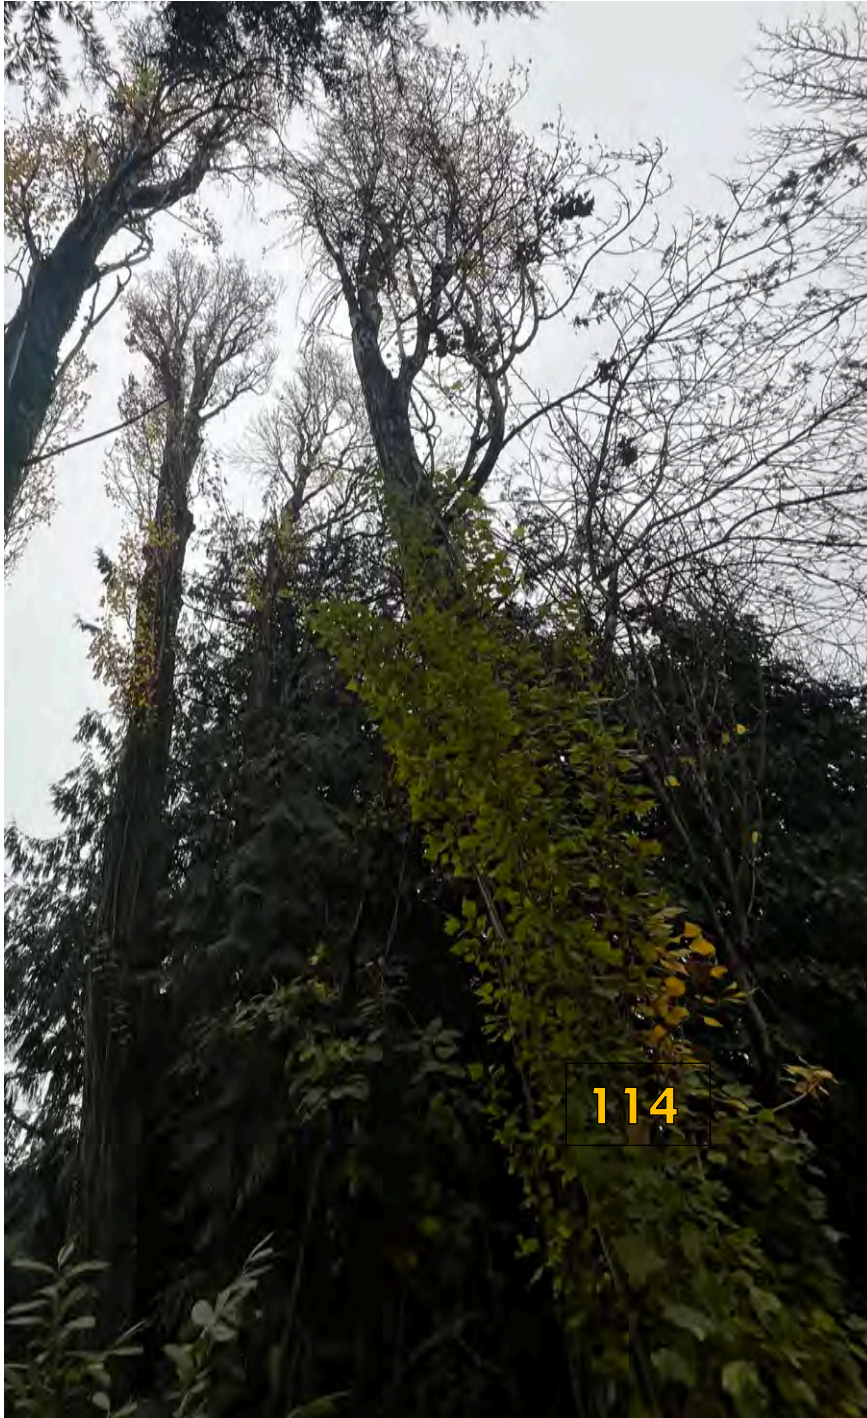
**Tree #114** is an overmature black cottonwood with a DBH of 21 inches, and an average canopy radius of nine feet. Its health and structural condition are poor. Ivy is climbing its trunk and its canopy is off-balance to the south.

*PHOTO 3: Tree 114 located near the southeast property corner. Note off-balance canopy.*
