June 28, 2025

**Project:** Pre-construction assessment for lot re-development at 4115 78<sup>th</sup> Avenue SE, Mercer Island, WA. Parcel number 3623500210.

**Objectives:** Evaluate health of existing trees and establish criteria for the preservation of those to be retained.

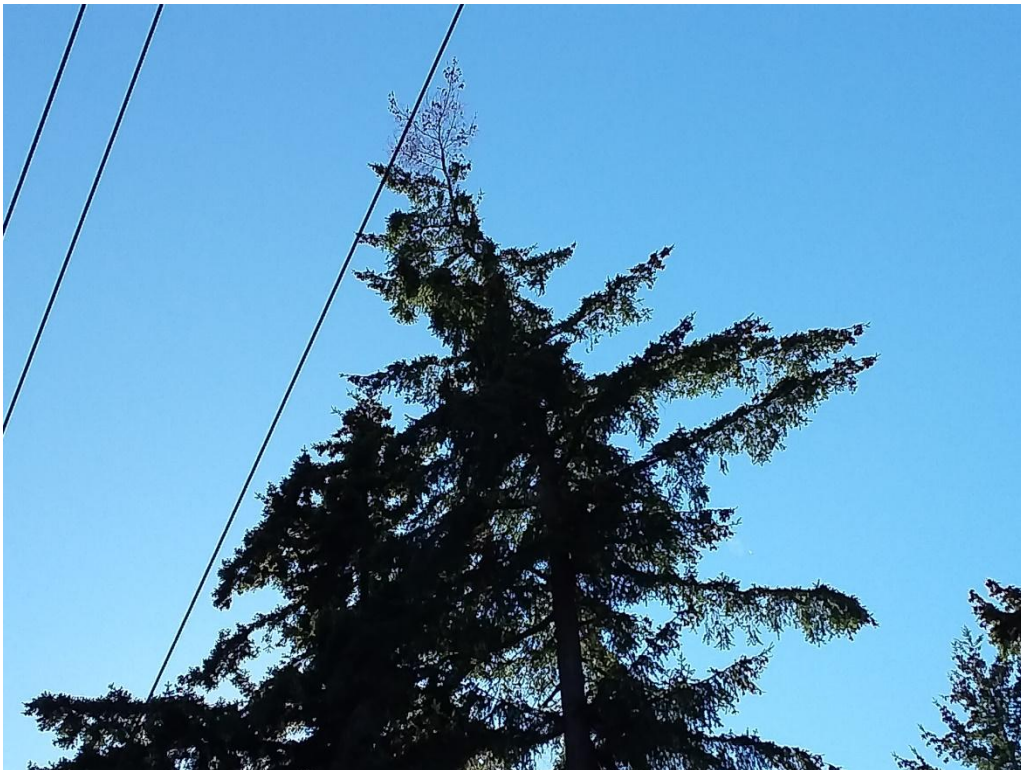
1. Douglas fir (*Pseudotsuga menziesii*) 27.5" DSH, 80' tall standing 34' WSW of the north corner marker and 10' E of the SE corner of the 4105 house's foundation. It is either on or just north of the property line. The top of the tree has been damaged, likely in the 2006 storm, and bends over to the northeast. It began showing signs of discoloration and thinning in 2022 and currently exhibits 12' of dieback (Figure 4). There are a handful of large dead branches hanging in the tree. The overall canopy has limited to no new growth and poor color. Heavy cone load present.

Figure 4. Looking up and SW at the top of the #1 fir.

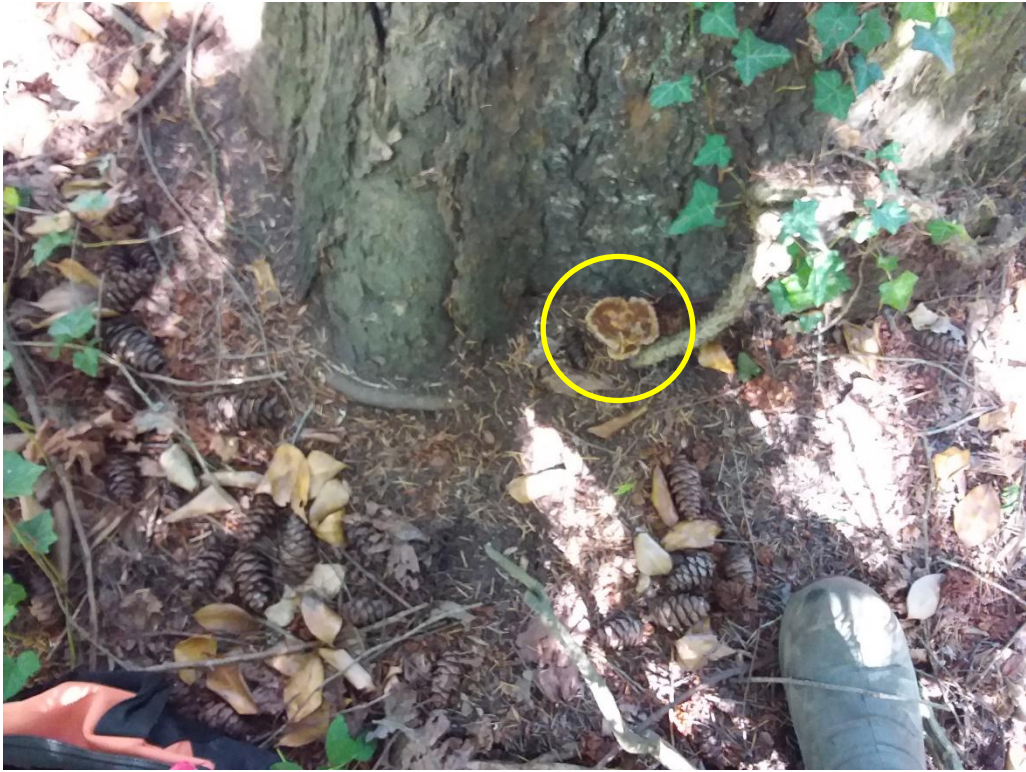
2. Douglas fir 26.5" DSH, was damaged near the 55' mark, reaches 65-70' tall on multiple, malformed spars. Three of the spars go horizontal and carry excess weight at their ends. Heavy cone load, exhibits average new growth and color. It stands 26' ENE of the west corner marker post, about 5' above the line, and 10' SSW of the SW corner of the foundation of the 4105 house. It shows a marked lean to the NE from its base and returns to vertical above the 18' level. Base of the stem is non symmetrical, nearly square to the east and west. There are cracks visible on the north and south faces, almost directly across from each other, indicative of a beam fracture, with fresh pitch seeping and fairly fresh reaction wood visible. There is fungal fruiting body on the south side of the tree's base that is likely *Heterobasidion annosum* (Figure 5).

Figure 5. The fungal fruiting body at the base of the #2 tree.

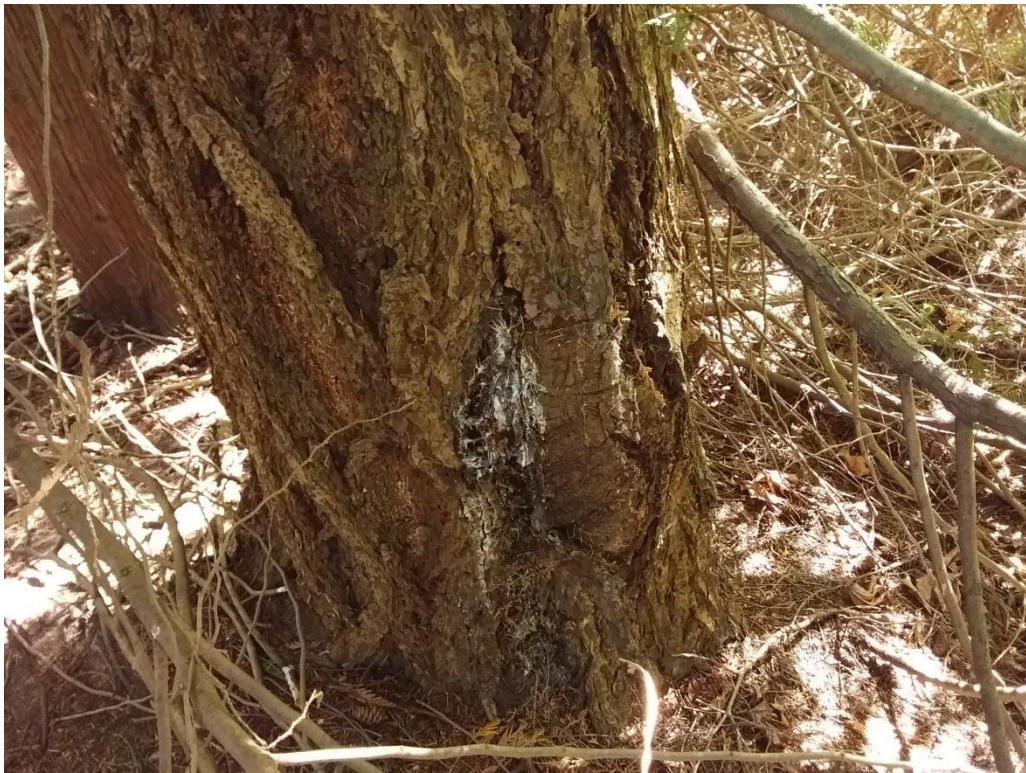
3. Douglas fir 26.5" DSH, 75' tall with average new growth and color. Stands 13' SSW of the #2 fir. Tree has a large canker in the west quadrant of its base that is 24" tall, 12" across, with bleeding present around its north edge (Figure 6). Couple of smaller ones are visible on the south face of the trunk in the 16-18' range and then three larger ones between 25' and 30' are present on its NW face.

Figure 6. Canker at base of #3 tree.

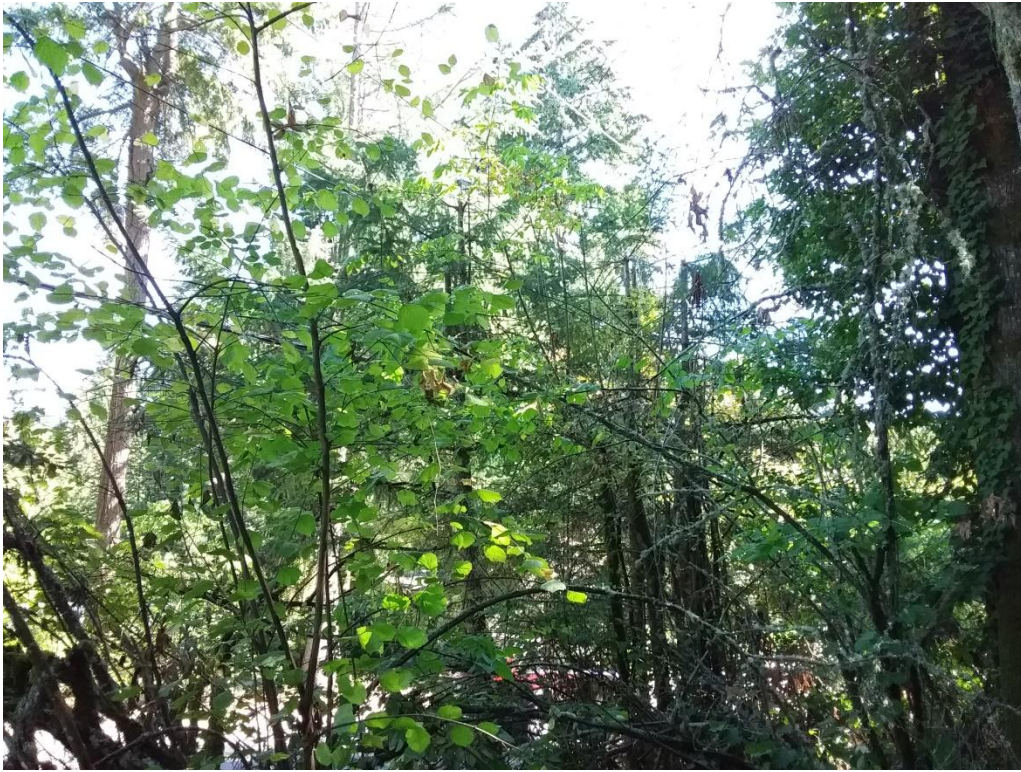
There's a clump of trees east of the #6 and #7 maples that are standing beneath the power lines and have been topped multiple times. They are fully in the ROW. Most are maples but there are three or four Douglas firs (Figure 7). They range from 4-8" DSH.

Figure 7. Looking SE at the line of scrub trees beneath the wires.

The most reasonable construction entry point is off of 78<sup>th</sup>. It would make sense to remove the existing scrub trees beneath the wires, both from the standpoint of their being poor species choices to be beneath the wires in the first place and from their structures being compromised by having been repeatedly topped. Post construction a number of more suitable trees can be established to take their places.

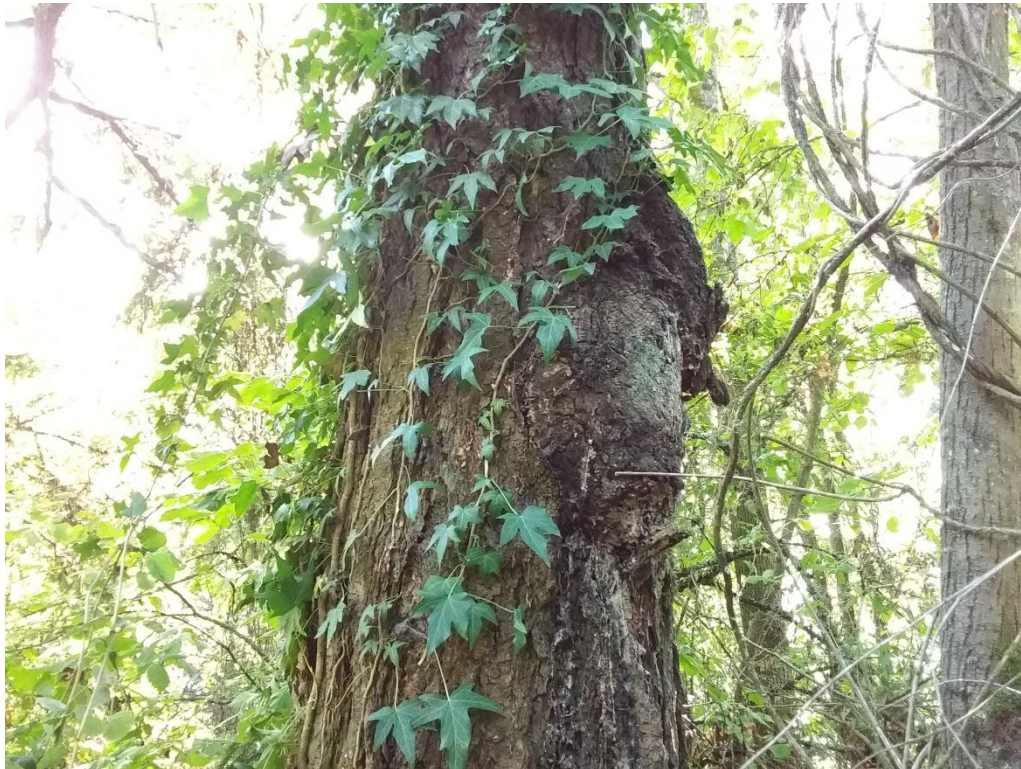
18. Douglas fir 22" DSH, close to 85' tall standing 5' S of #17. Tree has a large canker on its north face at the 8' level that is 28" tall, 12" wide with decay likely present based on the canker's age and formation (Figure 8). Bleeding associated with it coming down the trunk on the north face. There are large cankers along the trunk from the 1/3 to the halfway point. Tree has a structural fault near the 55' mark and several large spars in the 10" caliper range are coming off south at this point and stretch out as far as 28' ft. Above the fault the tree is still vertical and appears to be in fair health. Majority of its canopy is above the halfway point.

Figure 8. Large canker low on the column of the #18 tree.

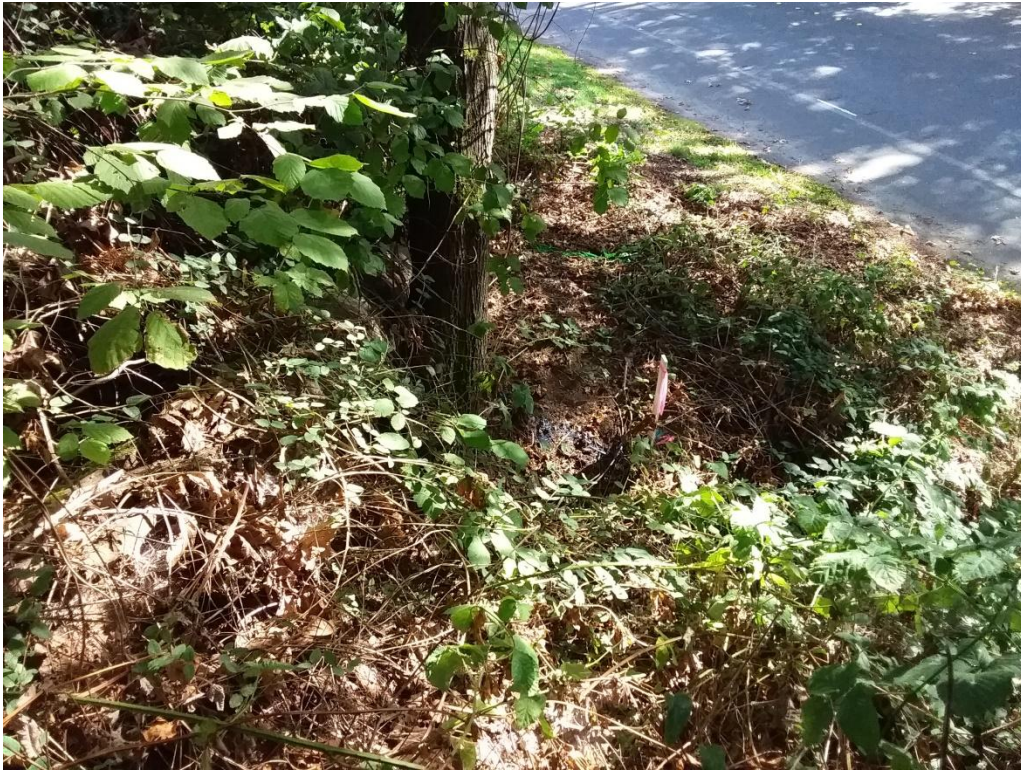
20. Big Leaf Maple 16.5" DSH, 45' tall, spreads west and reaches over the bike lane roughly 20' off its base and no more than 12-14' in the other directions. Tree separates into four main stems at the 10' mark. The stems are fairly separate from each other but their scaffolds are overextended, and conflict, as they reach into the west and southwest for light. Base of this tree is at the bottom of the slope nearly level with West Mercer and 6.5' nearly due east of the south corner marker (Figure 9).

The #20 tree (16.5" DSH) is offsite, in the right-of-way, and more than 30' from the closest construction impact.

Figure 9. Looking down and to the south showing the placement of the #20 tree.

In general, the #20 tree requires weight reduction pruning at the extremities to prevent limb breakage. The #21 tree requires pruning to remove the broken and dead branches and to reduce weight on the laterals to prevent their failure(s). And while the large #22 maple is in the ROW a serious discussion should be had with Mercer Island as to whether the tree should be retained based on its condition and placement. It does lock down the top of the embankment but if it continues to decline at its current rate the tree is going to come apart and land in West Mercer. There really are no good places to prune the tree back to in order to reboot its structure.

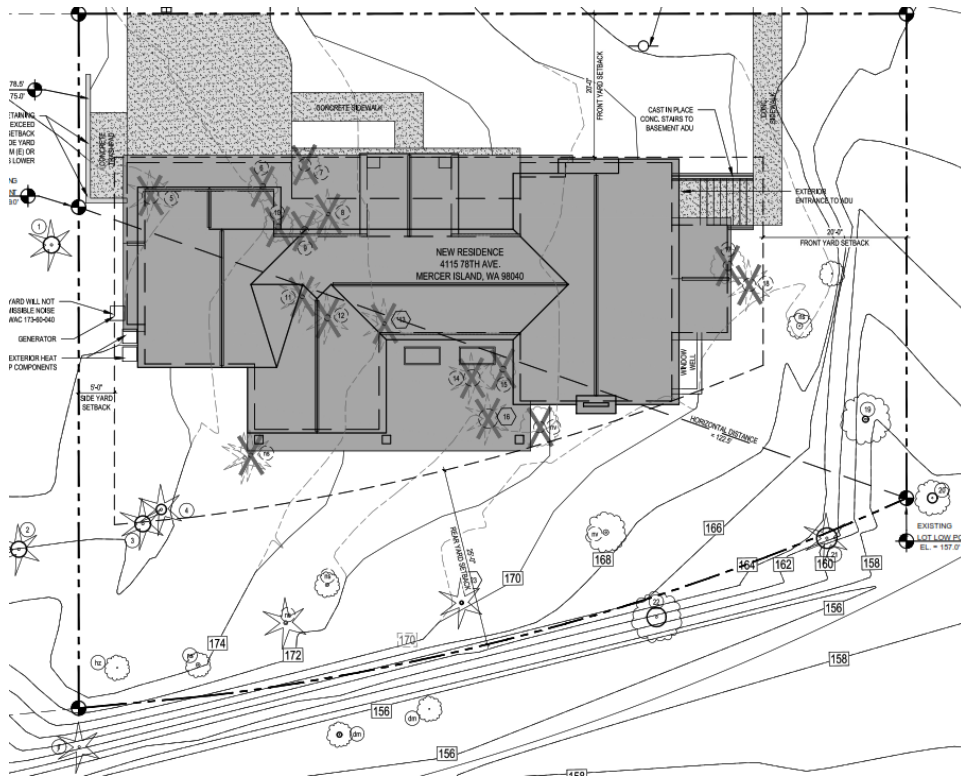
Figure 11. Excerpt from the site plan showing the layout of the proposed home.

The #4 cedar (17" DSH) will be the nearest tree to any potential impact. The site plan excerpt in Figure 11 shows that the excavation for the back right corner of the covered patio area will come no closer than 13' to the base of the cedar.

Using the #4 cedar as the example, with the proposed new rear patio 13' from the tree's base and it having a 17" DSH, if the cut for the patio ran all the way across the cedar's rooting space it would result in impact at a linear distance equal to 76% of the tree's CRZ (13'/17'). The chart shows that this could equate to a 22% loss of the cedar's Critical Root Area. However, because the cut will make a right angle turn away from the tree 12' short of its center line the actual loss of rooting space will likely be less than half that volume or around 10% CRA. The cedar should be fine long term.
