Arborist Report

To: RKK Construction c/o Logan Galyan, Sturman Architects
Site: 2434 73rd Ave SE, Mercer Island, WA 98040
Re: Tree Inventory and Assessment
Date: October 7, 2025
Project Arborist: Julian Garcia
ISA Certified Arborist PN-9969A
ISA Qualified Tree Risk Assessor
Reviewed By: Haley Sonerholm
ISA Board Certified Master Arborist PN-7512BM
ISA Qualified Tree Risk Assessor
Referenced Documents: Site Plan A1.1 (Sturman Architects, August, 27, 2025)
Attached: Table of Trees
Tree Site Map

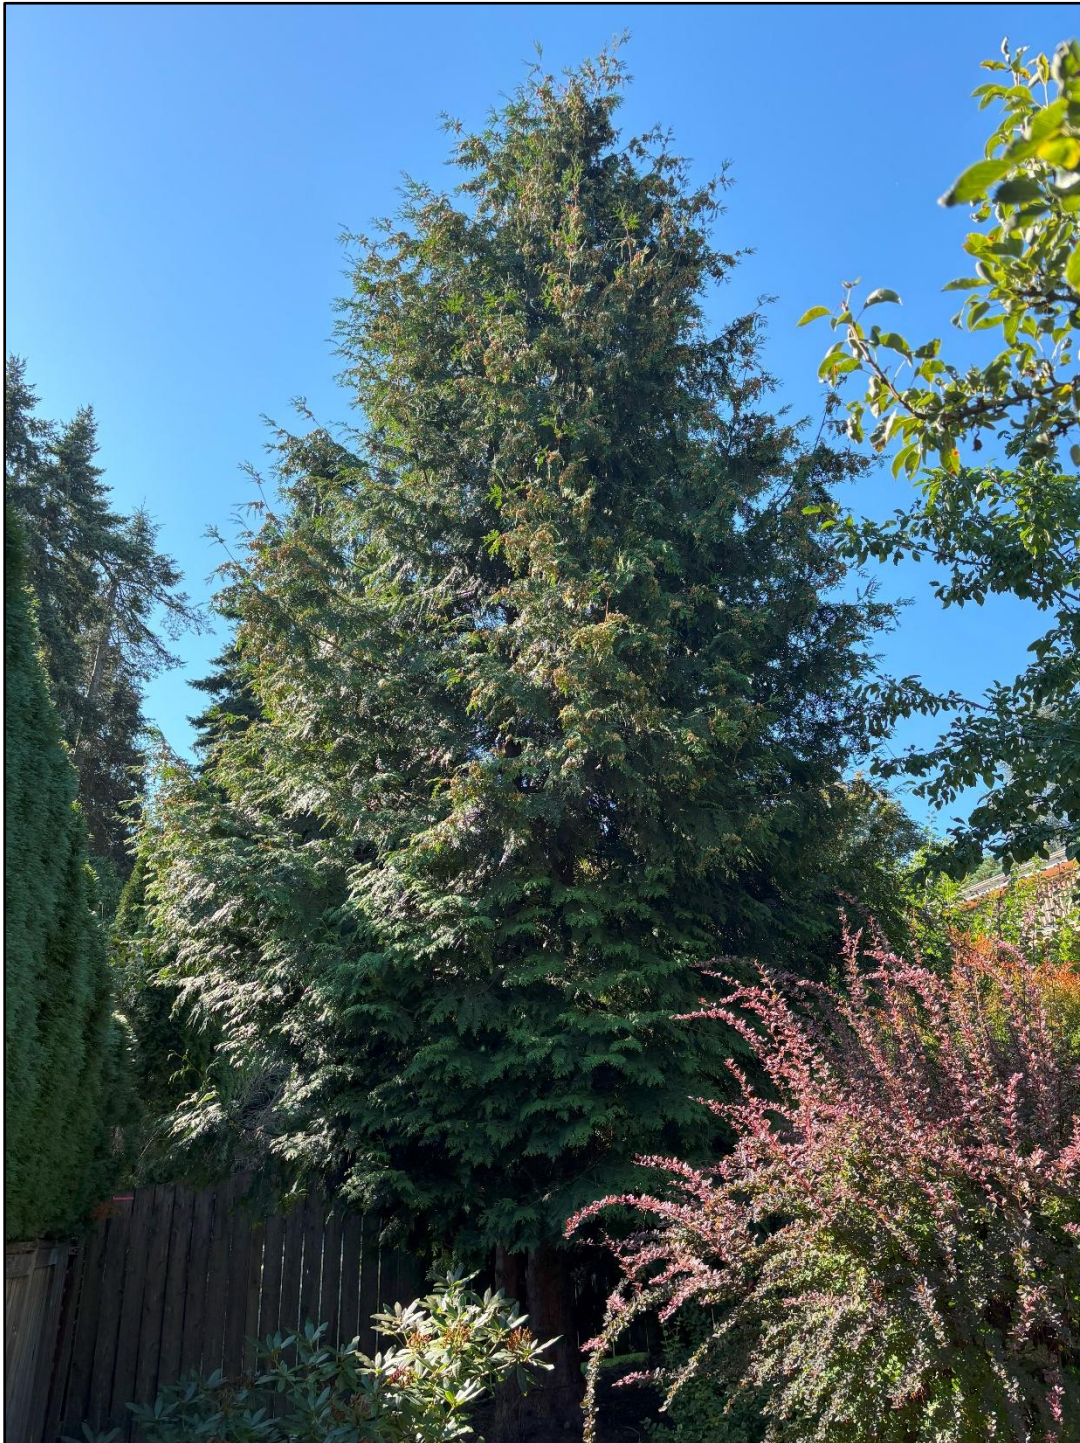
Tree 679 is proposed for removal because the provided site plans show a storm drain line running 0.5 feet northeast of its trunk (see **Photo 1**). The trenching and installation of this utility line would sever a large portion of the root system negatively impacting tree health and stability.

Photo 1. Tree 679, viewed from the north, is proposed for removal due to a proposed storm drain line running within one foot of its trunk.

For this project a total of two replacement trees will be required to replace the one large tree (tree 679) proposed for removal.

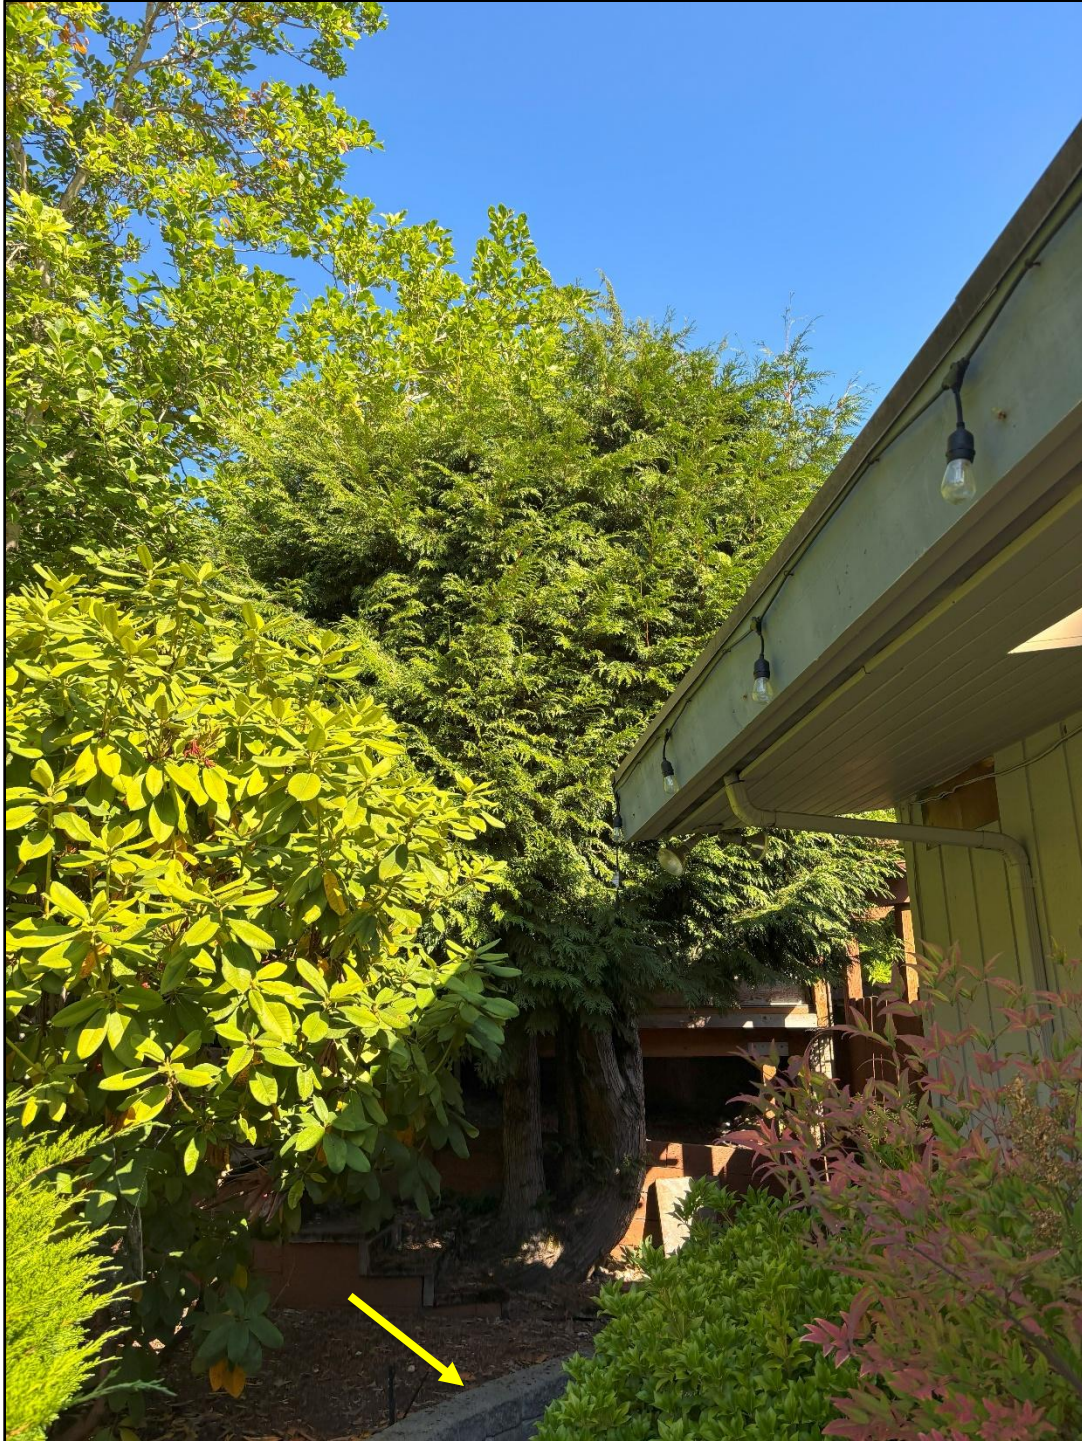
Photo 2. Tree 680, viewed from the south, is growing near the northern property line. The landscaping wall, indicated by the arrow, is proposed to be removed and replaced with two new walls. I recommend tree protection measures in order to retain this on-site tree.

According to provided site plans, and in correspondence with the client, the existing landscaping wall approximately four feet south of tree 680 will be removed and replaced with two new walls (see **Photo 2**). I recommend removing the concrete blocks of the existing wall by hand to avoid damaging any roots growing near or against the wall. Depending on the design of the new walls, they should be installed by hand digging or alternative excavation techniques to best protect existing roots. Any fill that is used to gently slope the grade to the east should be native soil from the site and six inches of space should be left around the base of the tree.

Further, I recommend placing tree protection fencing at the RLOD, applying six inches of wood chip mulch, and installing temporary irrigation to minimize negative construction impacts to tree 680. In general, this species has a good tolerance to construction activity and therefore I believe it can be successfully retained if these tree protection measures are followed.

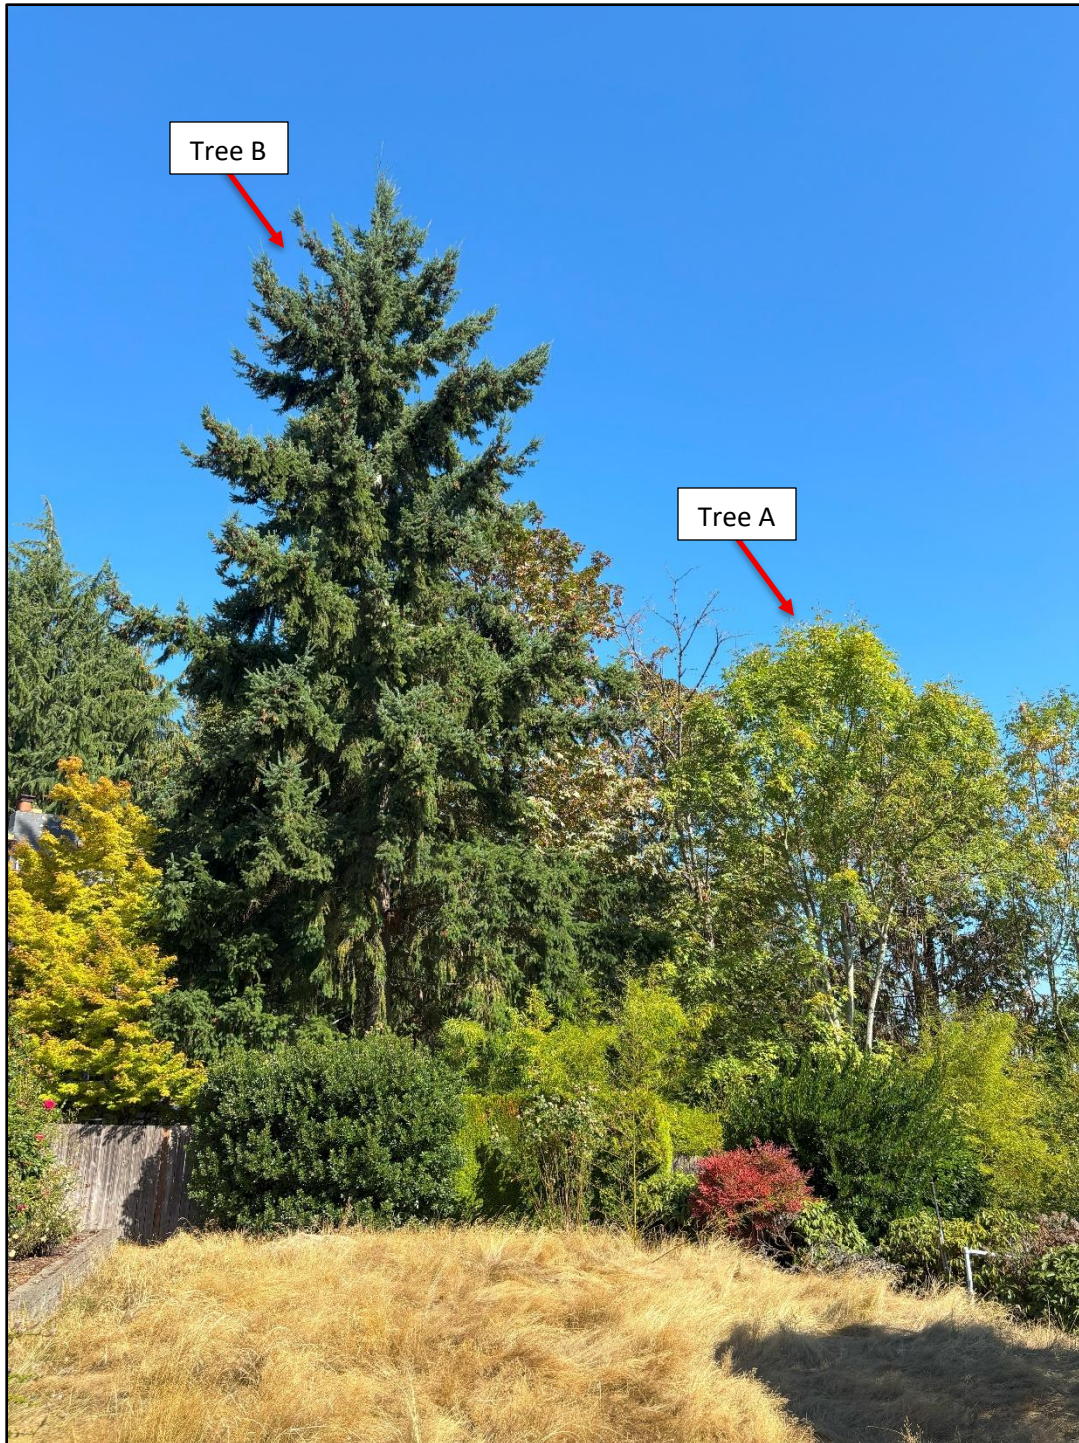
Off-site trees A and B are located adjacent to the northern property line of the site (see **Photo 3**). Provided plans show silt fencing running through the RLODs of trees A and B. Installing silt fencing by trenching damages retained trees by severing their roots. Instead, the silt fencing should be weighted down on the surface using sandbags or gravel.

Photo 3. Trees A and B, viewed from the south, should be protected consistently with the standards outlined in MICC 19.10.080 and **Appendix C** of this report.
