August 11, 2025

JN 25259

Subject: **Geotechnical and Critical Area Study**
Proposed New Residence
3427 – 72nd Avenue Southeast
Mercer Island, Washington

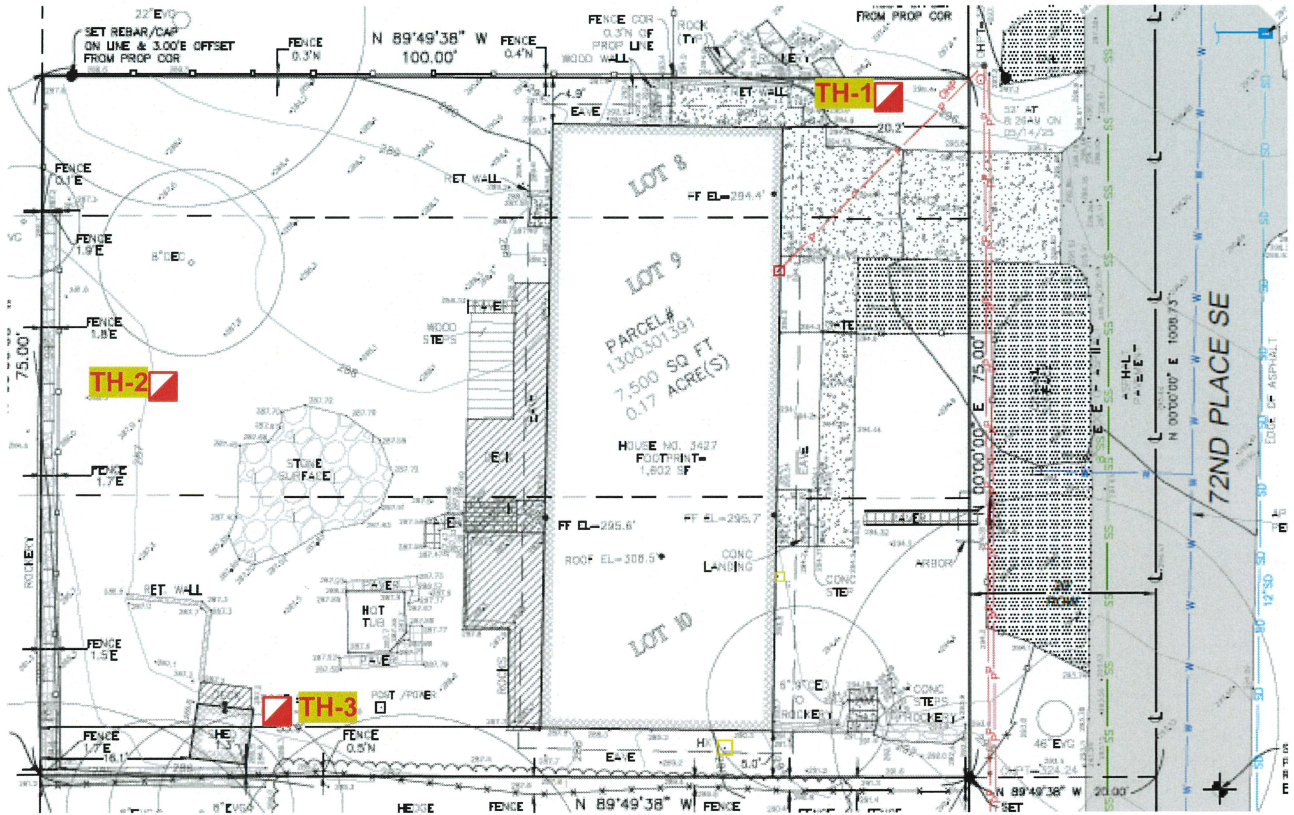
SITE EXPLORATION PLAN
3427 - 72nd Place S.E.
Mercer Island, Washington

During our visit to the site, we observed the excavation of three test holes at the locations shown on the attached Site Exploration Plan. Logs for the test holes are also attached. All three of the test holes found similar subsurface conditions. Beneath the grass and/or landscaping was an approximate 12-inch layer of gravelly, silty sand fill that had been spread over the original topsoil, likely during the development of the current home. Beneath the topsoil was a layer of loose, heavily-weathered, gravelly silty sand. At a depth of approximately 3 feet, the test holes revealed dense, gravelly, silty sand that has been glacially compressed. This soil is referred to as glacial till (aka "hardpan"). Geologic maps of the area confirm that glacial till is the geologic unit underlying the site and surrounding lots. No groundwater was encountered in the test holes. The impervious nature of the glacial till prevents the downward migration of water. It is not uncommon to find at least localized zones of subsurface water perched on top of the impervious glacial till following extended wet weather.
