Jason Koehler
jason@rkkconstruction.com
RE: RKK NOA (2508-021)

Arborist Report Narrative

Address: 4115 78th Ave SE, Mercer Island WA

Tree Table for 4115 78th Ave SE Mercer Island 12-09-2025

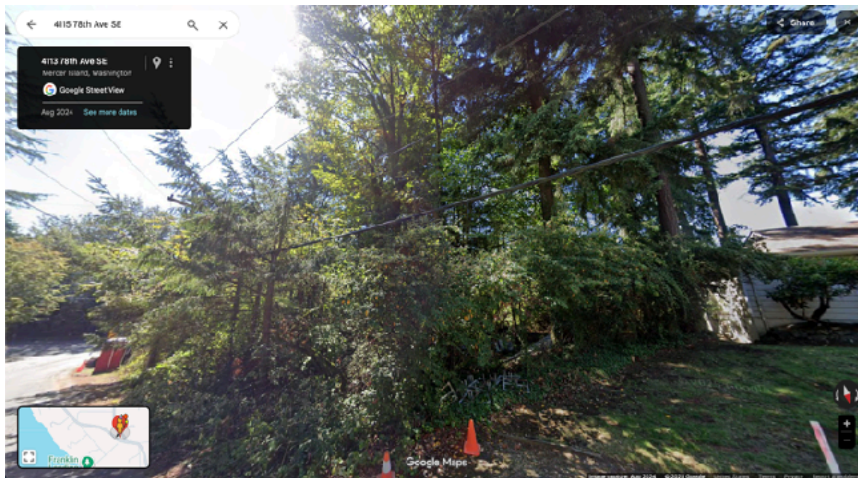
Looking SE along W Mercer Way, towards 78th Ave SE. Subject property on left. The slope is steepest along this boundary, and trees play a part in slope retention.

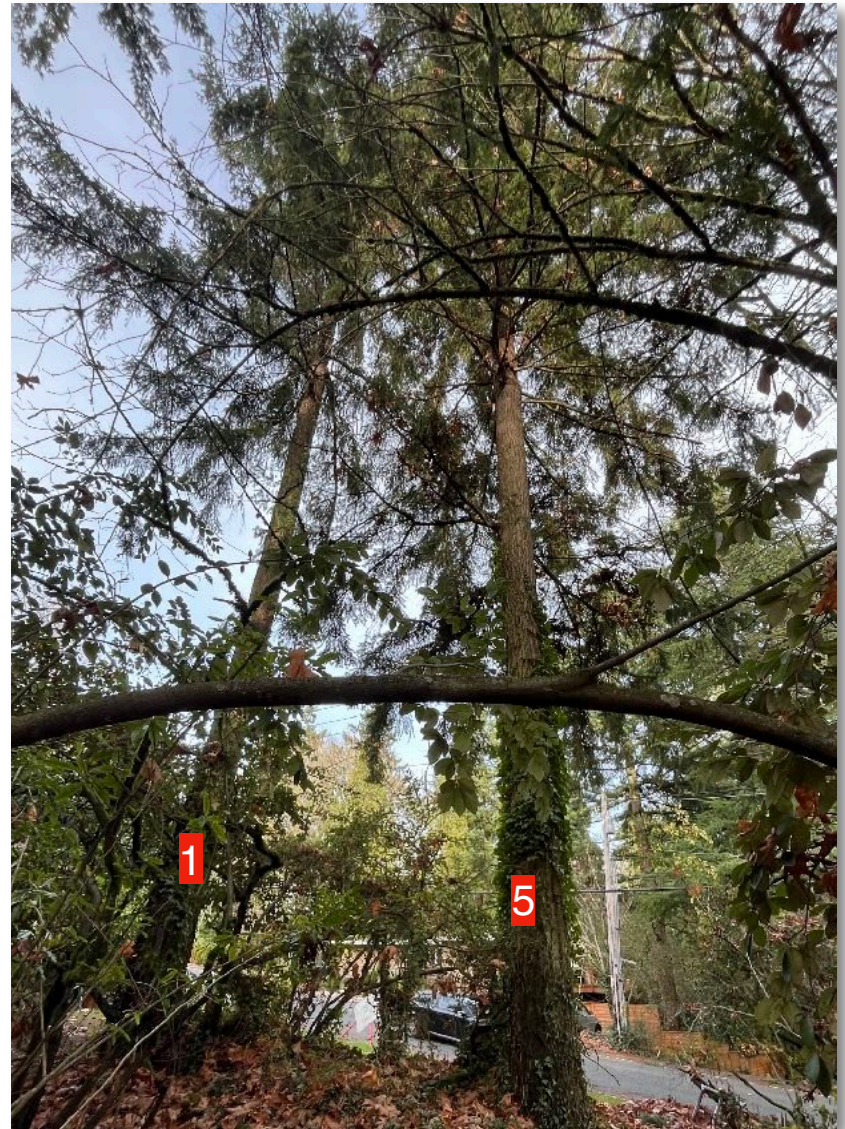
Looking N from onsite, adjacent tree 1 and onsite tree 5 at the N corner of the property

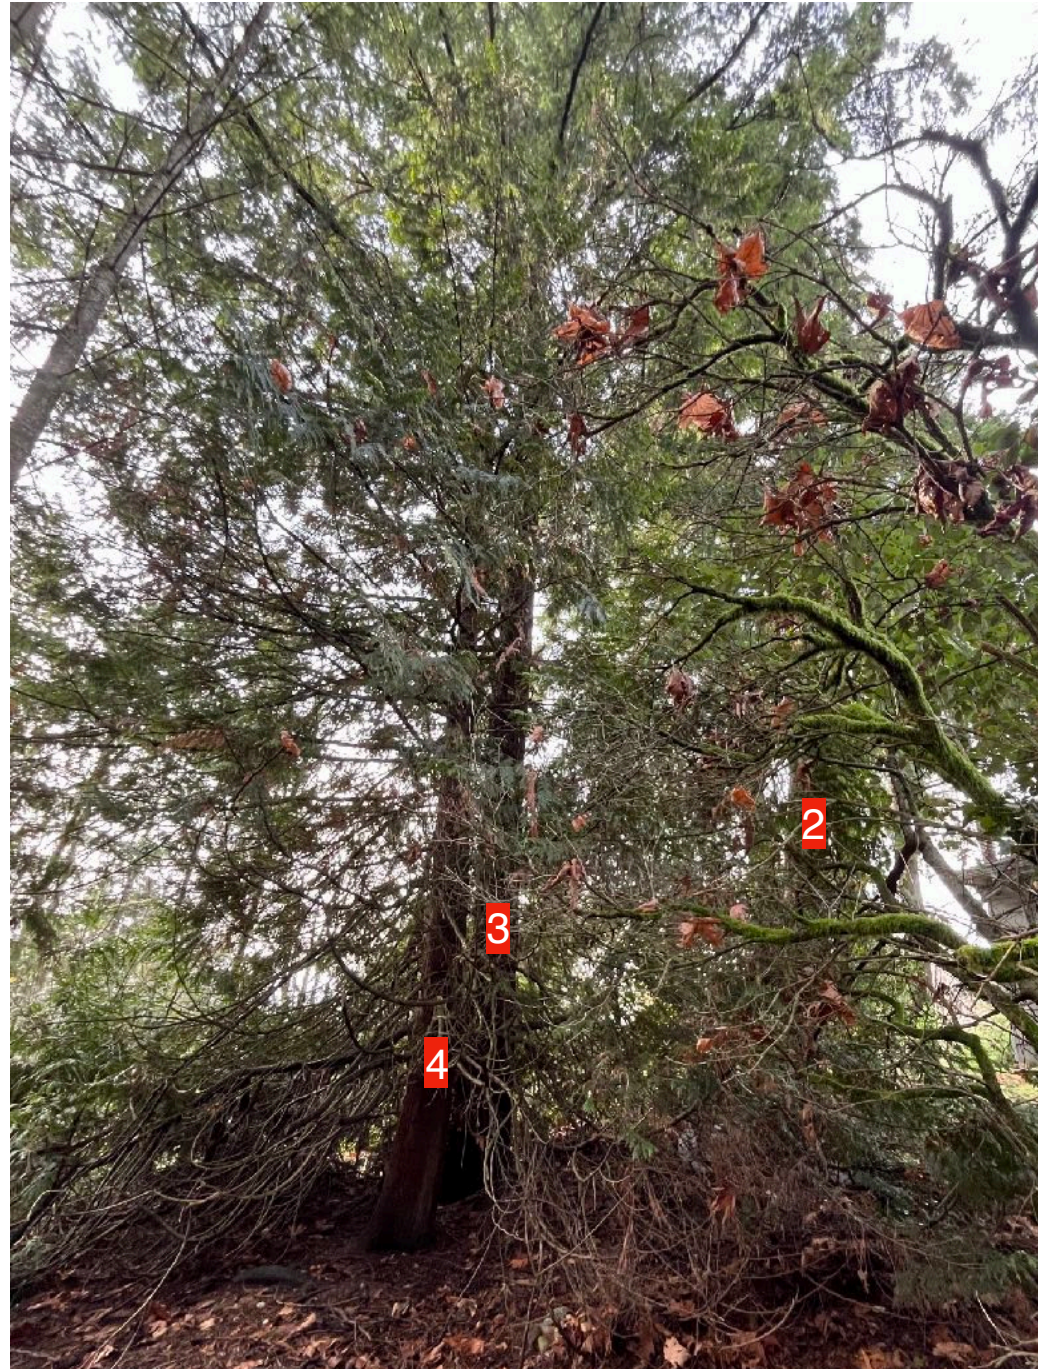
Trees 3 and 4 are close together, offsite tree 2 in background.

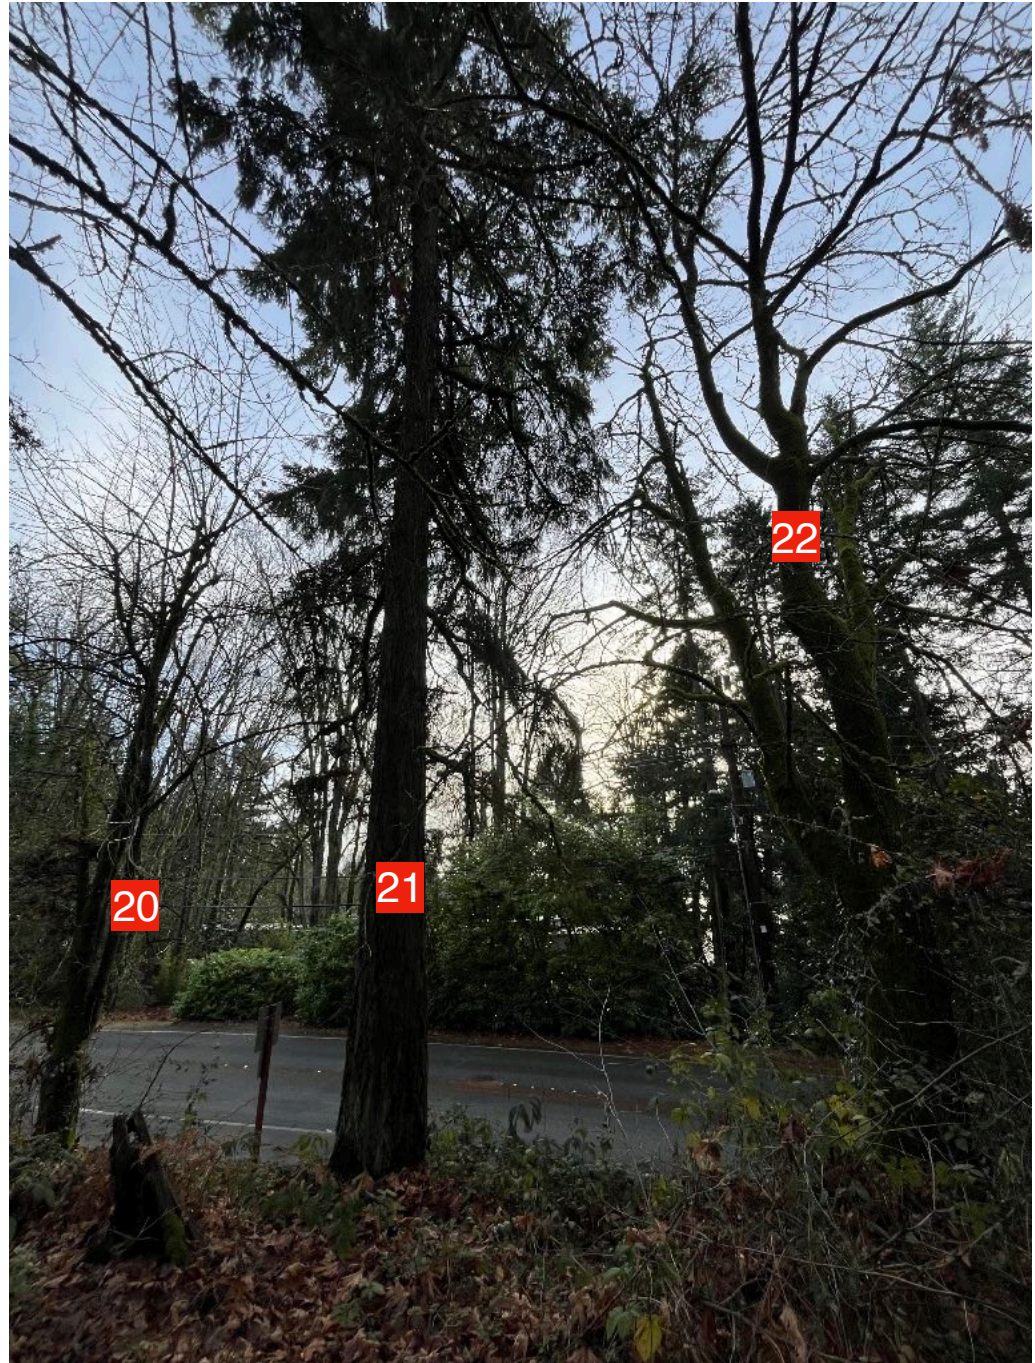
ROW trees: One ROW tree #22 will be removed to accommodate civil plans/storm pipe/catch basin. 6 replacement trees will be planted for this tree, which are included in the totals below.

Trees 20, 21 and 22

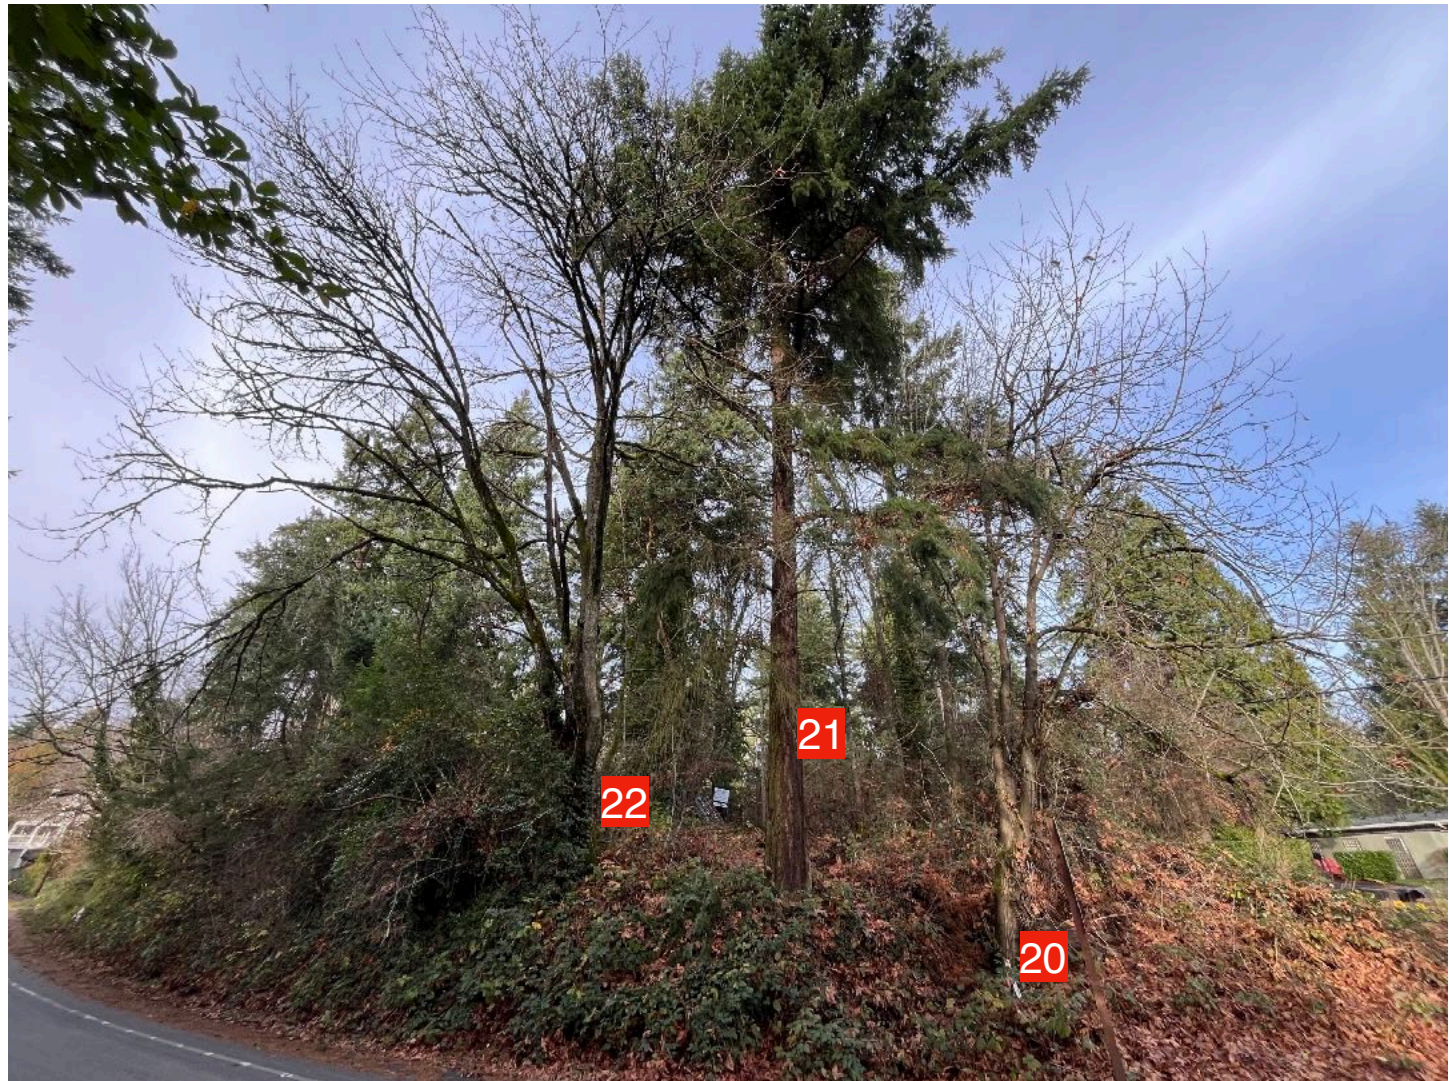
Looking N from Mercer Way, trees 20, 21, 22

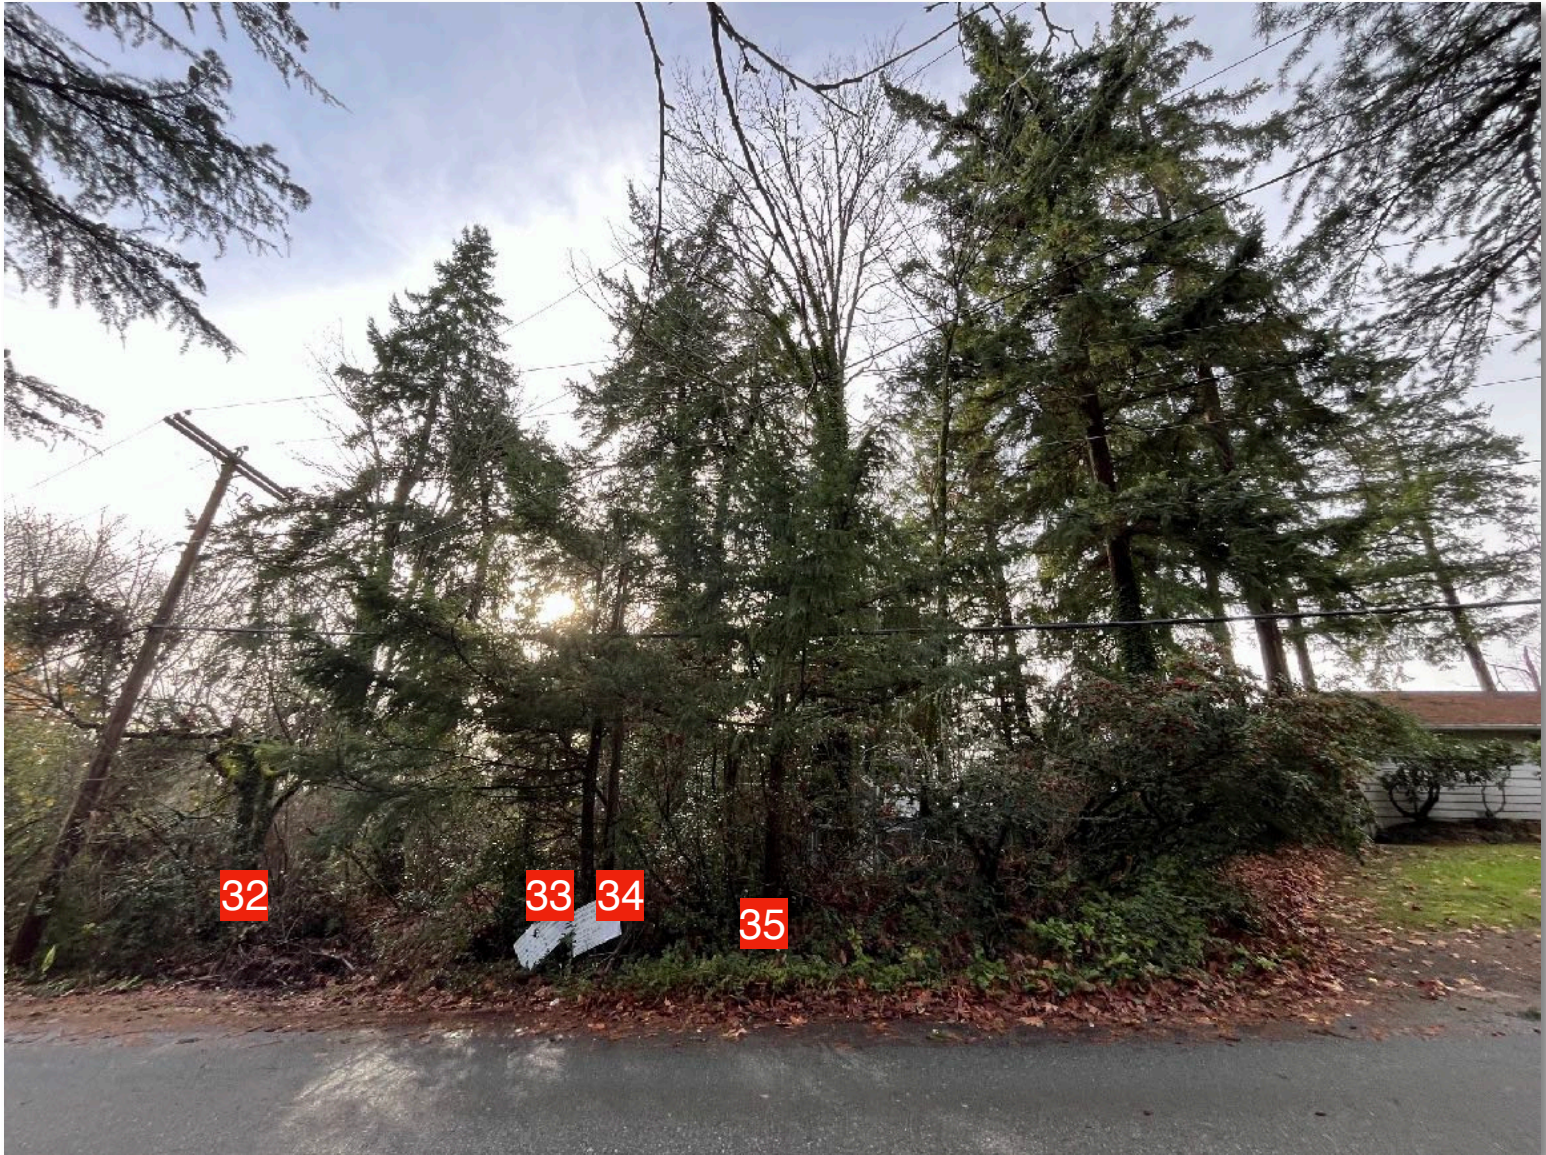
Looking S from 78th, trees 32, 33, 34, 35 are located along the street and have been height reduced.
