## **Arborist Report**

**February 7th, 2022**

Imani Homes  
2900 78th Ave Se  
Mercer Island, Wa

Seattle Tree Consulting  
Douglas Smith (Certified Arborist PN 6116-A/TRAQ)  
3907 Aurora Ave N.  
Seattle, Wa. 98103  
(206)457-5706  
[doug@seattletreeconsulting.com](mailto:doug@seattletreeconsulting.com)

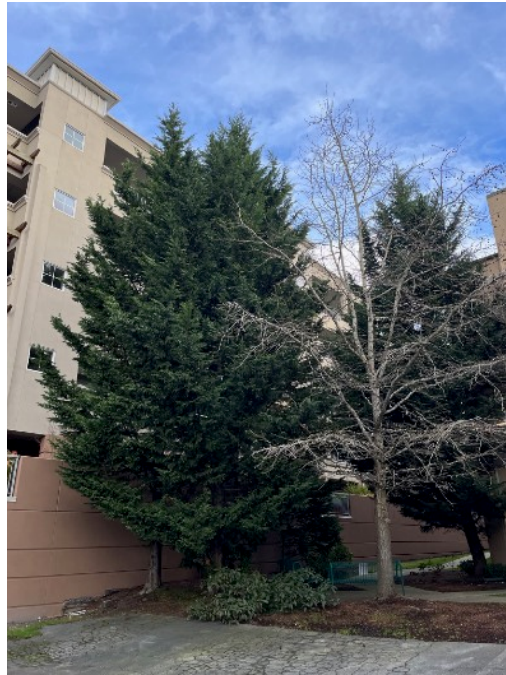
Trees #1-4 above

- 1. Leyland Cypress (*Cupressus x Lelandii*). 12" DSH. Condition 1. 12' CRZ radius.
- 2. Leyland Cypress (*Cupressus x Lelandii*). 10" DSH. Condition 1. 12' CRZ radius.

- 3. Leyland Cypress (*Cupressus x Lelandii*). 19" DSH. Condition 1. 19' CRZ radius.
- 4. Sweetgum (*Liquidambar styraciflua*). 12" DSH. Condition 1. 13' DLR. 12' CRZ radius.

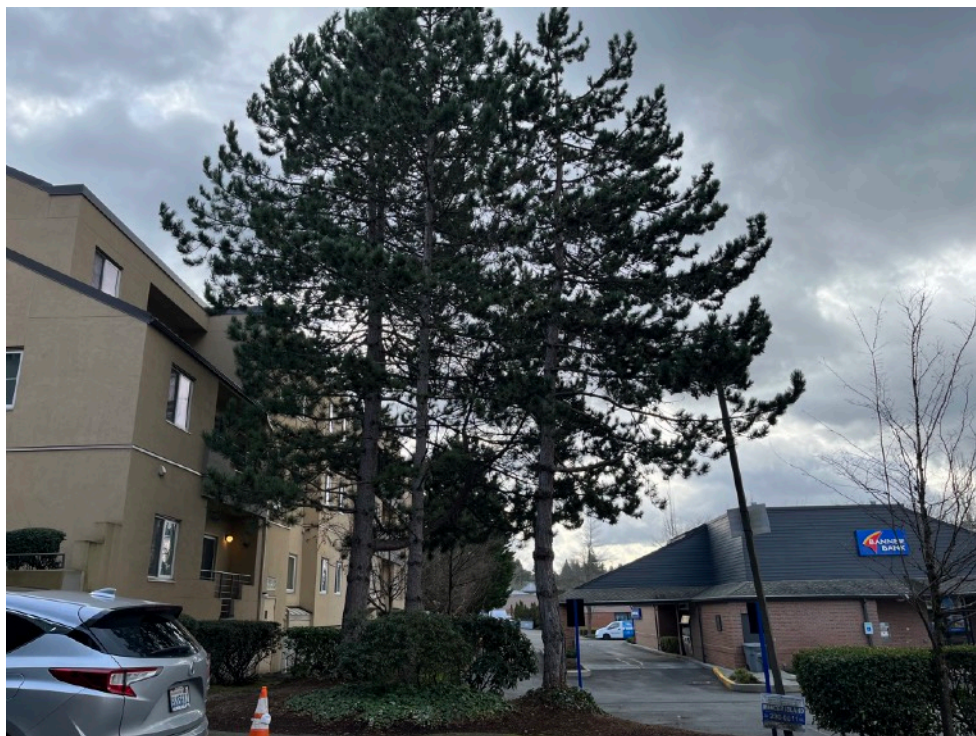
Trees #5-7 above

- 5. Austrian Black Pine (*Pinus nigra*). 20" DSH. Condition 1. 20' CRZ radius.
- 6. Austrian Black Pine. (*Pinus nigra*). 10" DSH. Condition 1. 10' CRZ radius.

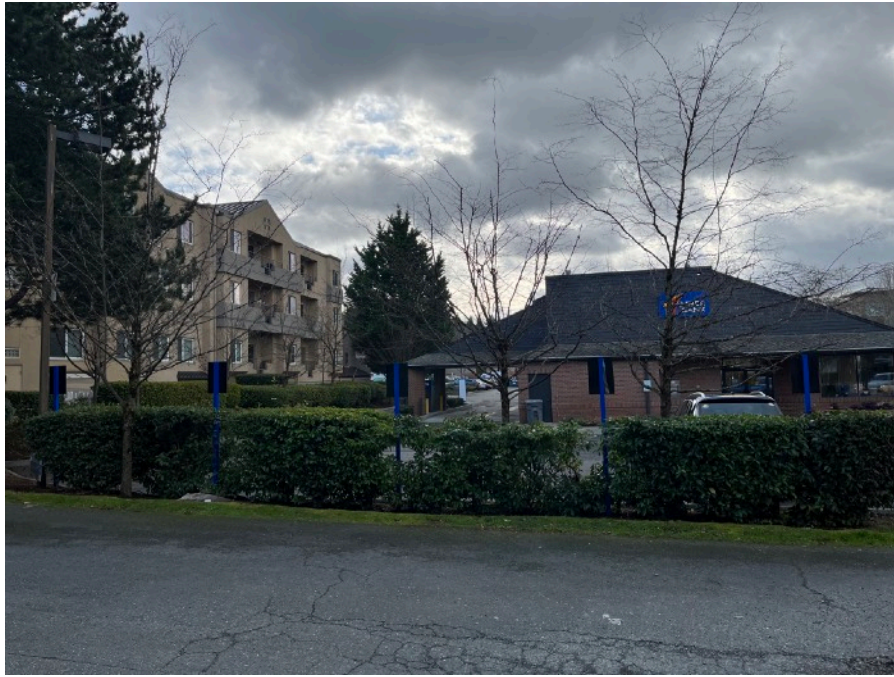
**Trees #8-10**

- 7. Austrian Black Pine. (*Pinus nigra*). 20" DSH. Condition 1. 20' CRZ radius.
- 8. Sawleaf Zelkova (*Ulmus serrulata*). 4" DSH. Insignificant tree.
- 9. Sawleaf Zelkova (*Ulmus serrulata*). 5" DSH. Insignificant tree.

- 10. Sawleaf Zelkova (*Ulmus serrulata*). 4" DSH. Insignificant tree.
- 11. Red Maple (*Acer rubrum*). 13" DSH. Condition 1. 14' DLR. 13' CRZ radius.
- 12. Red Maple (*Acer rubrum*). 13" DSH. Condition 1. 14' DLR. 13' CRZ radius.
