## Arborist Report

To: Jody & Steph Biggs  
Site: 2411 60<sup>th</sup> Ave SE Mercer Island, 98040  
Re: Tree inventory  
Date: April 9, 2024  
Project Arborist: George White,  
ISA Certified Arborist PN-8908A  
ISA Qualified Tree Risk Assessor  
Reviewed By: Connor McDermott  
ISA Certified Arborist PN- 8704A  
ISA Qualified Tree Risk Assessor  
Referenced Documents: Site Plan A1.1 (Sturman Architects, 1.22.2024)  
Attached: Table of Trees  
Tree Site Map

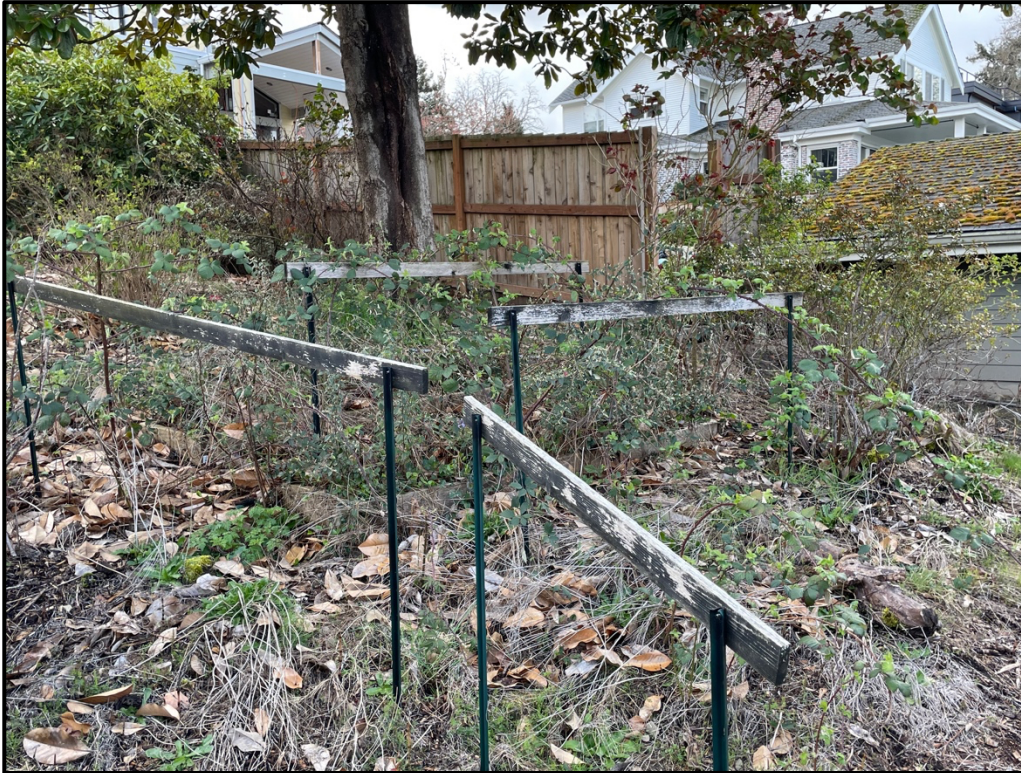
I noted low levels of invasive vegetation on-site including Himalayan blackberry (*Rubus bifrons*), English ivy (*Hedera sp.*), and Cherry laurel (*Prunus laurocerasus*). Invasive plants should be removed prior to construction.

**Photograph 1.** Invasive Himalayan blackberry east of the existing structure.

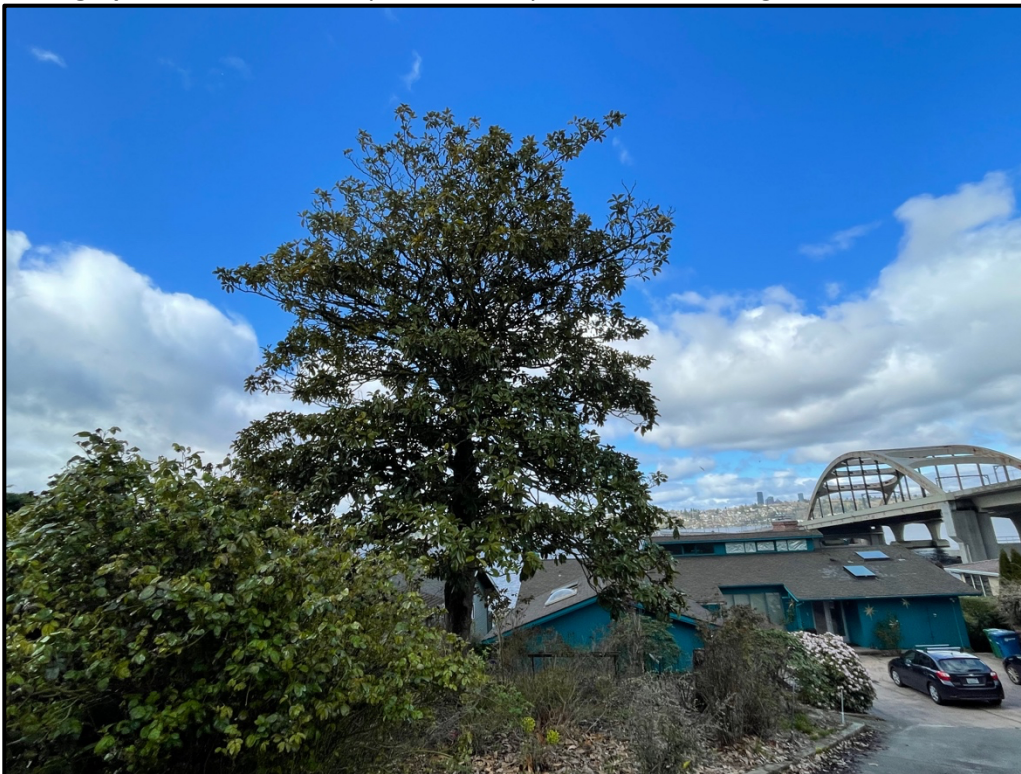
**Photograph 2.** Tree 120 as viewed from the driveway. This tree can be easily retained if protected with tree protection fencing installed at its RLOD.

Tree 120 should be protected with tree protection fencing installed at its RLOD, a radius of 16 feet extending from the center of the tree. No impacts are proposed within the RLOD.

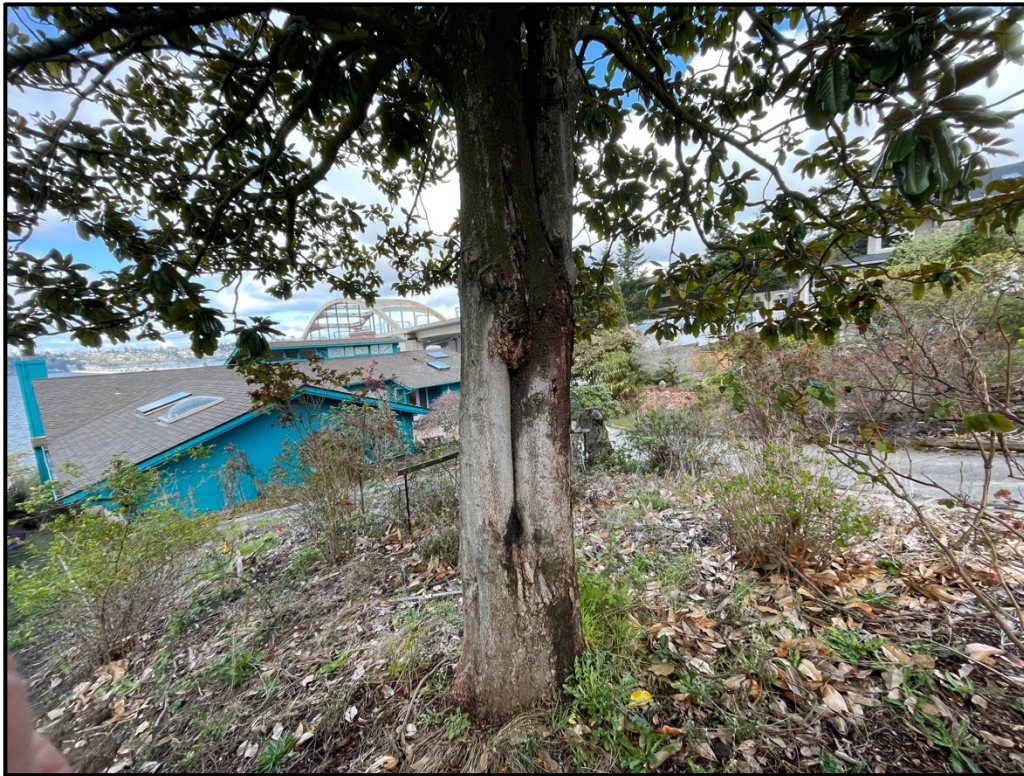
Tree 120 is a 19.7-inch southern magnolia (*Magnolia grandiflora*) in good health and fair structure. The tree is codominant at approximately 3 feet above grade with a narrow union and included bark. The trunks fuse together partially at about 5 feet above grade.

**Photograph 3.** Narrow, codominant trunks that have fused together on tree 120.

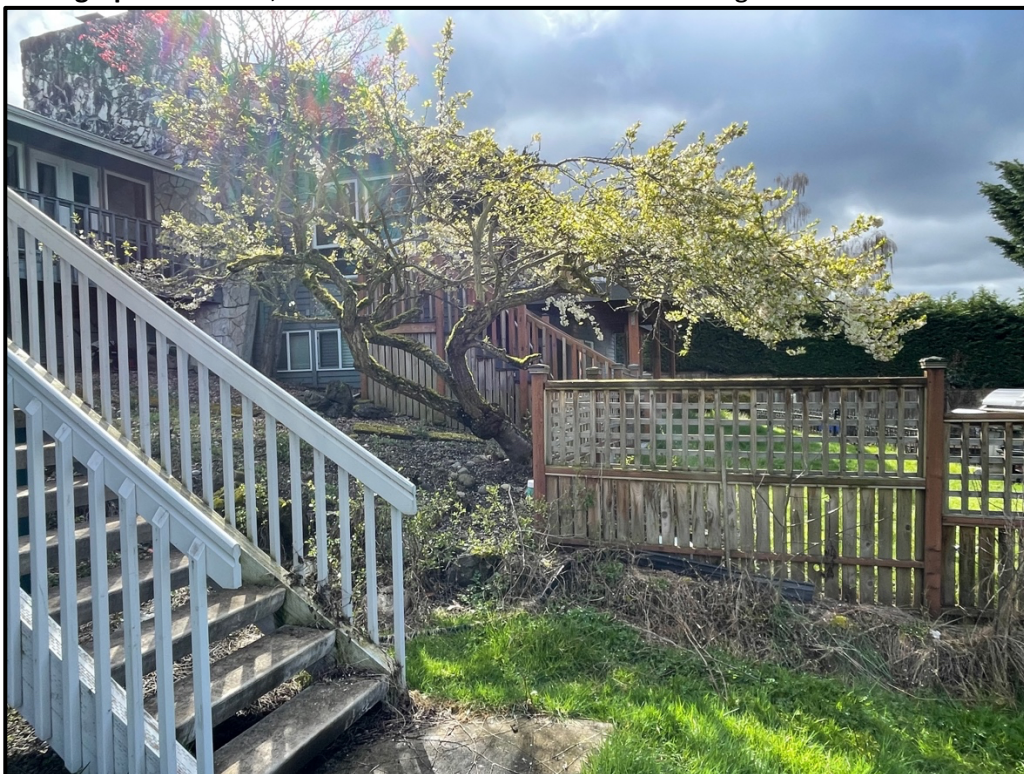
**Photograph 4.** Tree A, a flowering plum located south of the subject property. This tree can be effectively retained if protected at the property line.

While the dripline of tree A extends over the property line by 2-3 feet, its 8-foot RLOD is located entirely within the adjacent property. In my opinion, this tree can be retained if protected at the property line.

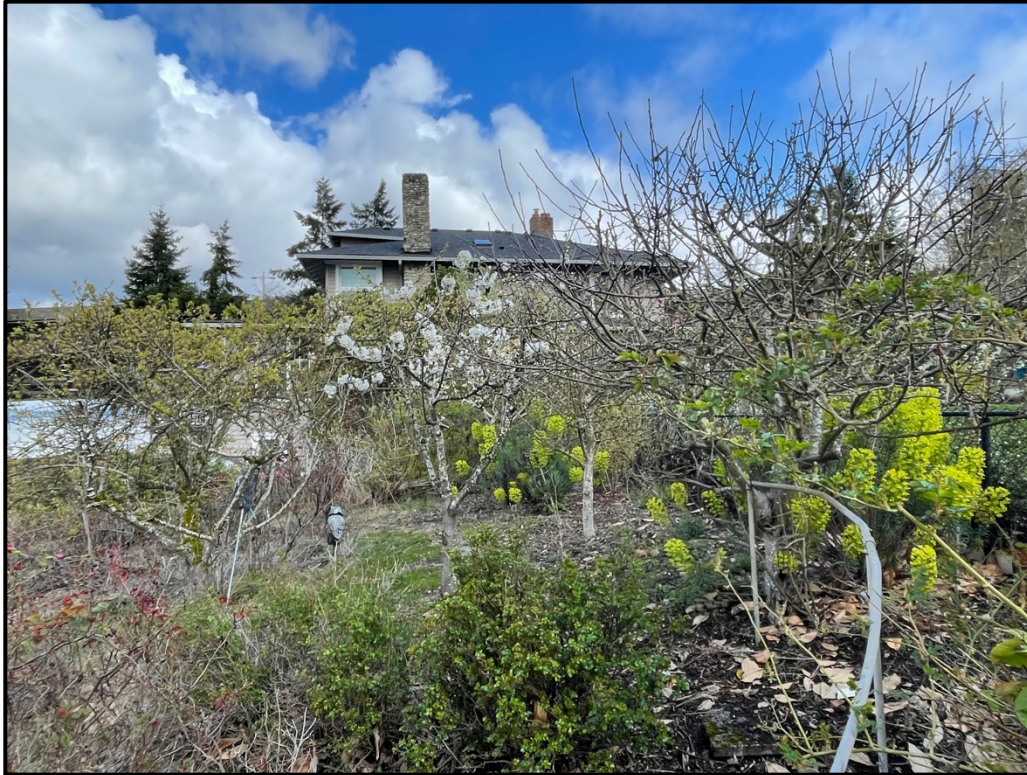
There are several additional trees located on-site that are below regulated size including hinoki cypress (*Chamaecyparis obtusa*), florida dogwood (*Cornus florida*), lace-leaf Japanese maple (*Acer palmatum* 'Seiryu'), apple (*Malus domestica*), Flowering cherry (*Prunus serrulata*), plum (*Prunus domestica*), and pear (*Pyrus communis*).

**Photograph 5.** Several ornamental trees, and fruit trees that are below regulated size also exist on-site.
