January 30, 2024
Project No. 23-017

Subject: Geotechnical Services Report
 Beachfront DADU
 4649 Forest Ave SE, Mercer Island, Washington

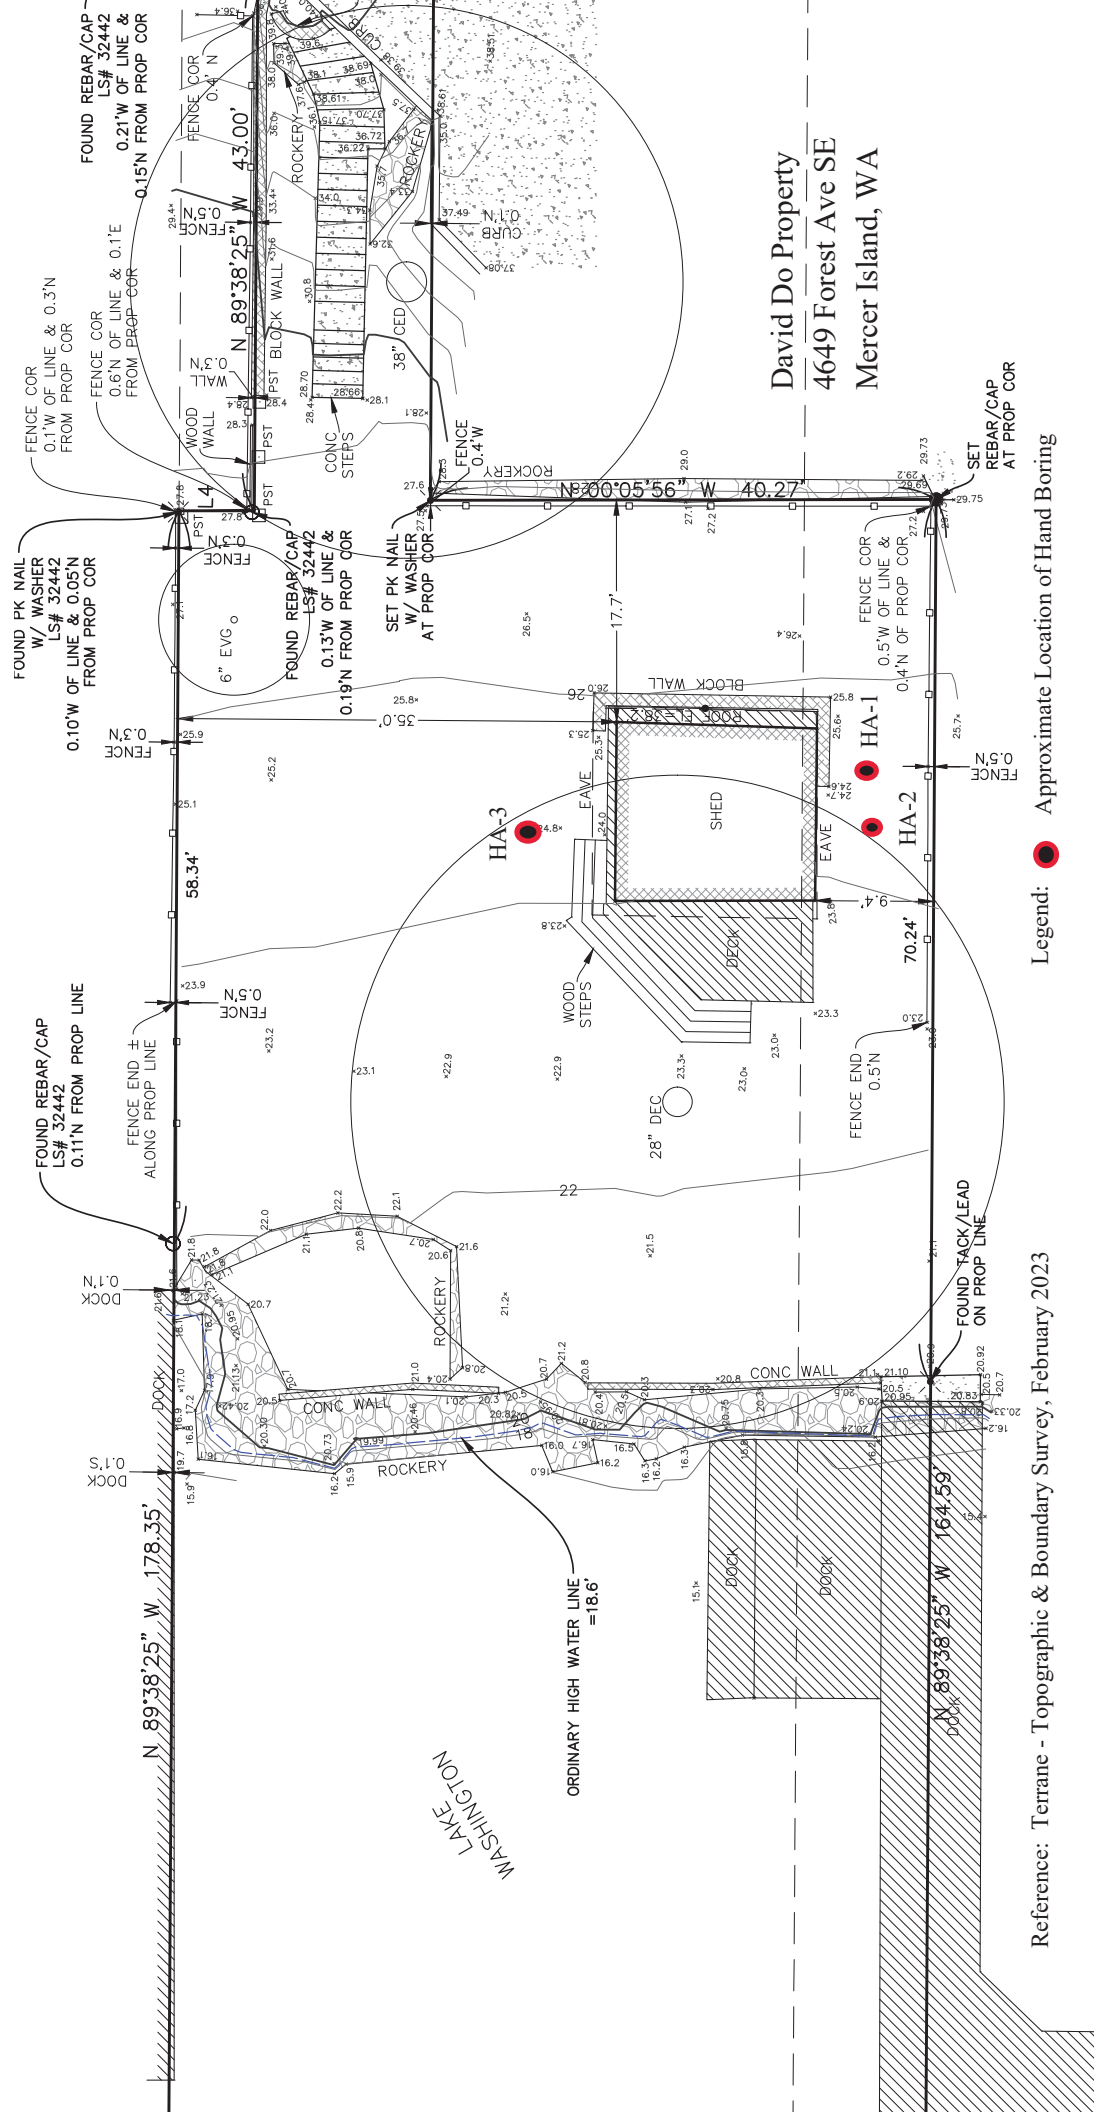
On October 22, 2023, 3 exploration borings – hand augers - were excavated on the subject site. See Figure 1, Site and Exploration Plan for boring locations. The borings generally encountered a small thickness of clean sand overlying silt sediments. The massive silt sediments were observed at a depth of 2.1 feet on the south side of the property, contained an approximate 18 inch layer of medium dense sand and then became all silt below a depth of 5-1/2 feet. On the north side of the property the silt sediments were observed at a depth of 2 feet and extended for the full depth of the boring to 9.5 feet. The hand auger logs are attached with this report.

HA - 1 Near midpoint on south side of cottage/shed. Approximate elevation 25 feet.

HA - 2 Moved 2 feet west from HA-1. Approximate elevation 25 feet.

HA - 3 Near midpoint on north side of cottage/shed. Approximate elevation 25 feet.
