ARBORIST REPORT

5330 Butterworth Road
Mercer Island, WA

May 28, 2024

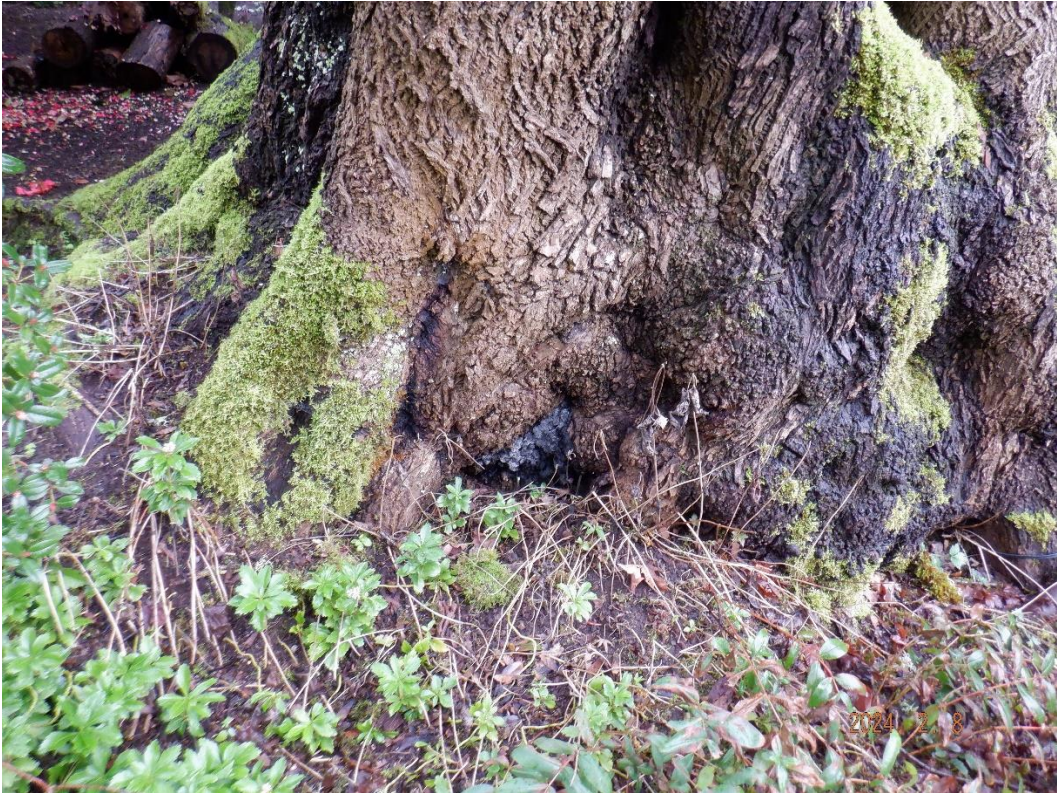
Five of the subject trees were found to be in a ‘poor’ condition. Tree #3 is a mature native bigleaf maple at the front of the property. It has an advanced soft rot infection, *Kretzschmaria deusta*. This is evident by multiple fruiting bodies of the fungus observed on the root crown and lower trunk. See pictures

below. These appear as black crusty nodules resembling dried tar. Tree #18, another mature bigleaf maple also has an advanced infection. There is risk of complete trunk failure for both of these.

Base of Tree #3, advanced soft rot infection

To reduce the risk associated with Trees #3 and #18, significant crown reduction or retrenchment pruning is recommended. Reduce the height by roughly 50%. This will dramatically decrease the loading on the lower trunks and make the trees much more stable.

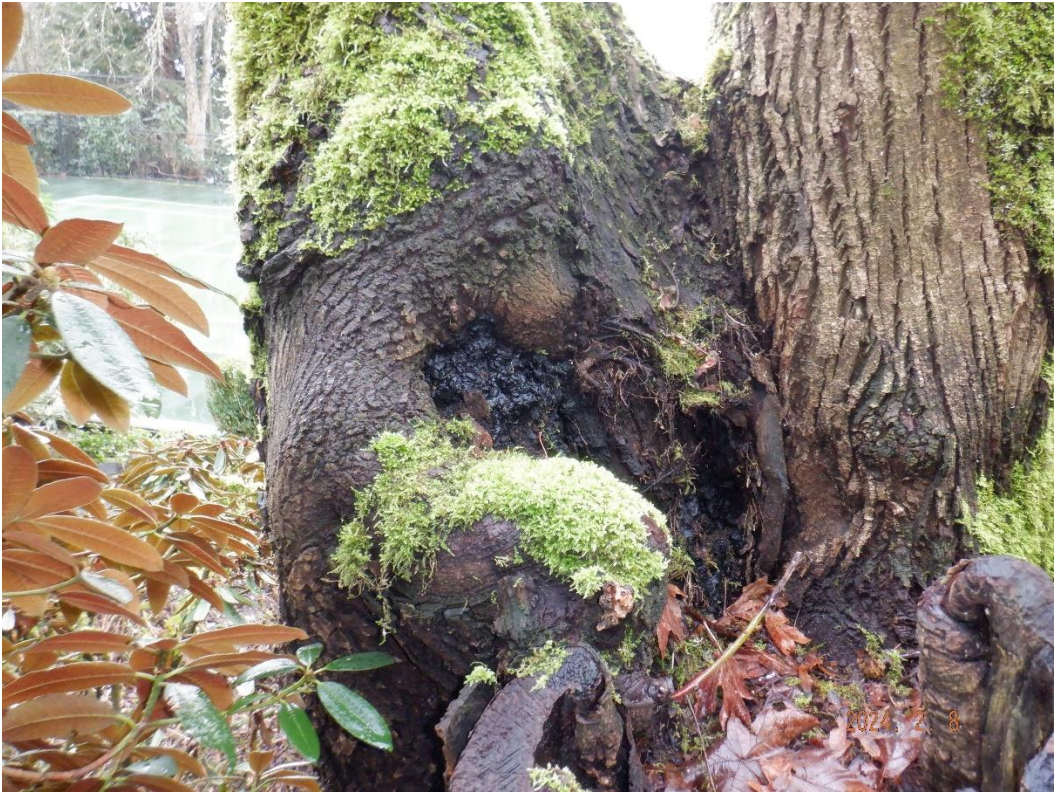
Base of Tree #3, advanced soft rot infection

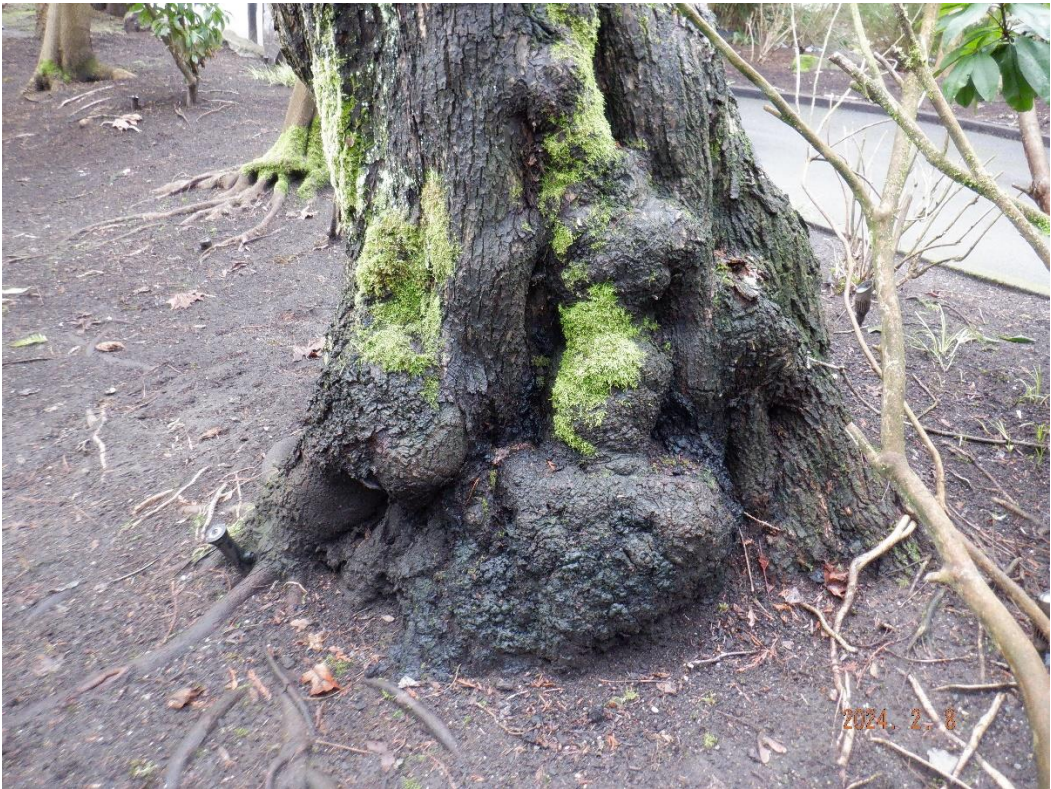
Lower trunk of #18, advanced soft rot infection

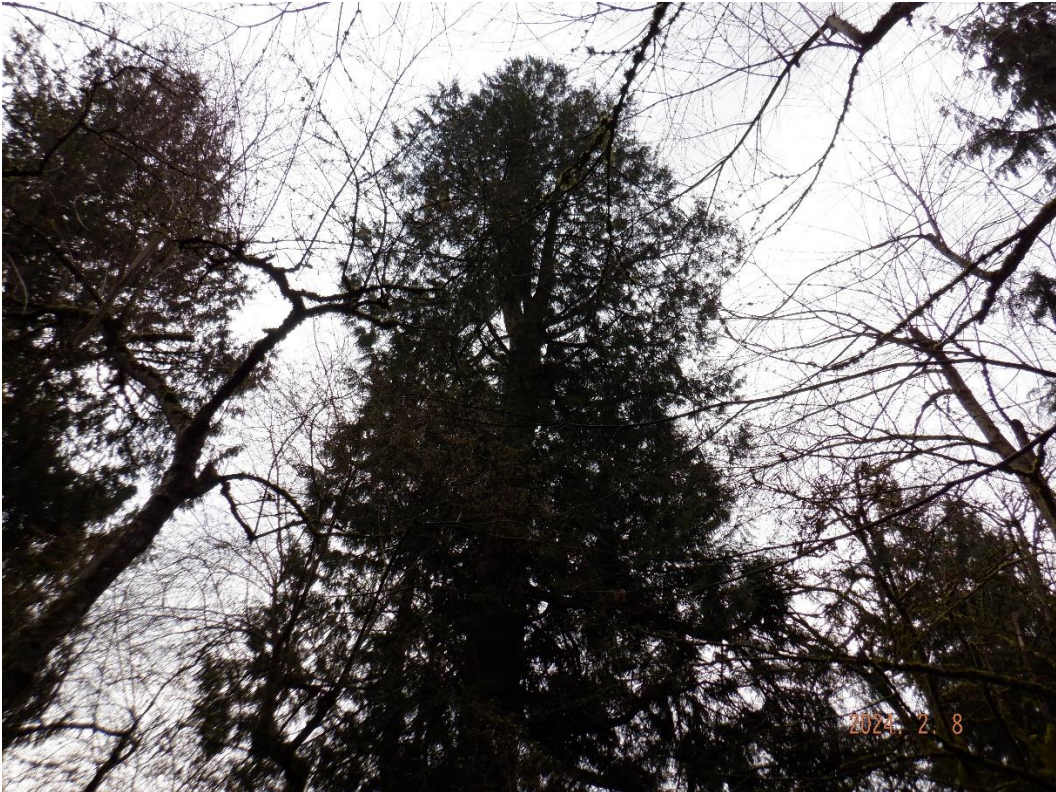
Upper crown of #23, decent vigor

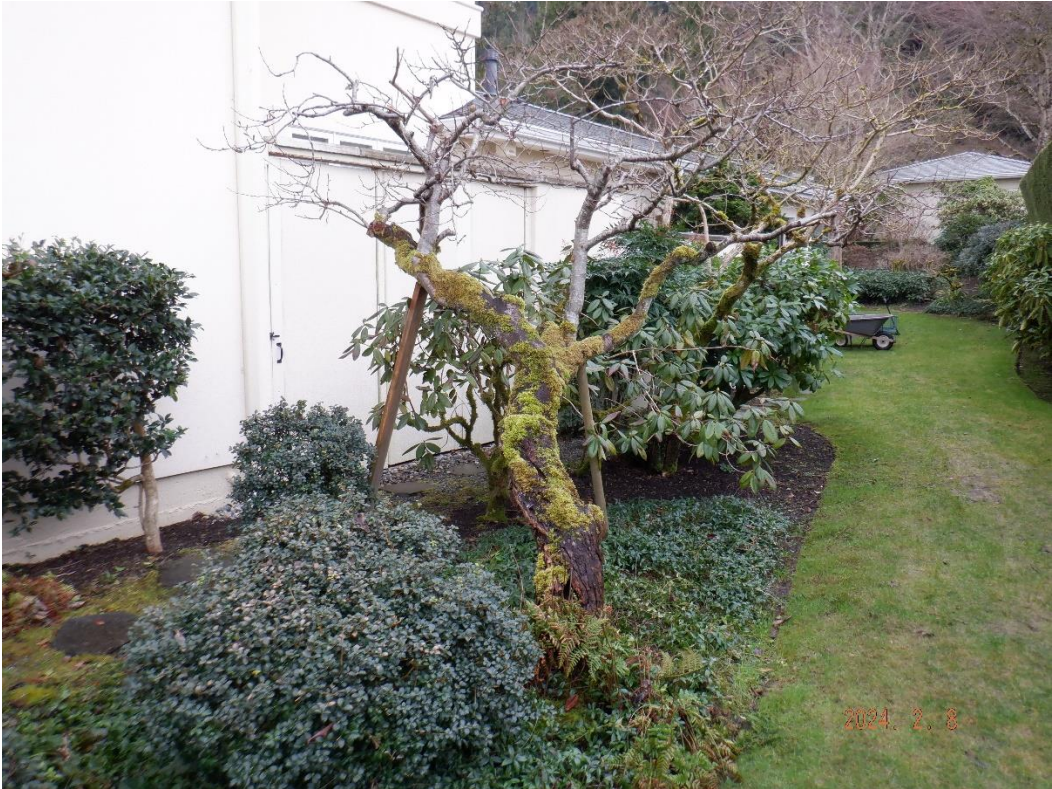
Tree #34 is a semi-mature to mature apple variety. The root crown has failed in the past. The tree is being propped up by wooden posts. It is low risk and can be left if desired.

Tree #34 has failed at the root crown and is being propped up

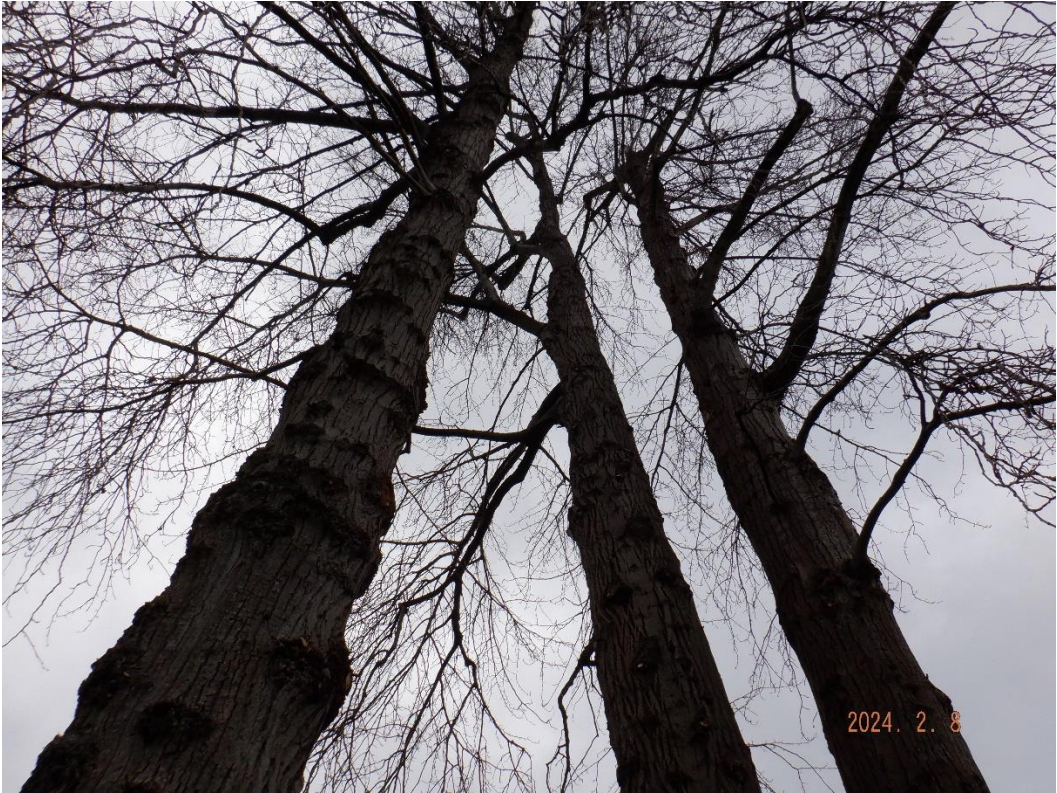
Tree #39 is a semi-mature to mature black cottonwood. It has advanced decay within the mid and upper stem, evident by nesting holes or open cavities. There is an elevated risk of trunk or stem failure. This tree is well within the striking distance of the house.

Tree #39 in middle, multiple nesting holes/cavities on mid and upper bole

Tree #39 has significant decay within the mid and upper trunk. Habitat snagging this tree to a safe height of +/- 20-feet is recommended to abate its hazard potential.

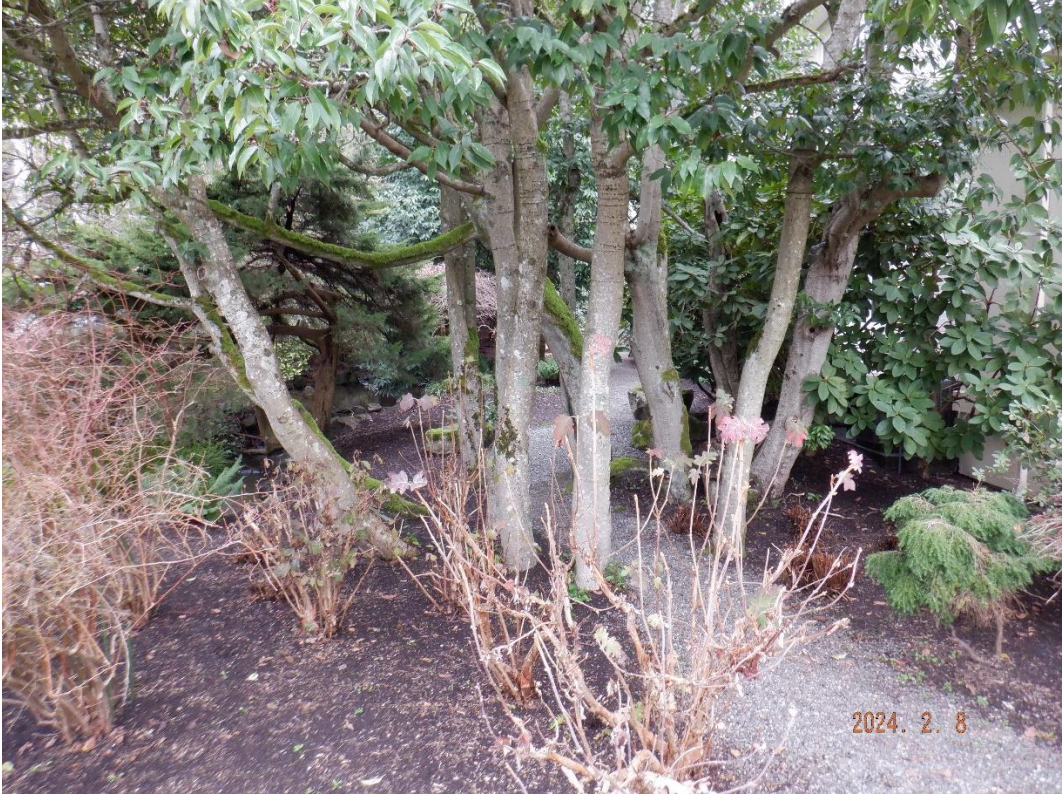
Portuguese laurel cluster (#45) south of house, most are of non-regulated size
