November 6, 2024

Project: Pre-construction assessment for property re-development at 4661 Forest Avenue SE, Mercer Island, WA. Parcel number 4045000065.

Objectives: Evaluate health of existing trees and establish criteria for the preservation of those to be retained. Provide risk assessments as necessary.

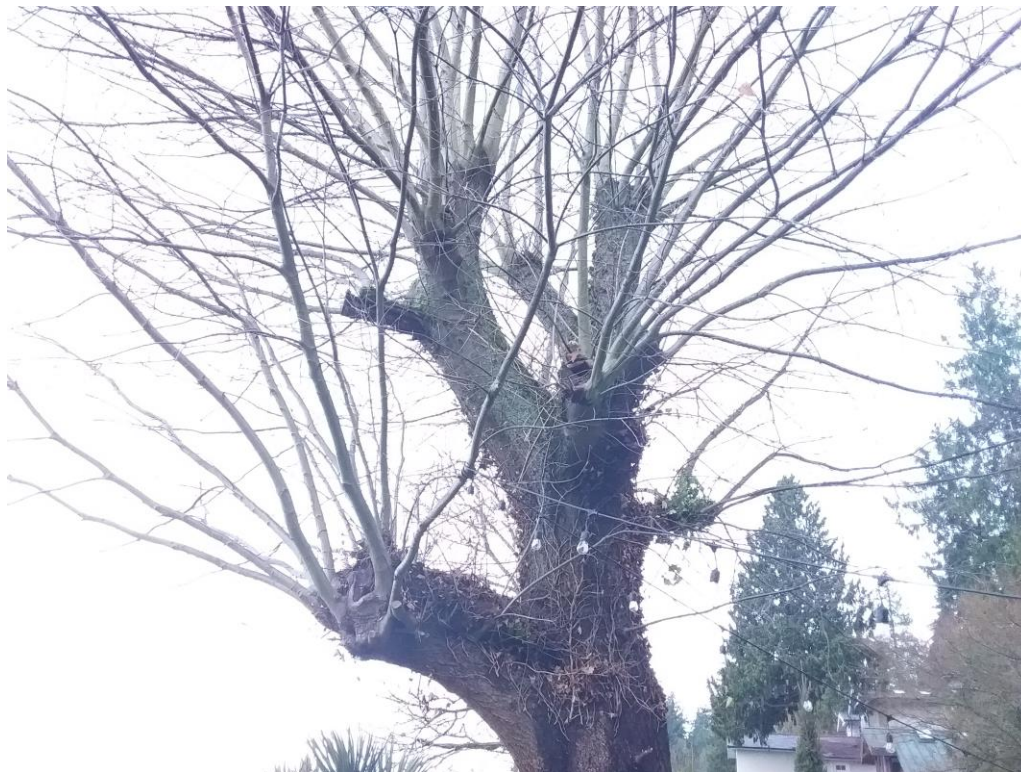
1. Pin oak (*Quercus palustris*) 40" DSH standing 19' W of the NW corner of the existing house, 9' S of the north property line, and 35' E of the sea wall. The tree was cut back to the property line between 2007 and 2009 (Figures 7 and 8) and then was severely stubbed back between 2013 and 2015 (Figures 9 and 10). The top cuts were made between 25' and 28' above grade and the scaffolds were cut back to no more than 8' off the main stem. Currently there are epicormic sprouts extending off each of the cut points in groups of 5-10 and out 12-25' long. There is conflict and some die back present (Figure 11-13). Tree exhibits good health with decent new growth and color. It reaches up to near the 50' level and has a 20' radial spread. There is utility vault, maybe a pump house, in the northwest quadrant of the root spread 4' off the base of the tree (Figure 14). Concrete stairs lead up from the lower yard to the lower concrete patio. The tree has engulfed the top stair and a couple of the large stones lining it (Figure 15). There is uplift of the concrete path leading to the concrete patio and uplift in the patio itself (Figure 16). This tree is Exceptional by definition.

Figure 11. Looking north at the structure of the #1 oak.

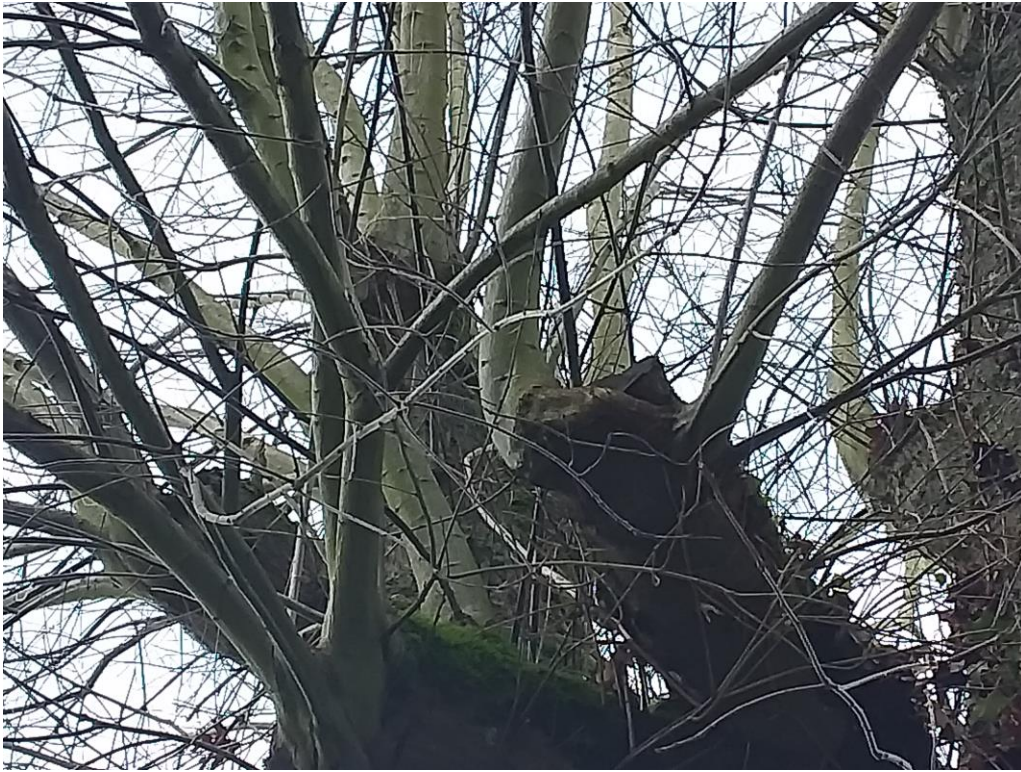
Figure 12. Looking up into the canopy of the #1 oak showing dieback on stub.

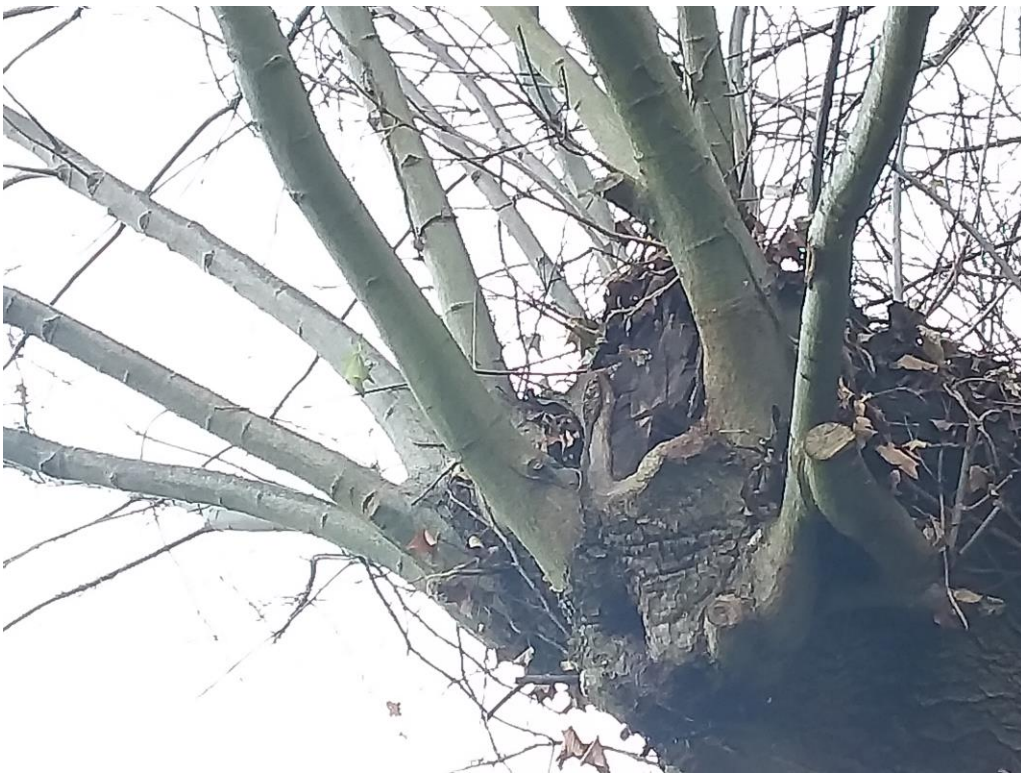
Figure 13. Showing decay and atrophy at another of the stub points on the #1 oak.

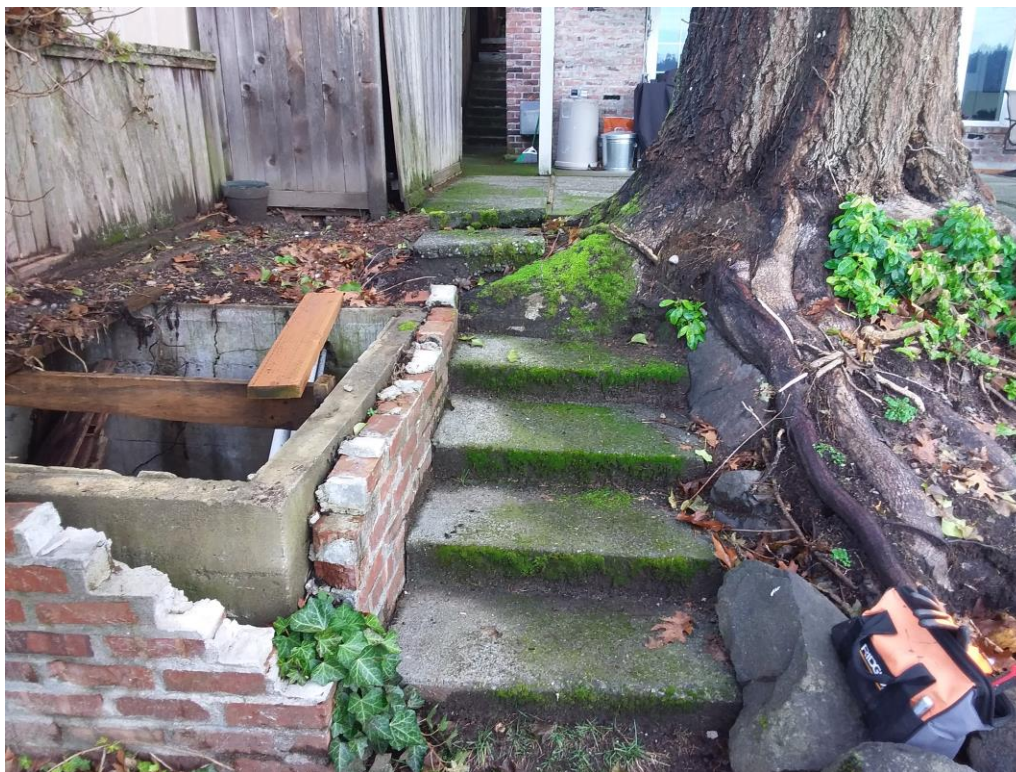
Figure 14. Looking east at the base of the #1 oak showing the pump vault.

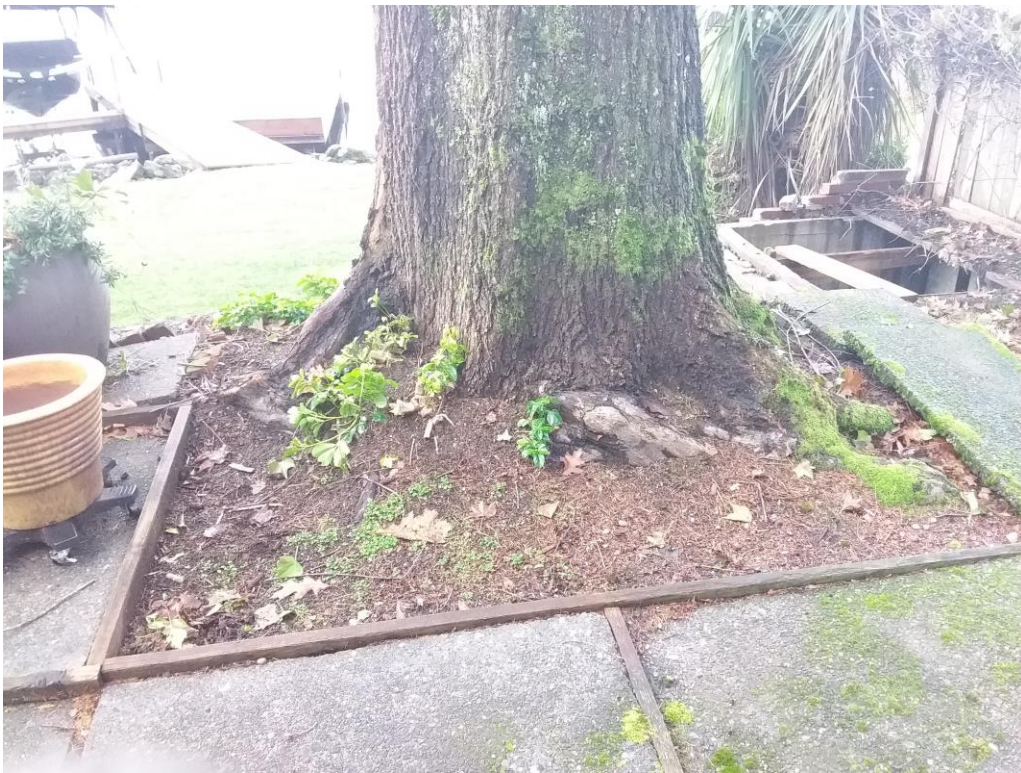
Figure 16. Looking west at the base of the #1 oak showing uplift of patio.

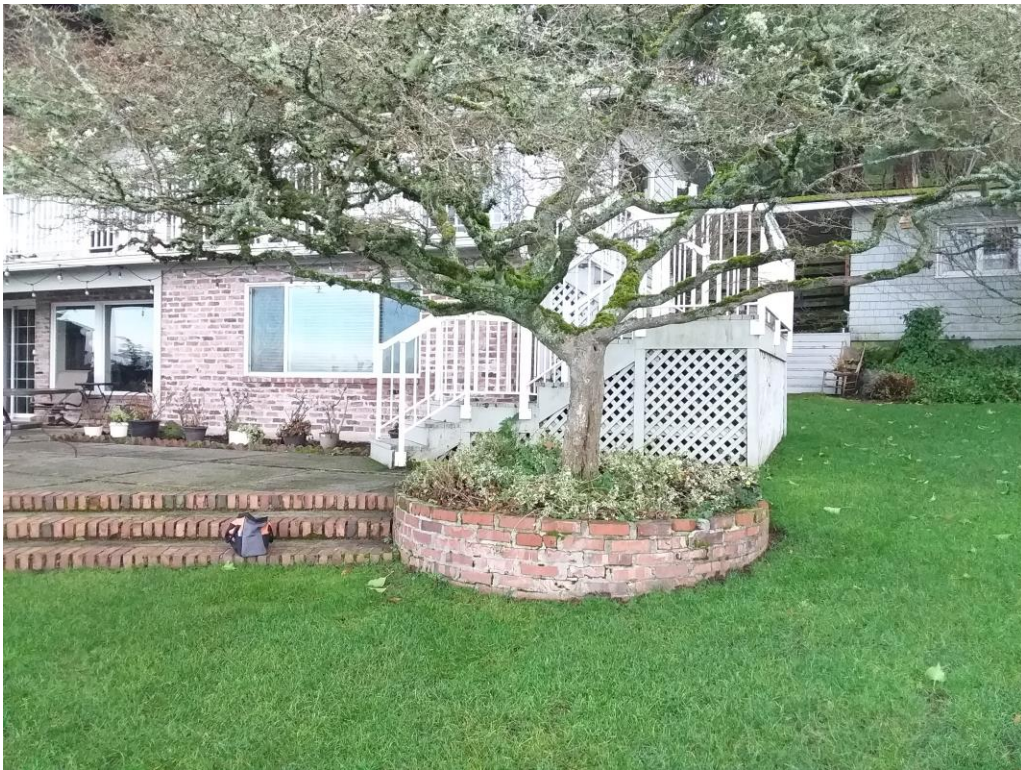
2. Japanese Snowbell (*Styrax japonica*) 9.5" caliper, 9' tall, with nearly a 9' radial spread, standing in a circular planter box at the south end of the rear patio (Figure 17). The brick wall is three feet out from the base of the tree. The tree separates at the 42" level and the scaffolds spread nearly horizontal. Exhibits below average condition with die back at the ends throughout the canopy.

Figure 17. Looking east at the #2 Styx in the planter

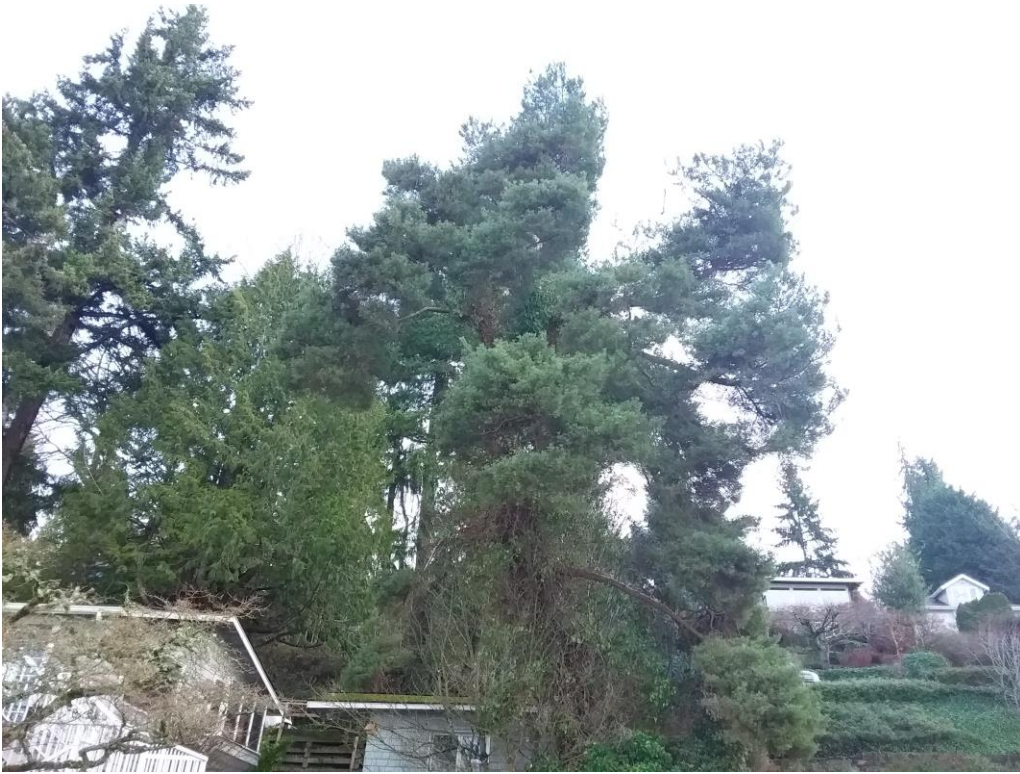
4. Shore Pine (*Pinus contorta*) 24" DSH, 50' tall standing 26.5' S of the house foundation and 8' W of the southwest corner of the little boathouse building. Ivy has filled the canopy to within 8' of the top and out the branches (Figure 18). It was recently cut at the base of the tree. Pine is in fair health but many of the branches are overextended and the canopy is windswept. There is a little existing fence filled with ivy that runs east to west 3' S of the tree. Just outside this fence and 16' E of the base of the tree there is some kind of drain system (Figure 19). This tree is Exceptional by definition.

Figure 18. Looking east at the #3 pine showing the ivy growing through the tree and its structure.

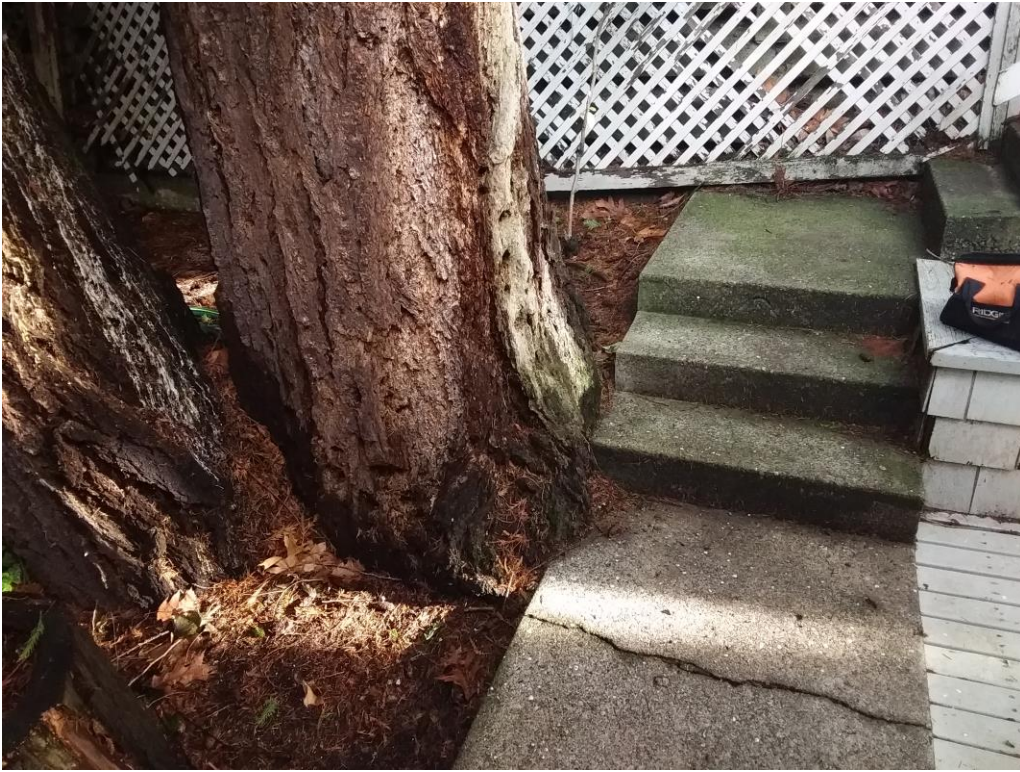
6. Douglas fir (*Pseudotsuga menziesii*) 35" DSH standing at the base of the stairs leading down from the parking/driveway to the house (Figure 22). It's in another constrained, basically glorified planting bed, east of the northeast corner of the existing house. The retaining wall for the garage is 5' E of its base, the stairs leading down to the NE corner of the house are 4' W, of its base, the existing house foundation is 8' W, and the cross walk leading from the garage stairs to the house runs against the south side which has grown over it. The tree was topped or broke out near the 65' mark (Figure 23). The trunk below the topping point is vertical. Two large leaders rise above into the 100' range. One is nearly vertical but its attachment is offset to the column. Low average new growth. A subordinate spar (10" caliper) originates 4' below the cut line and grows up through the two dominants reaching close to 80' tall. Another 8" caliper subordinate comes off in the SE quadrant right at the cut point and reaches 75' tall. There is a torsion fracture low on the south face. Exhibits below average new growth. Tree is Exceptional by definition.

Figure 22. Looking down and east at the base of the #6 fir.

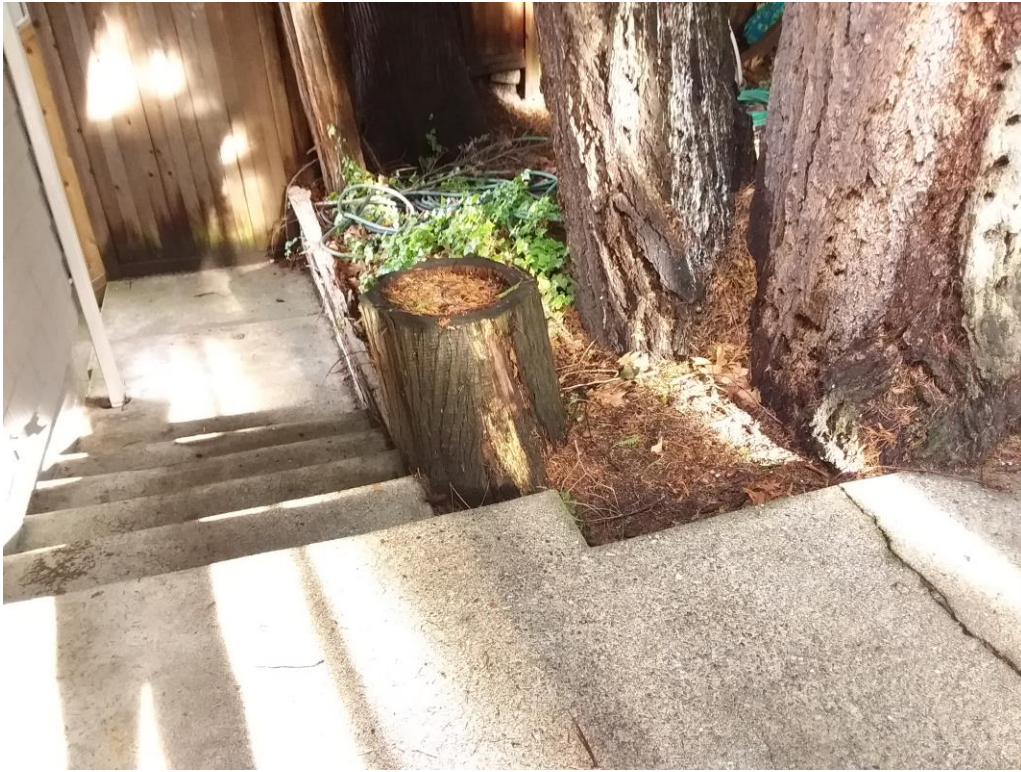
7. Douglas fir 26" DSH growing against the base of the #6 (Figure 24). The stairs are 3' W of its base, the house foundation is 7' W, the retaining wall for the garage is 6.5' E, and the cross walk is 28" S of its base. The foundation for the 4651 house is 14.5' to its north. The tree has two very large cankers in the 6' level (Figures 25 and 26). It leans slightly northwest from its base and never quite comes back to vertical. There is a damage point at the 24' level showing bleeding and indications of surface decay. Top of the tree bends over to the northwest. It might have been damaged by the larger #6 tree and/or have been topped near the 55' mark. The majority of its canopy extends west on large overextended limbs. It shows stunting in the upper canopy and is in below average condition.

Figure 24. Looking down and north at the bases of the #6 and #7 trees.

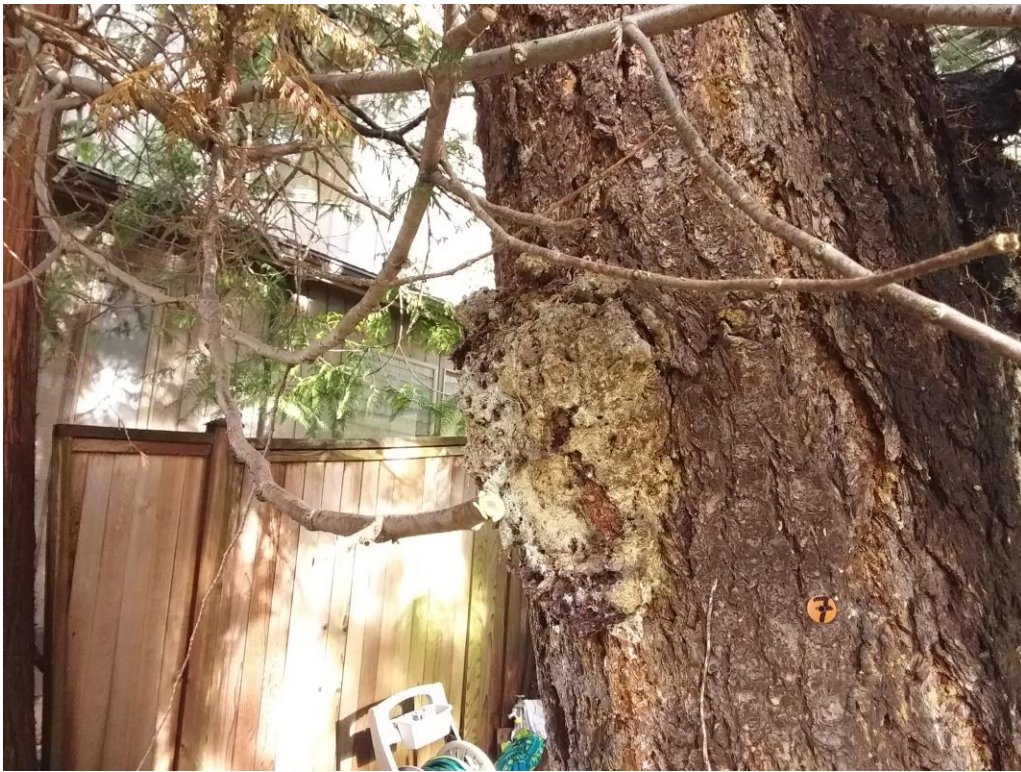
Figure 25. Canker at base of #7 fir.

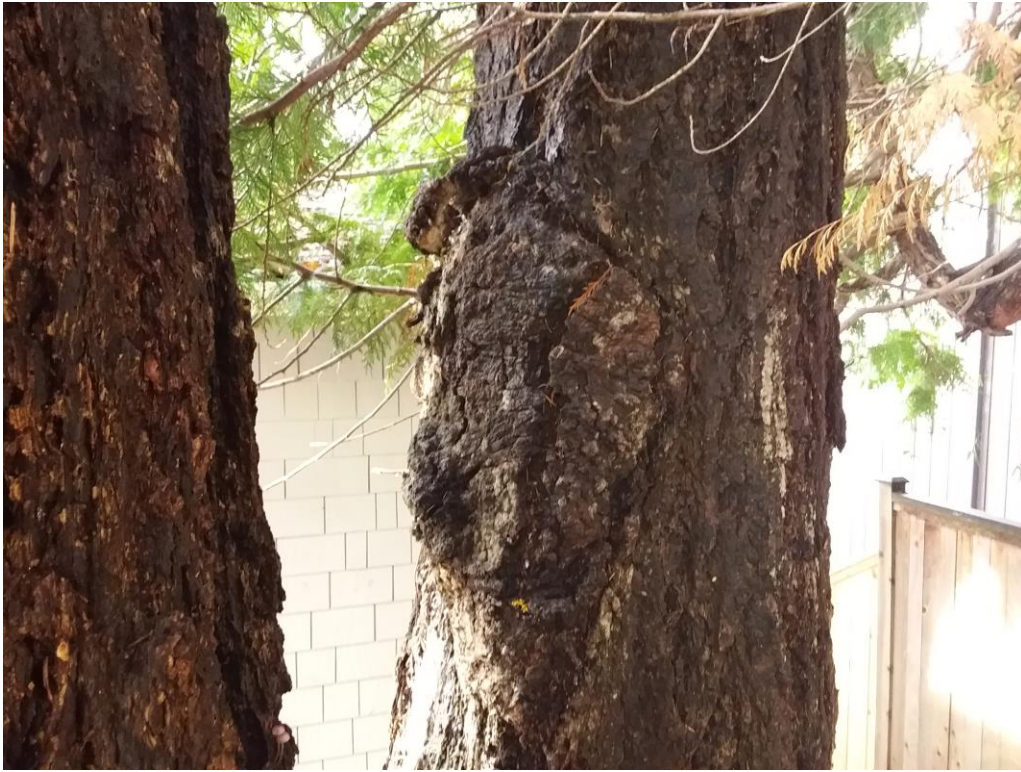
Figure 26. The other large canker at the base of the #7 tree.

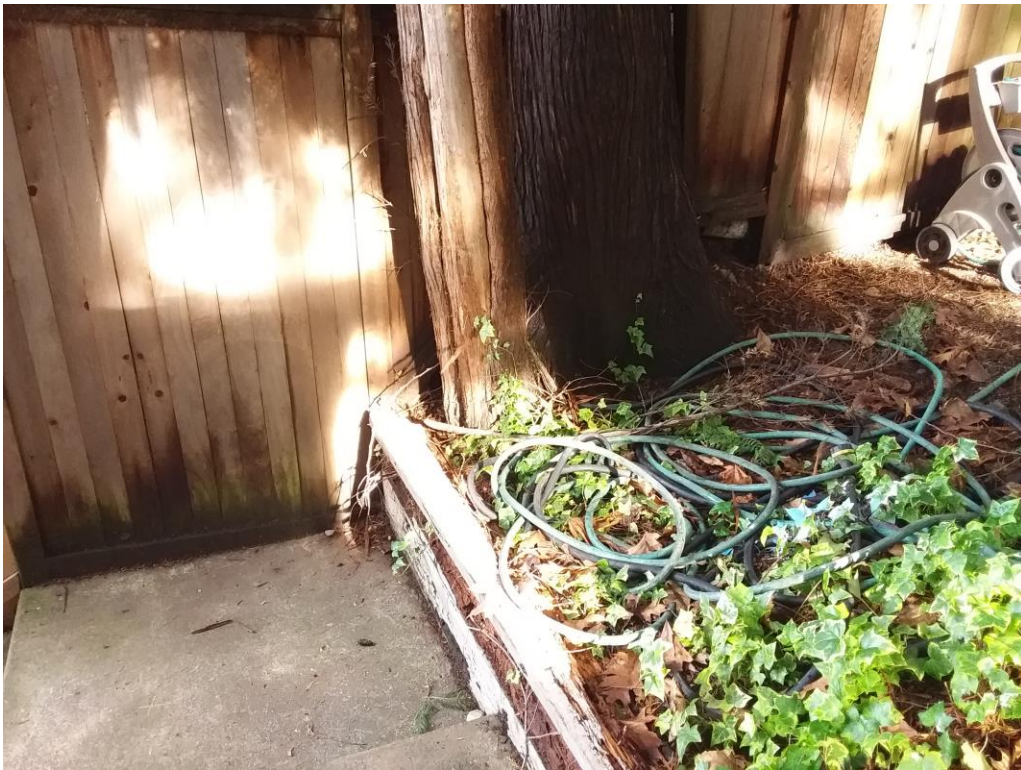
Figure 27. Looking down and north at the base of the #8 cedar. Note the wood retaining wall bowing out on the left (west) of the tree. The atrophy on the lower column of the subordinate spar is clearly visible.

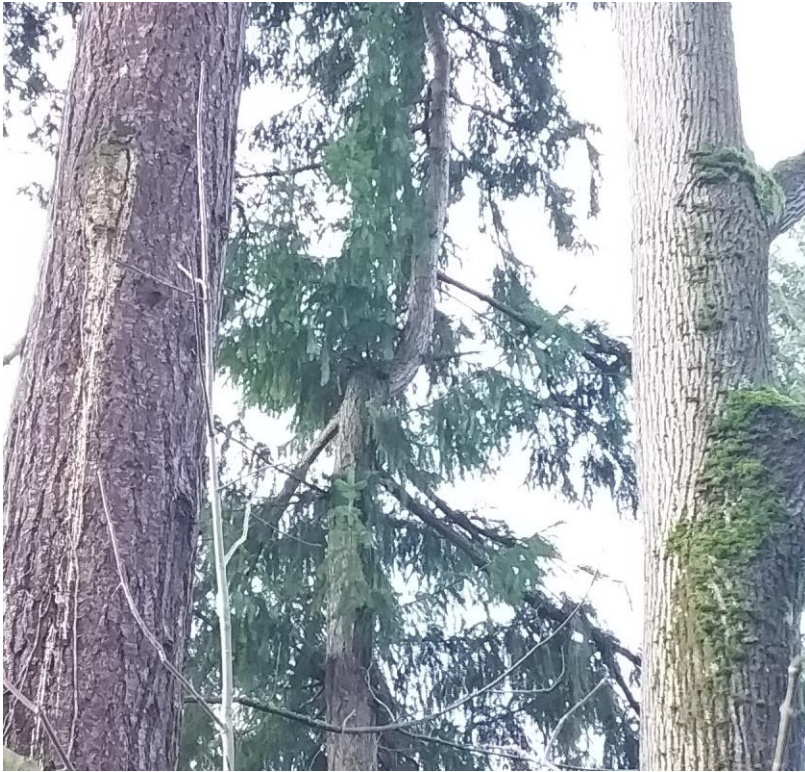
10. Douglas fir 20" DSH, 65' tall standing 9' E of the end of the retaining wall running down the east side of the lower driveway. Tree is in below average condition and its entire canopy goes to the west side. It leans slightly northwest from the base does not correct. Tree was damaged or topped near the 40' mark. It has a new leader that kinks markedly to the northwest turning vertical as it rises (Figure 29).

Figure 29. Looking up and west at the structural fault in the #10 tree.

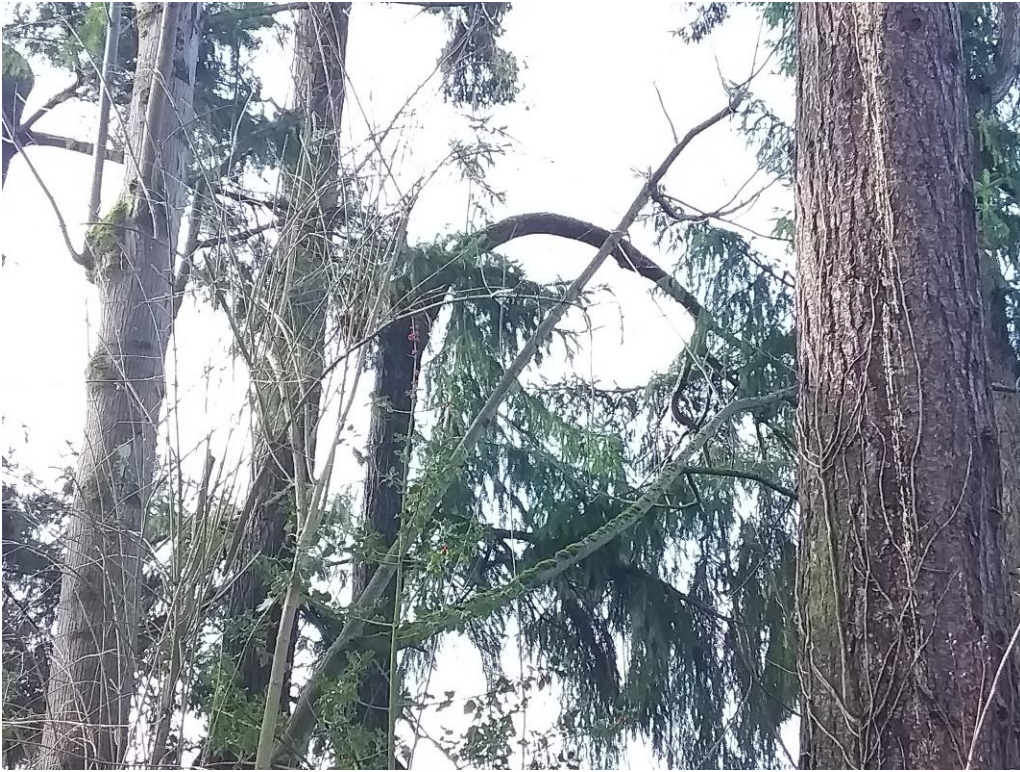
11. Douglas fir 20" DSH, topped near the 40' level, and now has one large leader bending over to the Northwest that extends nearly 25' over the driveway (Figure 30). It only has a couple of other live limbs. Base of the tree is 9' E of the east edge of the lower driveway and 17' N of the inside edge of the last curve of the driveway. There are fungal bodies at the cut point. Tree is in extremely weak structural condition.

Figure 30. Showing the spar coming off the top of the #11 tree.

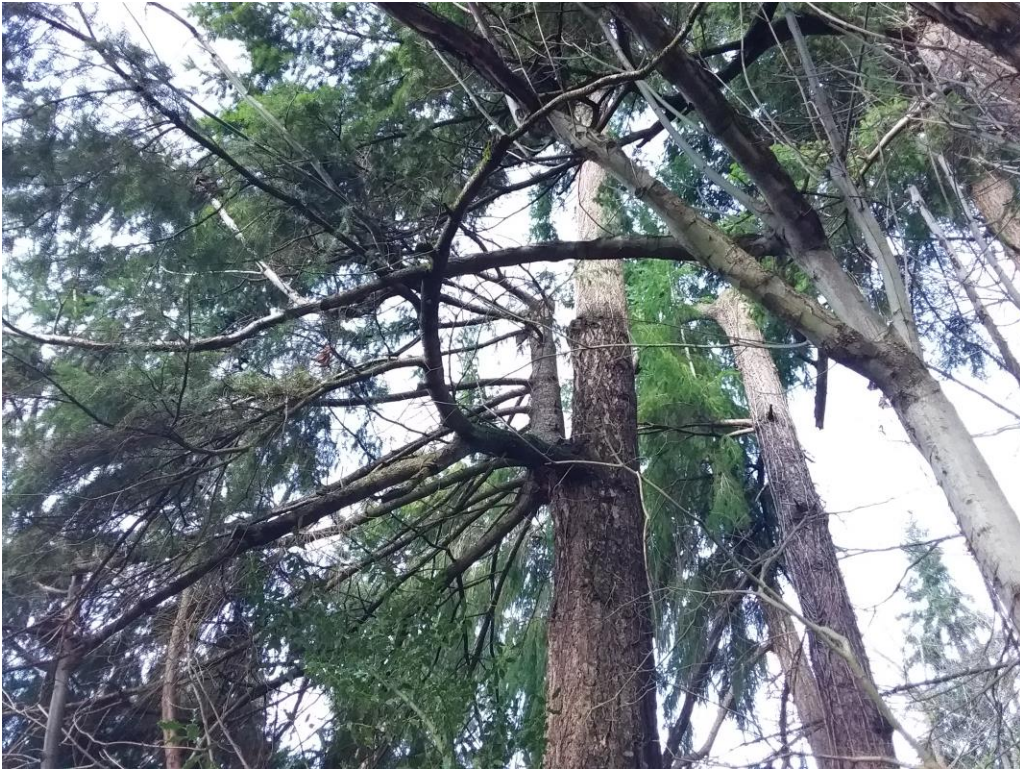
Figure 31. Showing subordinate spar coming off low on the column of the #12 tree.

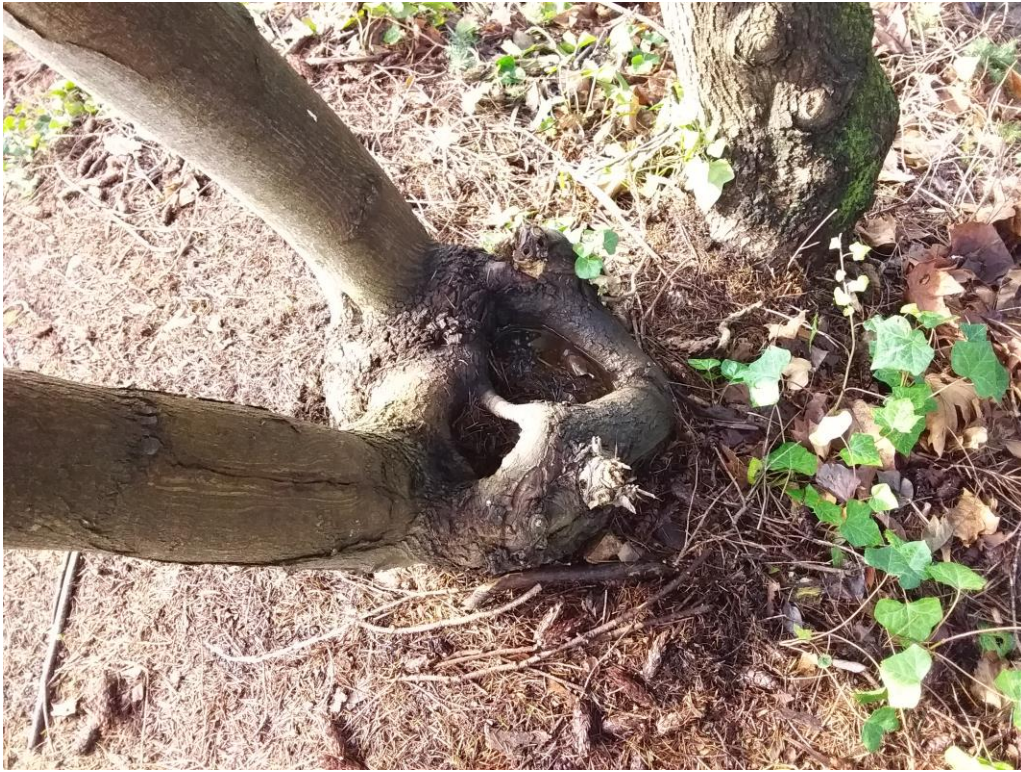
Figure 34. Looking down at the decayed base of one of the #13 maples.

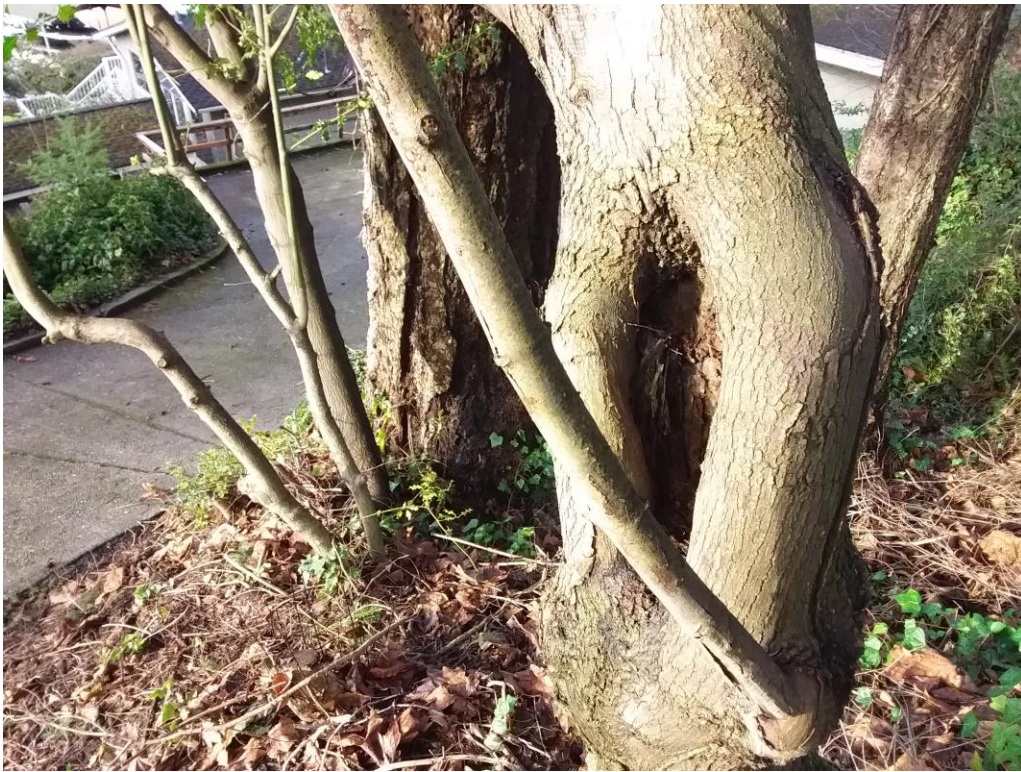
Figure 35. Decayed area at base of another of the #13 maple stems

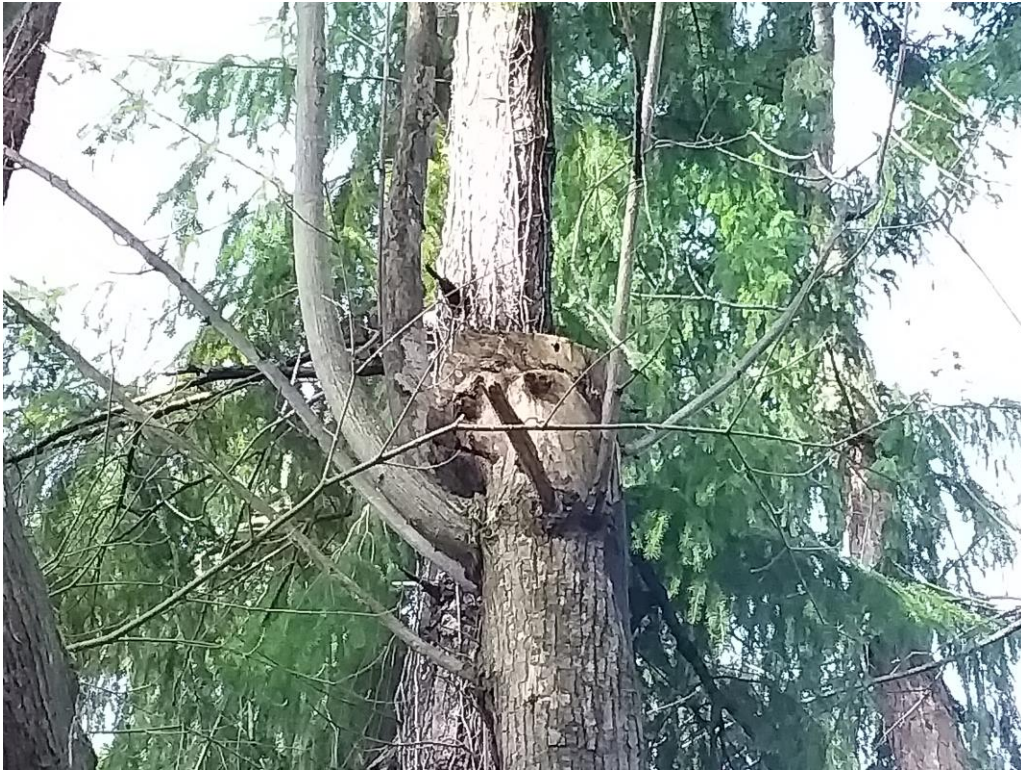
Figure 36. Decay at the topping point on one of the #13 stems.

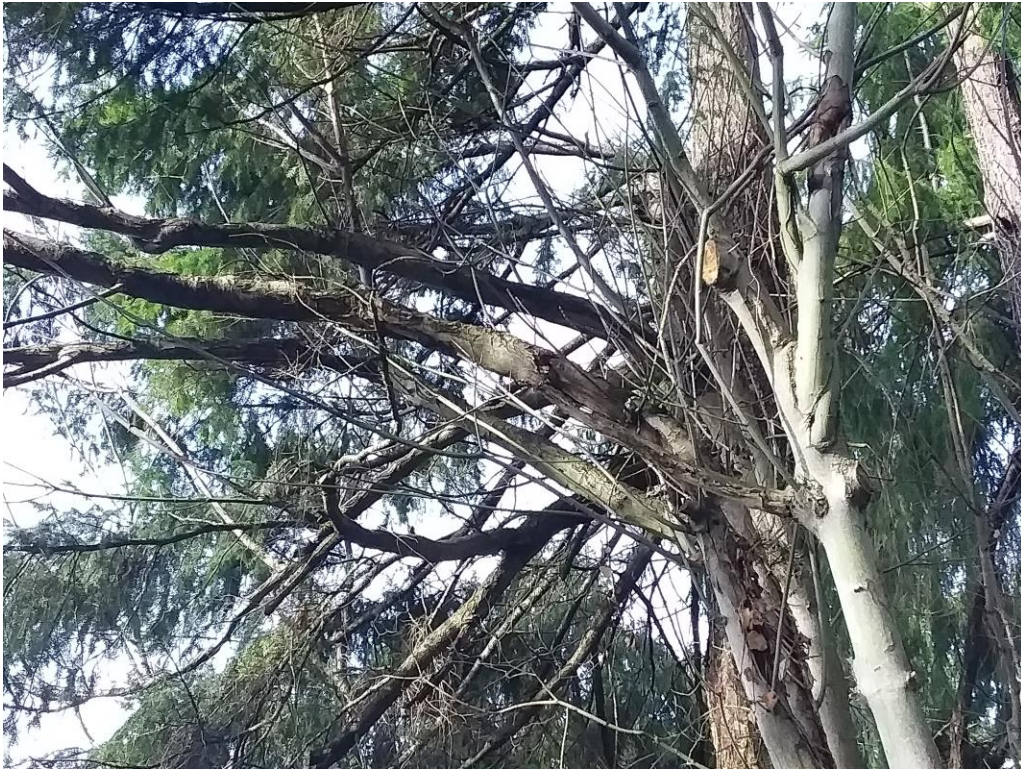
Figure 37. Sunscald on the branches coming off one of the #13 stems.

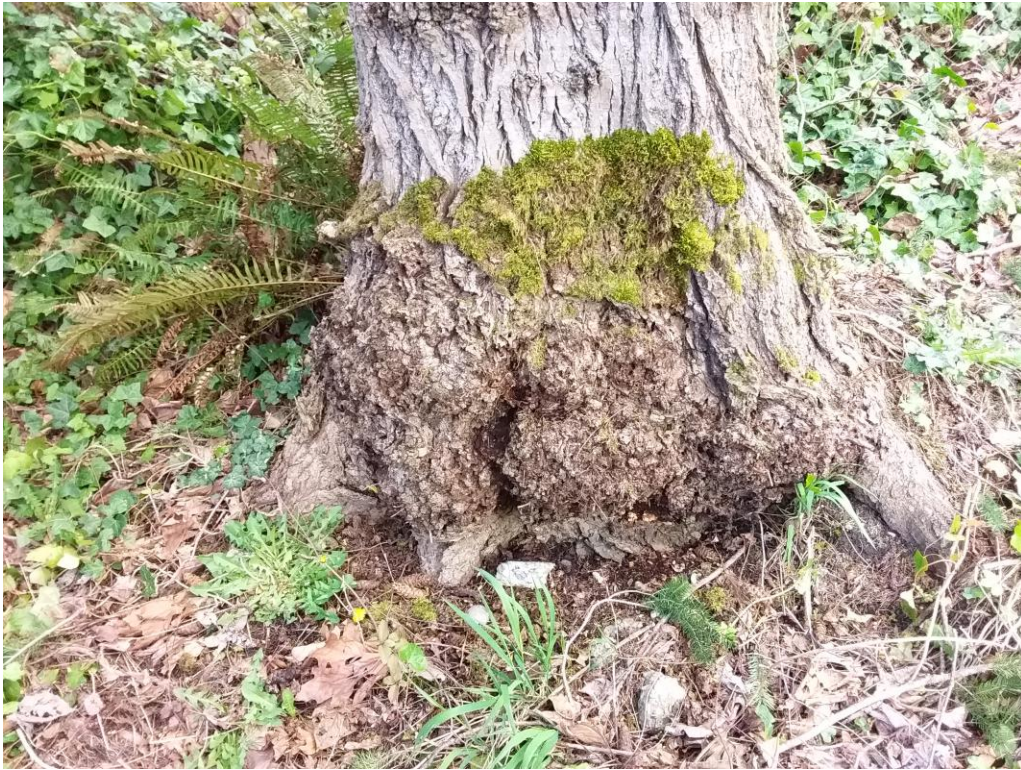
The #19 tree has a **probable likelihood of catastrophic failure** due to the degree of structural root damage and the advanced cankers along the lower trunk with their associated decay. It is tall enough to reach the 4649 home along with all the other targets listed above. It classifies as a **high risk**.

Figure 39. Canker on the south side of the #19 cottonwood's base.

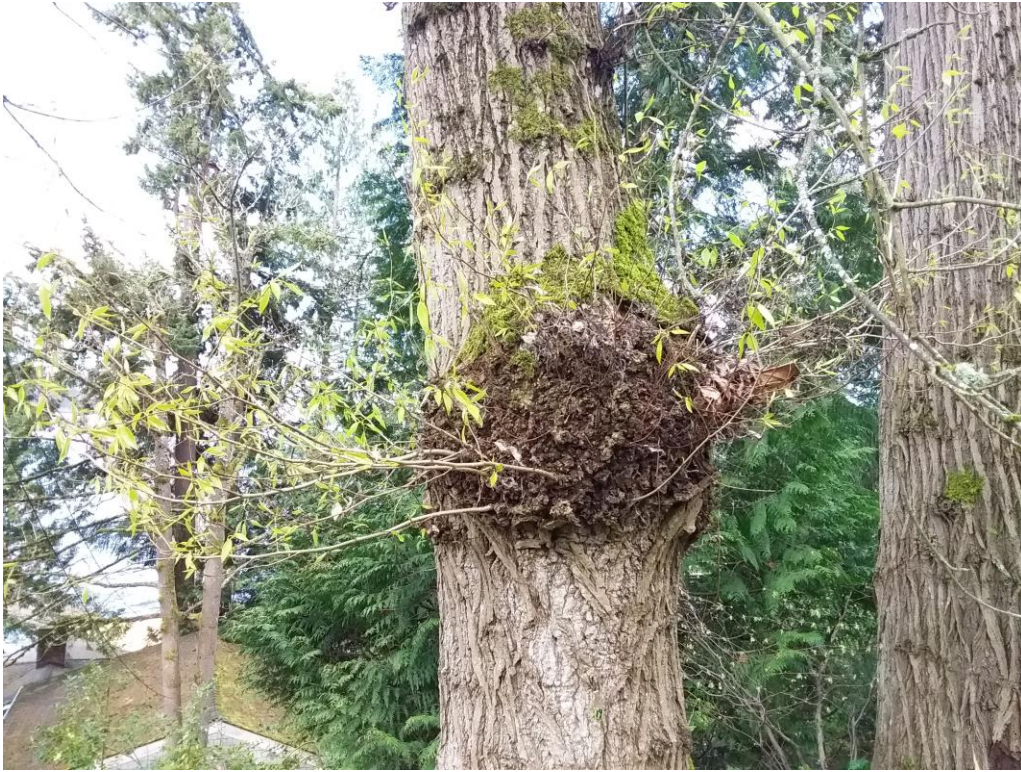
Figure 40. Canker at the 7' mark on the #19 tree.

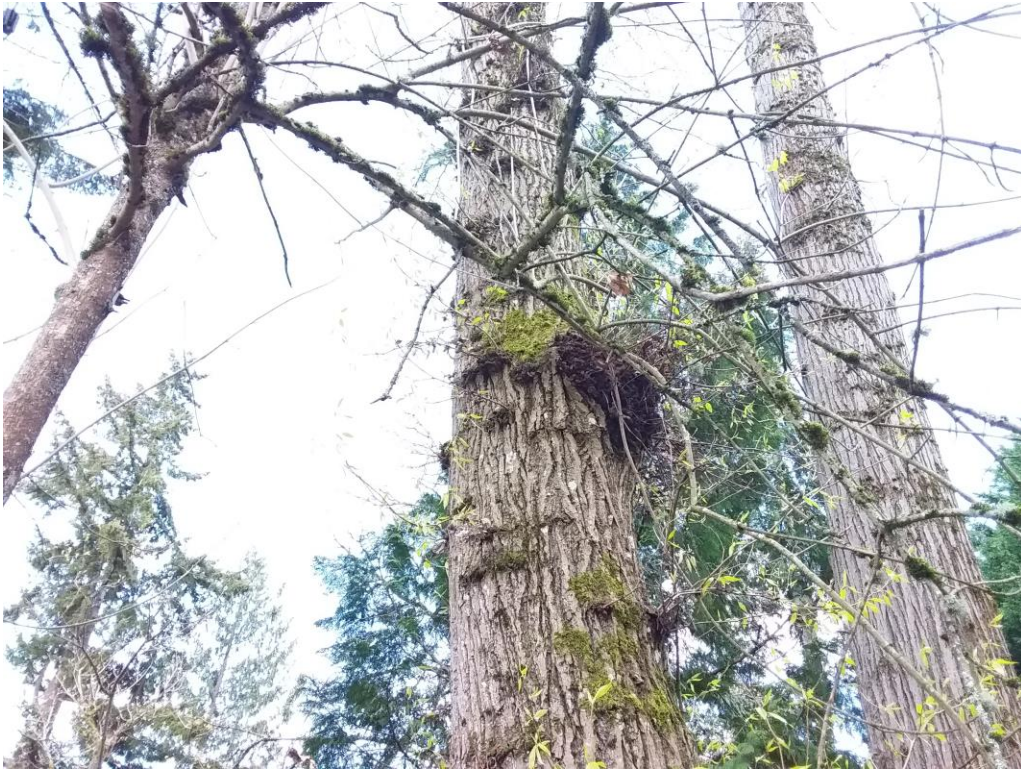
Figure 41. Looking at another structural root with pronounced decay.

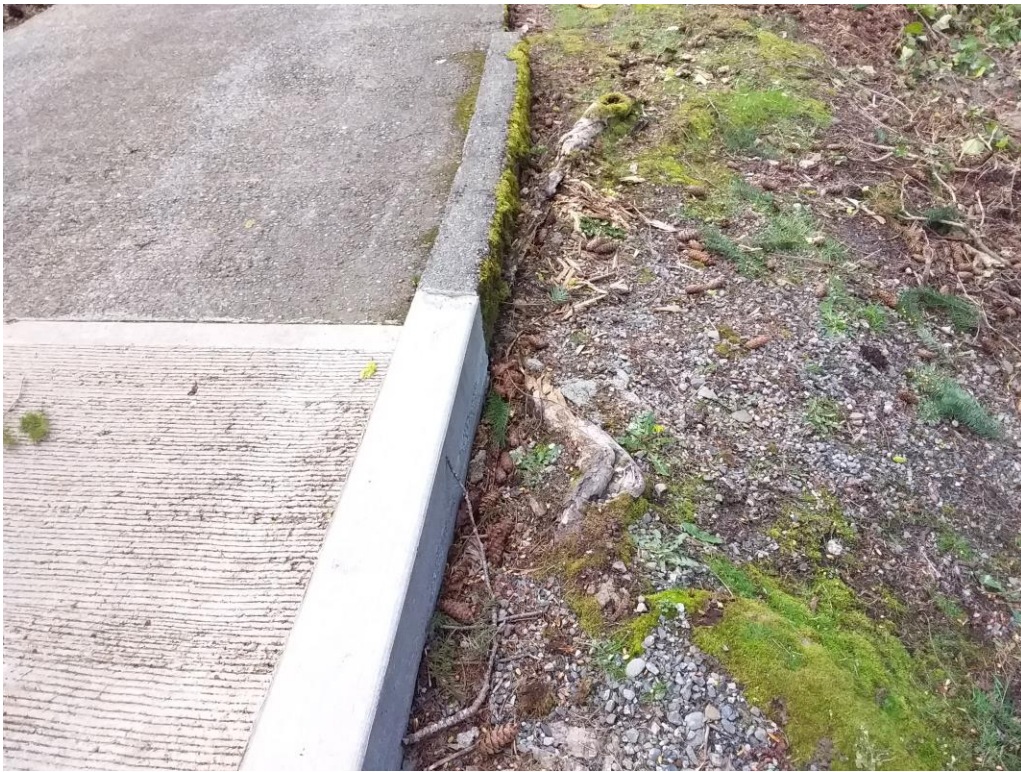
The #19 would be expected to have a 10' SRP. It does have large roots pressing up to and most likely under the existing entry drive which is only 7.5' away. The previous work on the driveway had to have cut through a large sector of the cottonwood's structural roots based on the proximity and extent. This tree should have been removed at the time due to impact concerns. The current driveway replacement impact will occur within its theoretical SRP.

Figure 43. One of the #19 cottonwood roots pushing up against the entry drive curb.

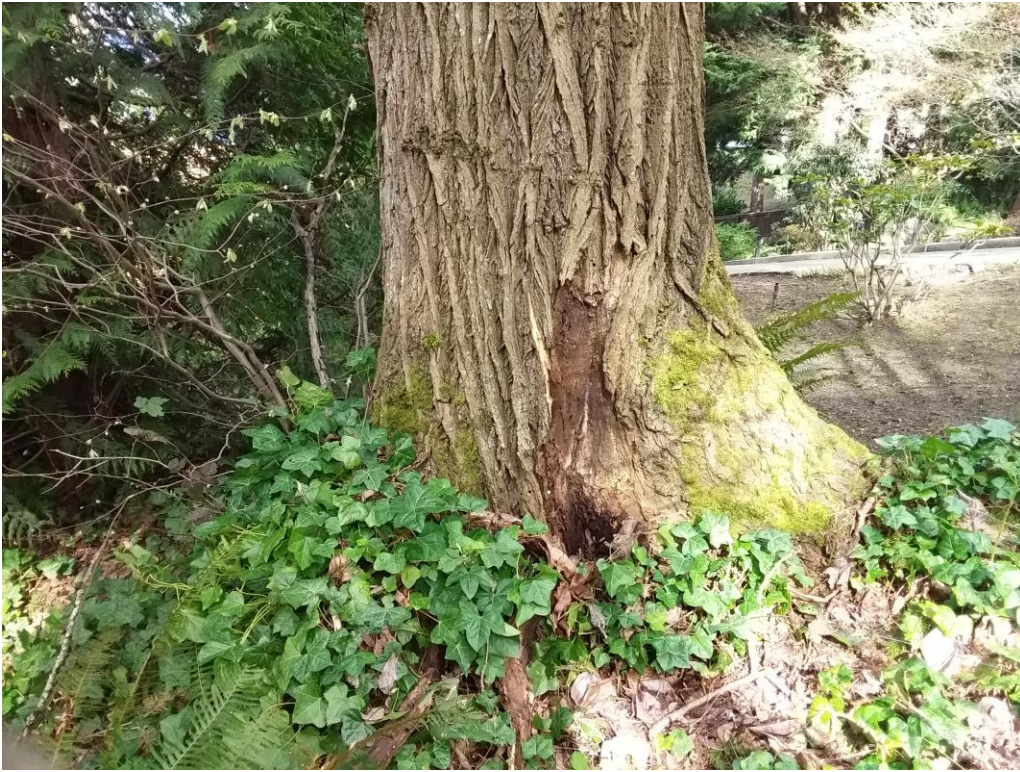
20. Cottonwood 33" DSH, 90' tall, more vertical than the #19 and 12' N of it. Scaffolds extend out as much as 40' mainly to the northwest. Two large ones cross over the neighbor's driveway to the north. One large one reaches west far enough to hit the subject garage. Some epicormic sprouting on this tree, decent new growth, fair color. Has an area of atrophy or damage at the base at the southeast face (Figure 44). The tree has reportedly dropped several large limbs across the driveway.

Figure 44. Decay at the base of the #20 cottonwood.

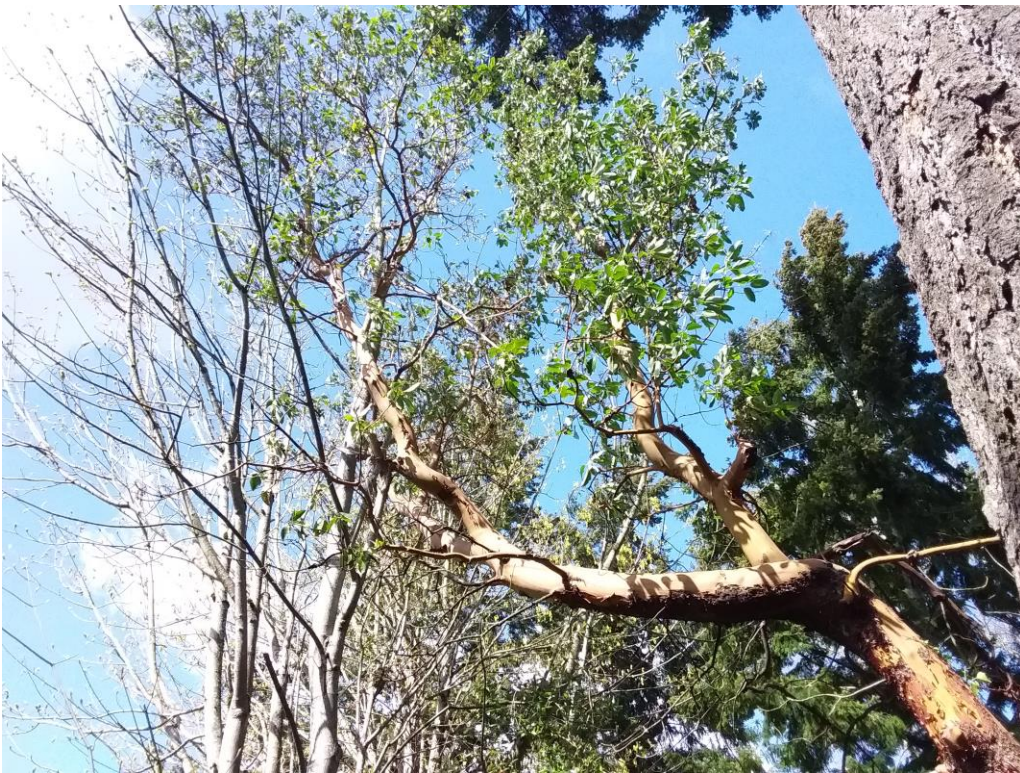
28. Pacific Madrone (*Arbutus menziesii*) 15" DSH whose base is 14' N of the #27. It grows SSW at a 40 degree angle from the base, kinks over to nearly horizontal near the 18' level, goes out another 8' nearly due southwest and bifurcates. One scaffold continues to go horizontal to the west-southwest; the other goes south and begins to turn upright. Another spar goes vertical from the first bend and up to do nearly the 45' level. Tree is in good condition with nearly a full canopy, very little canker sign, and only slight dieback. It crosses through the #26 maple and is rubbing it in a couple spots (Figure 47). Tree is Exceptional by definition.

Figure 47. Looking SW at the #28 madrone going through the #26 maple.

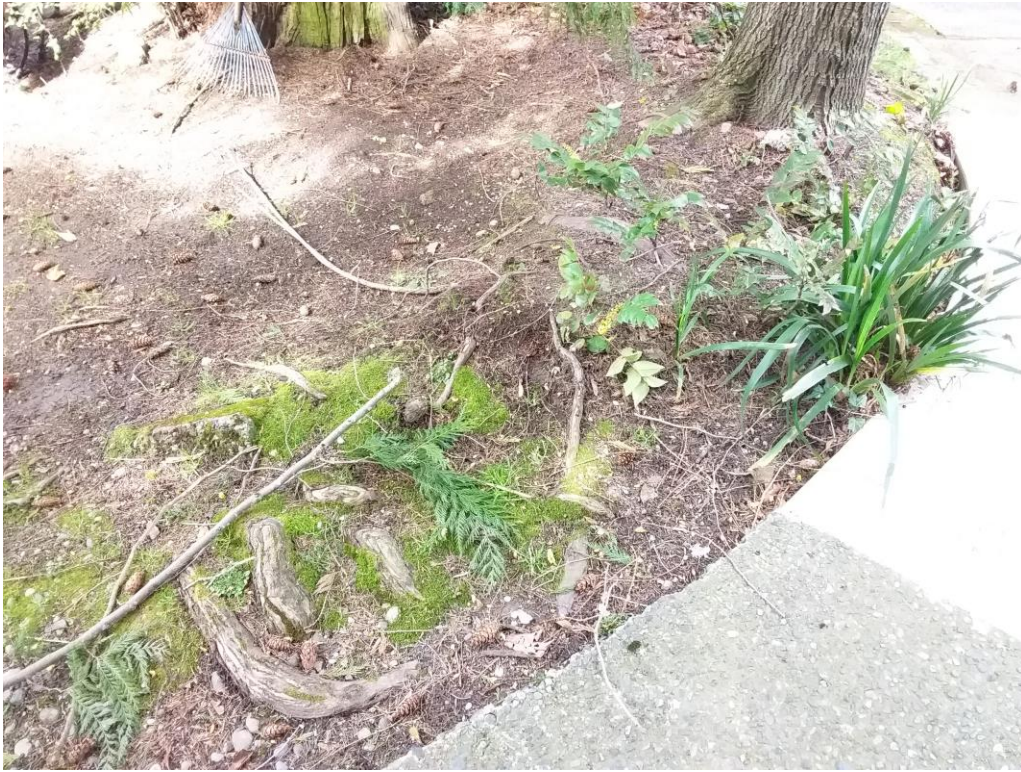
Figure 48. Roots of the #30 cedar pushing up against the driveway.

Either the #30 cedar or the #32 fir will have to be removed depending on the final layout of the driveway. Neither is in great condition but neither is in such poor condition that it can be condemned outright.
