November 6, 2024

Project: Pre-construction assessment for property re-development at 4661 Forest Avenue SE, Mercer Island, WA. Parcel number 4045000065.

Objectives: Evaluate health of existing trees and establish criteria for the preservation of those to be retained. Provide risk assessments as necessary.

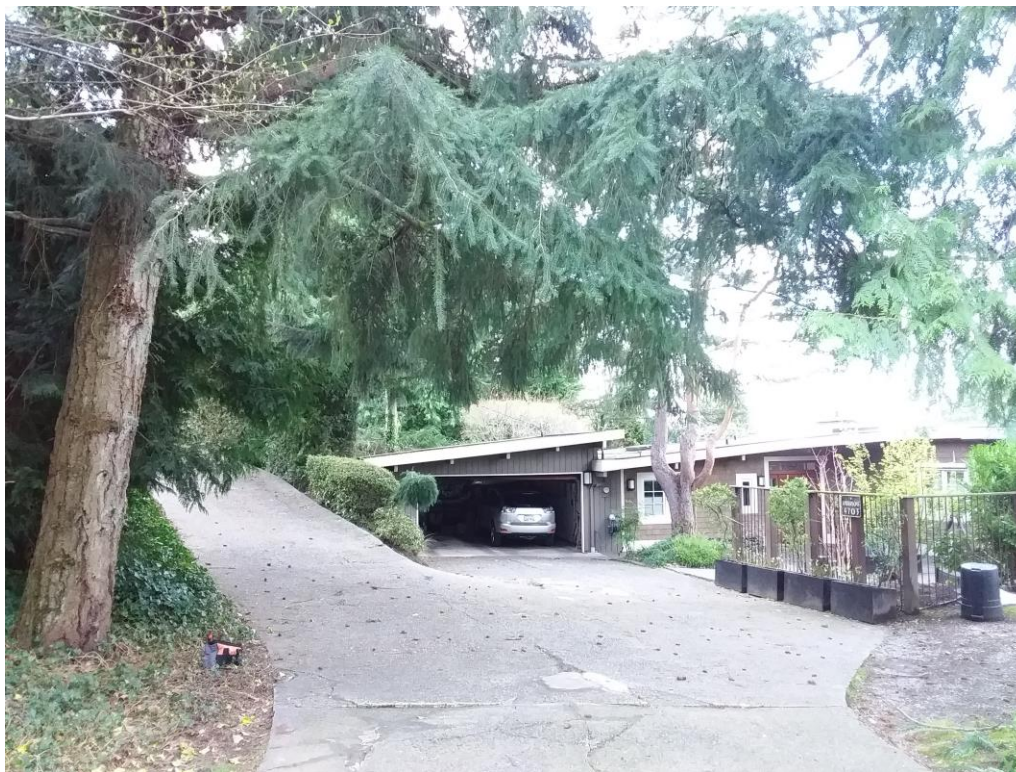
It appears on the site plan that the new driveway will set about 12" closer to the #32 fir. Which means that the cut for the edge forms could be 2.5' closer to the tree resulting in 30-40% of its existing SRP being severed on its west side. It will necessitate the removal of the fir. If there is a desire on the part of the home owners to retain the #32 tree then this part of the driveway will have to shift west to maintain the fir's existing root system undisturbed. It is a 'better' tree than the #30 cedar all things considered.

Figure 50. Looking south at the #32 fir extending over the driveway

Either the #30 cedar or the #32 fir will have to be removed depending on the final layout of the driveway. Neither is in great condition but neither is in such poor condition that it can be condemned outright.
