February 5, 2024  
PanGEO Project No. 23-386

Subject: Geotechnical Engineering Report  
Mercer Island Beach Club - Proposed Bulkhead Removal  
8326 Avalon Drive, Mercer Island, Washington 98040

**GEOTECHNICAL ENGINEERING REPORT**  
**MERCER ISLAND BEACH CLUB - PROPOSED BULKHEAD REMOVAL**  
**8326 AVALON DRIVE**  
**MERCER ISLAND, WASHINGTON**

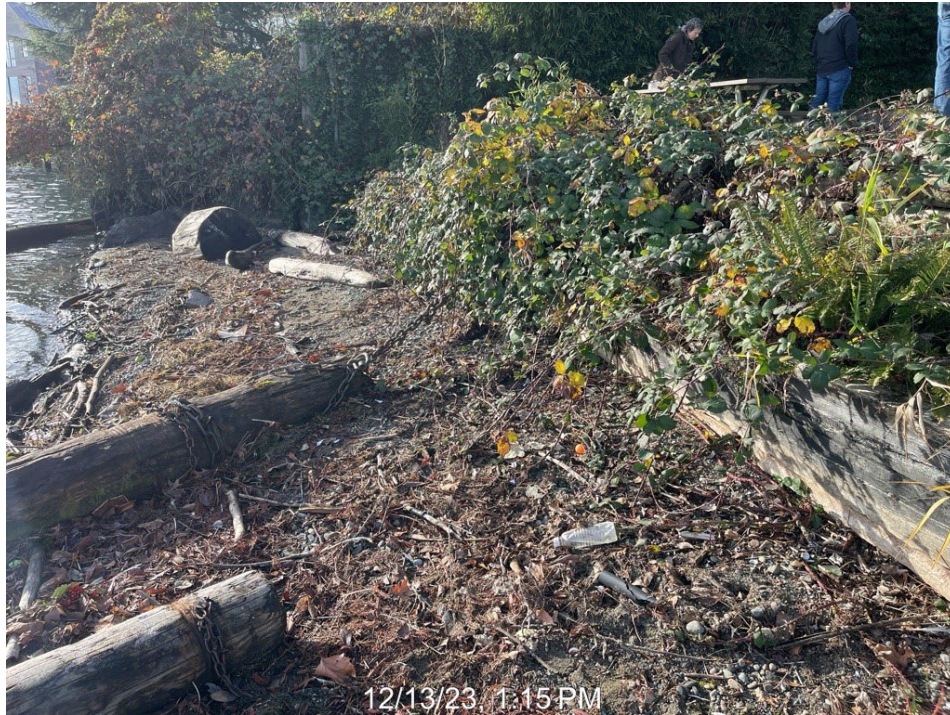
**Plate 1.** Looking south along shoreline of Lake Washington at failing timber bulkhead

We understand that the proposed development plan includes the removal of the low timber bulkhead that is currently failing, as well as several boulders that are functioning as part of the bulkhead. In addition, the fill soil behind the bulkhead will be removed, so that the area can be re-graded at a low angle to generally match the existing beach area directly north of the bulkhead removal area.

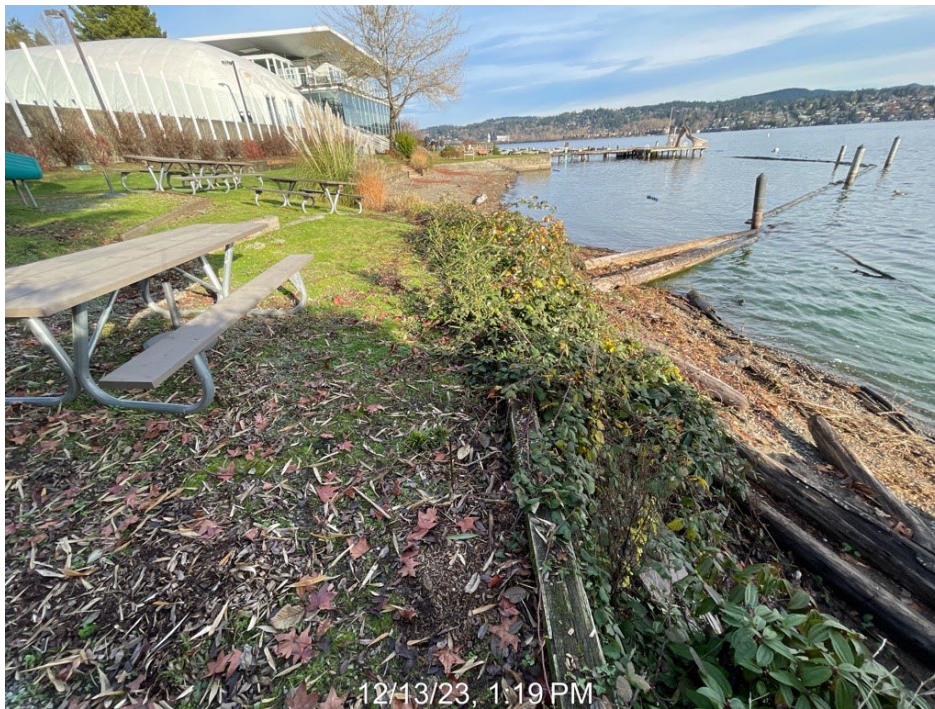
**Plate 2.** Looking north along top of failing timber bulkhead

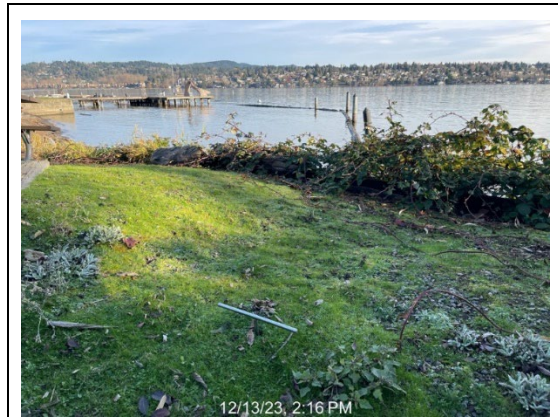
**Fill:** We anticipate that the area upland of the failing timber bulkhead was originally a beach, and therefore backfill was used to raise grade behind the bulkhead. Using a ½-inch diameter soil probe, we were able to easily probe to a depth of three feet below the ground surface in the area behind the existing bulkhead (see Plate 3 to the right). Based on the loose nature of the soil, and the location, we interpret the soils behind the bulkhead to be fill.

**Plate 3.** Note 3-foot-long steel hand probe pushed to full depth through loose fill soils.

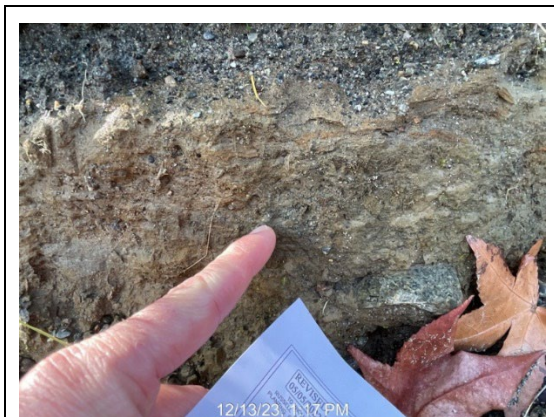
**Plate 4.** Exposed soils at the base of the failing bulkhead consisted of dense silty fine sand and very stiff sandy silt.

**Pre-Olympia Deposits:** We observed exposed soil conditions along the base of the deteriorating bulkhead to consist of dense silty sand and very stiff sand silt, which we interpreted to be the mapped older nonglacial deposits. We were unable to probe more than an inch into this soil unit with the ½-inch diameter steel hand probe. Plate 4 to the left depicts soils exposed at the base of the failing bulkhead.

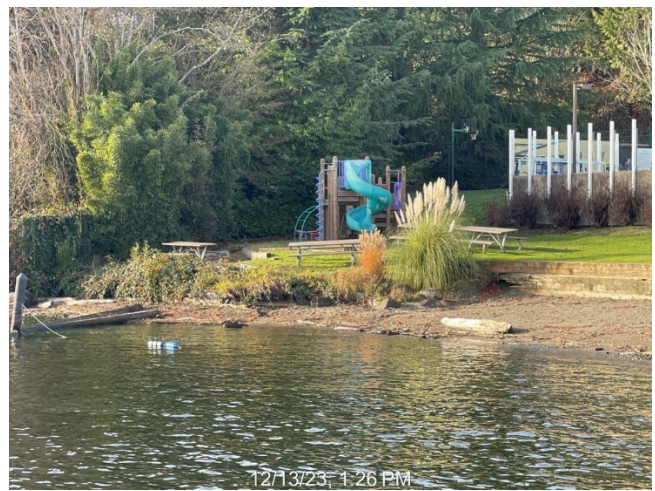
We observed the topography of the site in and around the area of the proposed bulkhead removal to be only gently sloping down to the east, towards Lake Washington. Plate 5 on the following page depicts ground conditions in the proposed bulkhead removal area.

***Plate 5.** Looking southwest at area of proposed bulkhead removal. Bulkhead is located below the picnic tables, but is obscured by vegetation growth.*

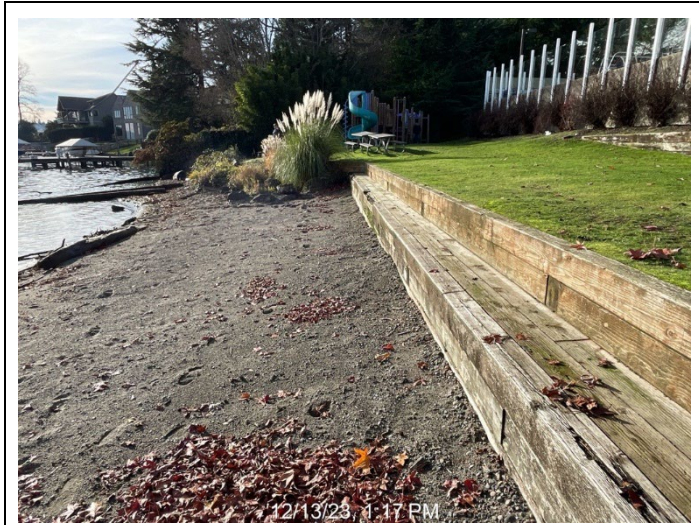
**Plate 6.** Looking south along existing beach area. Proposed bulkhead removal area in the distance. Proposed beach reconstruction will generally match the existing beach condition shown in photo.
