LAYTON TREE CONSULTING, LLC

ARBORIST REPORT

5330 Butterworth Road
Mercer Island, WA

March 11, 2025

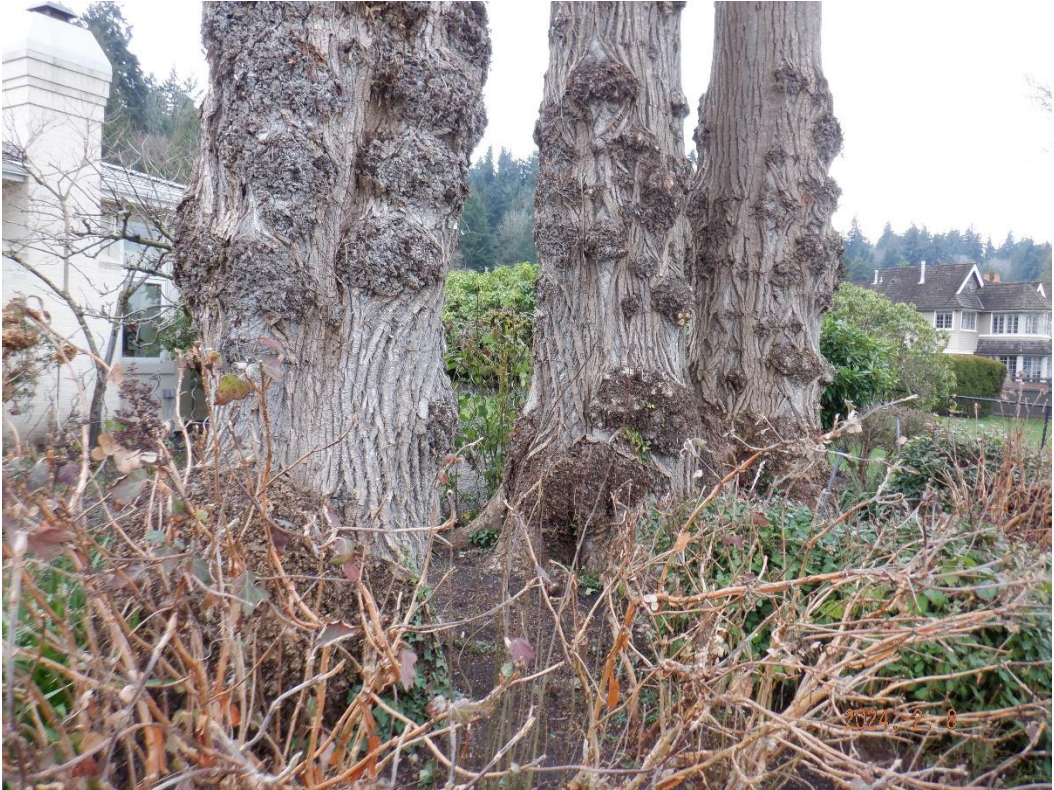
Lower trunks, #38, #39 and #40

Trees #38, #39 and #40 are semi-mature to mature black cottonwood. #39 has advanced decay within the mid and upper stem, evident by nesting holes or open cavities. There is an elevated risk of trunk or stem failure. These are not sustainable long-term and pose an elevated risk to nearby targets. These are being removed under a separate tree removal permit through the city.
