Arborist Report

Inventory and assessment of regulated and exceptional trees for proposed home renovation.

9640 SE 61st PL
Mercer Island, WA 98040
Parcel #4260000050

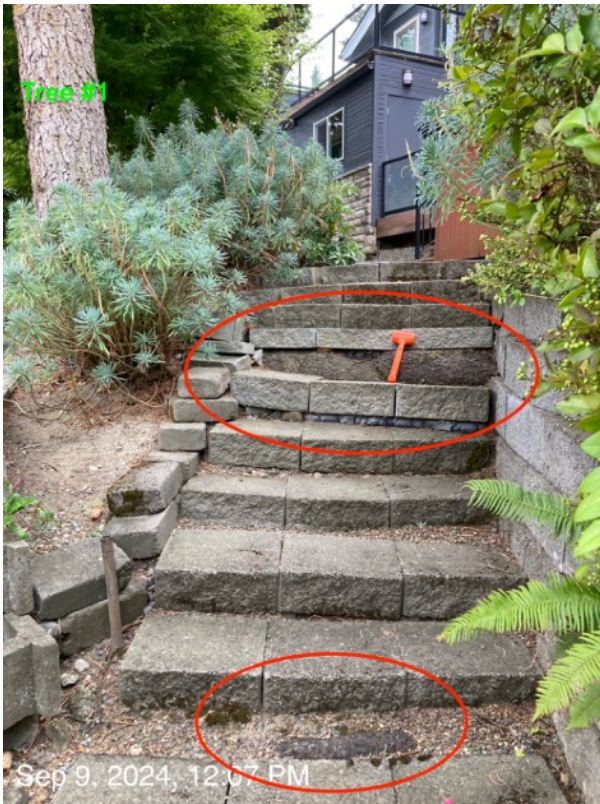
- Tree #1-Noted as healthy and vigorous throughout crown trunk and roots. Roots noted as severely limited on the east by a 4' tall block retaining wall. Response growth in roots is 100% away from 4' wall, under an adjacent staircase and a 2' retaining wall, directly to the NW. Stairs to NW noted as damaged, lifted and repaired using spray foam to support stairs around roots, Roots have displaced all soil under 2 stairs in the middle of the staircase.

- Tree #1-It is my professional opinion that the subject Blue Spruce has caused the aforementioned damage to adjacent wall and stairs due to root growth and soil displacement and is unlikely to survive needed root pruning required to make repairs to adjacent wall and stairs. Replacement tree planting will be required at 2:1 ratio, for trees >10" up to 24", as part of development plan. No impact is expected on adjacent retained trees due to the removal of the subject spruce.

Subject tree #1 has caused significant damage to stairs and wall to NW due to soil displacement from root growth.

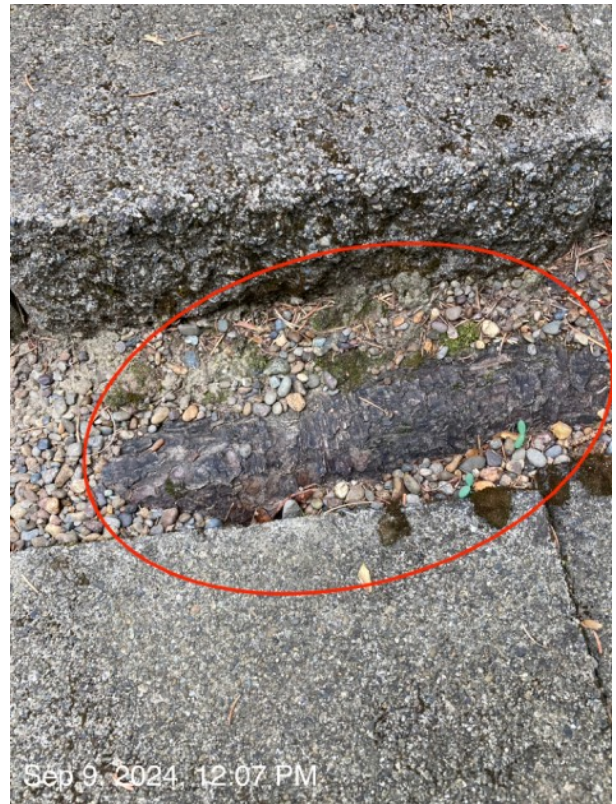
Large exposed roots would need to be cut to repair stairs, leaving tree #1 non-viable and non-wind firm.

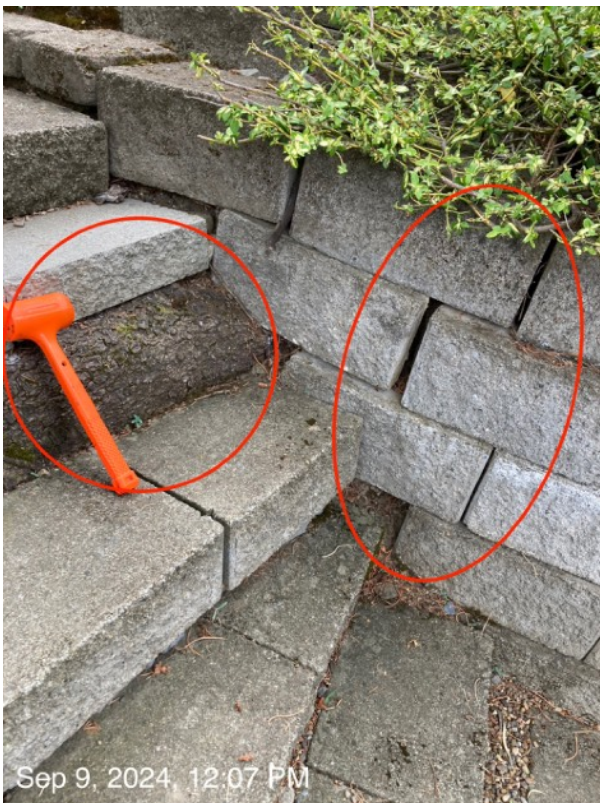
Significant damage from tree #1 to adjacent block retaining wall. Cutting of the offending root would leave the tree non-viable and non-wind firm.

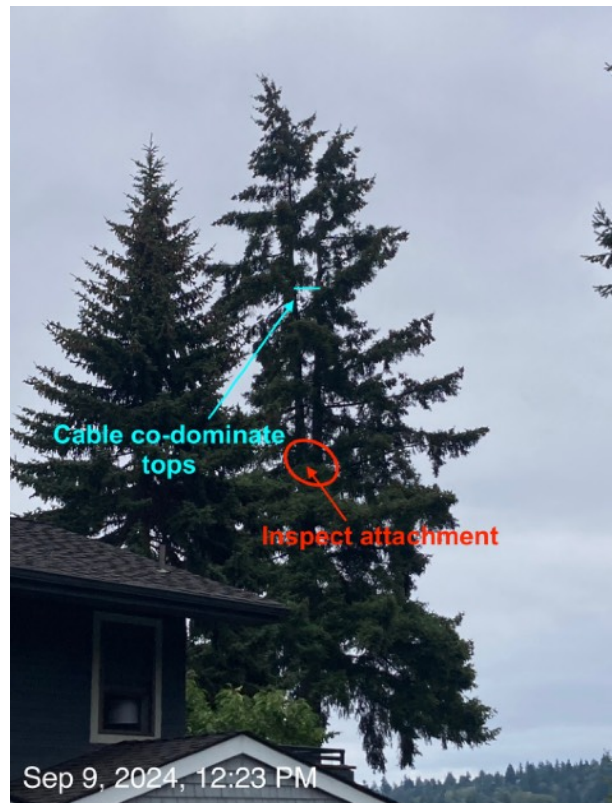
- Tree #2-Noted as healthy and vigorous throughout crown trunk and roots. Trunks noted as co-dominate @50'. Root collar noted as covered in English Ivy.

Tree #2 was found to be healthy and vigorous and well outside of the proposed area of activity. Inspection of the co-dominate attachment point and cabling is recommended, by a certified arborist.

- Tree #2-Retain and monitor. Attachment point of co-dominate tops should be areal inspected by a certified arborist for signs of failure, decay or severely included bark. Cabling of co-dominate tops at 2/3 height of tree, from split is also recommended. Root collar should be kept free of English Ivy. With no crown overhanging proposed area of disturbance and no construction activity or traffic within critical root zone, no tree protection measures should be necessary.

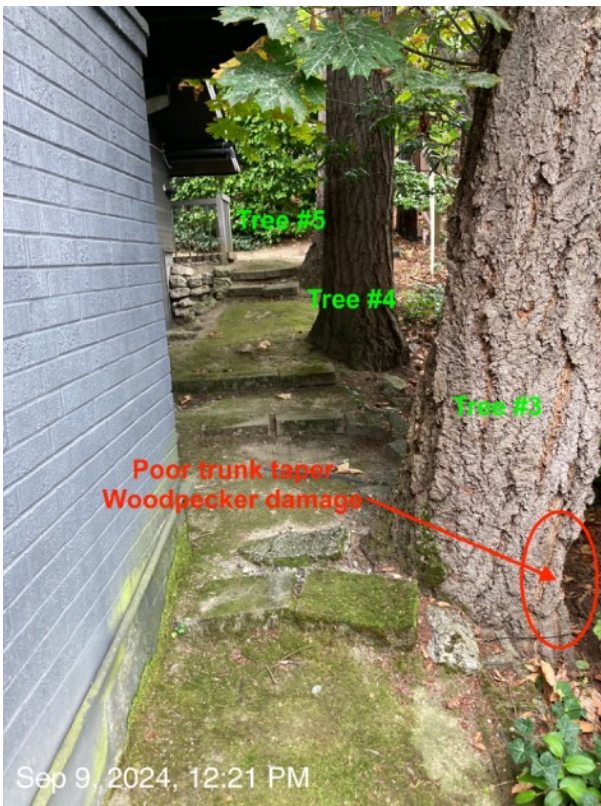
Trees 3-5 all grow in extreme proximity to home which will limit tree protection measures to signage on trunks. Poor trunk taper was noted on tree #3.

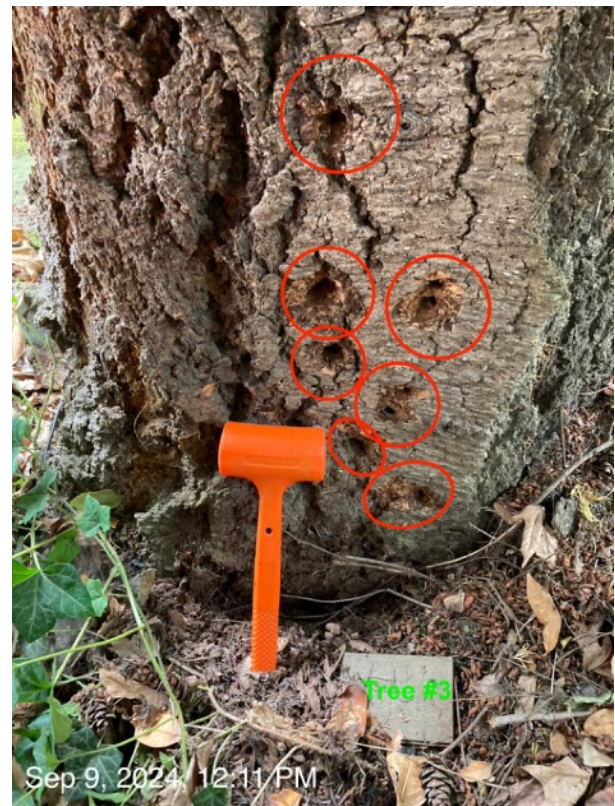
- Tree #3-Noted as vigorous throughout crown. Roots noted as severely limited on S by home foundation, within 3' of trunk. Roots limited to N by 8' high rock retaining wall. Trunk noted as having poor taper on N side with extreme response growth adjacent to area of poor taper. Multiple 1-2 inch diameter woodpecker holes noted in trunk, in area of poor taper. Hole depth is not into cambium layer at this time. Sounding of trunk yielded crisp tones.

Area of poor trunk taper on #3 was found to contain multiple woodpecker holes. Woodpecker feeding indicates insect presence and can be an indicator of interior decay. Holes were found to not be into cambium layer and response growth is excellent at this time. Retain and monitor

- Tree #3-Retain, monitor trunk for increased woodpecker activity. While poor trunk taper may indicate internal decay, response growth was found to be excellent and likelihood of whole tree failure was found to be no greater than possible, within the specified timeframe. Due to extreme proximity to home with concrete walk between tree and home, tree protection measures will be limited to laminated signage stating "protected tree" attached to tree trunks with tape. No excavation nor storage of materials shall be allowed within critical root zones for the duration of project. Pruning should be limited to crown raising, if needed for second story renovation, and be performed by a certified arborist.

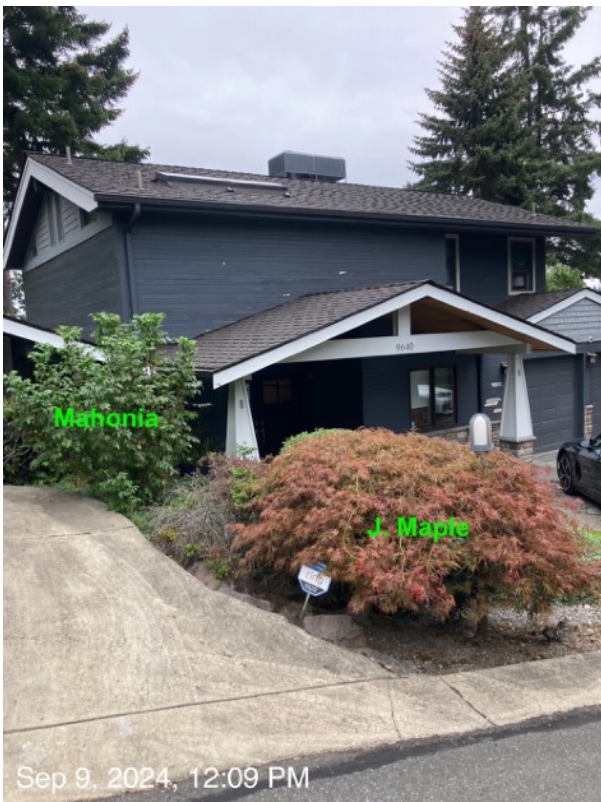
- Small planting bed adjacent to front door of home-Small J. Maple and Mahonia noted as being of high quality and vigor. All others reported as poorly pruned.

Only the J. Maple and Mahonia shrub were found to be worth saving in front bed.

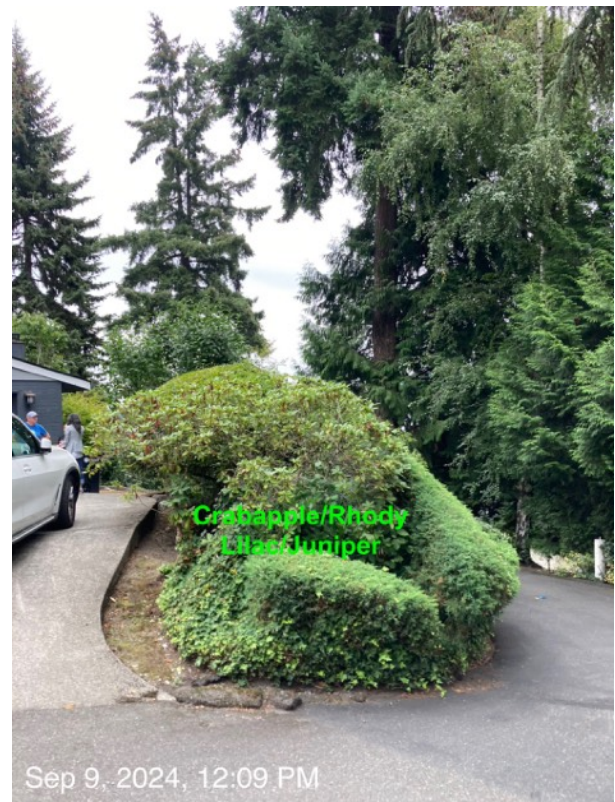
- Planting bed east of driveway-All shrubs noted as topiary pruned and sheared and of poor specimen quality due to pruning history.
- Flowering cherry E of home-Crown noted as previously reduced for view. Roots limited by an adjacent retaining wall which is failing and to be replaced. Tortrix beetle frass noted on trunk.

All trees/shrubs in bed to E of drive have been topiary pruned and could be replaced with more site appropriate trees/shrubs.

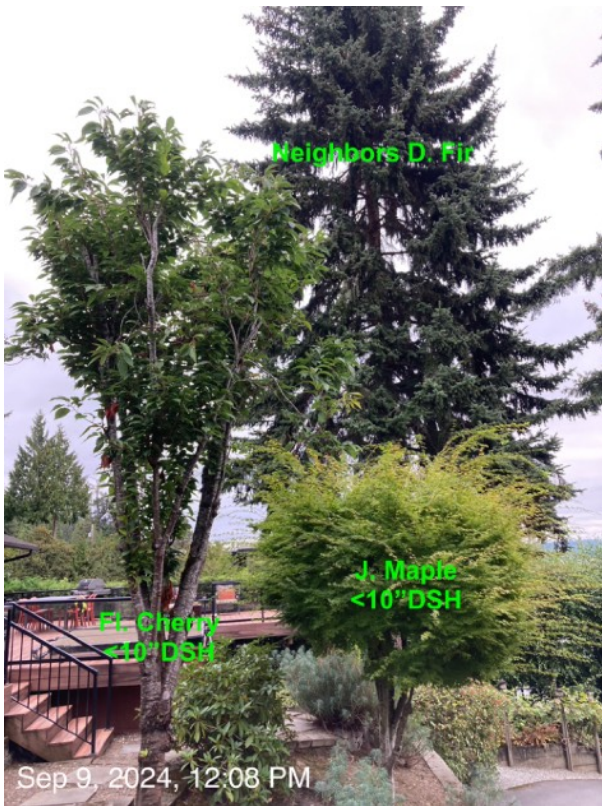
Non-regulated Fl.Cherry and J. Maple to E of house have been poorly pruned and are site inappropriate for view. Removal and replacement is recommended.

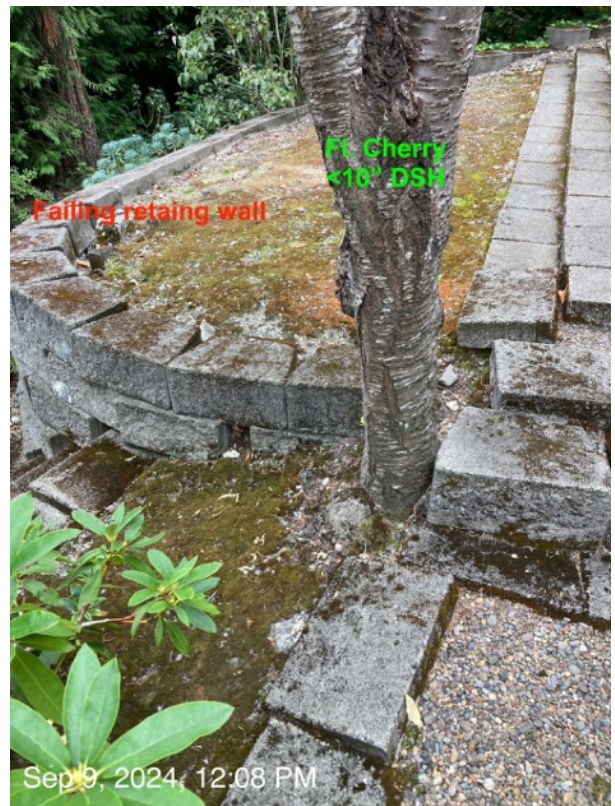
Extreme proximity to walls needing to be repaired of non-regulated Fl. Cherry make likelihood of survival low. Removal and replacement is recommended.

- Flowering cherry E of home-Due to proximity of wall being demolished, history of crown reduction pruning and high propensity for disease and infestation, the subject cherry is unlikely to survive demolition, is too large for transplanting and has a low likelihood of becoming a specimen quality tree. Removal and replacement is recommended. Tree replacement ratio for removed trees <10" DSH is 1:1.

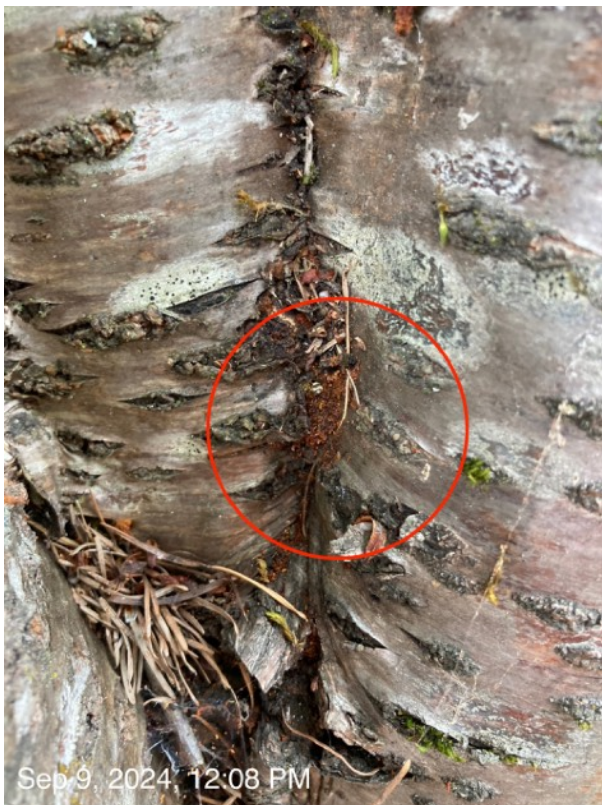
Tortrix beetle frass noted on trunk of Fl. Cherry.

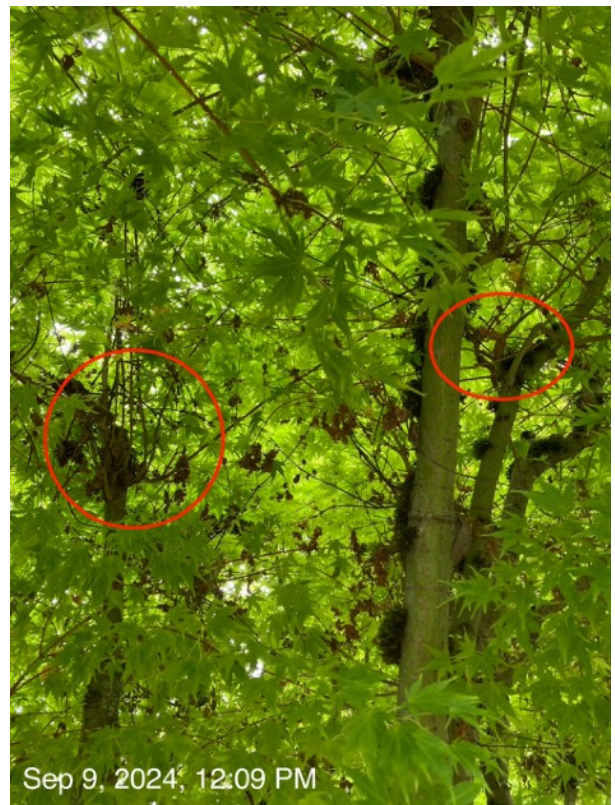
- Japanese Maple to E of home-Crown noted as severely reduced for view with vigorous response growth. Roots limited by retaining wall to E, which is failing and to be replaced.

J. Maple to the E of home has been severely headed. Crown restoration would take many pruning cycles and block view at a natural height.

- Japanese Maple to E of home-Due to proximity of wall being demolished, the subject J. Maple is unlikely to survive wall demolition. Due to history of crown reduction pruning, major crown restoration pruning, over many years, would be required to improve crown form to a semi-natural state. Due to size and location, transplanting would likely be costly and survival would not be guaranteed. Removal and replacement is recommended. Tree replacement ratio for removed trees <10" DSH is 1:1.

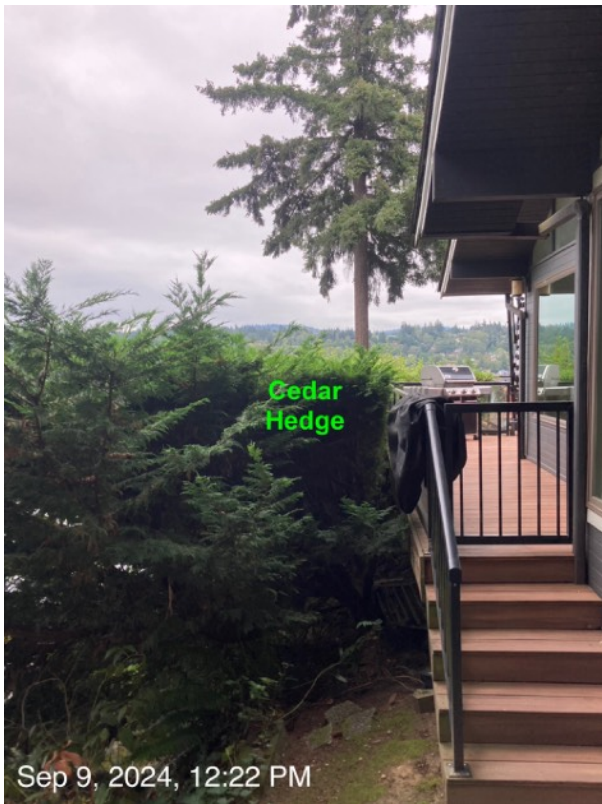
- Hedgerow on N property line-Noted as a mix of Cedar, Filbert, European Birch and Cherry which have been formally reduced on all sides and top to maintain view and property clearance. Trunks noted as covered in English Ivy. Cedar portion of hedge noted as overgrown on sides, overhanging neighbors home to N and in contact with deck on S.

Cedar portion of hedge on N property line noted as overgrown on sides. Cutting back may leave trees non-viable. Eventual removal and replacement with more site appropriate species.

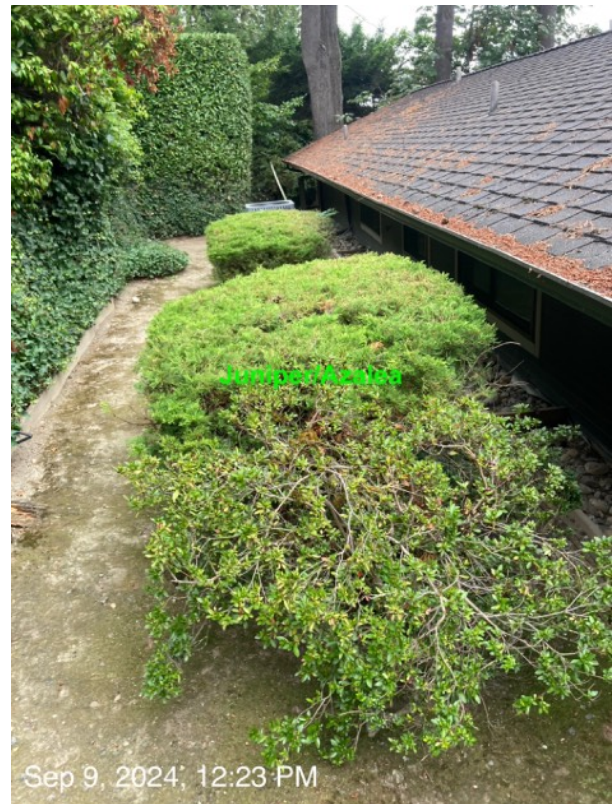
- Juniper and azalea hedge W of home-Noted as moderately vigorous and topiary pruned. Site conditions noted as severely compacted soil with low organic content.

Site conditions to W of home are noted as very poor and require amendments if plants are to thrive in this site.

- Juniper and azalea hedge W of home-Due to extremely poor cultural conditions, it is unlikely that the hedgerow to the west of the home will ever increase in vigor. Removal and replacement, along with major cultural improvements including soil amendments and de-compaction is recommended.

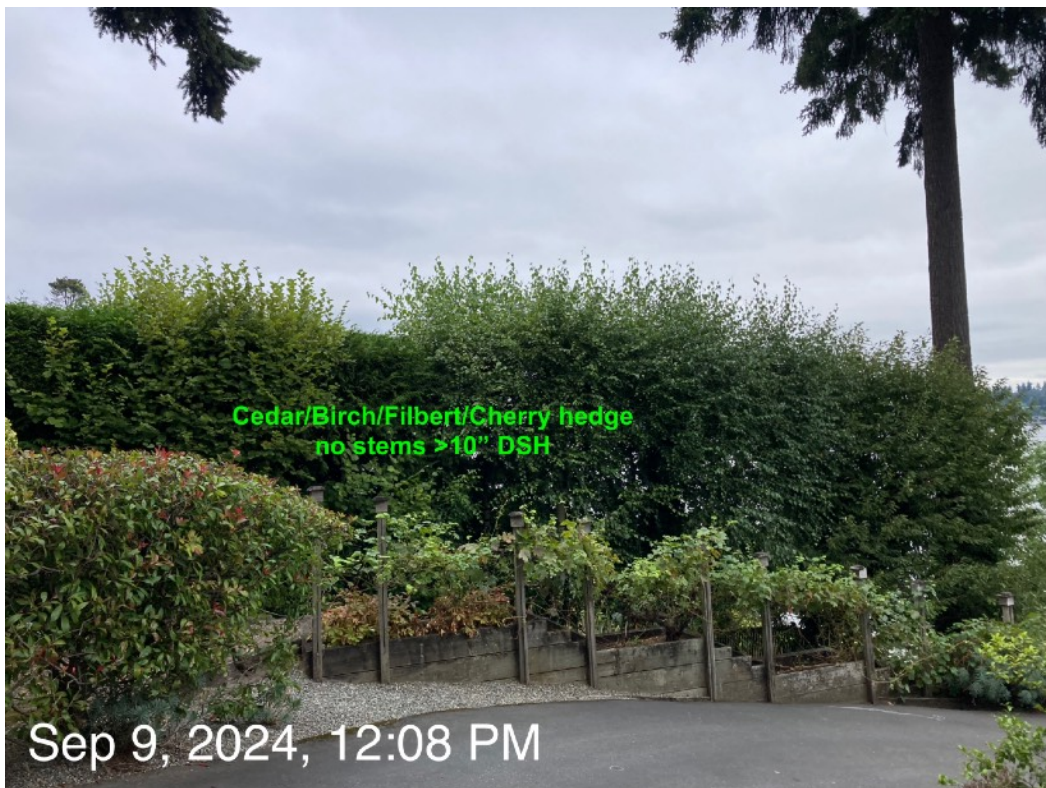
Hedge on N property line is mixed species, all of which are not generally recommended to be used in a privacy hedge which requires repeated reduction. A more appropriate species might be Yew, shore pine or Portuguese laurel.

- Hedgerow on N property line-While species within the subject hedgerow have performed adequately, the species within the hedge are not species which are generally used in hedges and generally do not perform well when being repeatedly reduced. At some point it is highly likely that the required reduction for view maintenance and clearance of neighbors property/deck will leave some or all of the trees within the subject hedge non-viable. In the future, if trees become non-viable, removal and replacement with more site appropriate trees, fencing or trees which are better suited for reduction pruning, may be required.
