Arborist Report

To: Covenant Living Communities and Services c/o Randy Gross
Site: 9150 Fortuna Drive, Mercer Island, WA 98040
Re: Tree Inventory and Assessment
Date: February 6, 2026
Project Arborist: Julian Garcia
ISA Certified Arborist PN-9969A
ISA Qualified Tree Risk Assessor
Reviewed By: Sean Dugan, Registered Consulting Arborist #457
ISA Board Certified Master Arborist PN-5459B
ISA Qualified Tree Risk Assessor
Referenced Documents: Conceptual Site Plans (Navix, February 5, 2026)
Attached: Table of Trees
Tree Site Map

Summary

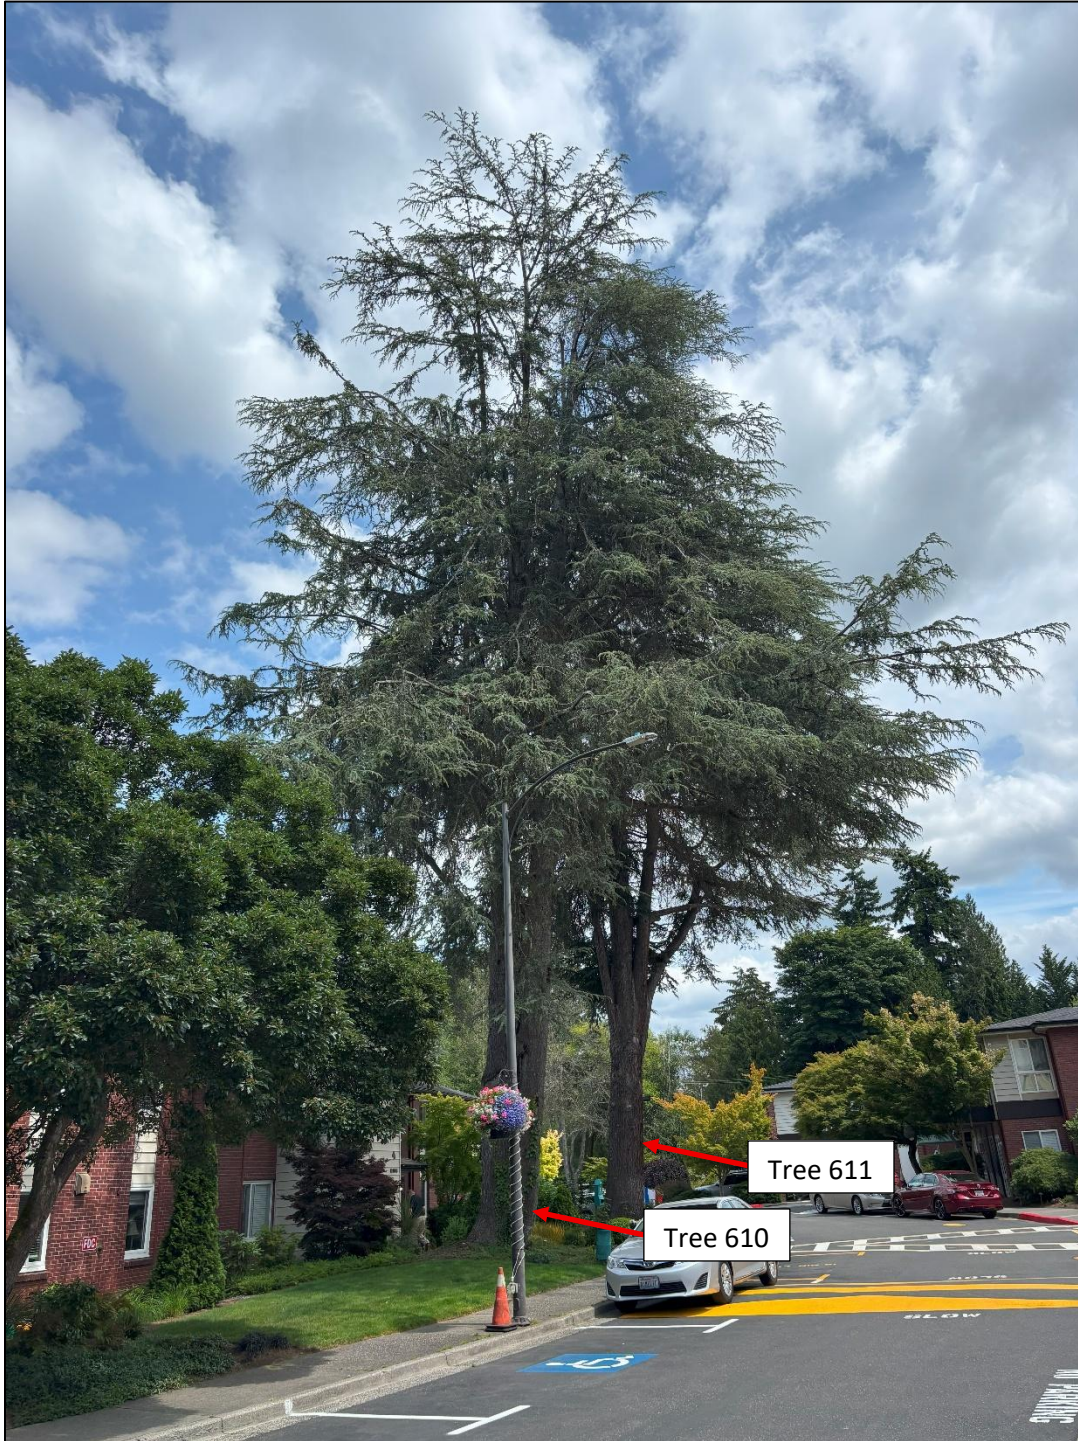
Trees 40 and 608 to 611 are exceptional trees in mostly good health and structural conditions located adjacent to Fortuna Drive SE (see Photo 1). They provide abundant shade to the housing buildings to the north and northeast. Although they are located six to ten feet from the existing sidewalk, I did not observe any heaving or cracking in the sidewalk caused by their roots. As previously stated, tree 610 failed during a windstorm in December 2025 and trees 40, 608 and 611 are proposed for removal in February 2026.

Photo 1. Looking east, trees 610 and 611 are landmark atlas cedars (*Cedrus libani ssp. atlantica*) adjacent to Fortuna Drive SE and the existing sidewalk. Tree 610 failed in December 2025 and tree 611 is proposed for removal on a separate permit in February 2026.

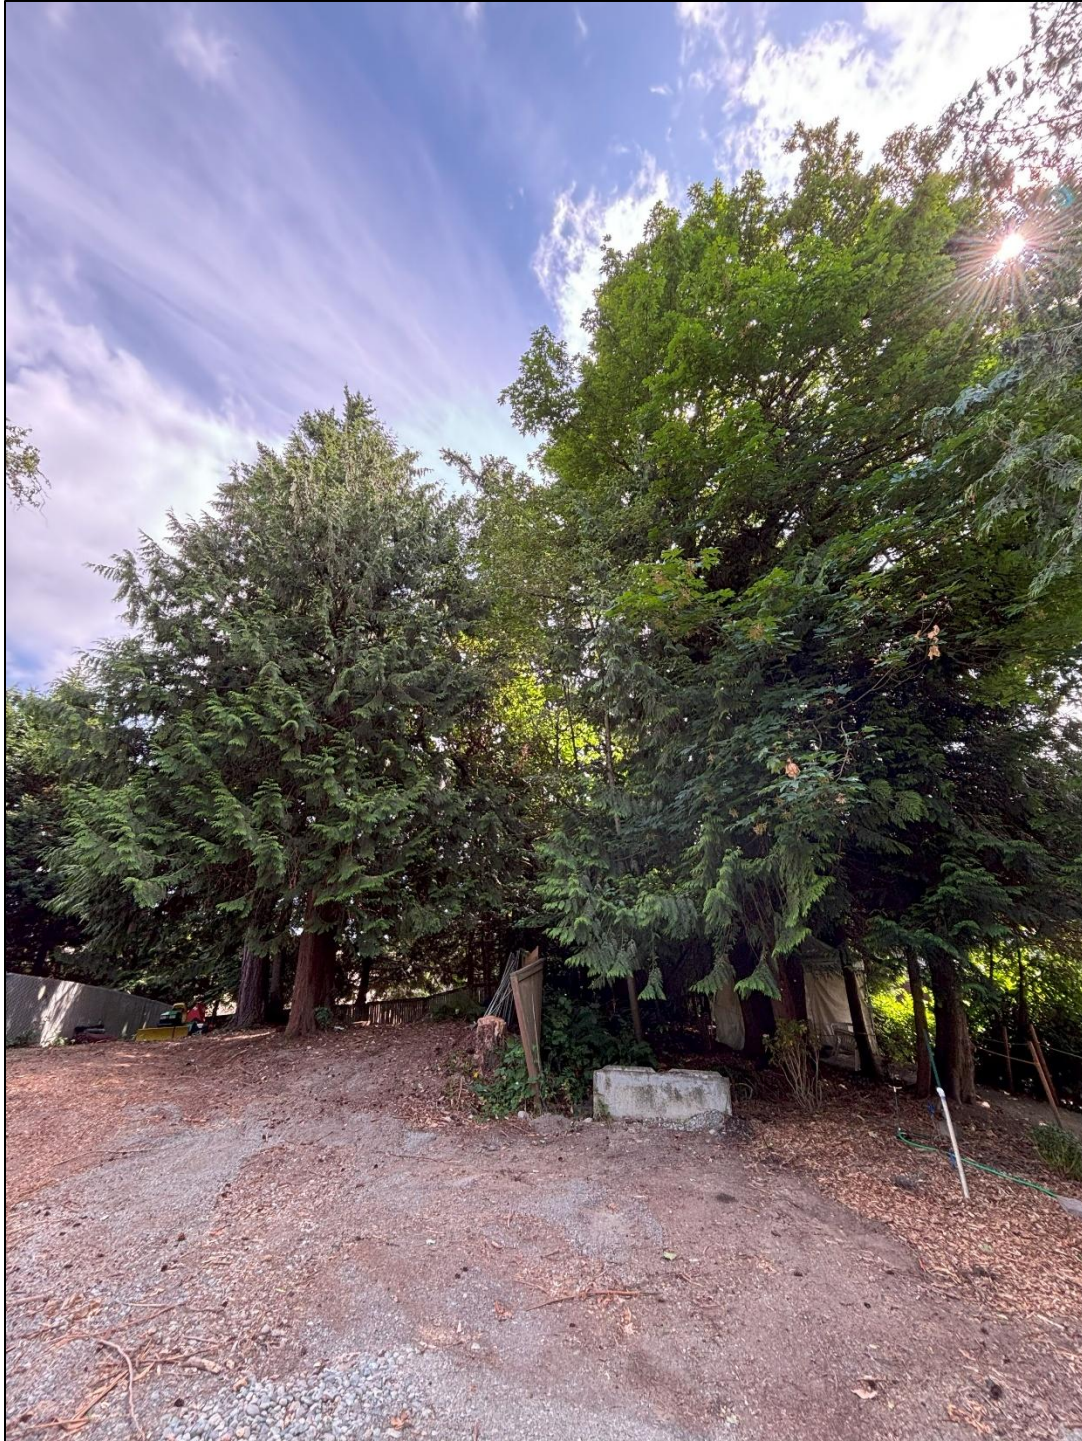
Trees 612 to 616 and 618 to 633 are part of a tree grove and meet the criteria of exceptional trees per MICC 19.16.010. The majority are native coniferous and deciduous species in fair to good health and structural conditions (see Photo 2).

Photo 2. Looking south, this is the tree grove on-site consisting of 21 exceptional trees. The majority of the trees in the grove are native species in fair to good health and structural conditions.

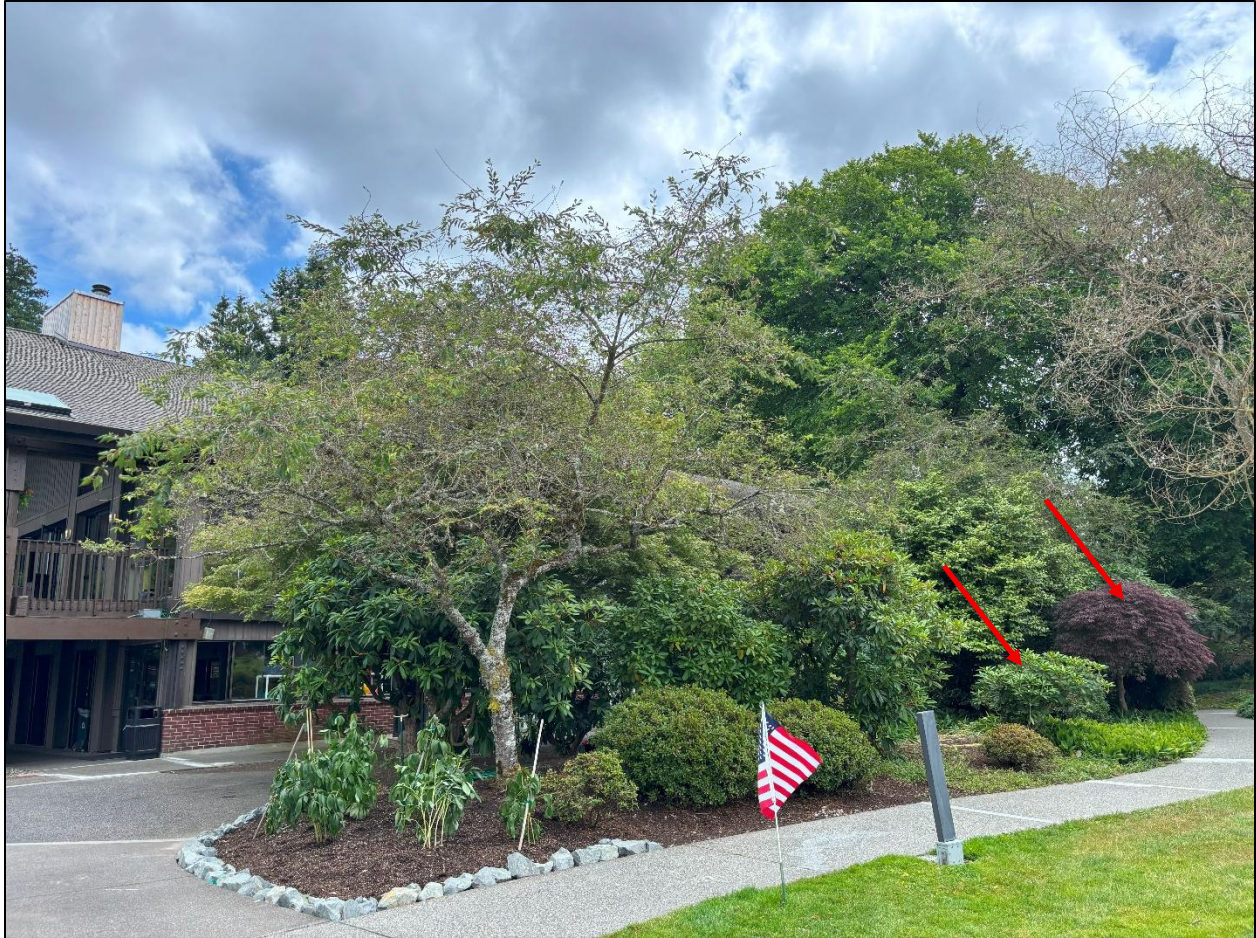
Richard Thuringer, of Covenant Living, explained community members' wishes to retain and transplant on-site Japanese maples (*Acer palmatum*) and other ornamentals trees near the existing lodge if possible (see **Photo 3**). I included these trees and labeled them "NR" (not regulated) if they had community sentimental value, but did not meet MICC definition of a large (regulated) tree (MICC 19.16.010).

Photo 3. Looking southeast, two examples of Japanese maples that the community hopes to retain per my conversation with Richard Thuringer of Covenant Living are indicated by arrows.
