Project: Vegetation management plan for select trees at 4645, 4649, and 4651 Forest Avenue SE, Mercer Island. Parcel Numbers 404500-0075, -0080, and -0085.

Contact: Scott Sinclair – Tree Harmony Arborists, LLC
PO Box 1261, Mercer Island, WA 98040
Phone - 206 275 0991 Email – paulscottsinclair@gmail.com

Objective: Evaluate risk for trees in range of houses, entry drives, walking paths, and parking. Make recommendations for removal, mitigation, and preservation. Promote health, correct structure, and insure longevity of those to remain. Create scenario for any mitigation planting required by the City.

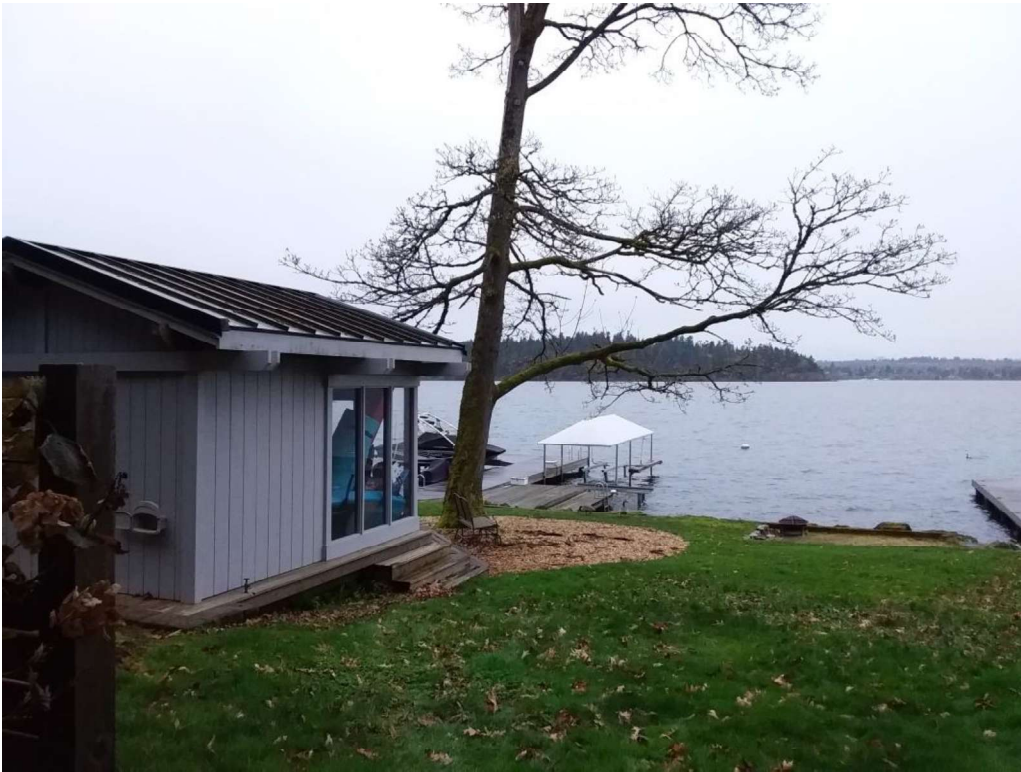
The #1 maple has a **probable likelihood of large stem or scaffold failure** based on the degree of dead material present and the species' propensity to crack off when in this condition combined with its location on the shore being exposed to the strong winds coming off of Lake Washington on a regular basis. The docks bracket the tree on the lake side and the boat shack sits close to its east side. This leaves little space available for material falling out of the tree to land without hitting a valuable target which results in the maple having a **high likelihood** of striking. The tree is thus categorized as **likely to fail and impact**. The consequences would be **significant** making the hemlock a **high risk** for stem or large scaffold failure.

Figure 3. Looking WSW at the location of the 31 maple. The branches shown are mostly viable. Note how close the docks and boat house are to the tree.

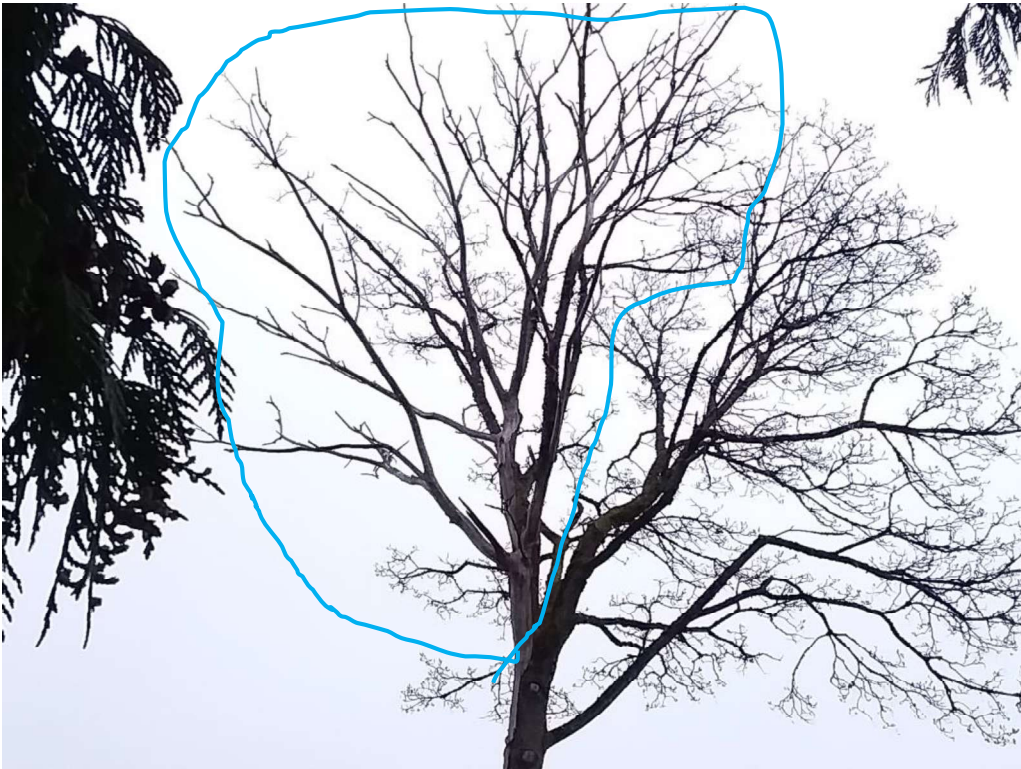
Figure 4. Looking up and SW and showing the large dead section that needs to be excised. It accounts for close to 2/3 of the upper canopy. The lowest limb showing is mostly viable. The ones between it and the dead section are about half viable.

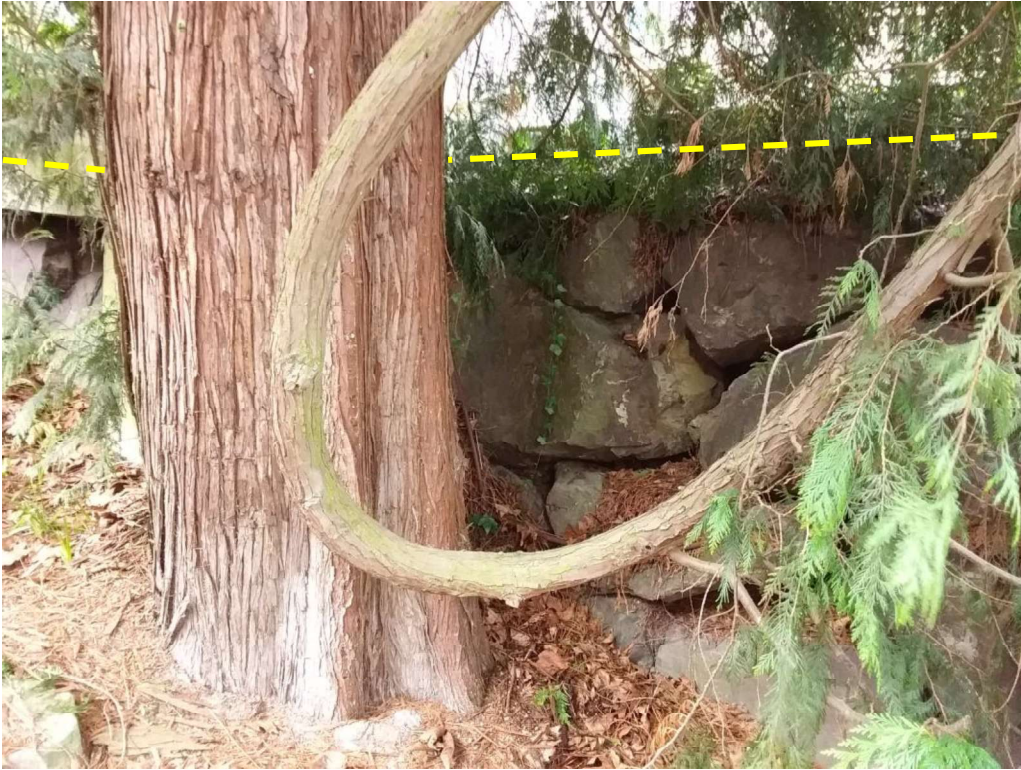
The #2 cedar will experience greater force loads from storm winds because of its height and stature. The protection it is afforded by the large evergreens on the 4661 property to the south will be lost in the next year or so as they will be removed to allow the redevelopment of the lot. It has multiple large elements with weak attachments that are over extended. It is characterized as having a **probable likelihood of large stem or scaffold failure**. It sits tightly between the 4651 parking area and the 4645 home and has a **high likelihood** of striking. This puts it in the **likely to fail and impact** row in the second matrix. Consequences will be **significant to severe** depending on the exact size of the failed section. The cedar is thus labeled as a **high risk** for stem or large scaffold failure.

Figure 5. Looking SE at the base of the #2 cedar. Note the level of the parking slab for the 4651 house.

The risk present in the #2 cedar can be mitigated by using reduction pruning techniques. The over-extended spars should be pruned back and down throughout this tree. The uppermost spars cannot be allowed get taller because of their propensity to shear off in storm winds. It may be necessary to remove one or more if there is not a means to prune them correctly because of their formation. The tree seems to have adjusted to the space and conditions under which it lives so could be maintained long-term.

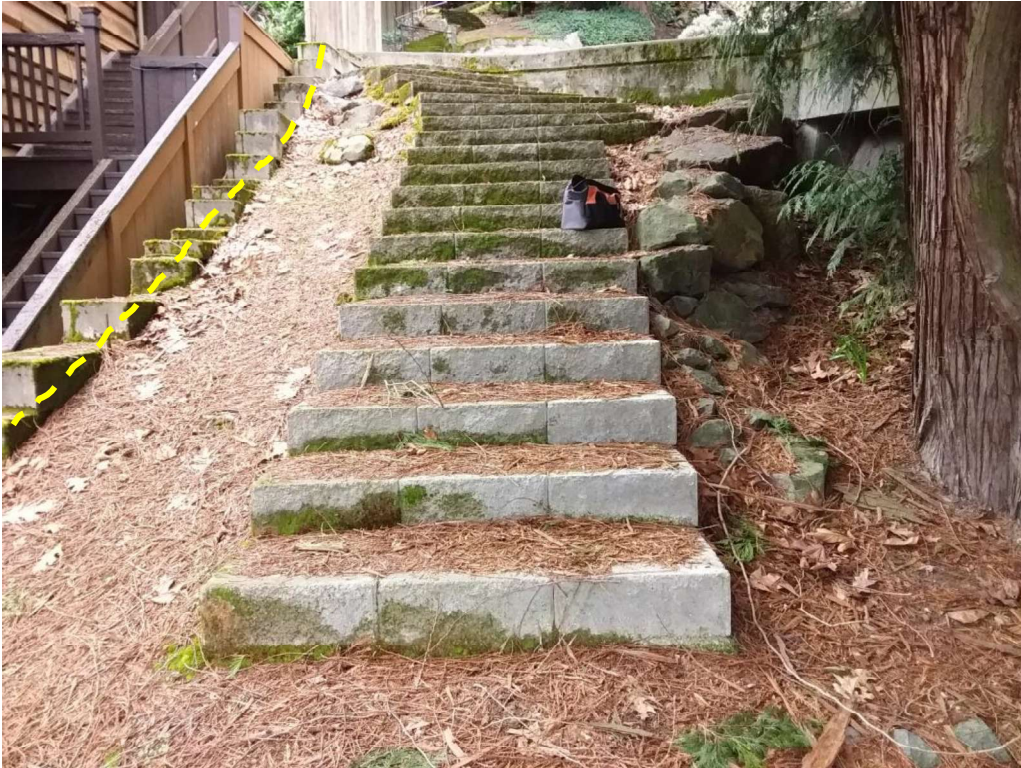
Figure 7. Looking east at the stairs leading up on the north side of the #2 cedar. Note the retaining wall on the left (north) side of the image).

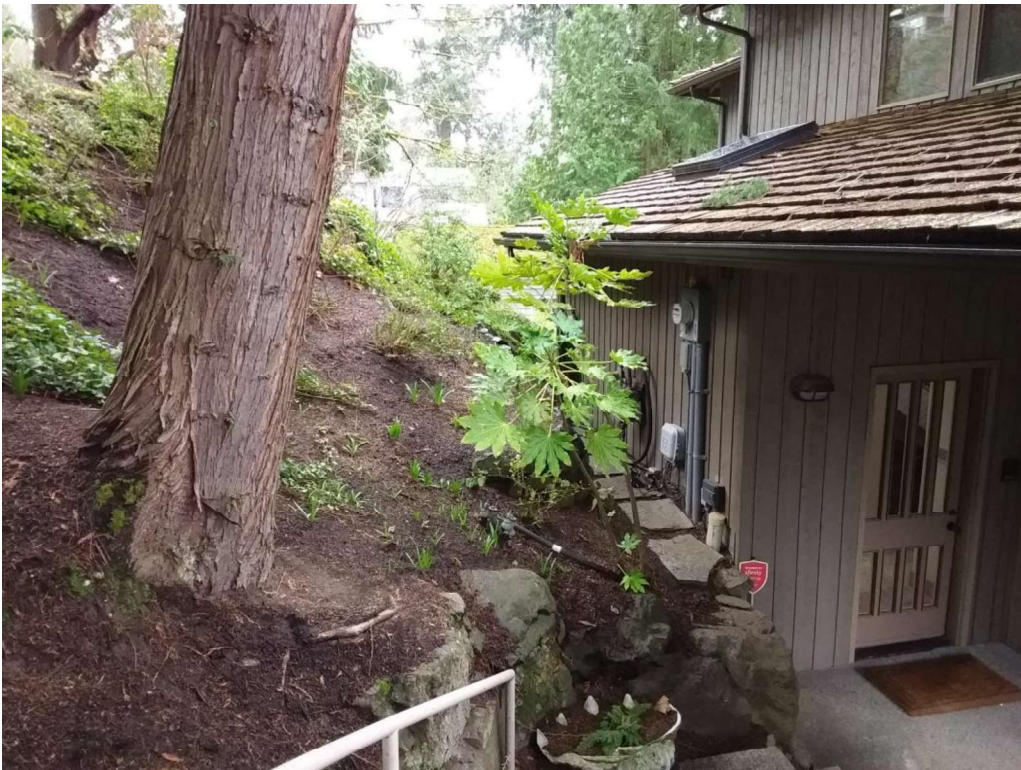
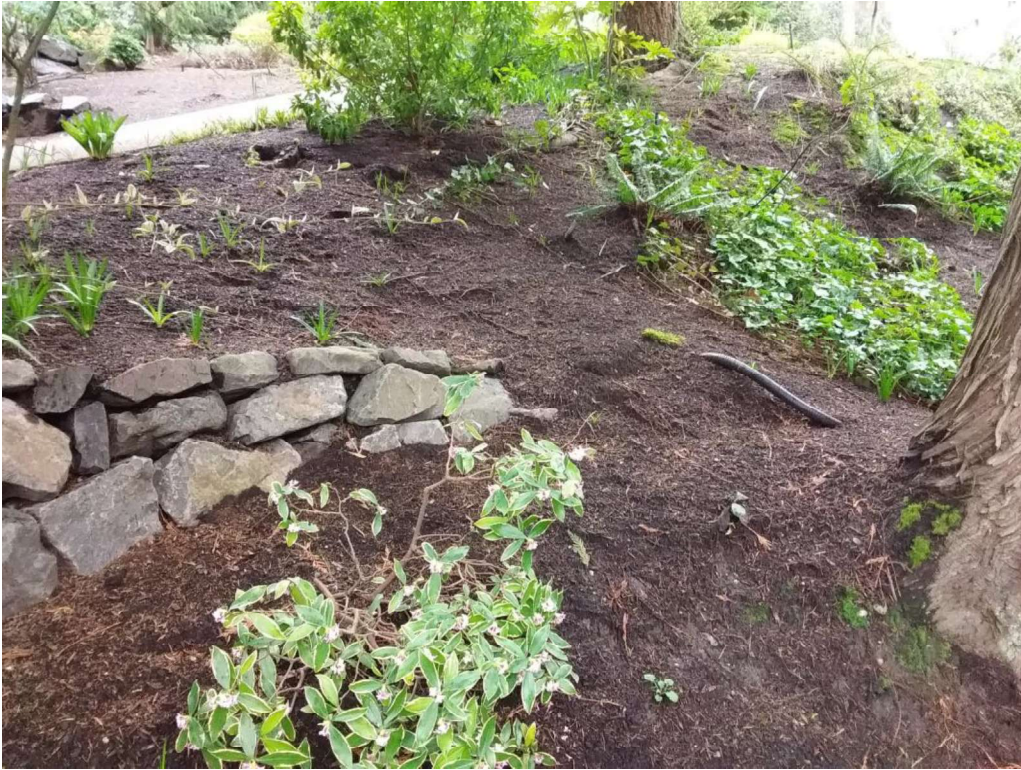
3. Western Red cedar 22.5" DSH, 70' tall, standing 8' E of the east side gutter line on the 4651 house near its NE corner. It is growing on a raised embankment and leans slightly to the west as it rises. A 5' tall stone retaining wall crosses 18" W of cedar's base and curves to intersect with the main retaining wall that starts 6' SW of the tree (Figure 8). The entry drive is 15' E of the tree and there is another small stone retaining wall that starts 5' NE of the tree (Figure 9). The cedar appears to be in fair condition. The majority of its canopy is off the west side.

The #3 and #4 cedars, even though they have grown up in place, have significantly constrained rooting spaces preventing the formation of full Structural Root Plates expected for trees their size. The cedars will also be suddenly exposed to wind loading because of the removal of the much large evergreens in the stand to their south. They have to be considered as having **possible likelihoods of catastrophic failure**. They are both tall enough to reach the 4645 house or its garage, would definitely crash across and block the driveway, and would take out the fence. They could also strike the #13 and/or the #14 trees causing them to fail or break apart and hit the home or garage. Putting all the scenarios together the two cedars are slated as having **medium likelihoods of failure and impact**. It would likely result in **severe** damage and the two trees are rated as being at **moderate risk** of catastrophic failure.

Figure 8. Looking south at the base of the #3 cedar.

Figure 9. Looking SE past the base of the #3 cedar. Note the retaining wall.

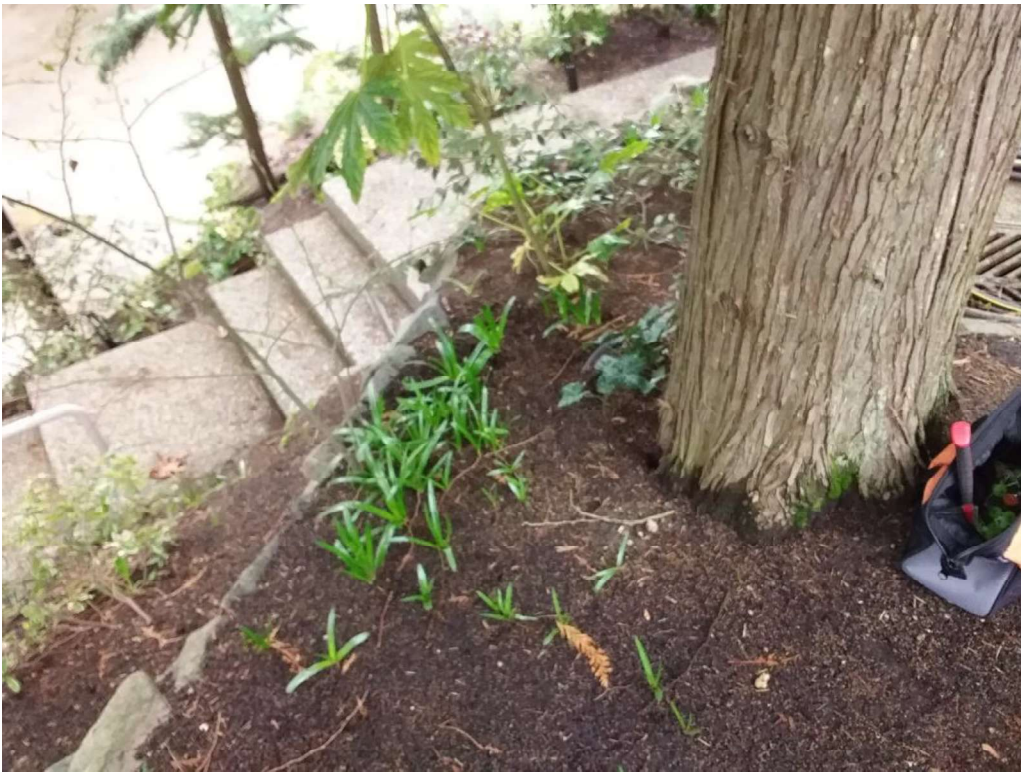
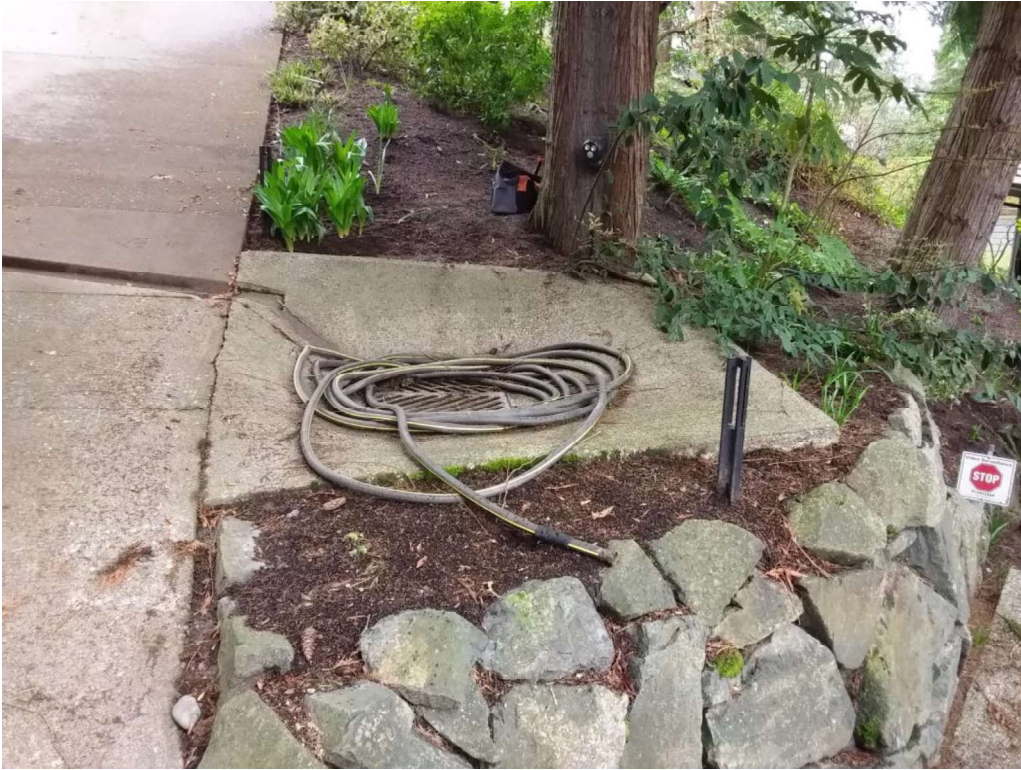
Figure 10. Looking down and north at the base of the #4 cedar above the stairs and small stone wall.

Figure 11. Looking south at the storm drain plate at the base of the #4 cedar. Note proximity of the driveway and stone wall.

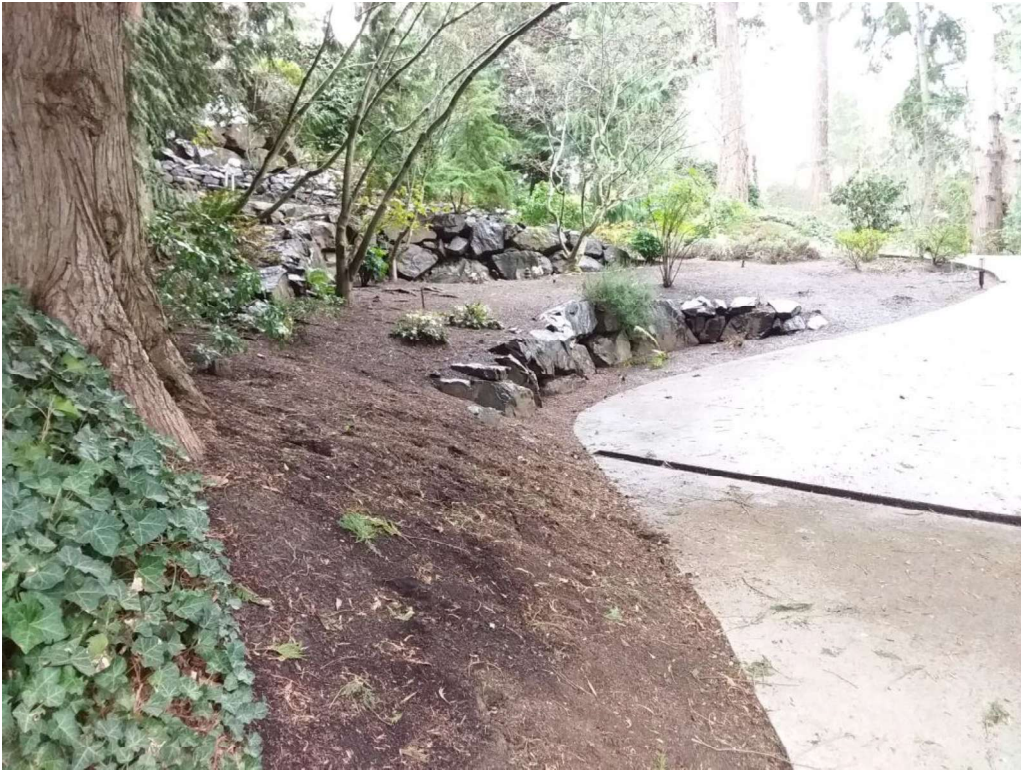
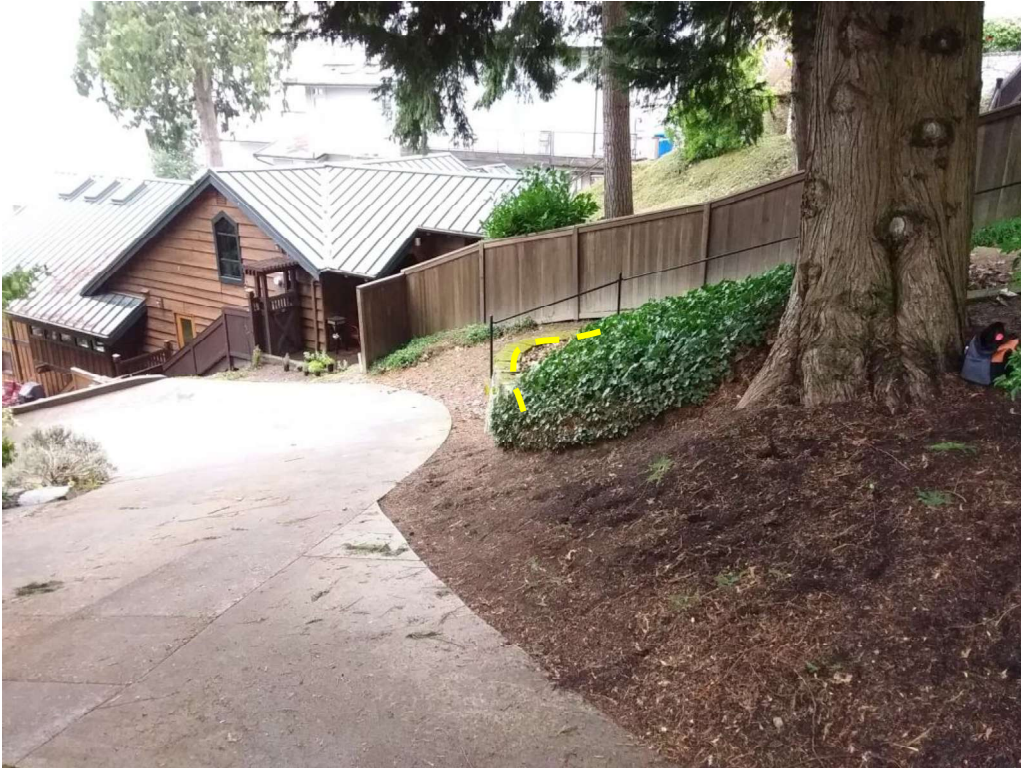
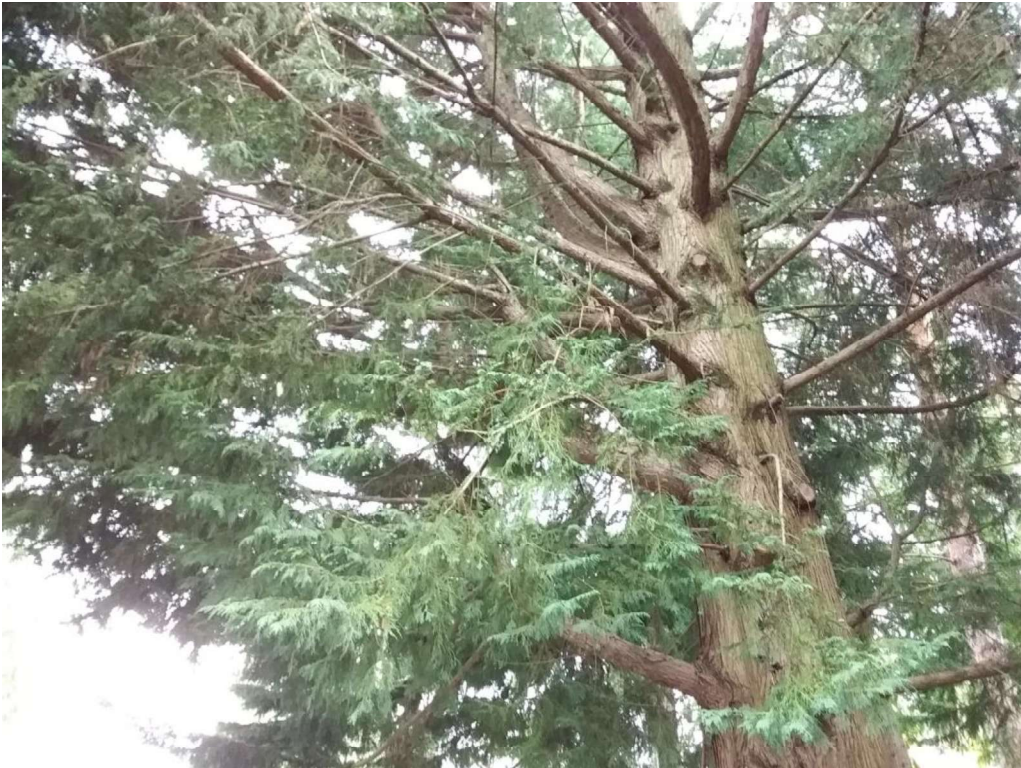
The #7 Leyland cypress has been experiencing scaffold and limb failure for the last few years. It has numerous over extended and overweight elements. It is characterized as having a **probable likelihood of large limb or scaffold failure**. Nearly all the elements that have failed and all those most prone to failure are on the west side of the tree and overhang the driveway. One of the limbs that broke out just missed a car coming down the driveway and another landed a couple of yards behind one of the home owners walking up the driveway. While normally the probability of persons or vehicles being struck by tree parts is quite low in magnitude repeatedly placing them in close proximity increases the chance of meeting in space and time considerably. The limbs are also coming lose more than one at a time which increases the struck-by probability. These combination of these factors puts the Leyland in the **high likelihood of hitting** column in the first matrix. This makes the breaking limbs and scaffolds **likely to fail and impact**. Consequences will be **significant to severe** depending on the exact size of the failed section and whether it hits a vehicle or person. The cedar is thus labeled as a **high risk** for limb or large scaffold failure.

Figure 12. Looking SSE at the driveway curve and stone walls on the south side of the #7 Leyland cypress.

Figure 13. Looking NNW at the driveway and retaining wall north of the base of the #7 Leyland.

Figure 14. Looking up and NNW at the canopy of the #7 Leyland.

Unlike the #2 cedar, the #7 Leyland cypress does not lend itself well to corrective pruning. Leylands do not have well developed laterals so there is no place along the length of a spar to make a proper pruning cut. Hence there is no means of doing the weight reduction pruning that is required to mitigate the risk present in the tree correctly. If nothing is done the limbs and spars will continue to over-extend in competition for light and breakage will keep happening. The broken elements open holes in the Leyland's canopy through which the storm winds can hit other elements that had been somewhat protected. The tree will just continue to delaminate. The most correct option is to remove and replace this tree.

The #7 Leyland needs to be removed. It has significant risk issues, no redeeming qualities (besides just being large), and no feasible way to mitigate the risk. Because of being condemned only four, rather than six, trees will be planted as replacements.

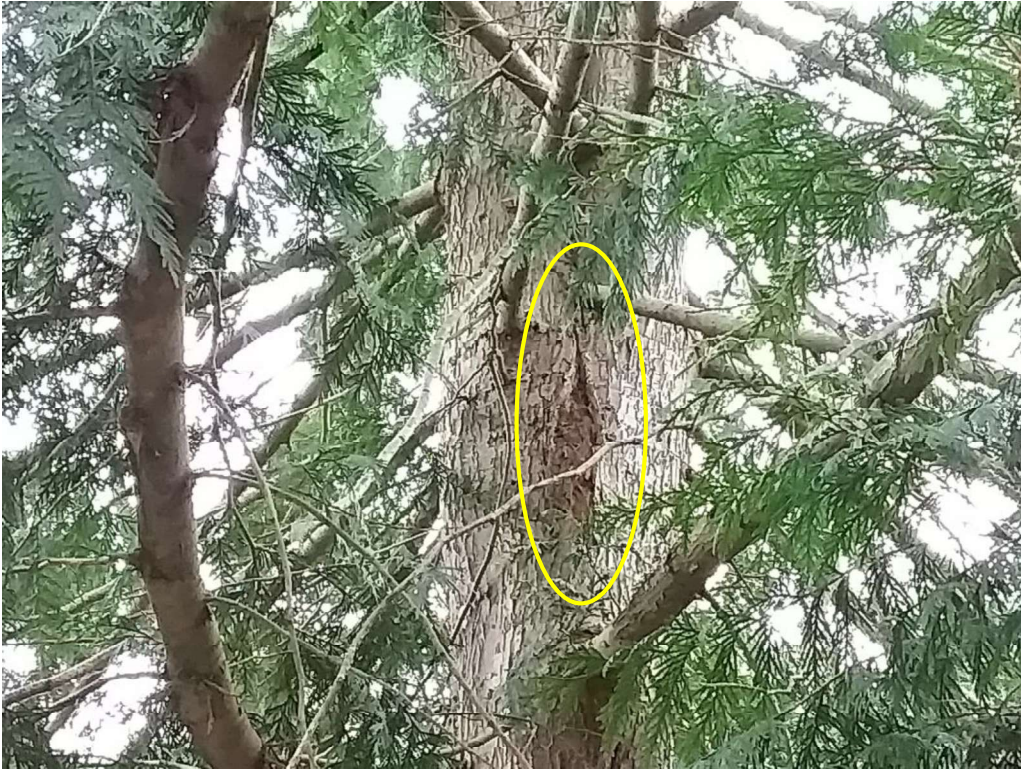
12. Western Red cedar 19" DSH, bifurcates at the 15' mark, and the two stems continue up to the 45' level. The separation is north to south and there is a noticeably active fracture plane showing fresh reaction wood (Figure 15). Tree stands 2' N of the entry drive and about 30' SW of the SW corner of the 4649 house.

The #12 cedar has an active fracture plane below its two stems which are close to broadside to the wind. The tree is not large enough currently to experience too great of wind loading. It is placed in the **possible likelihood of stem failure** row in the first matrix and, because the stems are not quite long enough to reach the 4649 house, in the **low likelihood of impact** column. This makes the tree **unlikely to fail and impact** and automatically a **low risk**.

Figure 15. Looking SW at the separation point on the #12 cedar.

The #12 cedar can be retained as is but it needs to be monitored annually. If the fracture plane continues to be active then installation of a brace rod will be required.

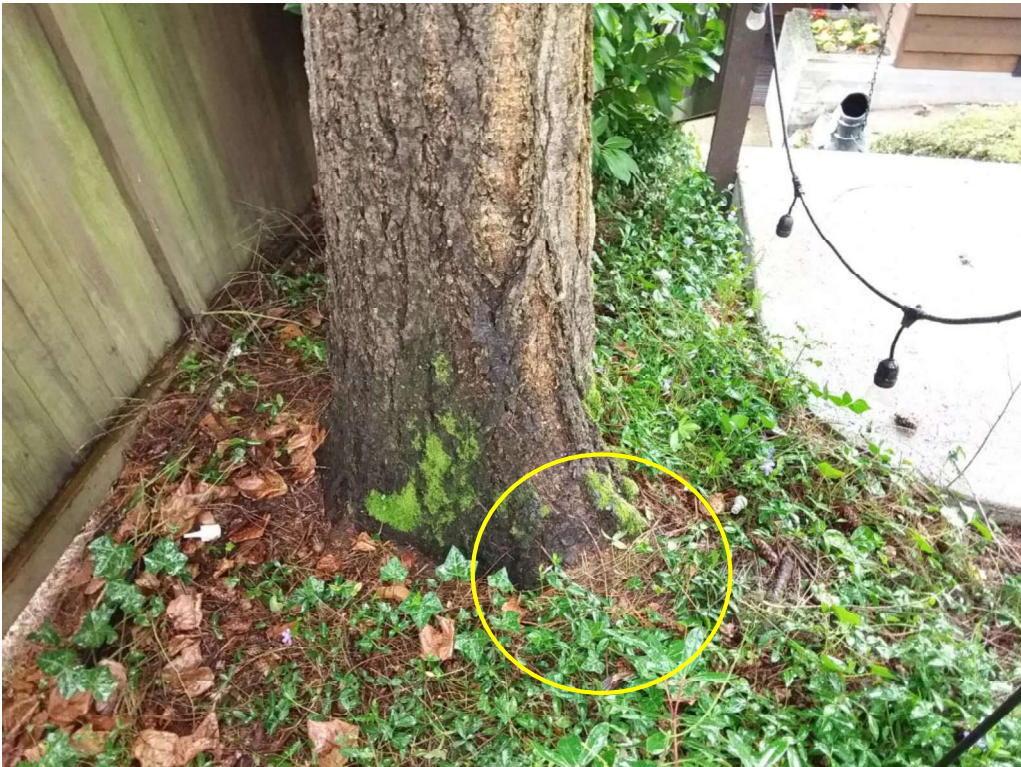
The tree is most likely to rotate over the NE root and either fall across the 4645 house or if it slides by that house's NE corner it will land on the 4639 house. If the tree has not developed enough structural root holding power on the south side it could be lifted over its base by a strong storm wind coming off the lake. If that occurs the tree will land on the 4645 garage. Whichever case happens in a catastrophic failure the tree has a **high likelihood** of striking.

So, under a catastrophic failure the #13 fir is **somewhat likely to fail and impact** and with a stem failure it is **unlikely to fail and impact** according to the first matrix. The consequences would be **severe** in either scenario. Therefore the #13 tree is slated into the **moderate or low risk** boxes in the second matrix.

Figure 16. Looking west and down at the base of the #13 fir. Note the proximity of the landing for the stairs on the north side of the tree. The large structural root is circled. There is little to no root crown flair evident in the other sectors of the base.

The #13 tree is going to be considered as a removal at this time because it makes the most sense to do so and it will give its two replacements a head start on replenishing the firs lost biomass.

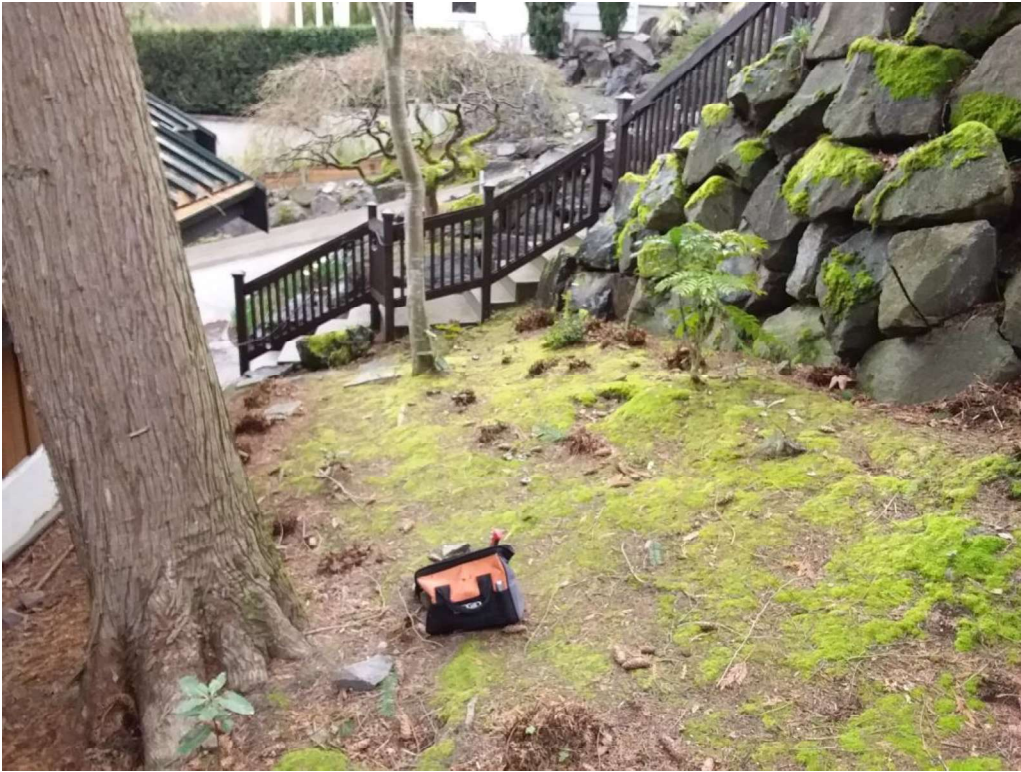
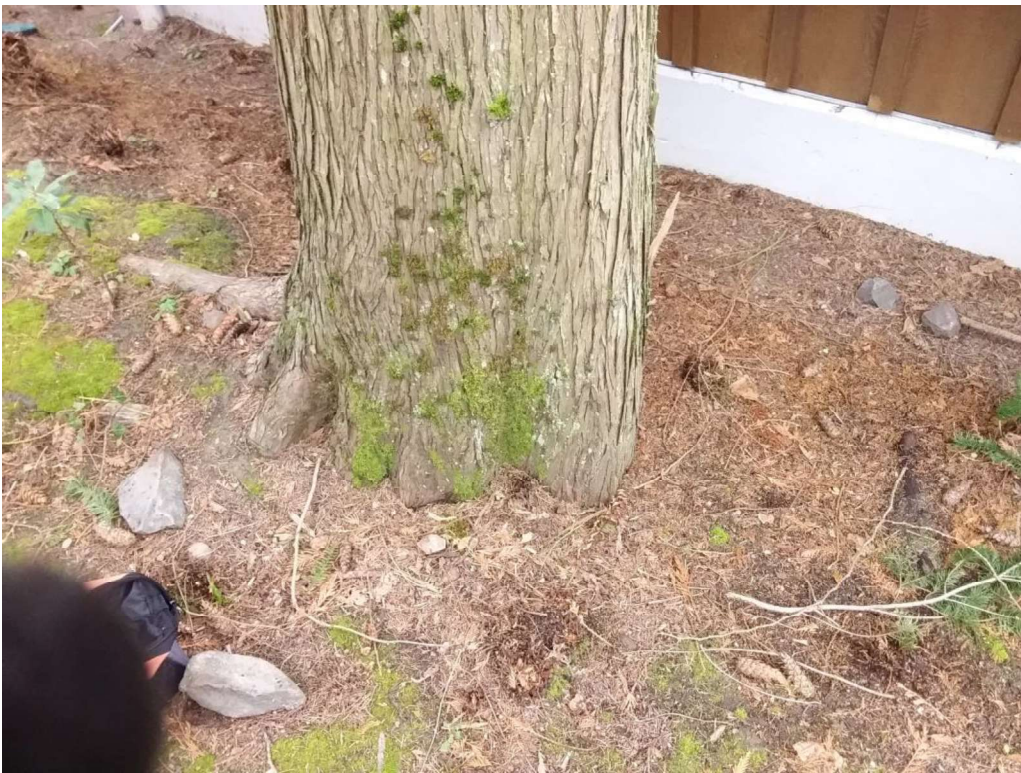
The #15 cedar was present when the 4645 garage was built in 2000. The garage sits 3' W of the tree and the excavation for it could have been as close as 6" off the base of the cedar cutting all the roots to that side. Post construction the cedar only developed structural roots to the south side and was obviously prevented from doing so to the west. The short stature of the cedar and the pronounced developed of the two subordinate spars are highly indicative of the tree reacting to destabilization. It will be listed as having a **possible likelihood of catastrophic failure**. Because it has the two large subordinates weighted to the west it will be listed as having a **possible likelihood of stem failure**.

If the #15 cedar fails catastrophically it will land against the driveway retaining wall but isn't tall enough to hit the house to the northeast. Hence the cedar is **unlikely to fail and impact** catastrophically. If either of the two stems crack over they have a **high likelihood** of striking the garage making the tree **somewhat likely to fail and impact** in regards to stem failure. It would likely result in **significant** damage and the two stems are rated as **moderate risks**.

Figure 17. Looking down and north at the base of the #15 cedar. Note the wall of the garage at the left side of the image.

Figure 18. Looking down and west at the base of the #15 cedar. Note the complete lack of structural root development on the north side of the tree. The 4645 garage wall is in the background.

The #15 cedar needs to have the two subordinates removed and the lower branches raised and/or pruned back to create proper roof clearance for the garage. The point of separation needs to be inspected to determine whether there is an active fracture plane present. If the joint is weak it may require reinforcement braces and/or reduction of the main stems.

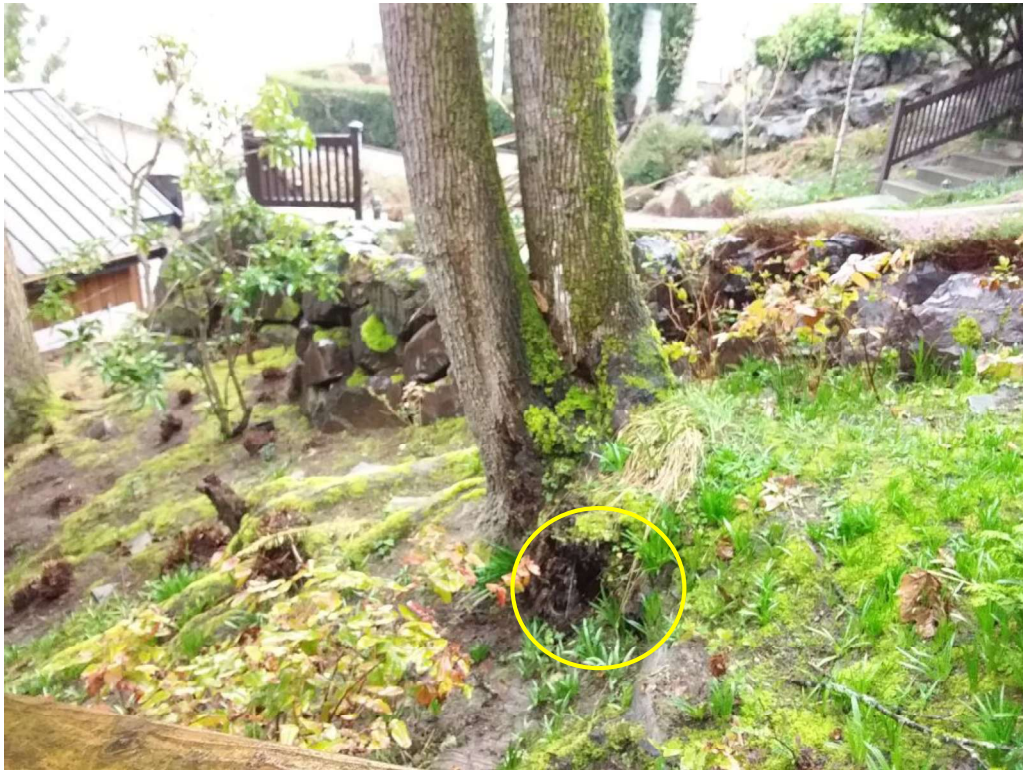
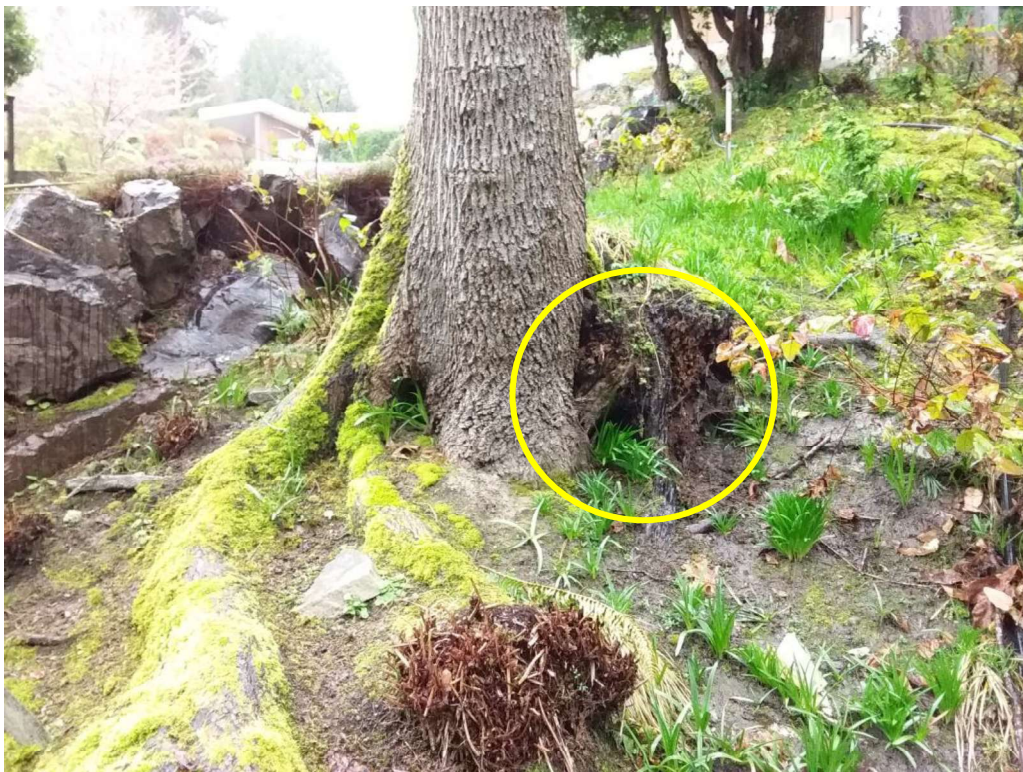
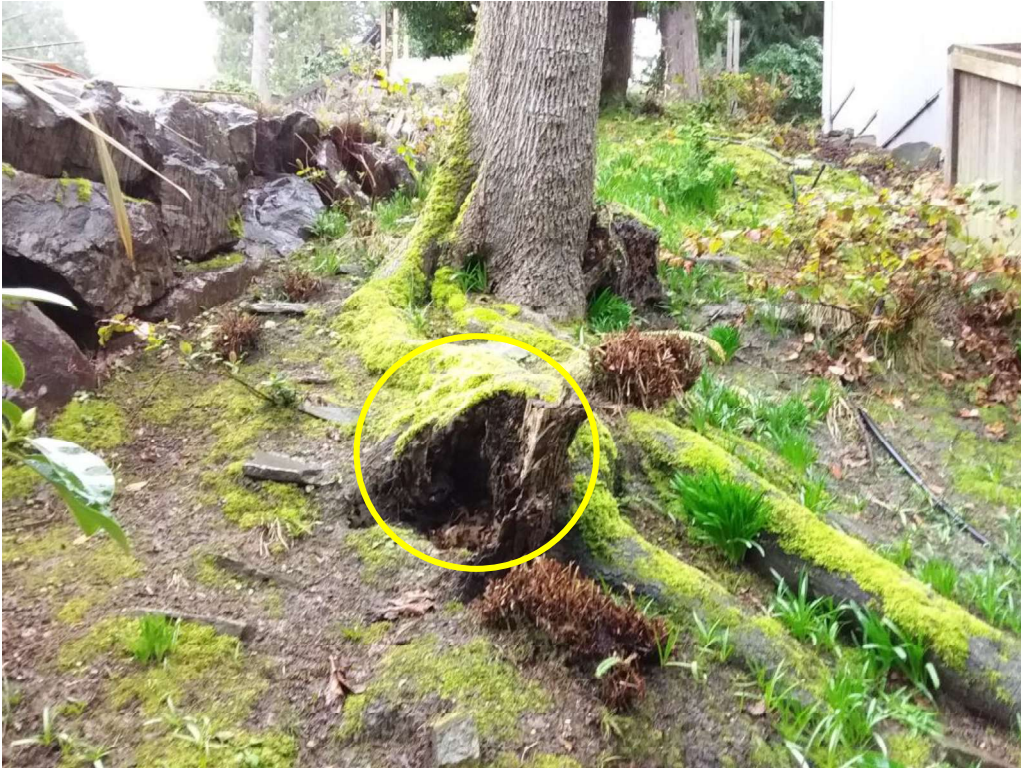
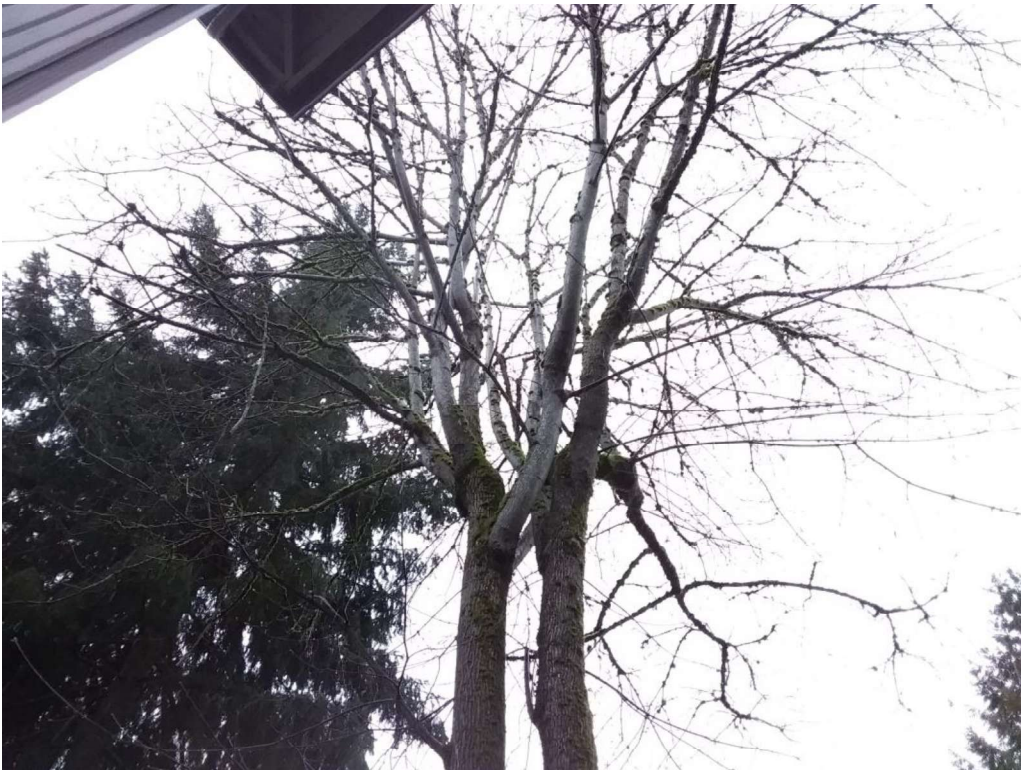
17. Big Leaf maple stump sprout with two current stems 12" and 13" DSH coming off of a large decaying base (Figures 19-21). The stems lean slightly until they reach 16-18' mark where they were either topped or damaged (Figure 22). Multiple scaffolds are crossing through each other as they reach into the 50' level. There is sun scald and associated decay on the surfaces of the larger scaffolds. Weak structure with heavy canopy high on the columns over a compromised support system. The base of the tree is 3' S of the stone retaining wall and 5' N of a concrete block retaining wall for the stairs leading down the side of the 4649 house.

The maples currently present are significantly compromised due to the extent of atrophy and decay in their bases and structural roots. Both have been topped low on the column, perhaps a couple of times, and both have poor canopy formations with high densities above the damage points. The two maples are listed as having **probable likelihoods of catastrophic, stem, or large scaffold failure.**

In cases like these, failures are more related to weight loads than to storm events. Generally the sections fall to the direction in which they are orientated or are weighted towards. The canopies of both the #17 and #18 maples have grown more to the south than in the other directions and the trees as a whole are weighted in that direction. When they fail, catastrophically or partially, either maple will have a **high likelihood** of hitting the 4649 house. This categorizes the two trees as **likely to fail and impact.**

Because the maples are close to the house they will not build up much momentum when they fail and because of their dense canopy formations the branches will likely ‘cushion’ the impact. Even if the maples crack off at the base the **consequences** of their failure should only be **minor.** This categorizes each maple as a **moderate risk** for catastrophic or stem/scaffold failure.

Figure 19. Looking NW at the base of the #17 maple and showing the open decay pocket on the south side (circled). Note the slight lean of the two stems.

Figure 20. Looking east at the base of the #17 maple. The decayed remnant of the original stump is circle. This is what the two lignotuberous sprouts originated from.

Figure 21. Looking east at the base of the #17 maple from a bit further back. Note the advanced decay in the main structural root.

Figure 22. Looking up and ESE at the canopy formation of the #17 maple.

Because the #17 and #18 maples are being condemned for their quite poor conditions, they should only have to be replaced on a one for one basis.

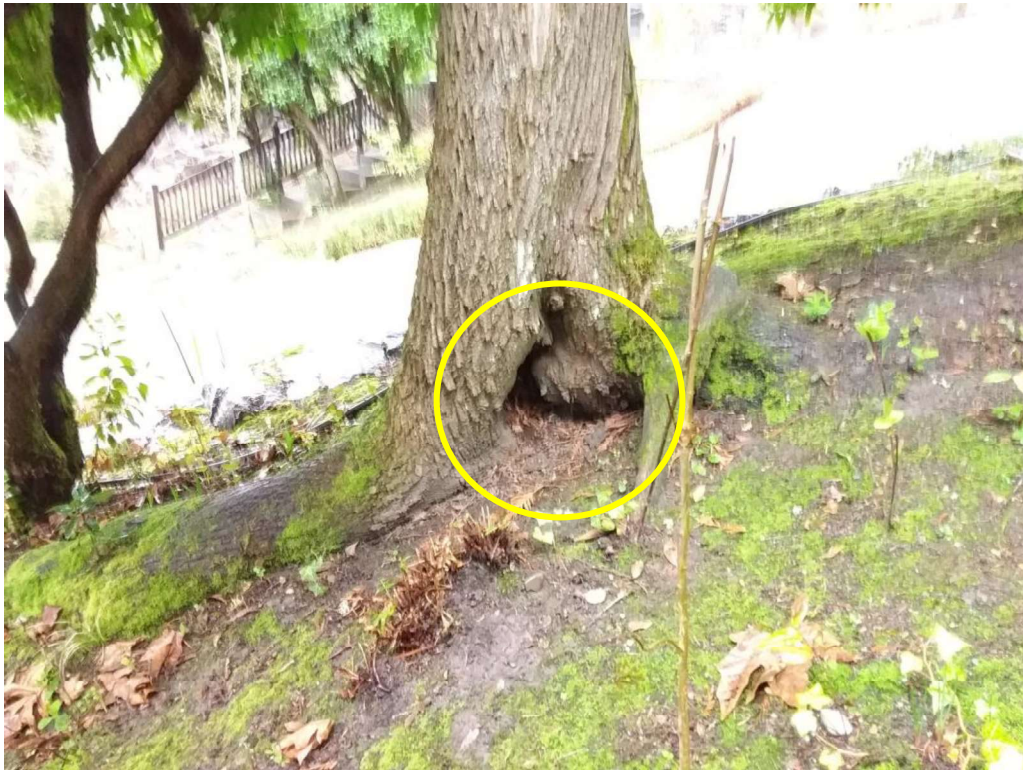
18. Big Leaf maple 11" DSH coming off of a compromised base (Figure 23). The tree is 'balanced' on two large structural roots going nearly due east and west. There is little root development to the north and south. The base is hollowed with some decay present. The tree only reaches about 45' tall and appears to have been maintained actively below that height. It is standing 17' W of the NE corner of the 4649 house, 11' N of the house foundation, and 4' S of the big stones at the beginning of the retaining wall lining the entry driveway to the 4645 house. It leans slightly south and only about half of the canopy seems to be viable.

Figure 23. Looking north at the base of the #18 maple showing the open decay. Note the formation of the large structural roots to the east and west upon which the tree seems to balance.
