## Arborist Summary Memo

Site: 7239 SE 27th Street, Mercer Island, WA

Re: Summary of arborist reports over last 5 years

Date: September 3, 2021

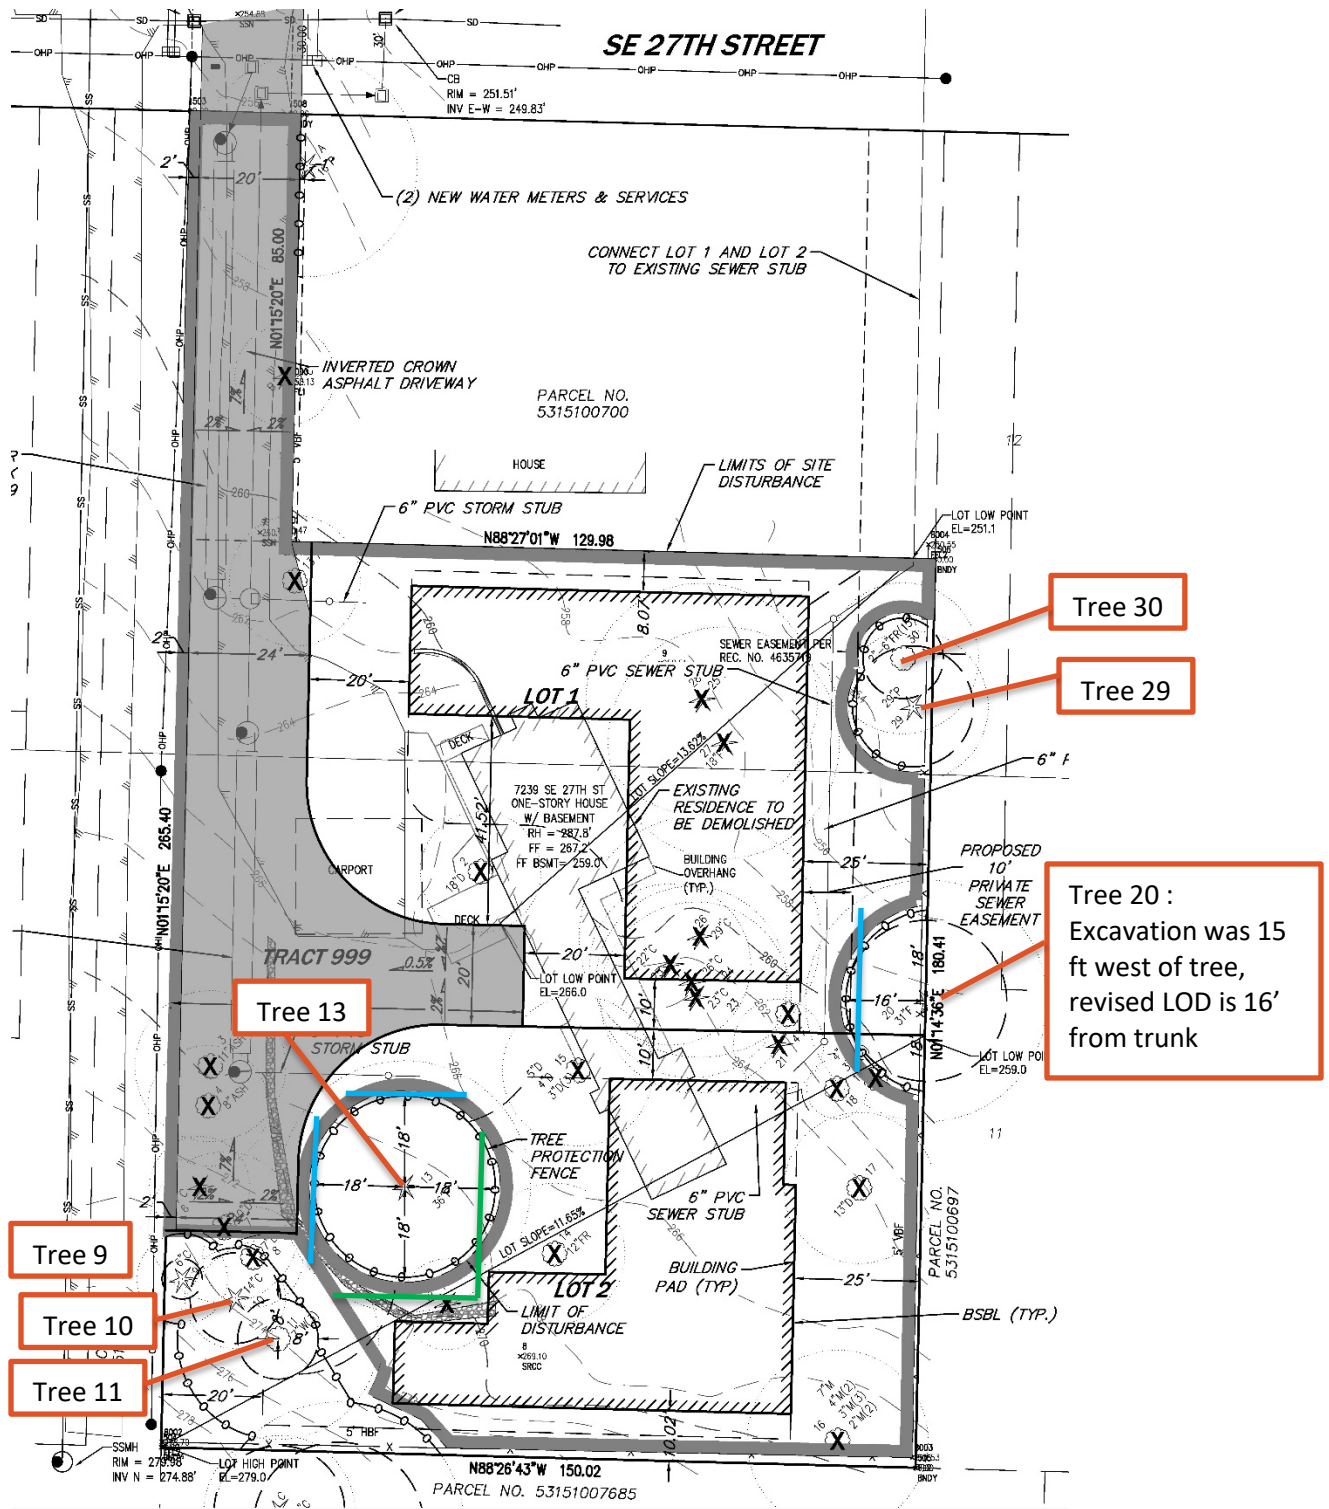
**Site Map.** Approximate locations of exploratory excavation. Green lines indicate 2019 trenches (22 ft south, 16 ft east). Blue lines indicate 2021 trenches (18 ft north, 18 ft west). Base map is most recent development plan provided to me by Core Design in July 2021.

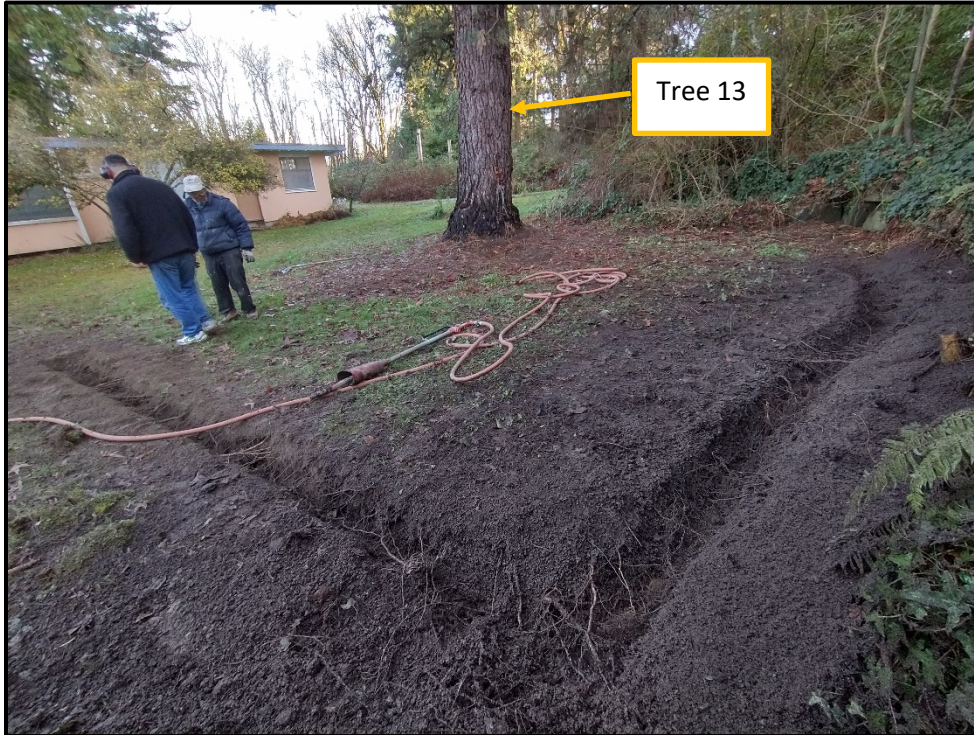
**Photograph 1.** Northern and western trenches of Tree 13 (2021)

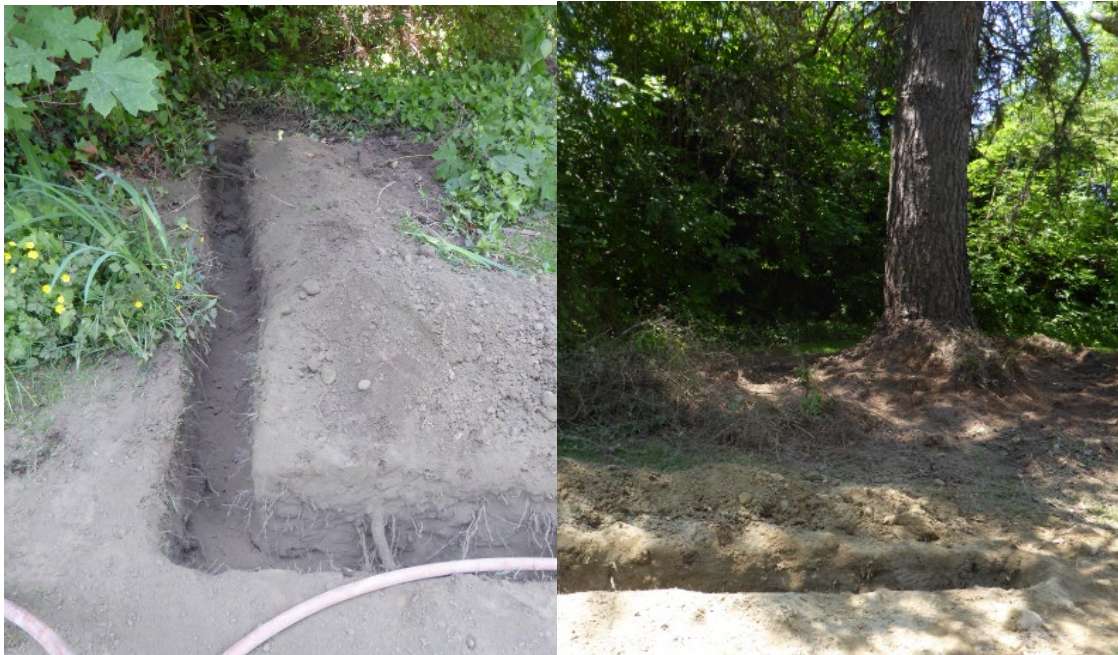
**Photograph 2.** Trenches from 2019 (S / E)

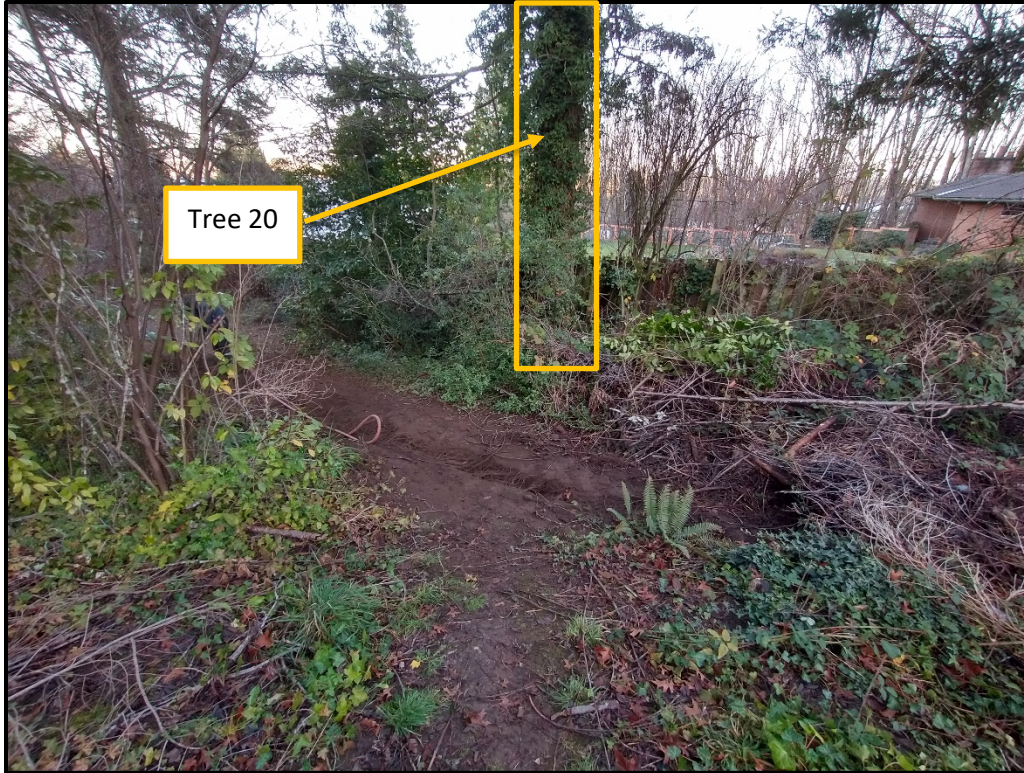
**Photograph 3.** View looking east towards Tree 20 (2021)

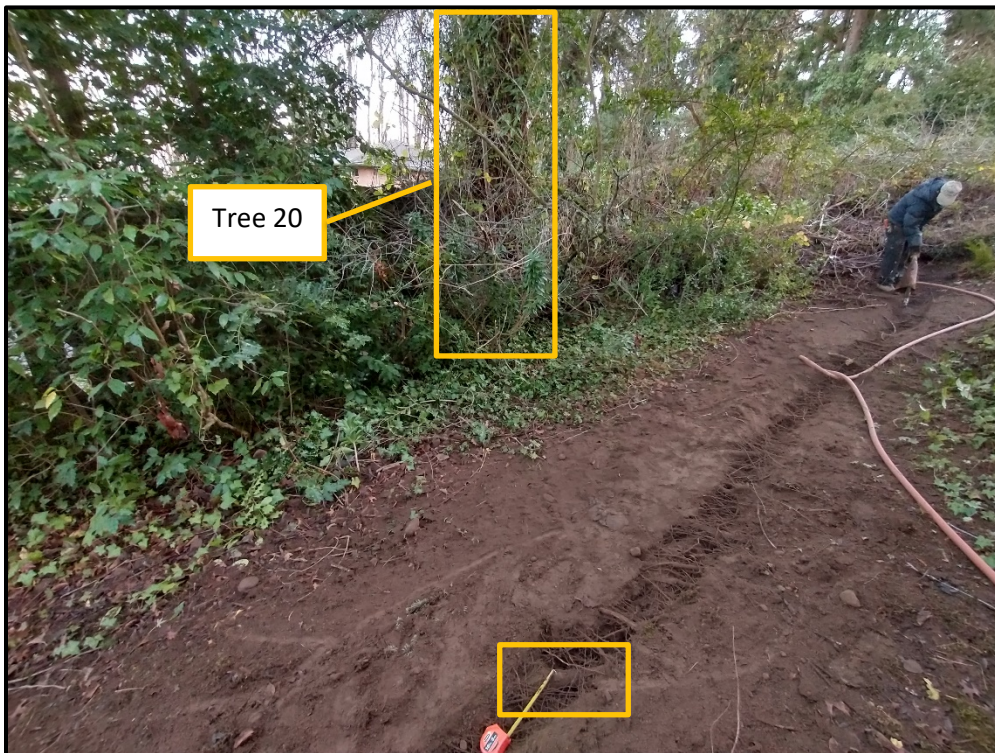
**Photograph 4.** Trench on west side of Tree 20 (2021)

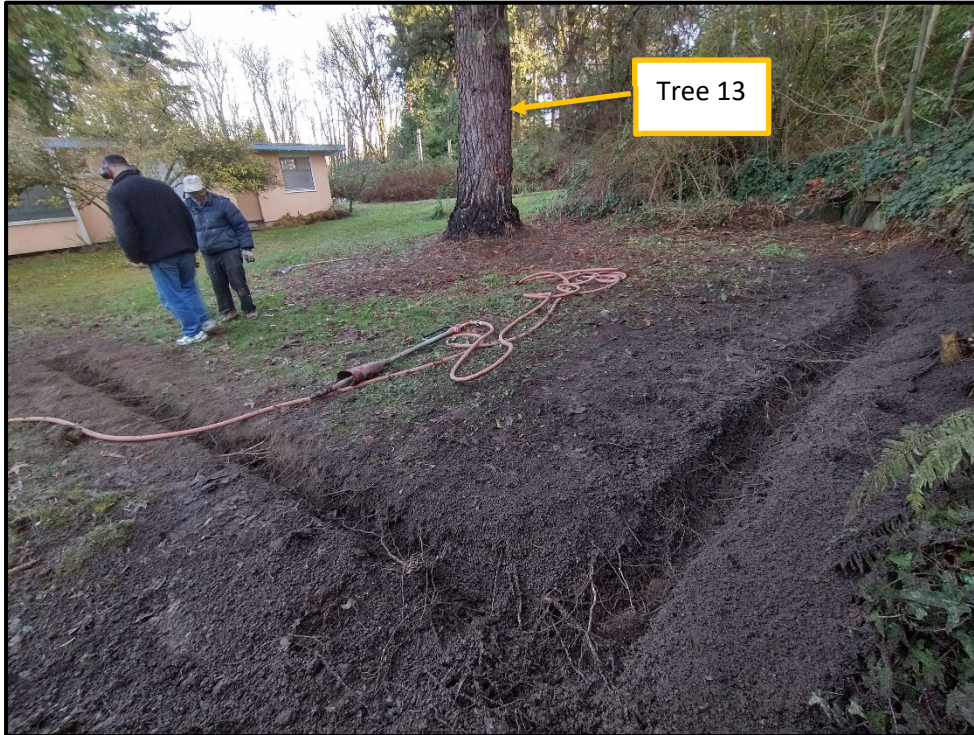
I observed the air excavation of trenches 18 feet north and 18 feet west of Tree 13. Both trenches were 20 feet long (see Photo 1). Excavation exposed mostly fine roots, less than 1 inch in diameter, and three structural roots along the trenches.

**Photograph 1.** Northern and western trenches of Tree 13.

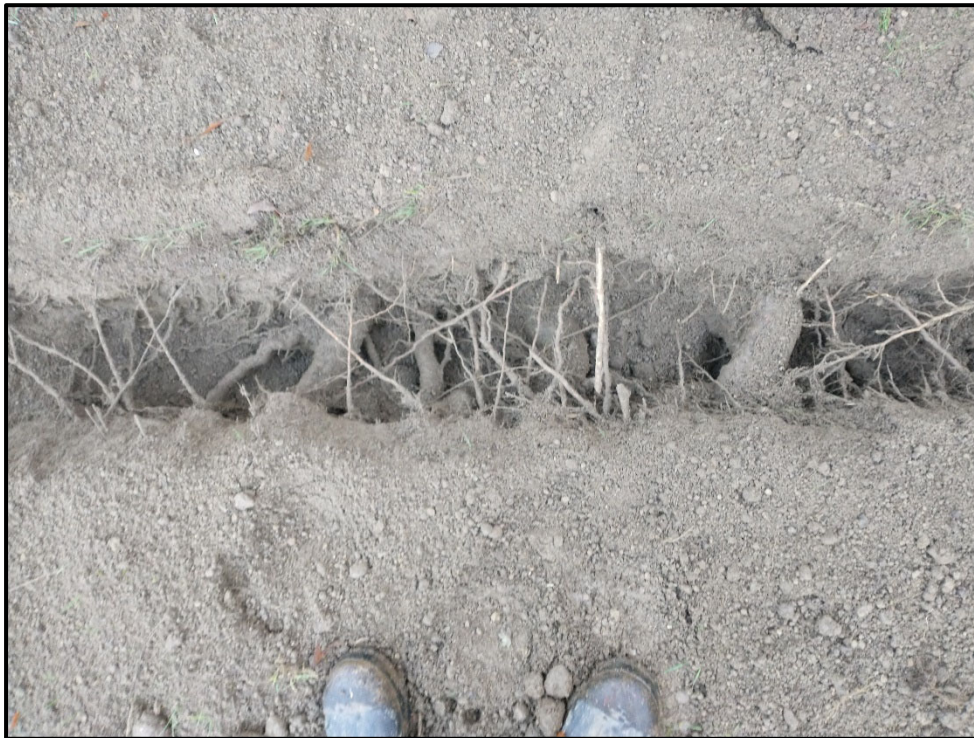
**Photograph 2.** Tree 13 trench with some structural roots encountered, although most roots were fine roots, or less than 1 inch in diameter.

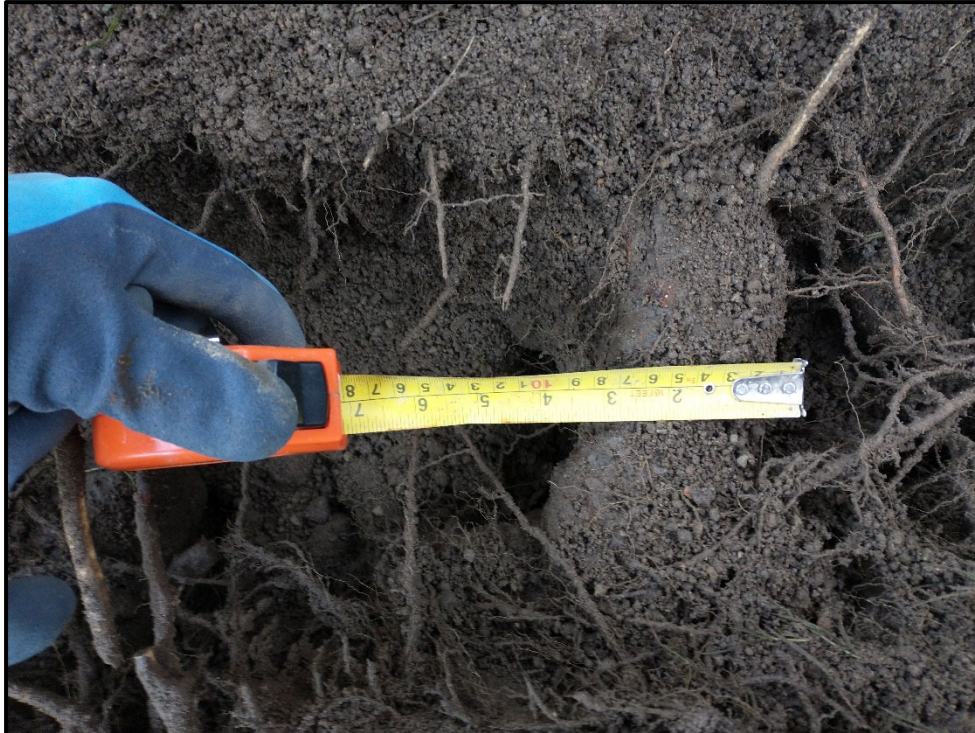
**Photograph 3.** Tree 13: Largest root exposed was 2.5 inch diameter, approximately 18 feet away from trunk on north side of tree.

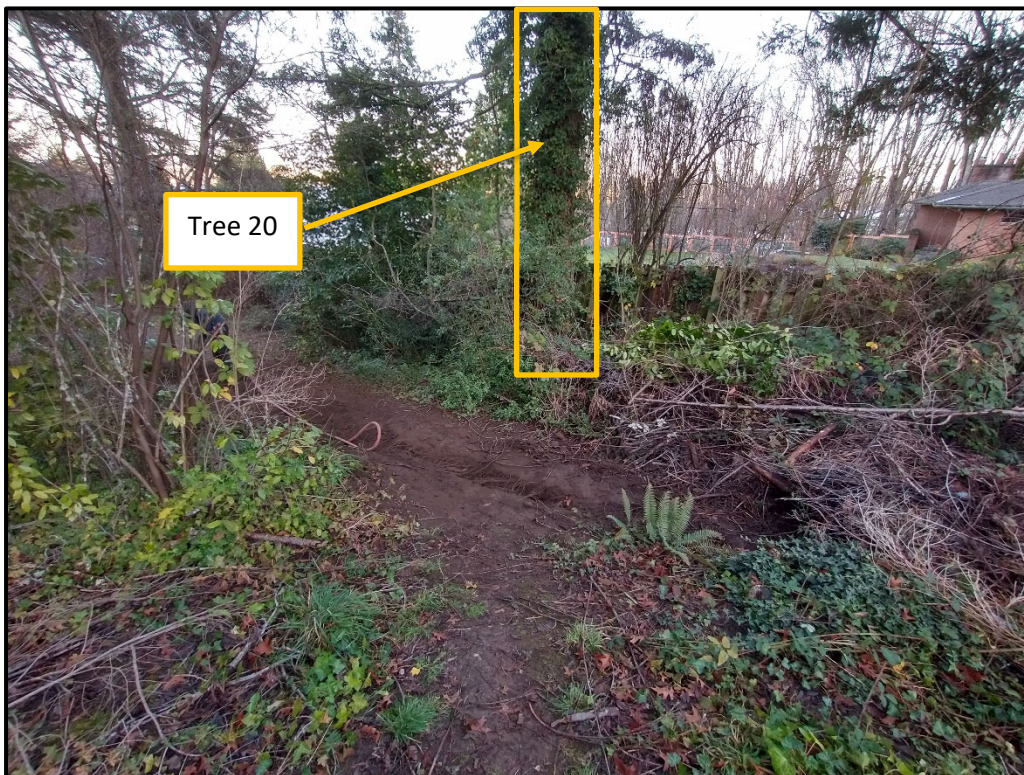
**Photograph 4.** View looking east towards Tree 20 with ivy growing on the trunk.

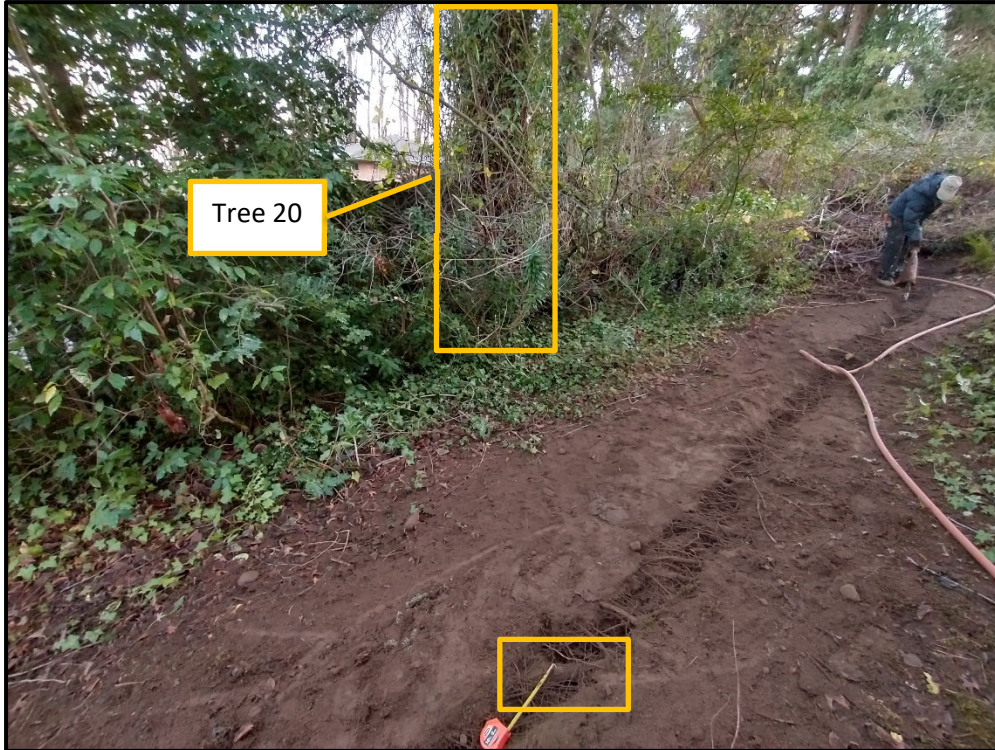
I observed excavation of a trench 15 feet west of Tree 20. The trench was 30 feet long (Photo 4). Mostly fine roots were exposed, in addition to four structural roots (Photo 5).

**Photograph 5.** Trench on west side of Tree 20. A 2-inch diameter root is in foreground and mostly fine roots exposed.

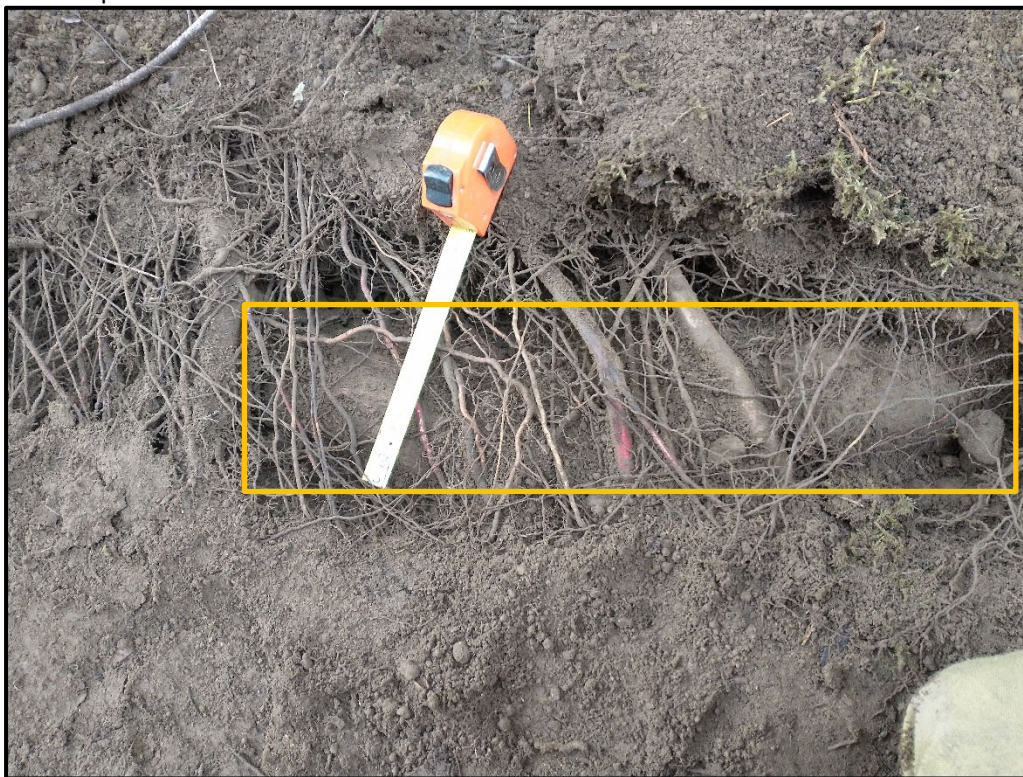
**Photograph 6.** Largest root encountered on site. Root measured 4.5 inches and grows horizontally along trench. Root should be preserved and excavation should not occur within 16 feet of the trunk of Tree 13.

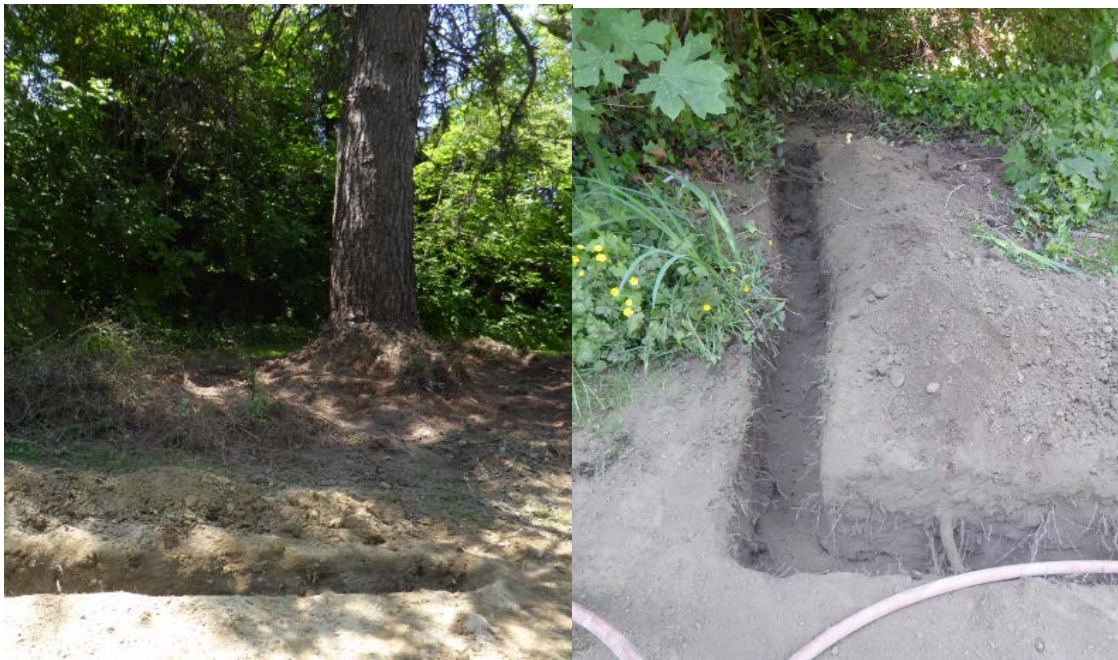
I observed the air excavation of a trench 22 feet south and 16 feet east of tree 13 at the above site address (see Photos 1a and 1b). Excavation exposed a low density of roots. Five structural roots were exposed east of the tree measuring less than three inches in diameter (see Photo 2). The largest root can be seen in photo 3.

Photos 1a (left) & 1b (right). These photos show the trench excavated by Root Cause.

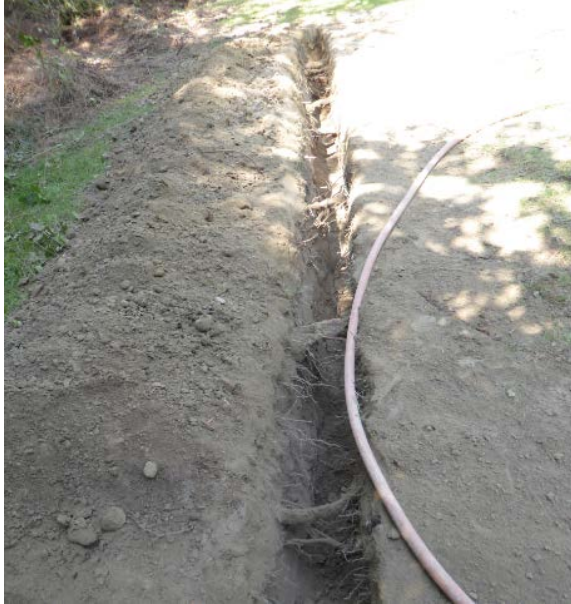
Photo 2. View looking to the north along the east trench. This view shows the low density of structural roots encountered.

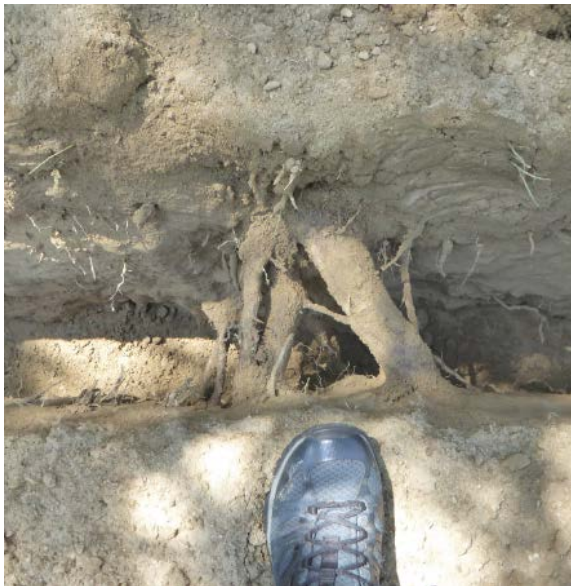
Photo 3. View of largest root exposed approximately 16 feet away from the tree.
