November 16, 2021

Project: Updated pre-construction assessment for lot re-development at 4001 W Mercer Way, Mercer Island, WA. Parcel number 3623500365.

Objectives: Evaluate health of existing trees and establish criteria for the preservation of those to be retained.

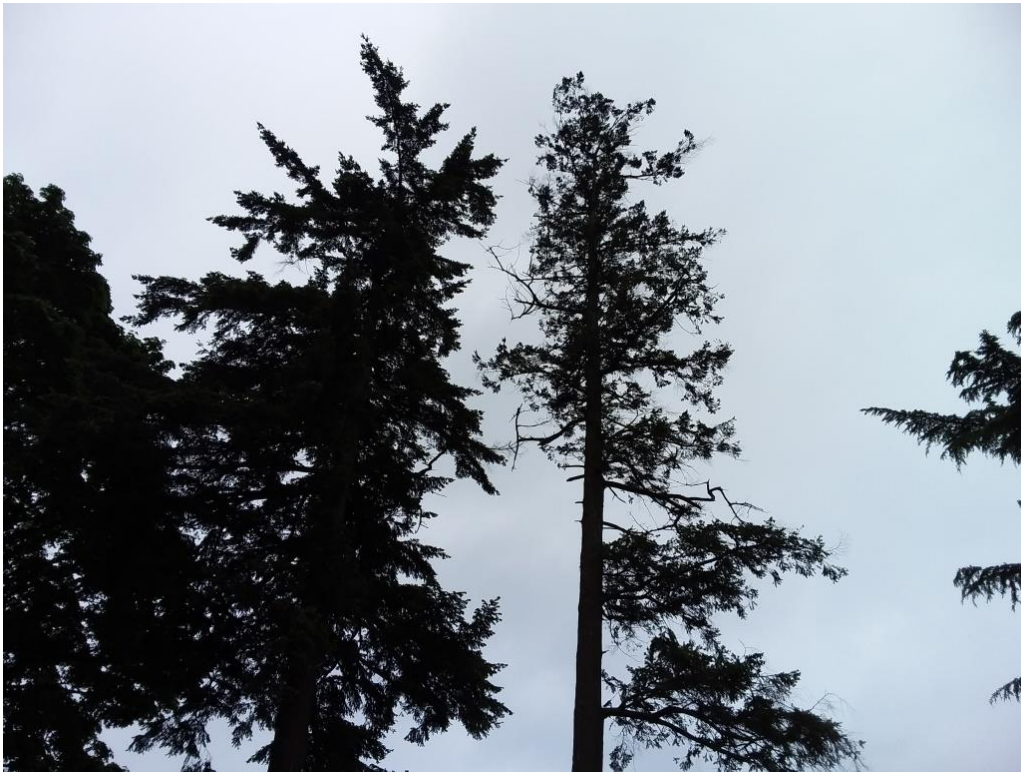
It is tall enough to reach the 3883 home to the north, completely across West Mercer Way on its east side, and it will bring down the main power lines no matter which way it falls. This means it has a **high likelihood of hitting** a significant target when it fails. As West Mercer is a heavily traveled road and there is an offset intersection at this location it is more likely than not that at least one vehicle will be involved when the tree fails. According to the first matrix this makes the tree **likely to fail and impact**. The tree's failure would result in **significant consequences** thus making the #1 fir a **high risk** for catastrophic failure.

Figure 4. Photo of canopy of the #1 fir. Compare to density of #2 tree. This tree has been removed since the original report was written in 2019.

The #1 fir was removed in 2020.

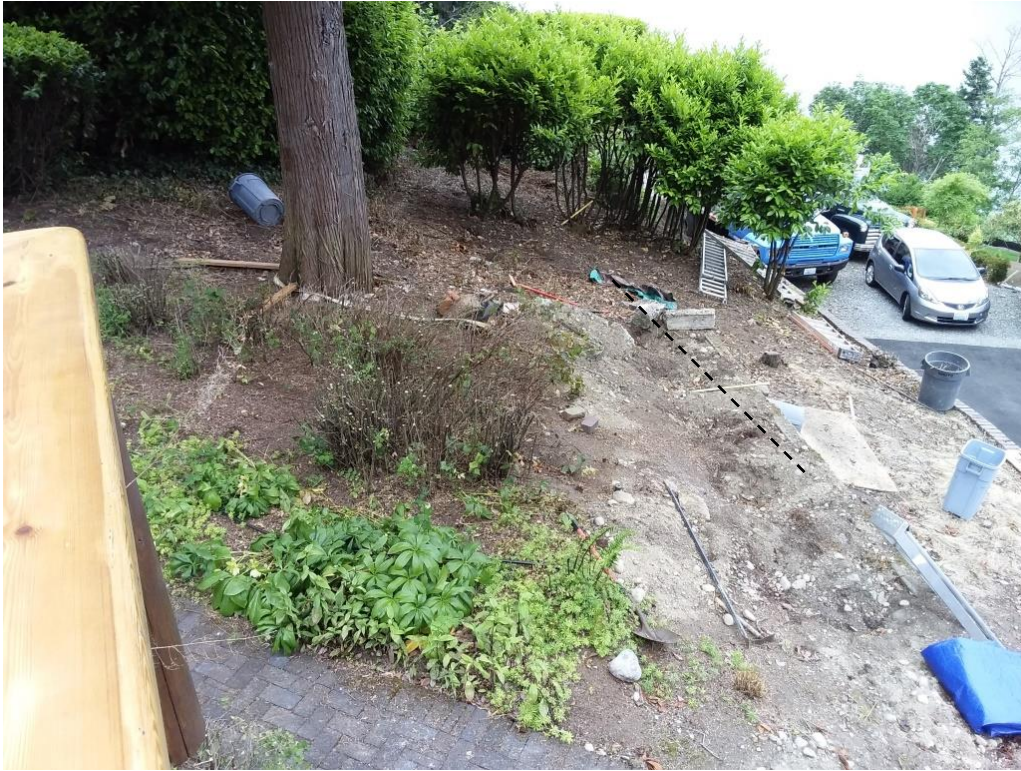
Figure 10. Photo showing the location of the retaining wall on the west side of the #13 cedar (black dashed line).
