LAYTON TREE CONSULTING, LLC

ARBORIST REPORT/TREE PLAN

7204 78th Avenue SE
Mercer Island, WA

March 7, 2022

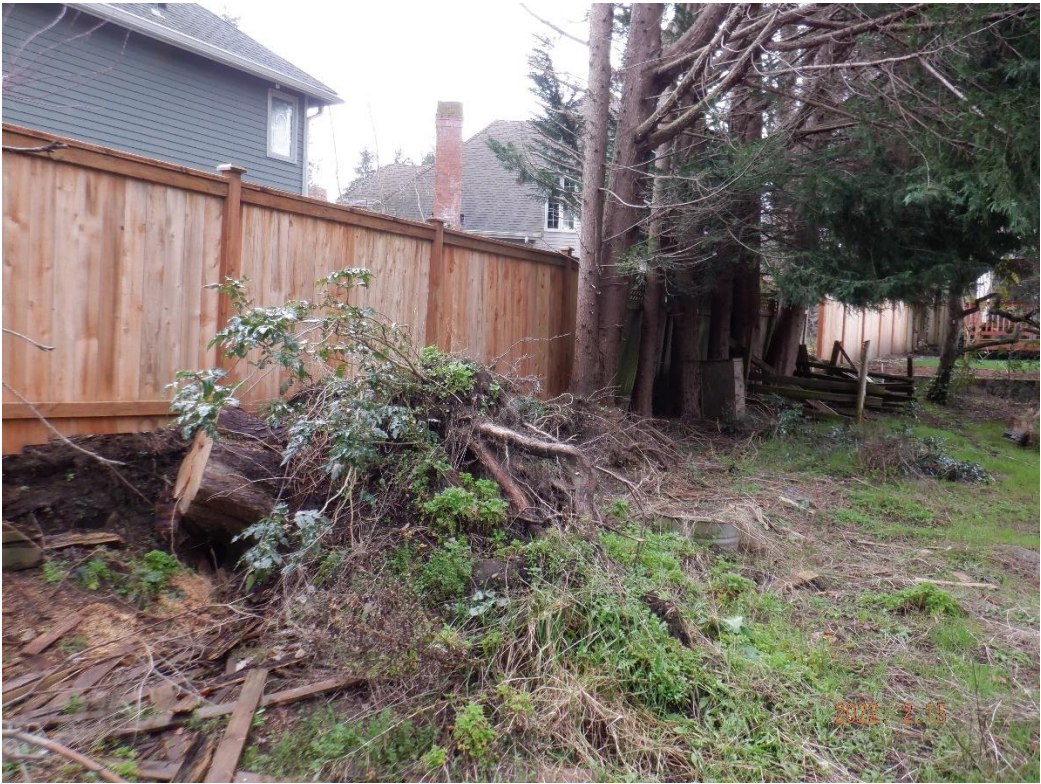
Trees #880 > #886 are a planted row of Leyland cypress adjacent to the east property line. Two Leyland cypress north of #880 uprooted in the past and failed. The remaining cypress have been significantly pruned back on their east sides by the neighbor and have asymmetric crowns to the west. These are in 'fair' condition.

Trees #880 > #886 on east property line, previously uprooted cypress trees in foreground

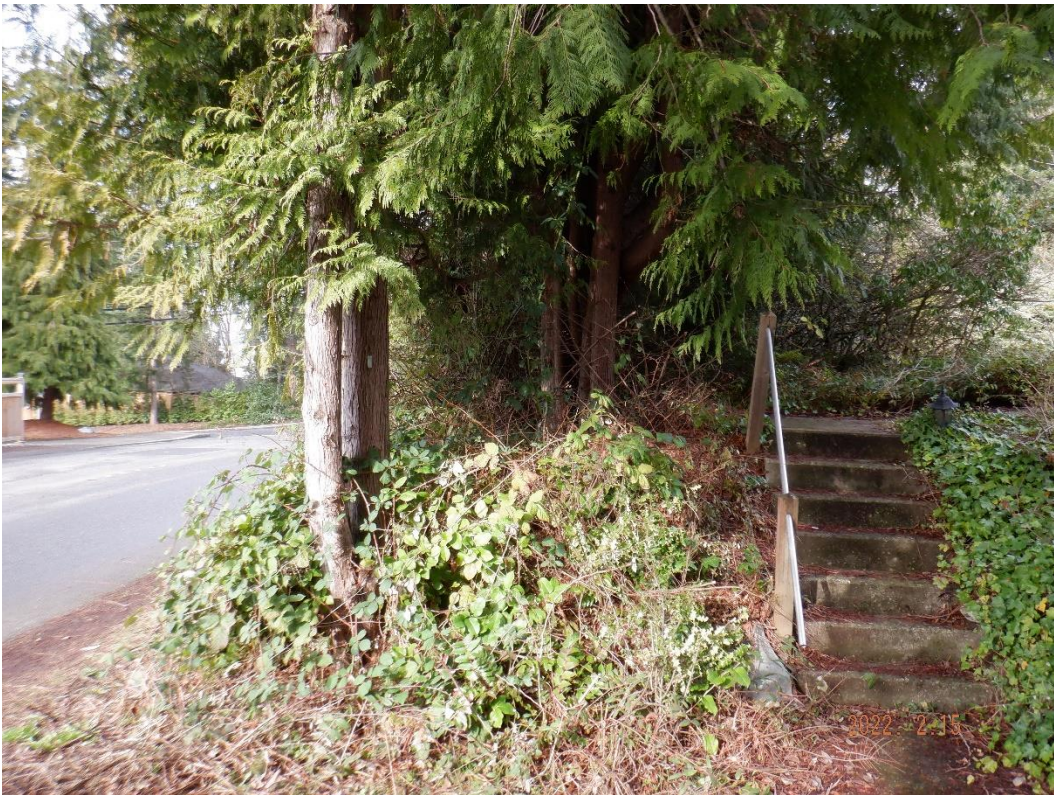
ROW trees west of existing house
