# Arborist Report

*Tree Inventory - March 2023  
(amended December 2024), (amended March 2025)*

Davey Resource Group (DRG) was contracted by Chung Ling (Vicky) Ou to inspect and provide an arborist report and tree protection plan for the property 3804 E Mercer Way in Mercer Island, Washington (PIN: 210700-0100). The client intends to develop the property.

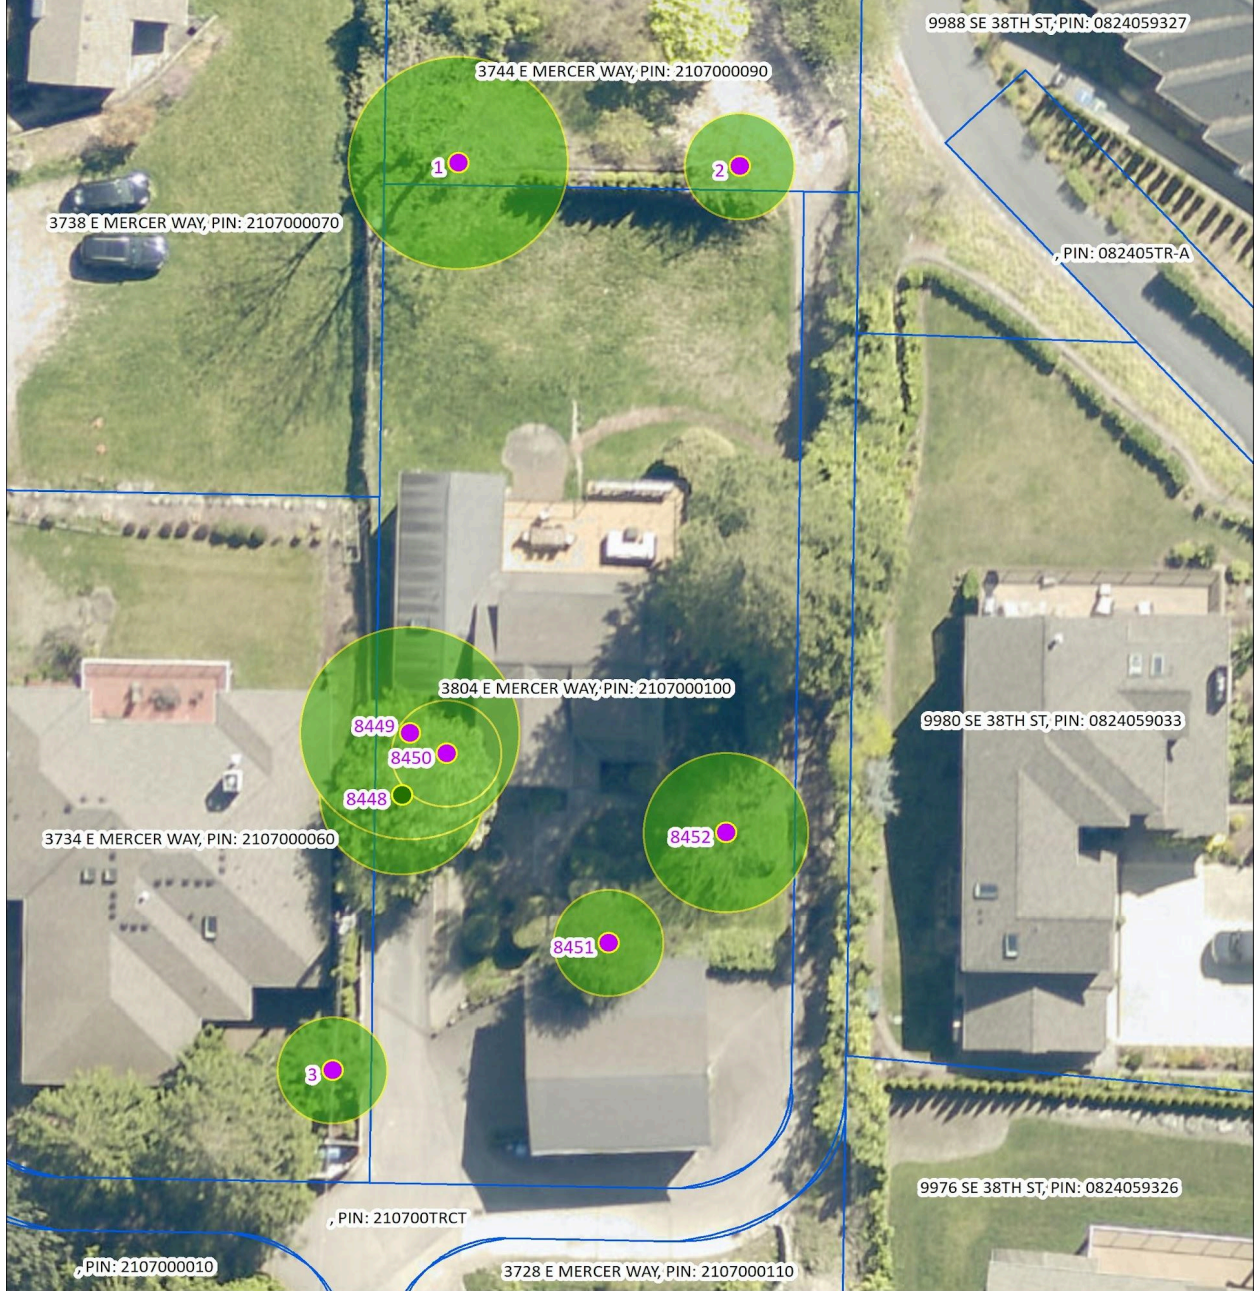
**Map 1- Site map overview showing tree ID number. Aerial photos are only used for reference. Map projections may distort tree canopy size and locations.**

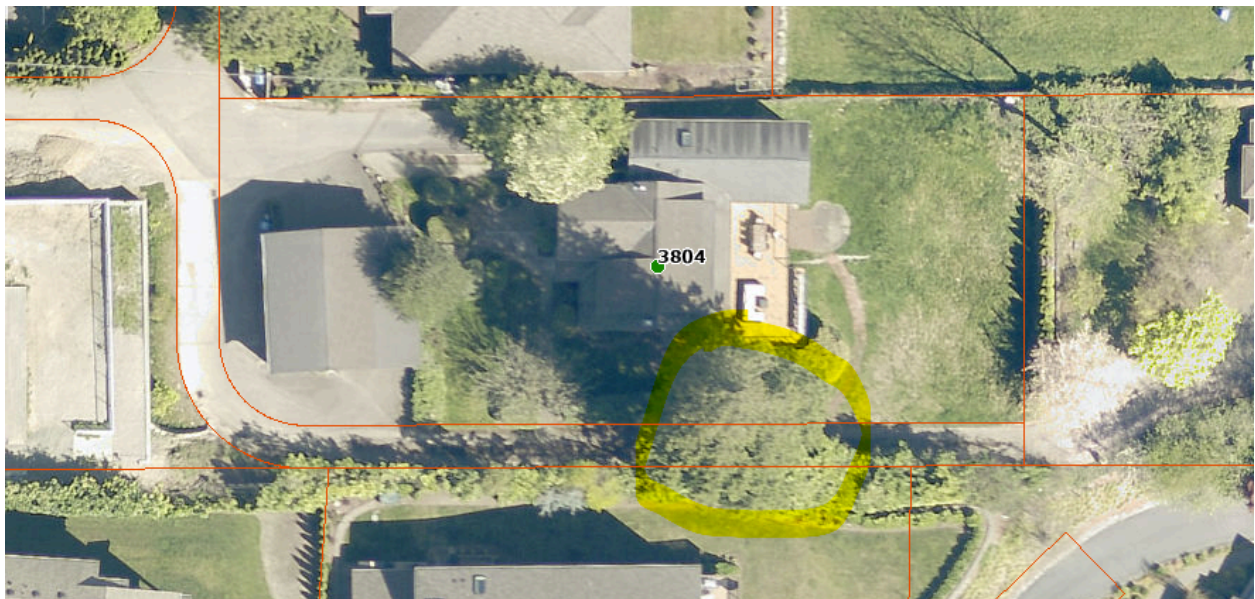
The City of Mercer Island has requested that all previously removed trees from the past five years be accounted for in this report. One tree was possibly removed from the subject property within this timeframe. The tree has been identified and circled in yellow from an image captured on the King County Parcel Map, however, it's unclear when the tree was removed.

*Image 2. An overview of the subject parcel with the previously removed tree circled in yellow.*

**As shown on the accompanying Tree Inventory & Replacement Worksheets, three (3) replacement trees are required to compensate for this previously removed tree.**

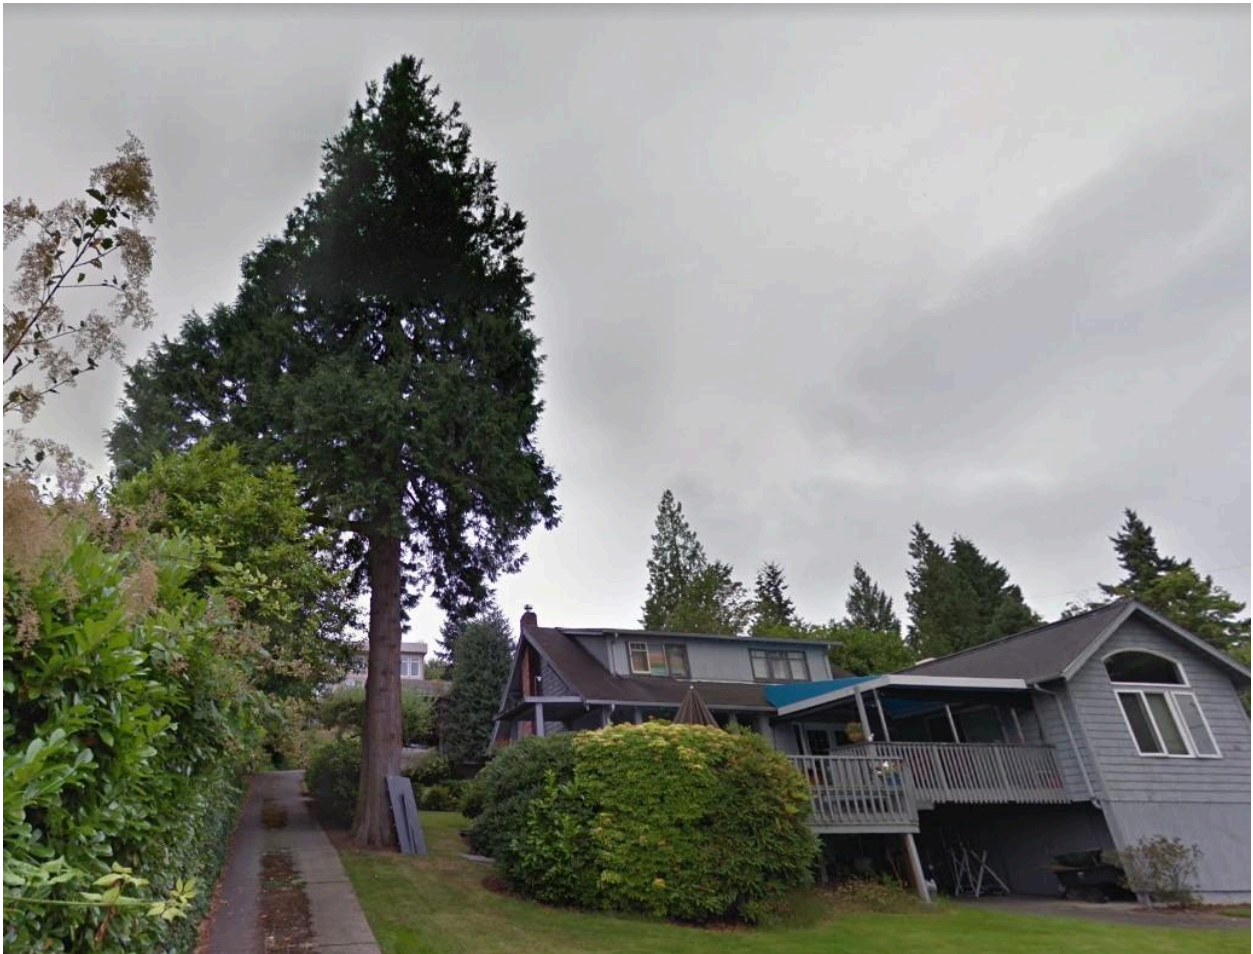
No stump or visible remnants of the trees remained on-site during the field inspection. Google Maps Streetview tool was used in order to determine the approximate size of the tree prior to its removal. The imagery was captured in August 2011. The image of the tree is included on the next page of the report, which shows remnants of 1x3" decking slats, leaning against the trunk providing a reference scale.

The tree appears to have been a tall-statured Western red cedar (*Thuja plicata*). Using other site objects and features as a reference, the estimated size (DSH) of the tree prior to its removal ranges from **26-30 inches** and is **NOT EXCEPTIONAL**.

***Image 3. Google Maps Streetview imagery of the removed tree dated August 2011.***
