DOWNSTREAM ANALYSIS
FOR
SINGLE FAMILY RESIDENCE
6175 SE 27TH ST
MERCER ISLAND, WA 98040

December 28, 2023
Revised: June 25, 2024

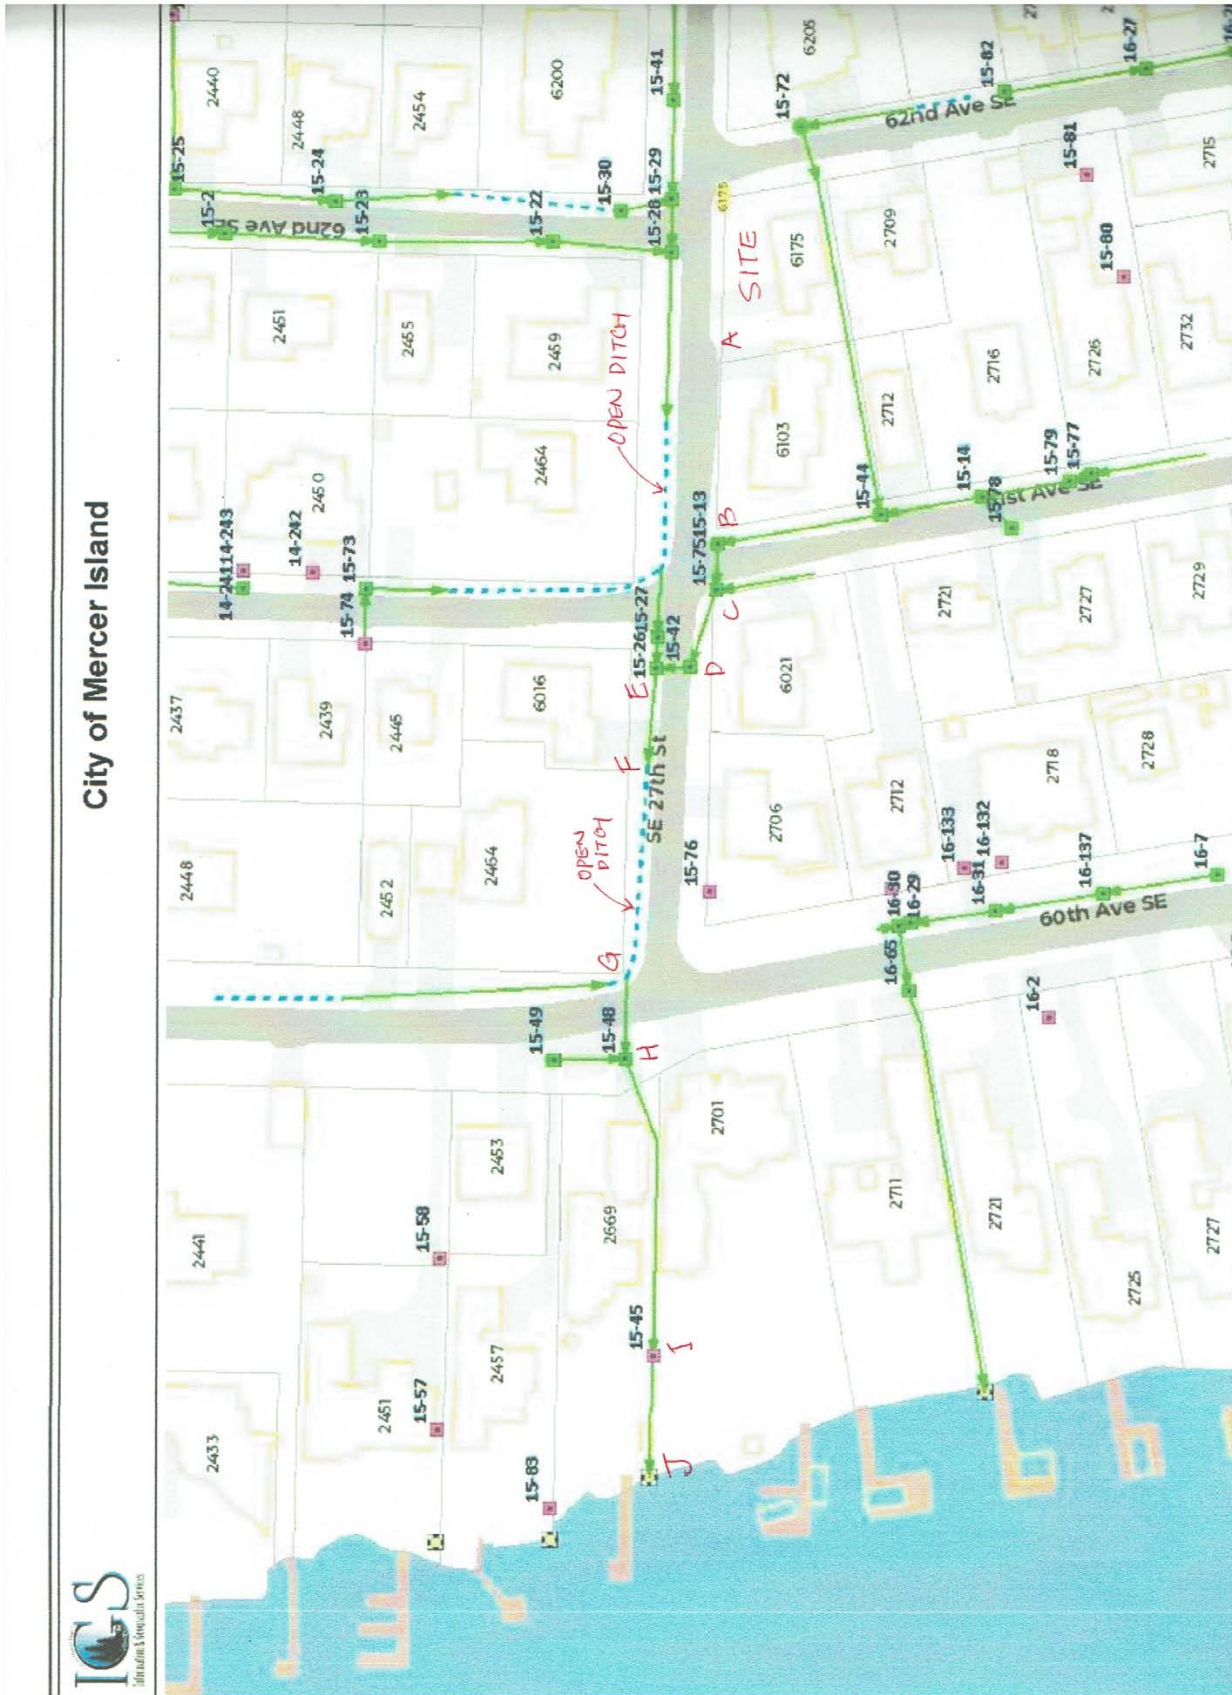
FIGURE 5: DOWNSTREAM MAP (NTS)

- Presently, site runoff sheet flows and discharges at the west property line to the neighbor’s property edge and continues westerly approximately 120 l.f. to a Type 1 CB (B) located at the southeast intersection of SE 27th St and 61st Ave SE (See Figure 5, Downstream Map). It continues in a 12” concrete pipe to the west edge of the street approximately 30’ in the lawn area to another CB (C). Then, it continues travels westerly at the same street side approximately 50 L.F. in a 12” DI pipe to another Type 1 CB (point D). From here, it crosses under the street to the north side to another Type CB (E) in the shoulder, approximately 22 L.F. It then continues westerly at the same north side of the street approximately 64’ to an open ditch (F). Then, it travels in the open shallow roadside ditch approximately 4’ to 15’ wide for another 130 l.f. to a 12” concrete culvert (G) at the northeast intersection of 60th Ave SE and SE 27th St. with new riprap inlet. The culvert extends approximately 50 l.f. into a catch basin (H) located at the driveway

pavement. Runoff continues travels westerly along the lot lines for another 187 l.f. to a catch basin (I) located in the yard of house number 2669. From here it discharges t the shore line of Lake Washington (J) approximately 75 l.f. away. The analysis is terminated for a total approximately distance of 728 l.f. During the downstream drainage field visit, only minor drainage issues were observed and no areas of any existing or potential major drainage problems were apparent.

The down stream drainage system as described above is not prone to stream bank erosion, siltation, and slide and does not threaten destruction of aquatic habitats. Catch basins as observed are mostly clean and sediment in the catch basins are below the invert of the outlet pipes. Open ditches have no sign of major erosion or scouring, or sign of street overtopping were apparent. Due to the fairly good slope of the analysis route, the conveyance pipes system does not appear to have a capacity problem or show any sign of overtopping in any of the structure.

No off-site mitigation is necessary as there are no observed major drainage issues during the analysis for the downstream portion and runoff discharges from this site will be very minimal to downstream system.
