DOWNSTREAM ANALYSIS
FOR
SINGLE FAMILY RESIDENCE
6175 SE 27TH ST
MERCER ISLAND, WA 98040

December 28, 2023
Revised: June 25, 2024
Revised: August 09, 2024

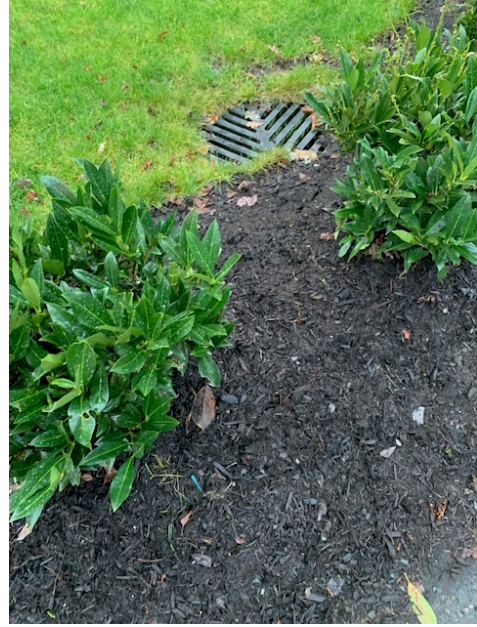
Catch Basin – At Point C

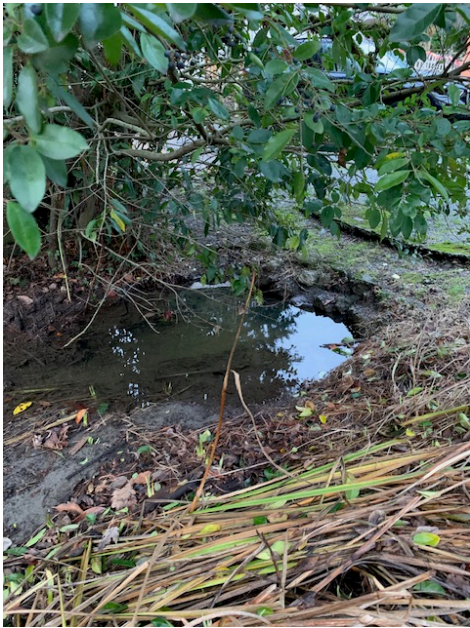
2. No existing or potential constraint or lack of capacity in the existing drainage system was apparent. Some ponding existed in the open ditch where culvert discharges but it will not prevent runoff from flowing in the ditch. There was no other standing water in the open ditch.

Culvert Discharge to open Ditch Point F

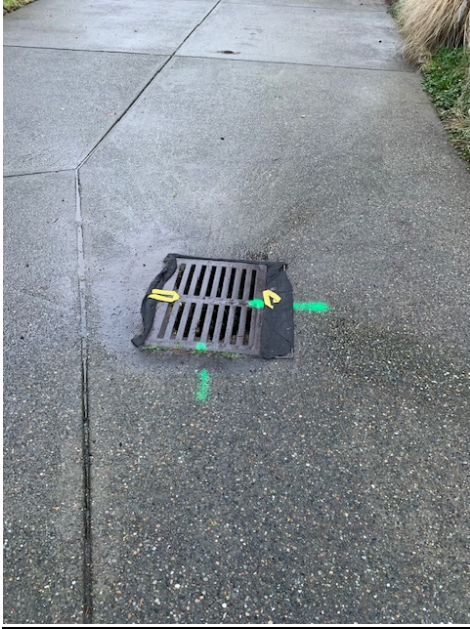
Catch Basin Point H driveway - West of
60th Ave SE - Looking West
