**Stormwater Drainage Report
274xx 62nd Avenue SE
Mercer Island, Washington
KC Tax Parcel #217450-3231
Permit #: 2402-xxx**

September 16, 2024

**Offe Engineers, PLLC
Darrell Offe, P.E.
13932 SE 159th Place
Renton, Washington 98058
425-260-3412
Darrell.Offe@comcast.net**

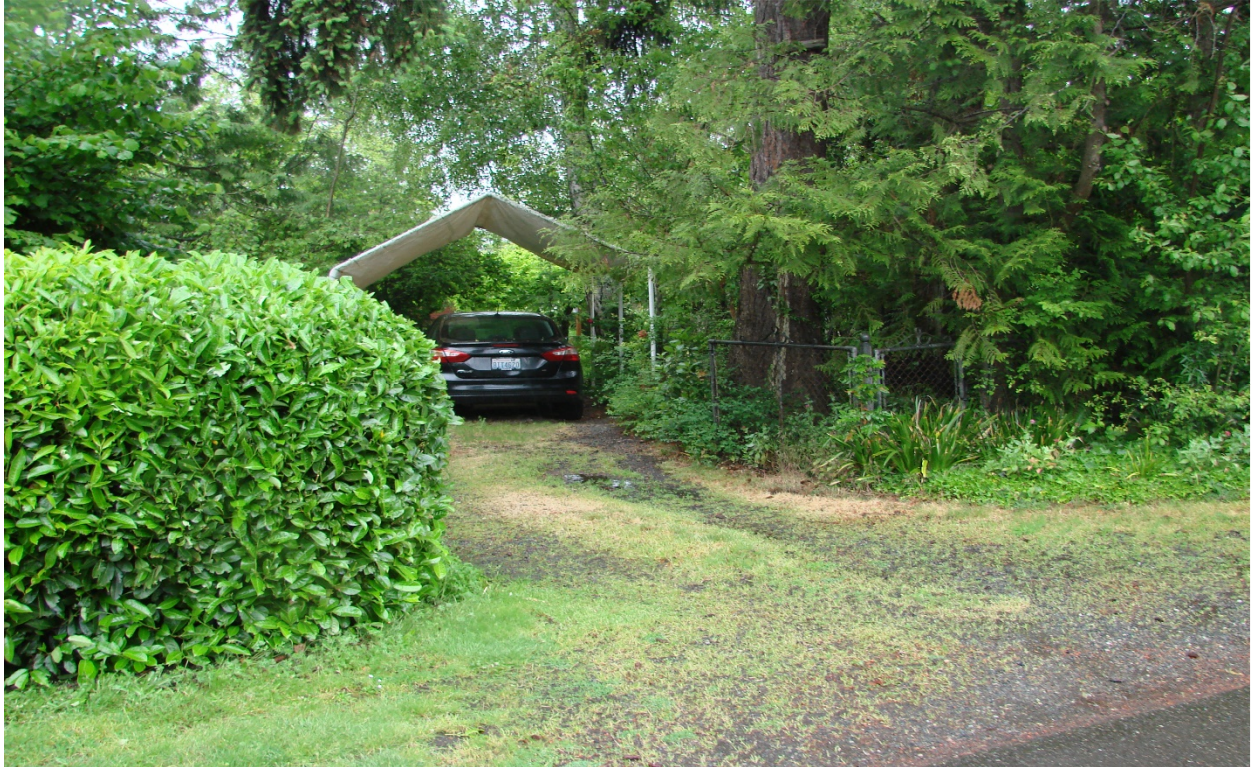
Photo #1 – Subject property from 61st Avenue SE – viewing west

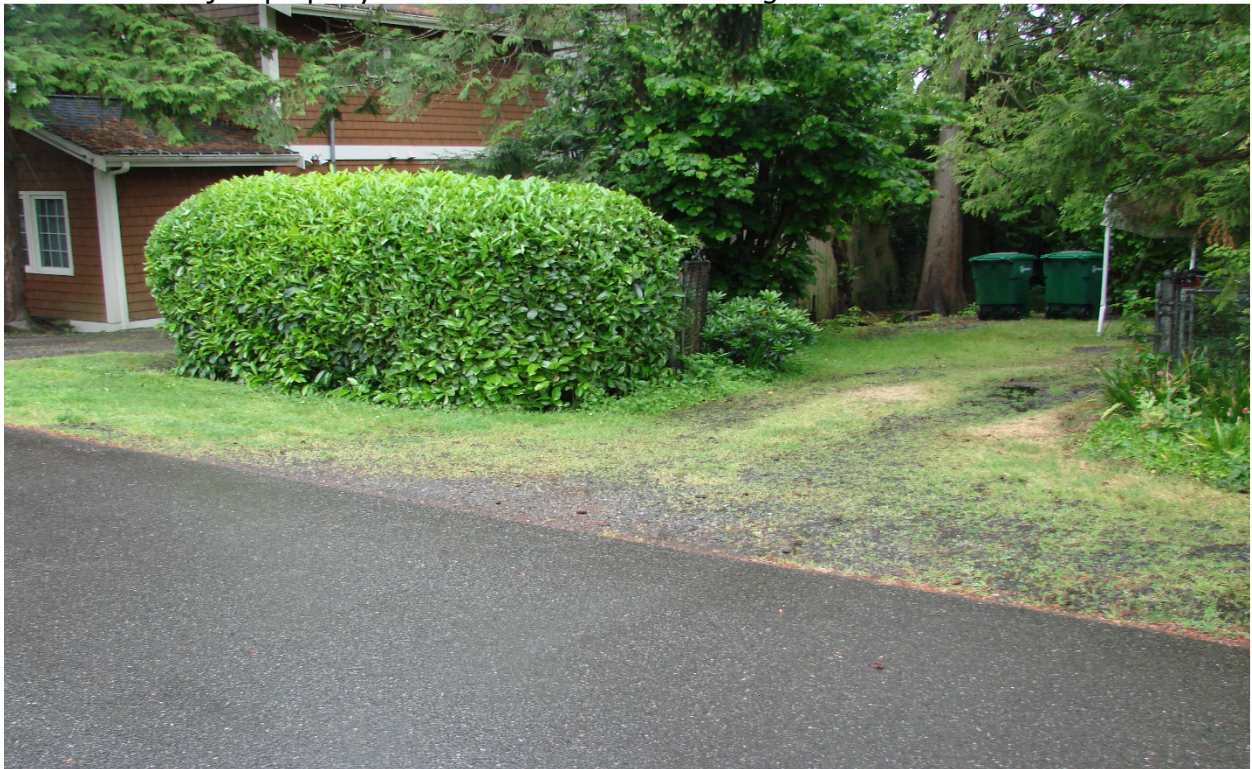
Photo #2 – Subject property from 61st Avenue SE – viewing southeast corner

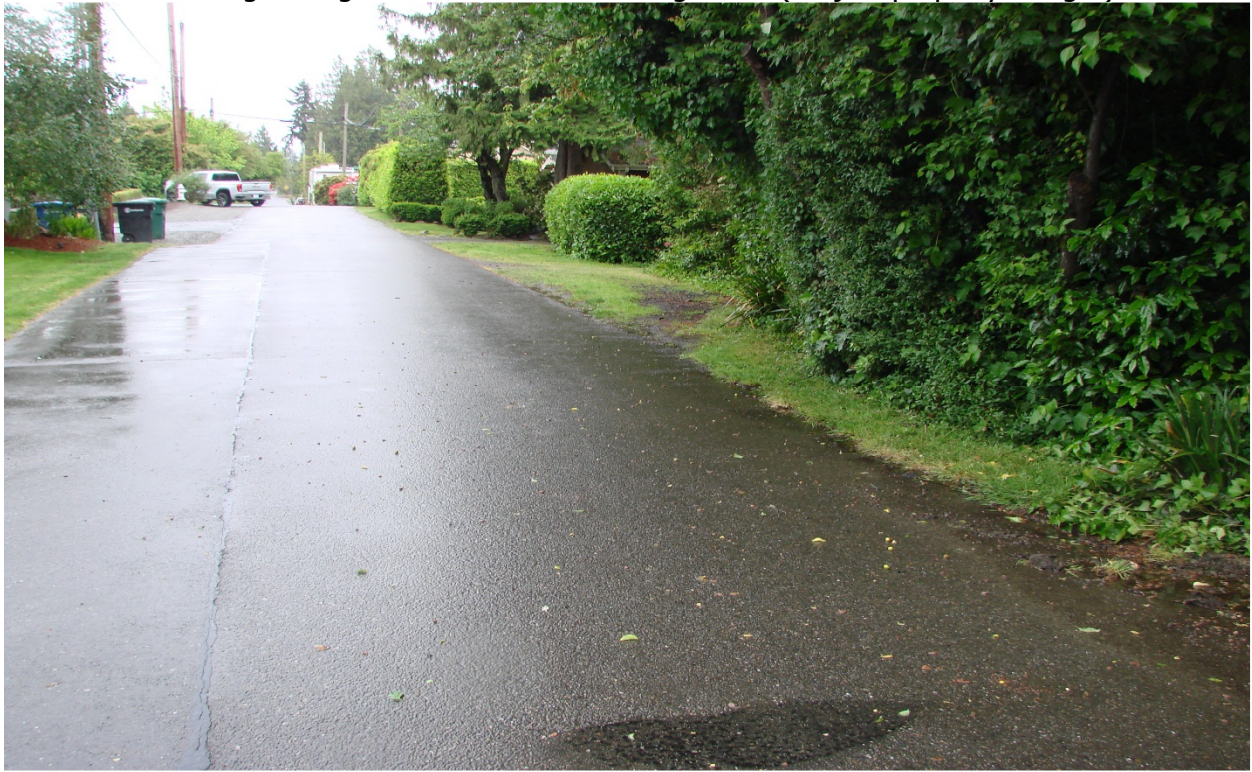
Photo #3 – Frontage along 61st Avenue SE – viewing south (subject property to right)

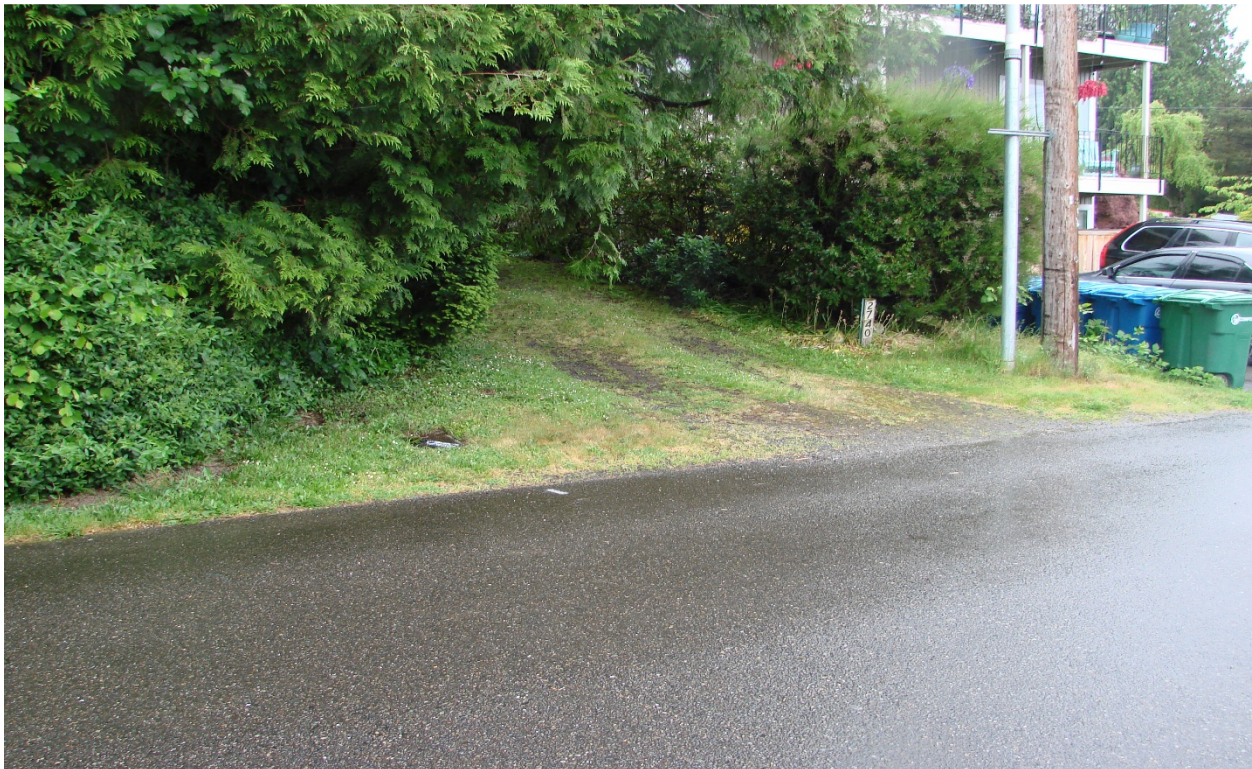
Photo #4 – Southwest corner of 2740 60th Avenue SE

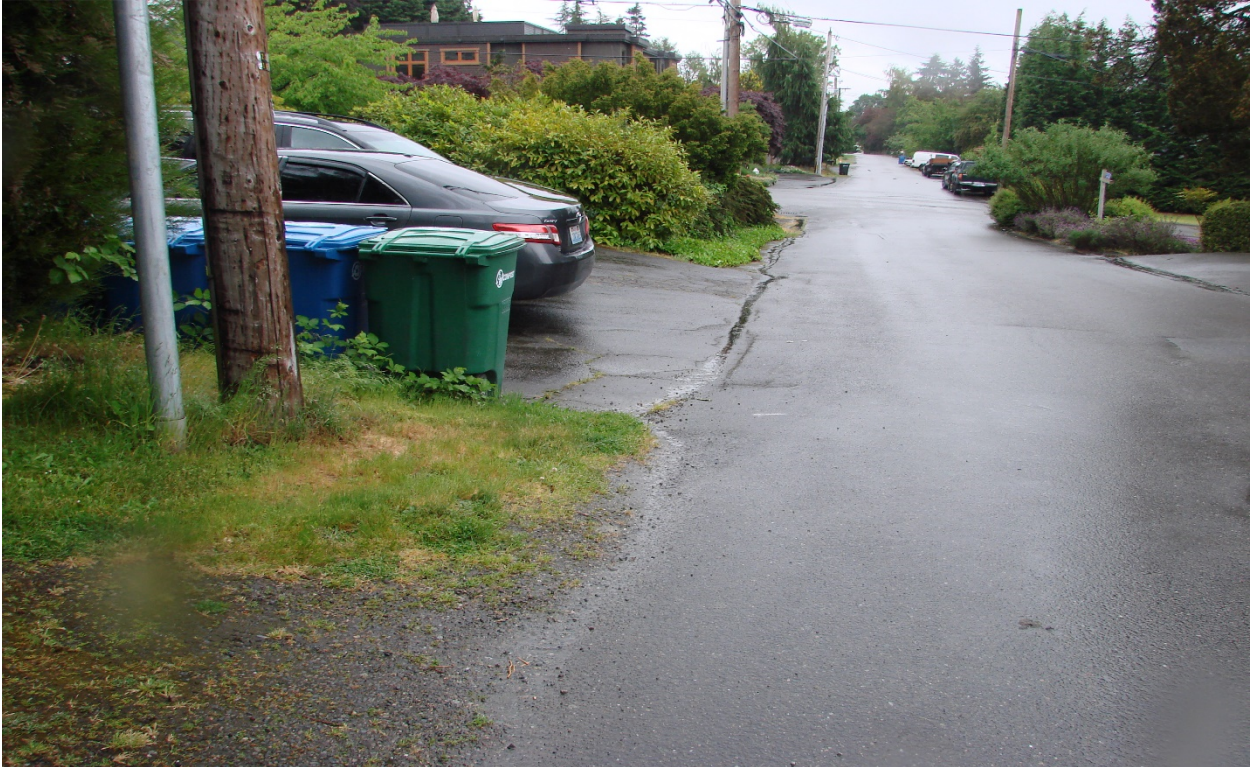
Photo #5 – West side of 60th Avenue SE at Southwest corner of 2740 60th Avenue SE – viewing south

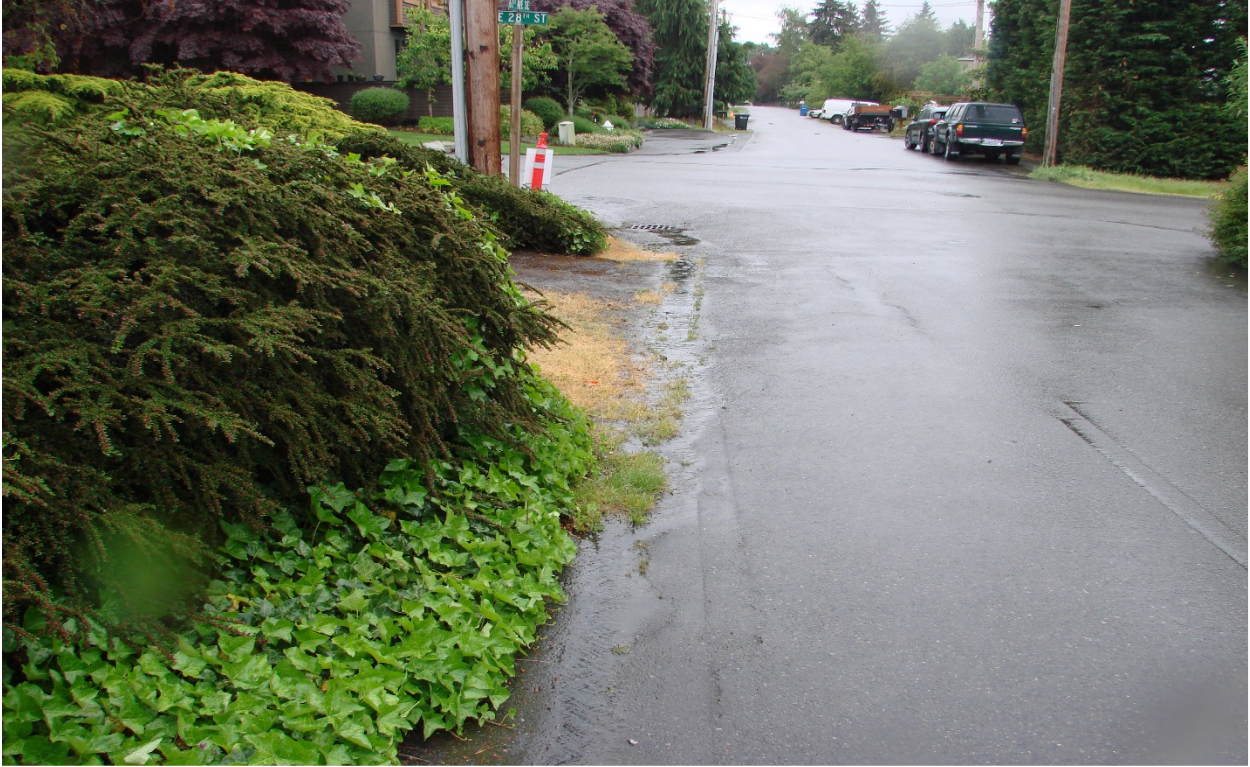
Photo #6 – West side of 60th Avenue SE – viewing south

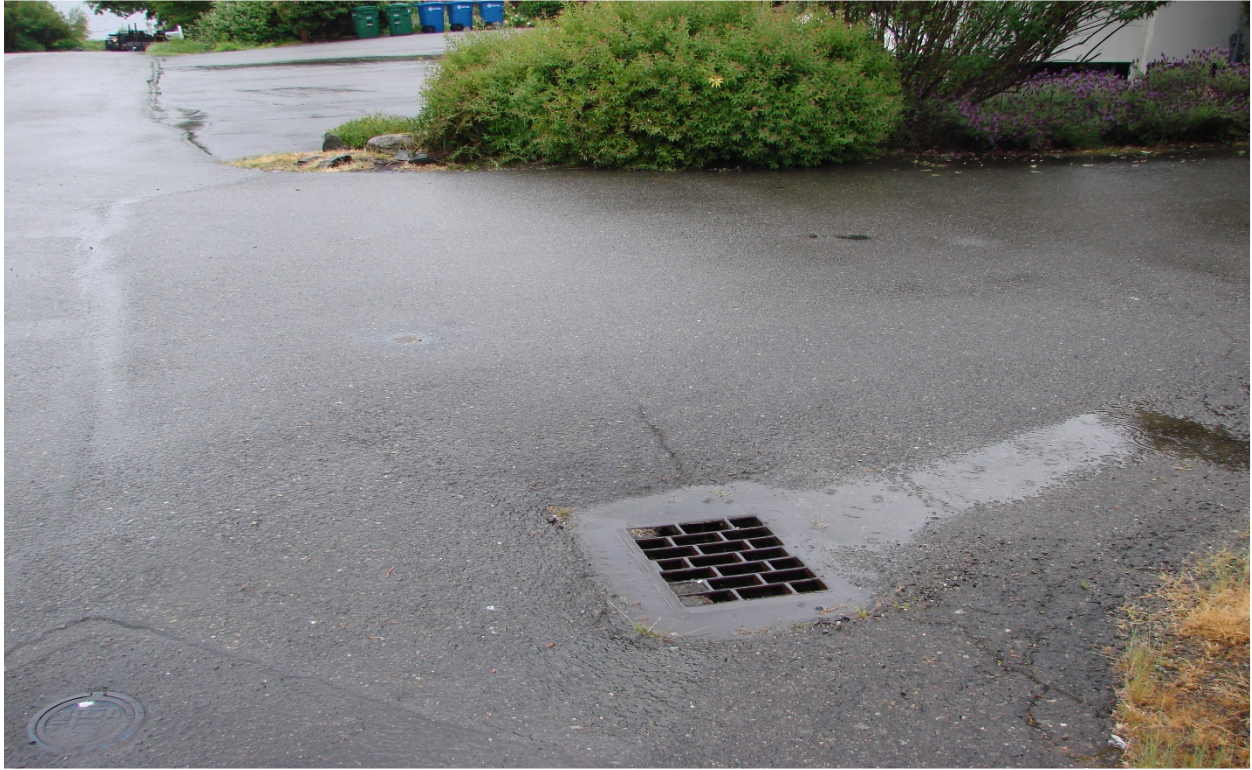
Photo #7 – Inlet City CB #16-16 at northeaasty corner of SE 28th Street & 60th Avenue SE

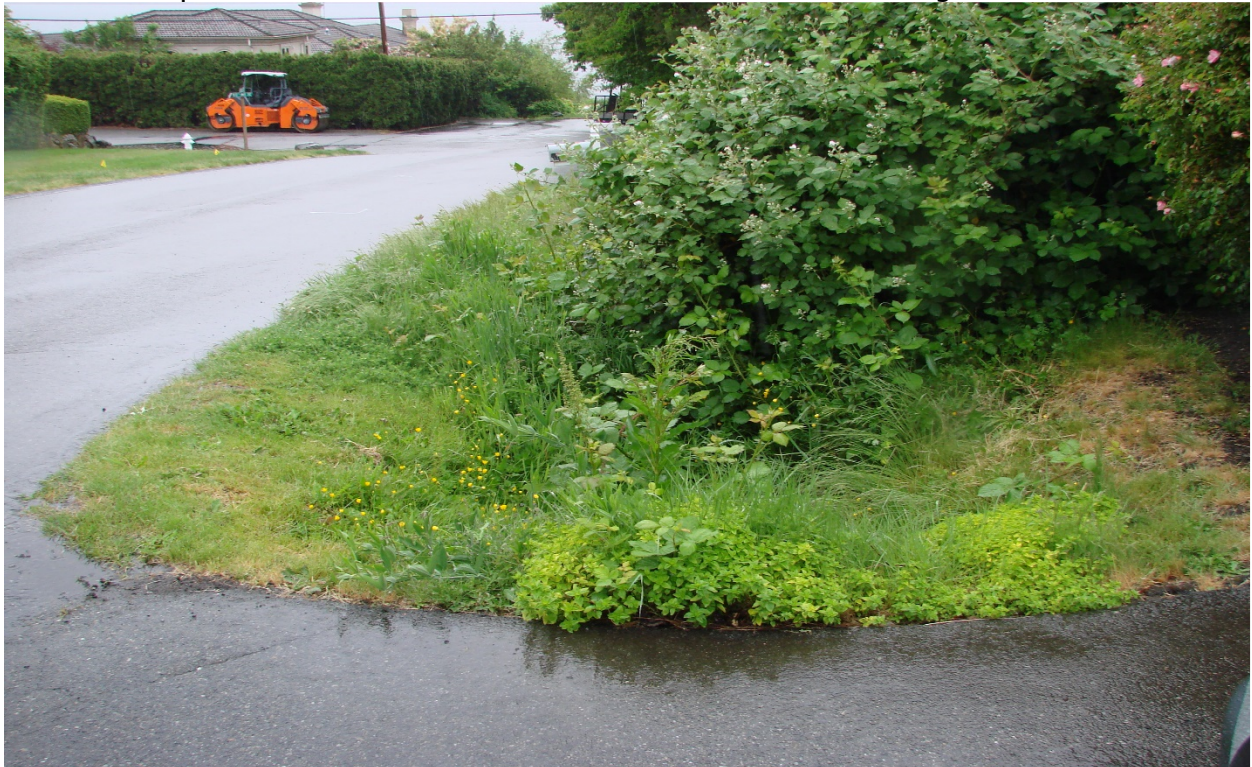
Photo #8 – Open roadside ditch on north side of SE 28th Street – viewing west

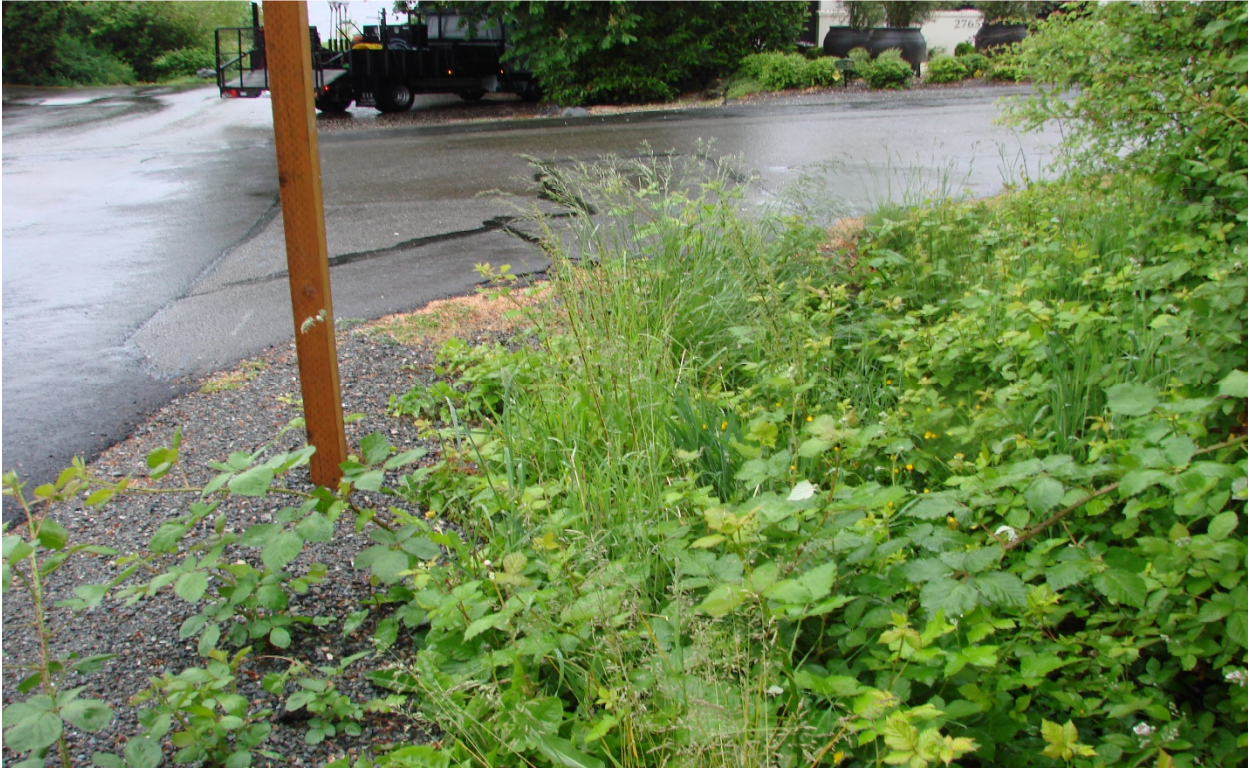
Photo #9 – Open ditch inlet at northeast corner of SE 28th Street & 60th Avenue SE

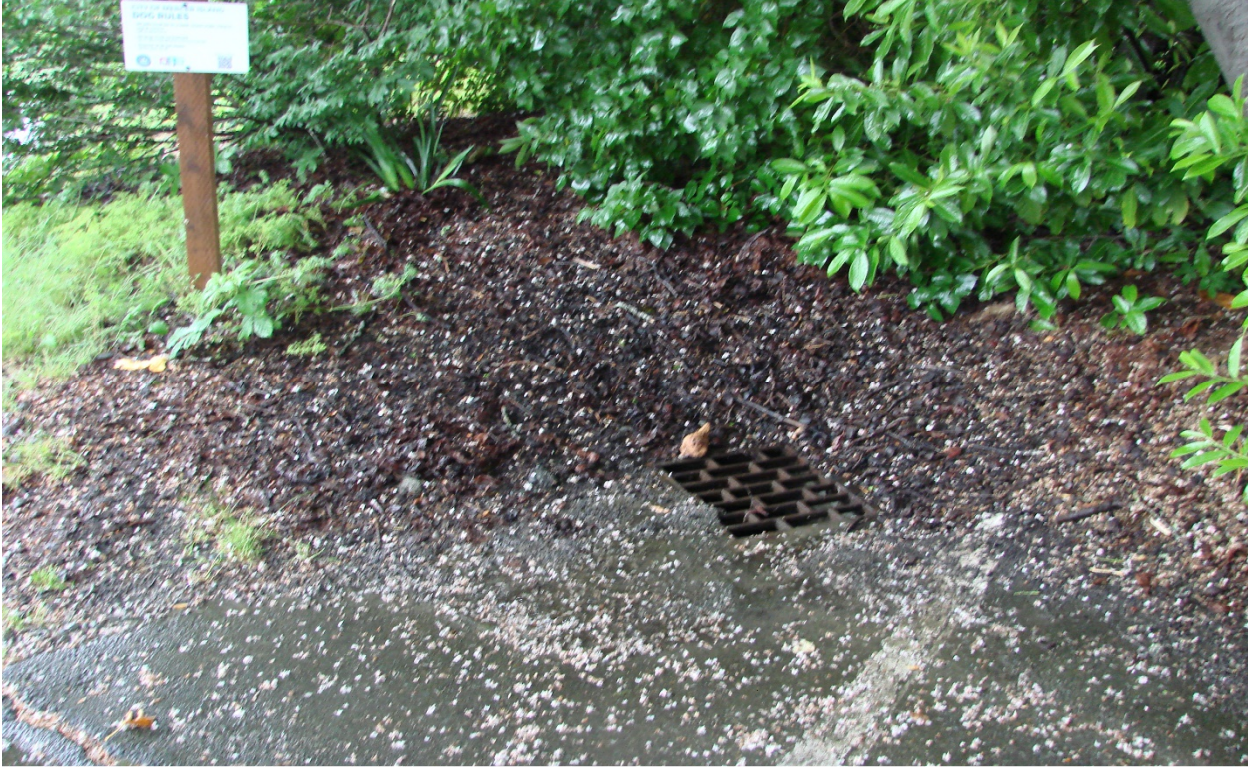
Photo #10 – City CB #16-11 within parking area of Calkins Landing Park (north side)

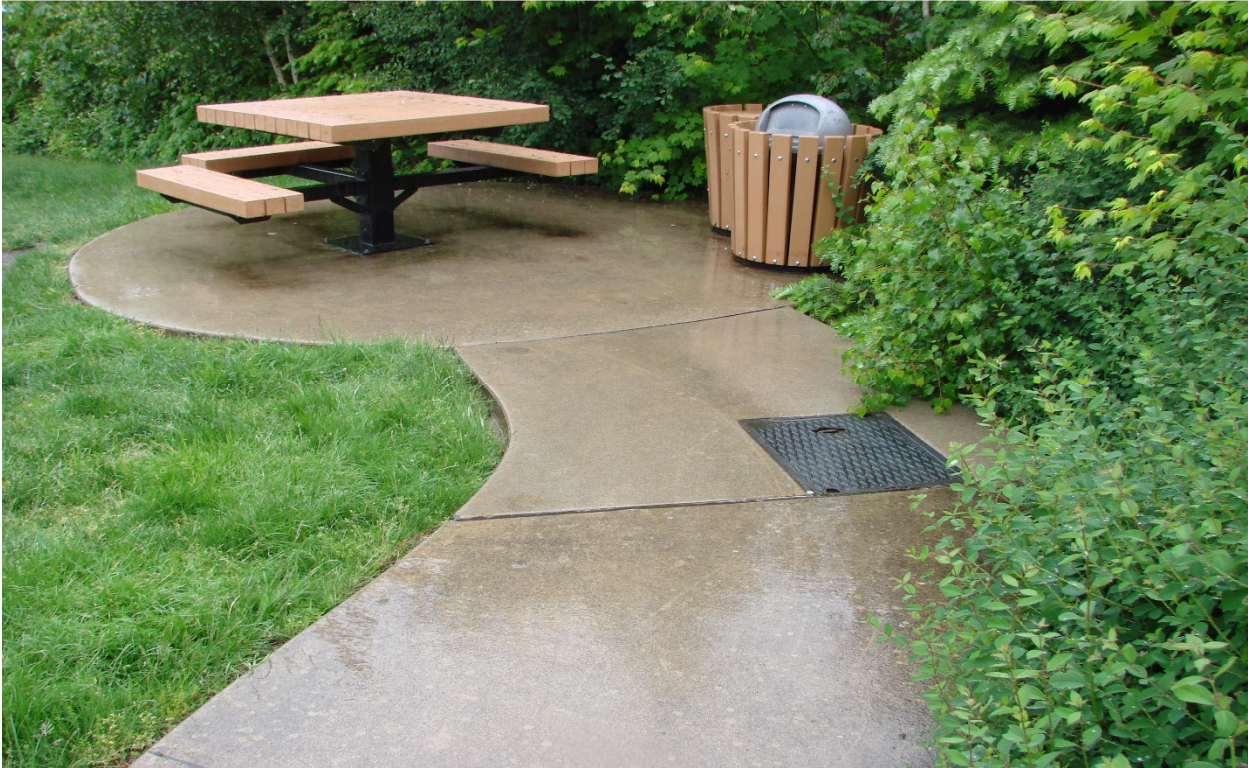
Photo #11 – City CB #16-13 within Landing Park (north side)

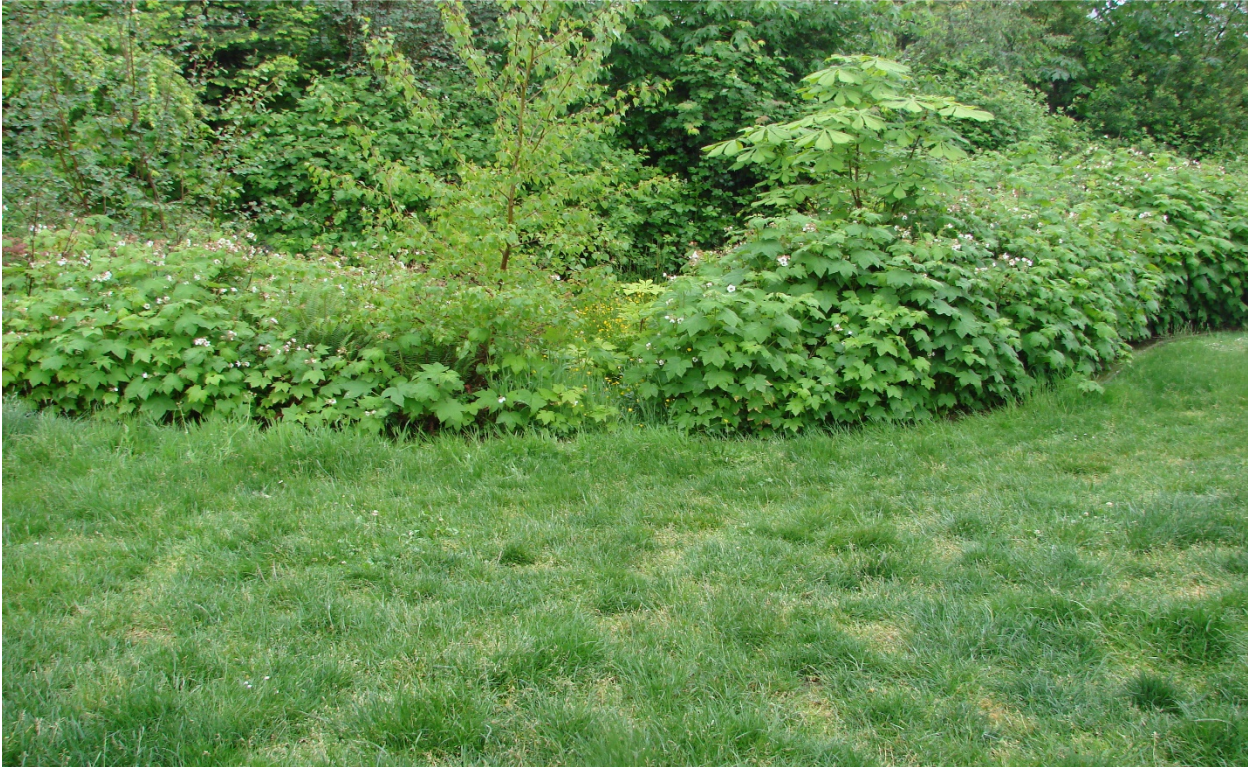
Photo #12 – Vegetated channel on south side of Calkins Landing Park – viewing southwest

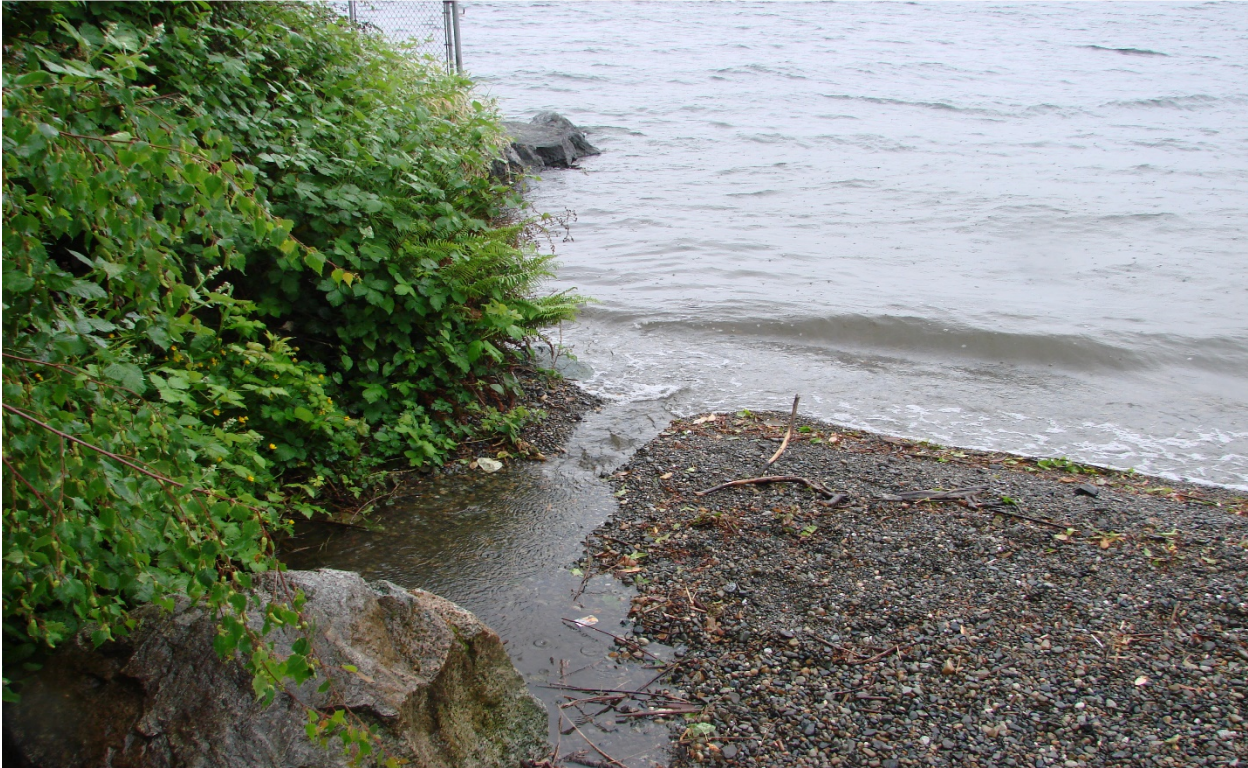
Photo #13 – Outfall into Lake Washington at beach head

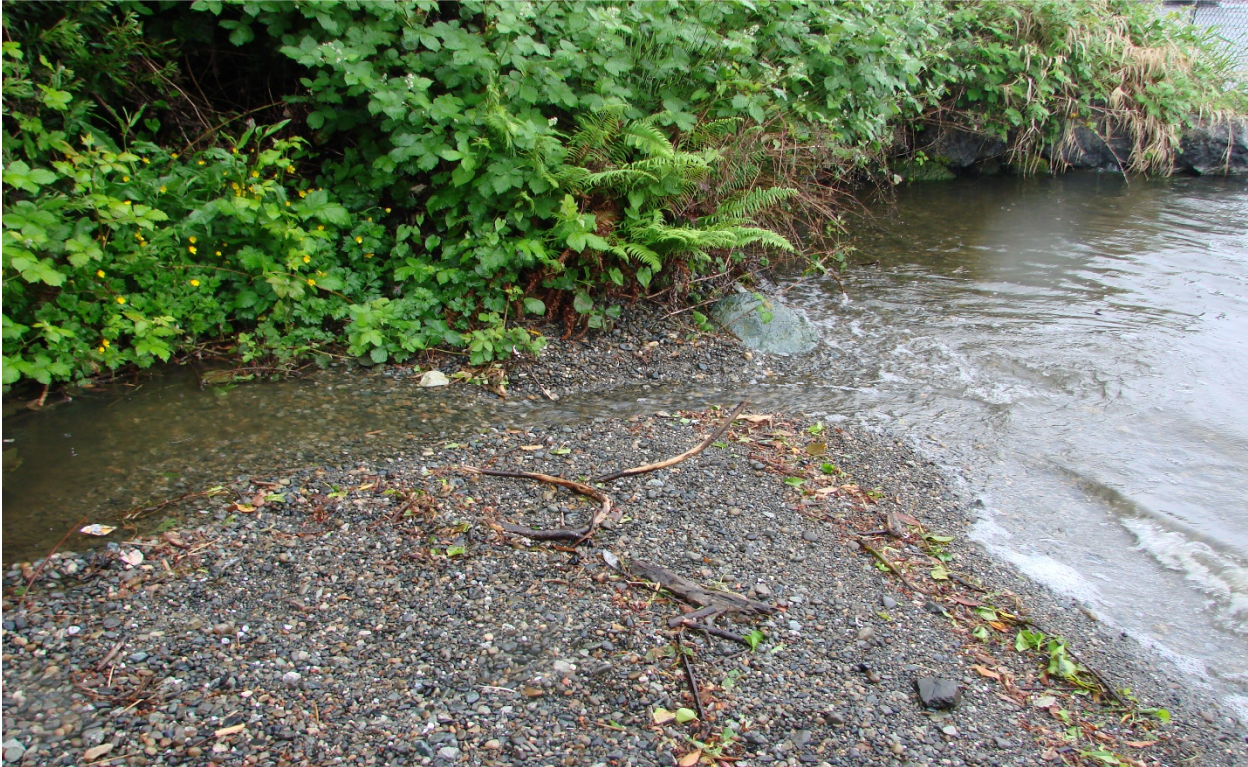
Photo #14 – Outfall into Lake Washington at beach head
