**DOWNSTREAM ANALYSIS**  
**FOR**  
**SINGLE FAMILY RESIDENCE**  
**2247 66<sup>TH</sup> AVE SE**  
**MERCER ISLAND, WA 98040**

November 11, 2024

**C2MY Engineers, LLC**  
P.O. Box 52883  
Bellevue, WA 98015-2883  
Contact: Choomeng Chin  
(206) 451-7856  
*cmchin.c2my@gmail.com*

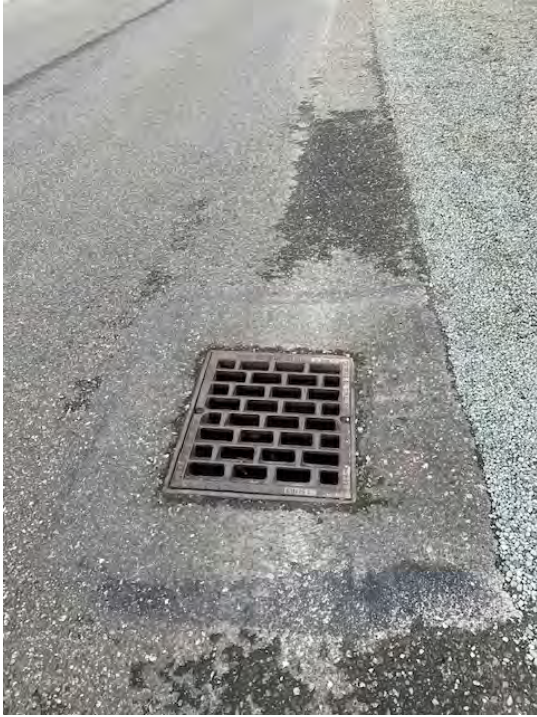
Catch Basin – At point A, Looking Downstream

- Presently, site runoff sheet flow at the west property line to the drainage system on Aubrey Davis Park drainage system that the 66<sup>th</sup> Ave SE drainage system is connected and discharge to. The proposed site drainage will discharge to the 66<sup>th</sup> Ave SE storm system at existing CB (A) with vaned grate on the street (See Figure 5, Downstream Map). This CB discharges easterly in an 8” DI pipe approximately 10 l.f. to another Type 1 CB (B) with solid locking lid located at the gravel shoulder. From here, runoff flows northerly in a 12” concrete pipe with PVC sleeve approximately 60 l.f. to another Type 1 CB (C) with vaned grate located on gravel shoulder. Runoff continues northerly for another 65 l.f. to yet another Type 1 CB (D) with vaned grate also in the gravel shoulder. It then continues northerly in a 12” concrete pipe approximately 90 l.f. to another Type 1 CB (E) with vaned grate on the paved shoulder east edge of the street. Then, it continues travels northerly approximately 25 l.f. to a Type 2 CB (F) with round solid lid located at the edge of travel way.

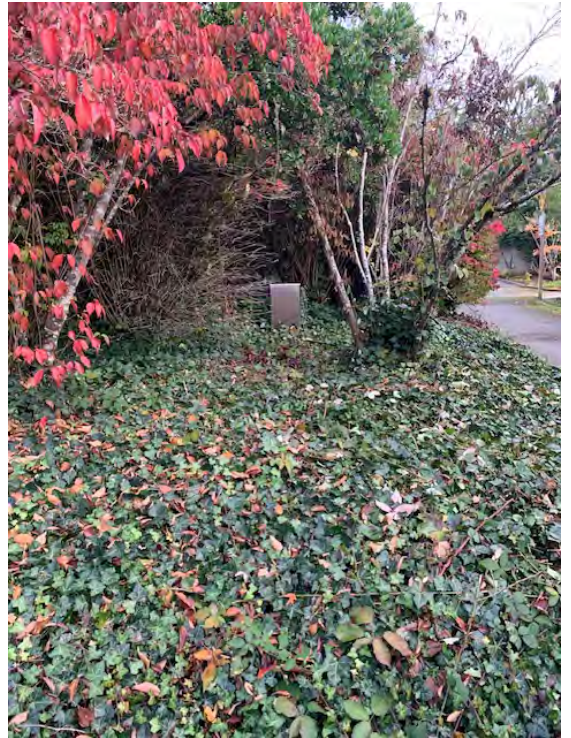
Catch Basin at point G

- From here, runoff travels westerly direction in an 18” concrete pipe approximately 110 l.f. to another Type 2 CB (H) with standard grate located within the Park property at the edge of a park trail. CB at point (G) shown on City GIS map is not visible in the field. Runoff then continues southwesterly along the east edge of trail approximately 85 l.f. to

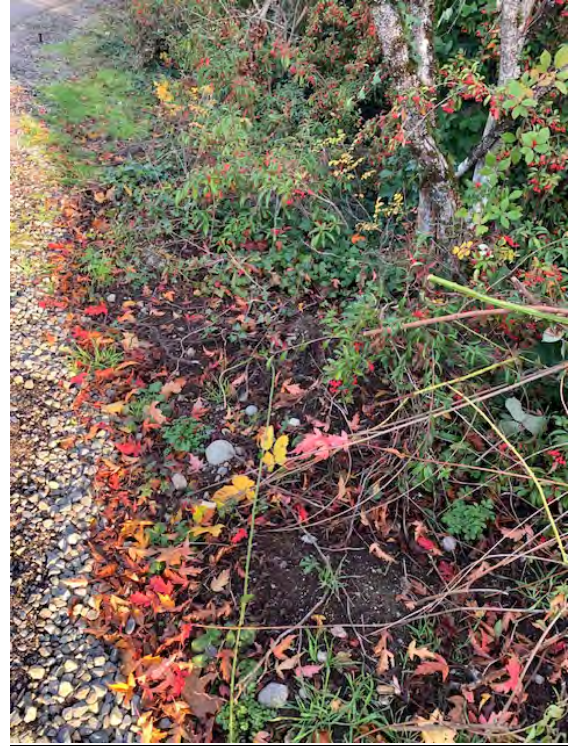
Catch Basin at Point J

another Type 2 CB (**I**) with standard grate. Then, it continues at the same side of the trails approximately 90 l.f. to another Type 2 CB (**J**) located at thick ground cover. At this point runoff continues northwesterly approximately 100 l.f. to another Type 2 CB (**K**) with standard grate location at the open lawn area near the playground. From here, it continues at southwesterly direction approximately 195 l.f. to another Type 2 CB (**L**) with vaned grate located at the east edge of W Mercer Way curb line. Then, it continues approximately 75 l.f. southerly to another Type 2 CB (**M**) at the same side of the street located at the curb line. From here, it continues to yet another Type 2 CB (**N**) with standard grate approximately 130 l.f. at the same street side curb line. Then, it travels westerly under open park area approximately 310 l.f. to another Type 2 CB with solid round grate located on the I-90 W on-ramp where the analysis is terminated for a total approximately distance of 1,345 l.f. During the downstream drainage field visit, no drainage issues were observed and no areas of any existing or potential major drainage problems were apparent.
