## Arborist Addendum

To: Ken & Phoebe Chu  
Site: 4332 W Mercer Way, Mercer Island, WA, 98040  
Re: Tree Assessment  
Date: March 20, 2025  
Project Arborist: Connor McDermott-Grossman  
ISA Certified Arborist PN- 8704A  
ISA Qualified Tree Risk Assessor  
Referenced Documents: Site Plan A-010 (Shudan He, October 31, 2024)

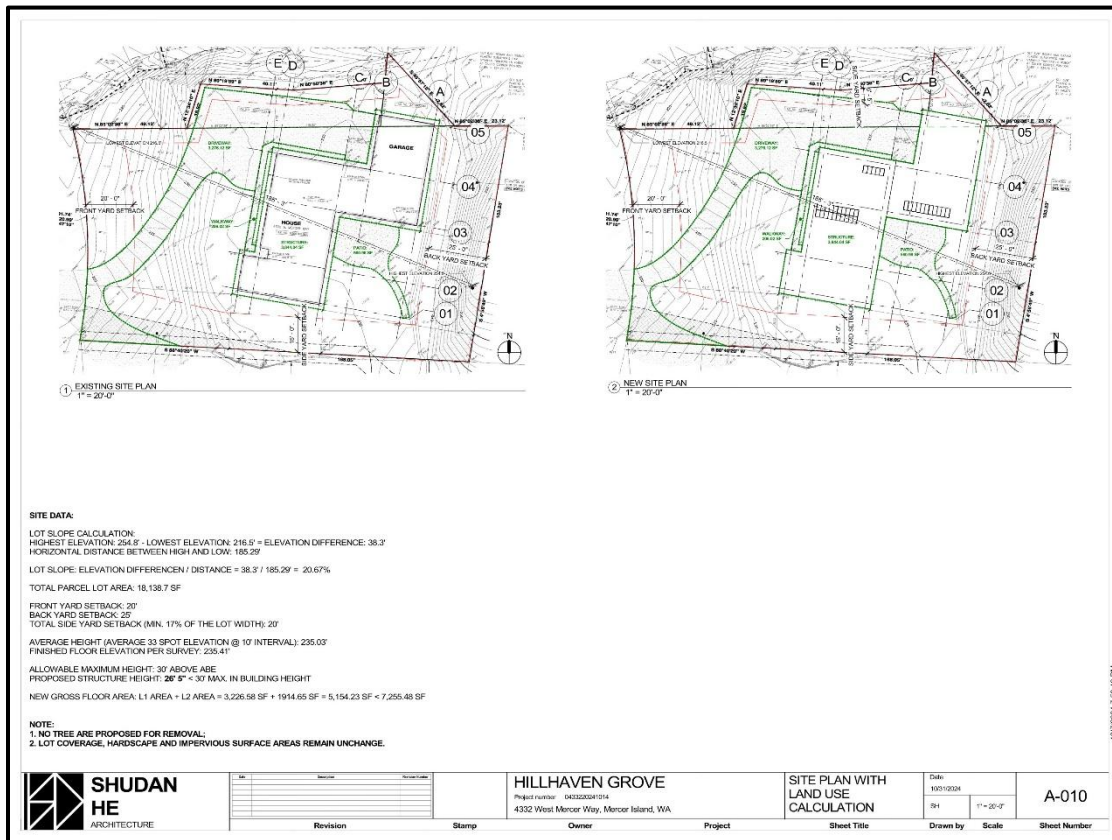
While no trees are proposed for removal the site plan does not detail tree protection on site. I recommend the site plan be updated to include the location of trees on-site and off-site, the recommended limits of disturbance (RLOD), and tree protection fencing. The RLODs for each tree can be found in the Tree Solutions Inc. report dated May 9, 2024. I recommend tree protection fencing to be installed at the hardscape limits on the north and west sides of the property (including trees 1, 18 through 40, E and D) and to the minimum limits of disturbance on the east side of the property (including trees 7, 10 through 15, 17, A, B, and C. Tree protection fencing should consist of 6-foot tall chain link fencing. Where trees are being retained as a group, I recommend the tree protection fencing extend to encompass the entire tree protection area.

Figure 1. The provided site plan with the existing site shown on the left and the proposed site shown on the right. The plan proposes the replacement of the existing single-family home with a two-story single-family home. No trees are proposed for removal and no changes are proposed to the existing lot coverage, hardscape, and impervious surface areas.

No work should occur within the tree protection fencing. If any work is proposed within the tree protection areas the project arborist should be contacted and approved methods of excavation be utilized within these areas. If civil plans propose changes to the hardscapes or impervious surface areas, I recommend Tree Solutions Inc. reviews the plans in order to assess impacts to adjacent trees.
