11255 Kirkland Way, Suite 300
Kirkland, Washington 98033-3417

Engineering Report

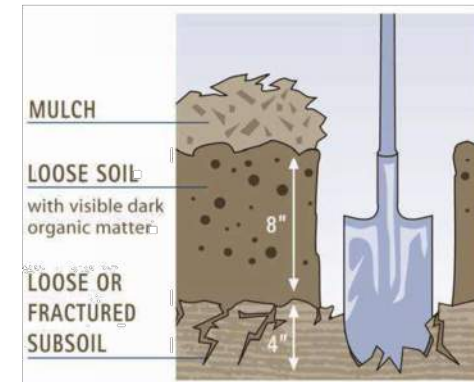
1. Leave undisturbed native vegetation and soil, and protect from compaction during construction.
2. Amend existing site topsoil or subsoil either at default "pre-approved" rates, or at custom calculated rates based on tests of the soil and amendment.
3. Stockpile existing topsoil during grading, and replace it prior to planting. Stockpiled topsoil must also be amended if needed to meet the organic matter or depth requirements, either at a default "pre-approved" rate or at a custom calculated rate.
4. Import topsoil mix of sufficient organic content and depth to meet the requirements.
5. More than one method may be used on different portions of the same site. Soil that already meets the depth and organic matter quality standards, and is not compacted, does not need to be amended.

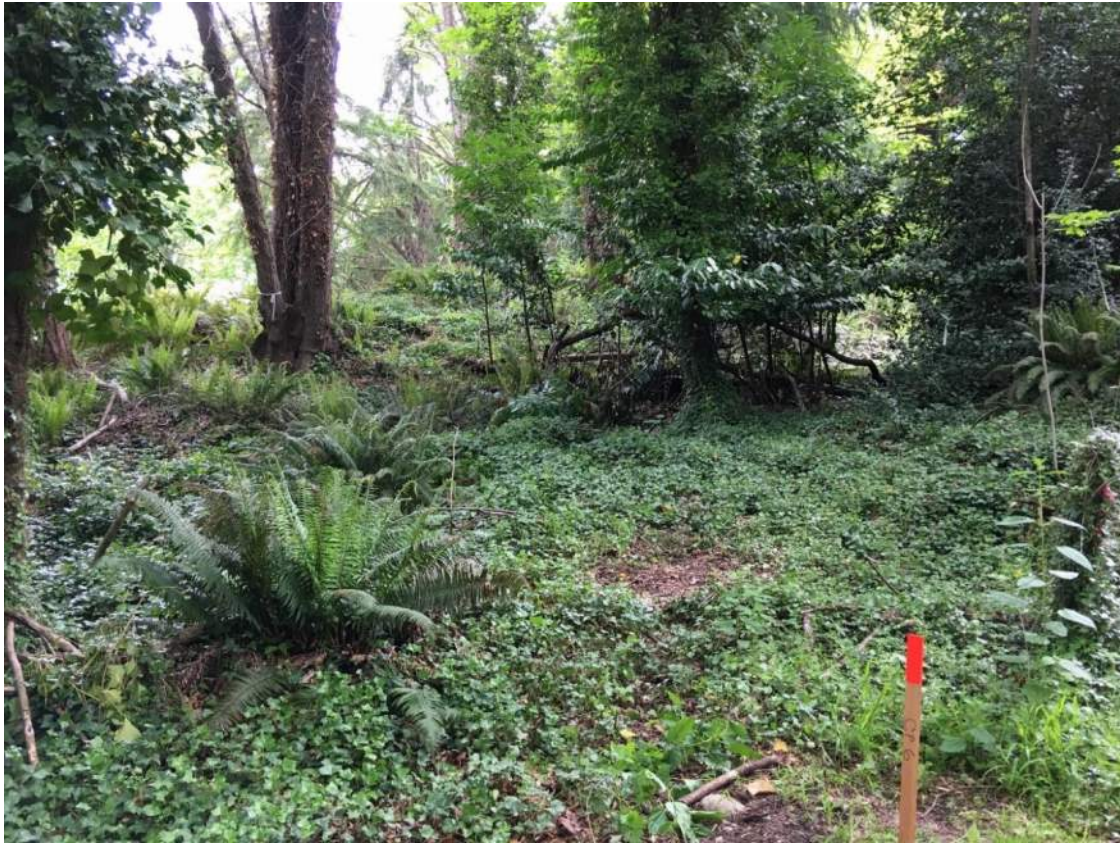
Plate 1. Looking northeast near the middle of the site at the general location of the proposed residence.

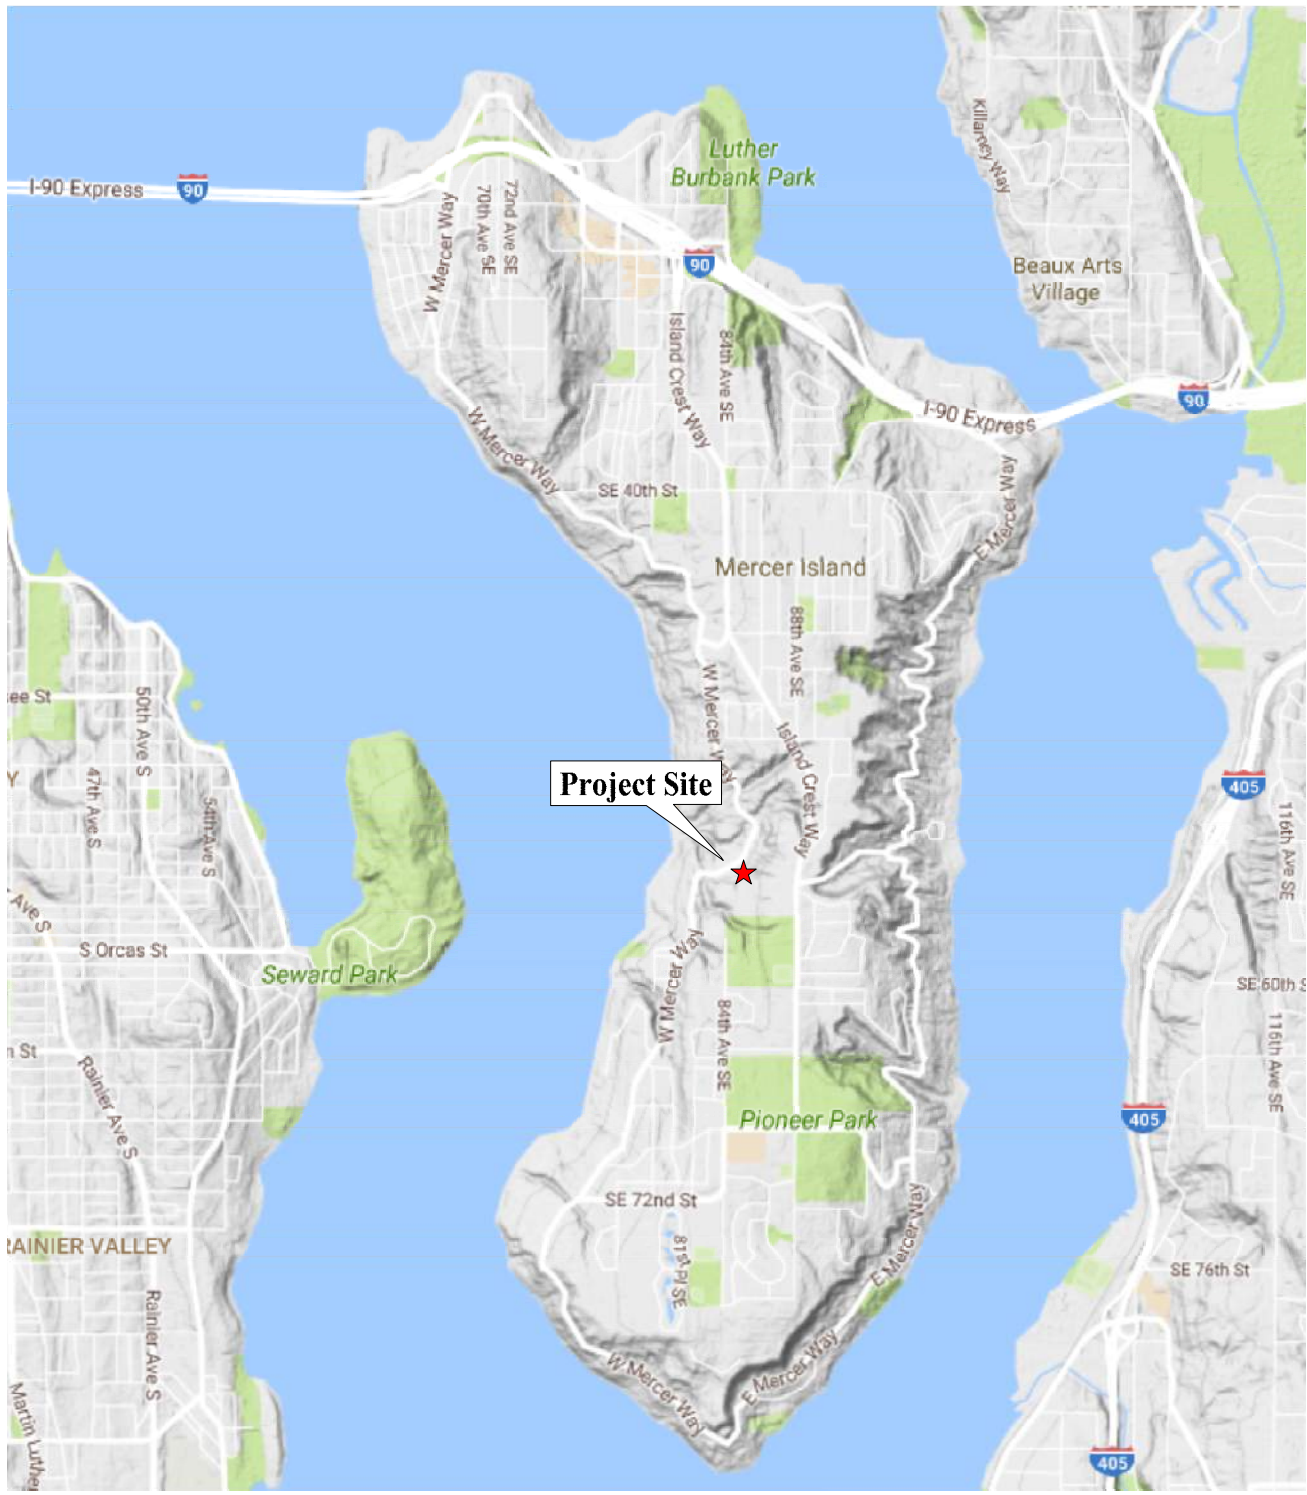
WSDOT, 2016, *Standard Specifications for Road, Bridge and Municipal Construction, M 41-10*.

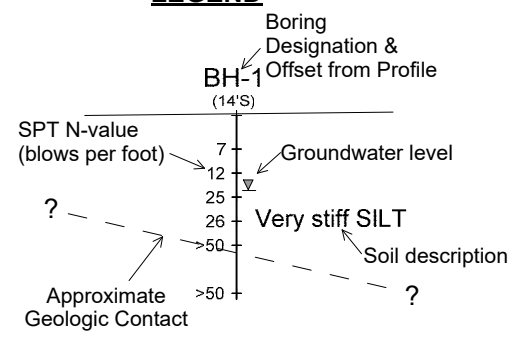
- Notes:
- Existing ground profile based on the topographic survey of 5236 West Mercer Way prepared by PACE Engineers, Inc. (2017).
 - See Figure 2 for location of Section A - A'.
 - See report text for a detailed explanation of the subsurface profile across the site.
 - The generalized soil profile is based on widely-spaced borings. Soil conditions may vary over a small distance, and the actual subsurface conditions may be different from the generalized soil profile depicted in this figure.

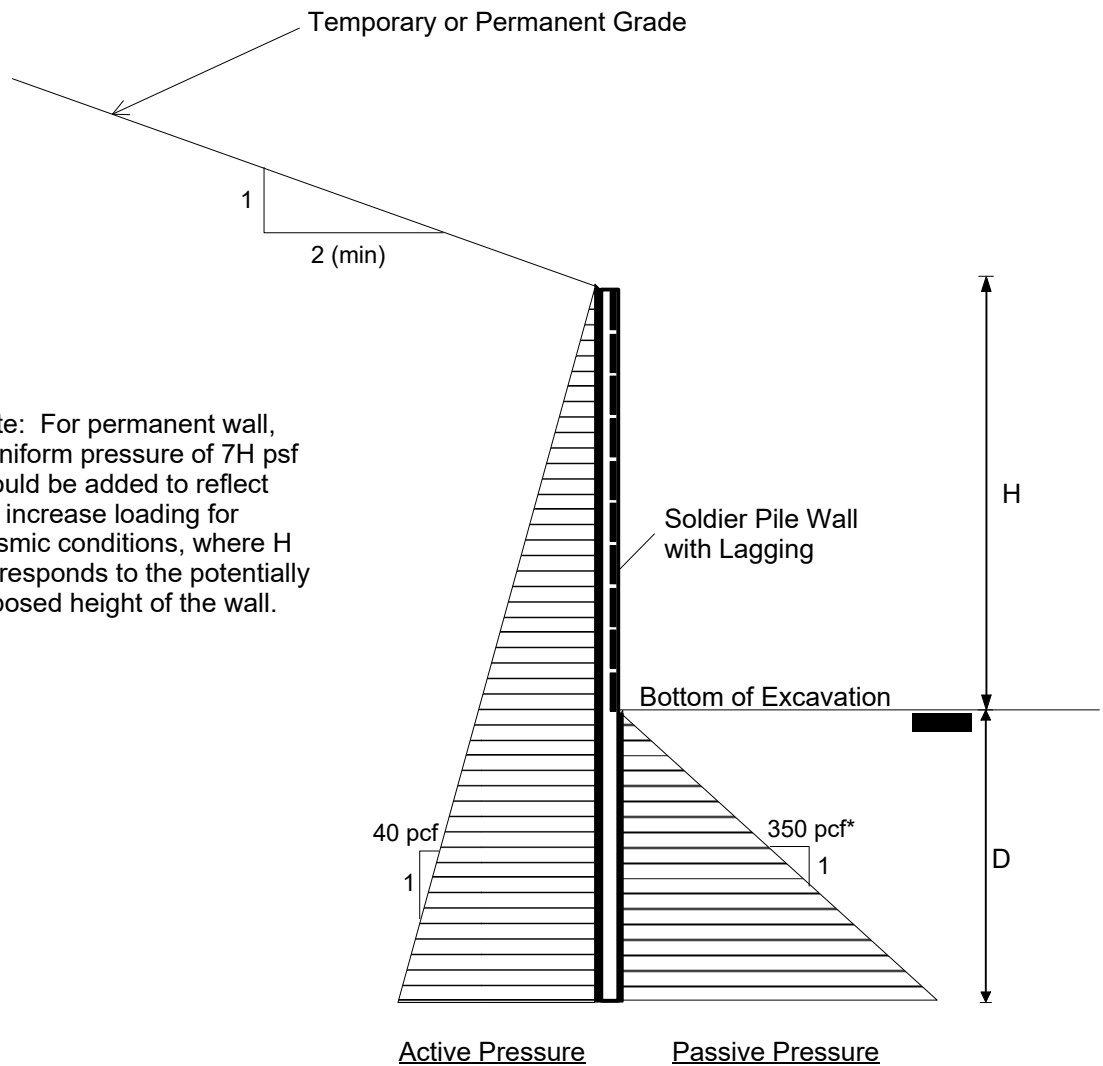
Note: For permanent wall, a uniform pressure of $7H$ psf should be added to reflect the increase loading for seismic conditions, where H corresponds to the potentially exposed height of the wall.

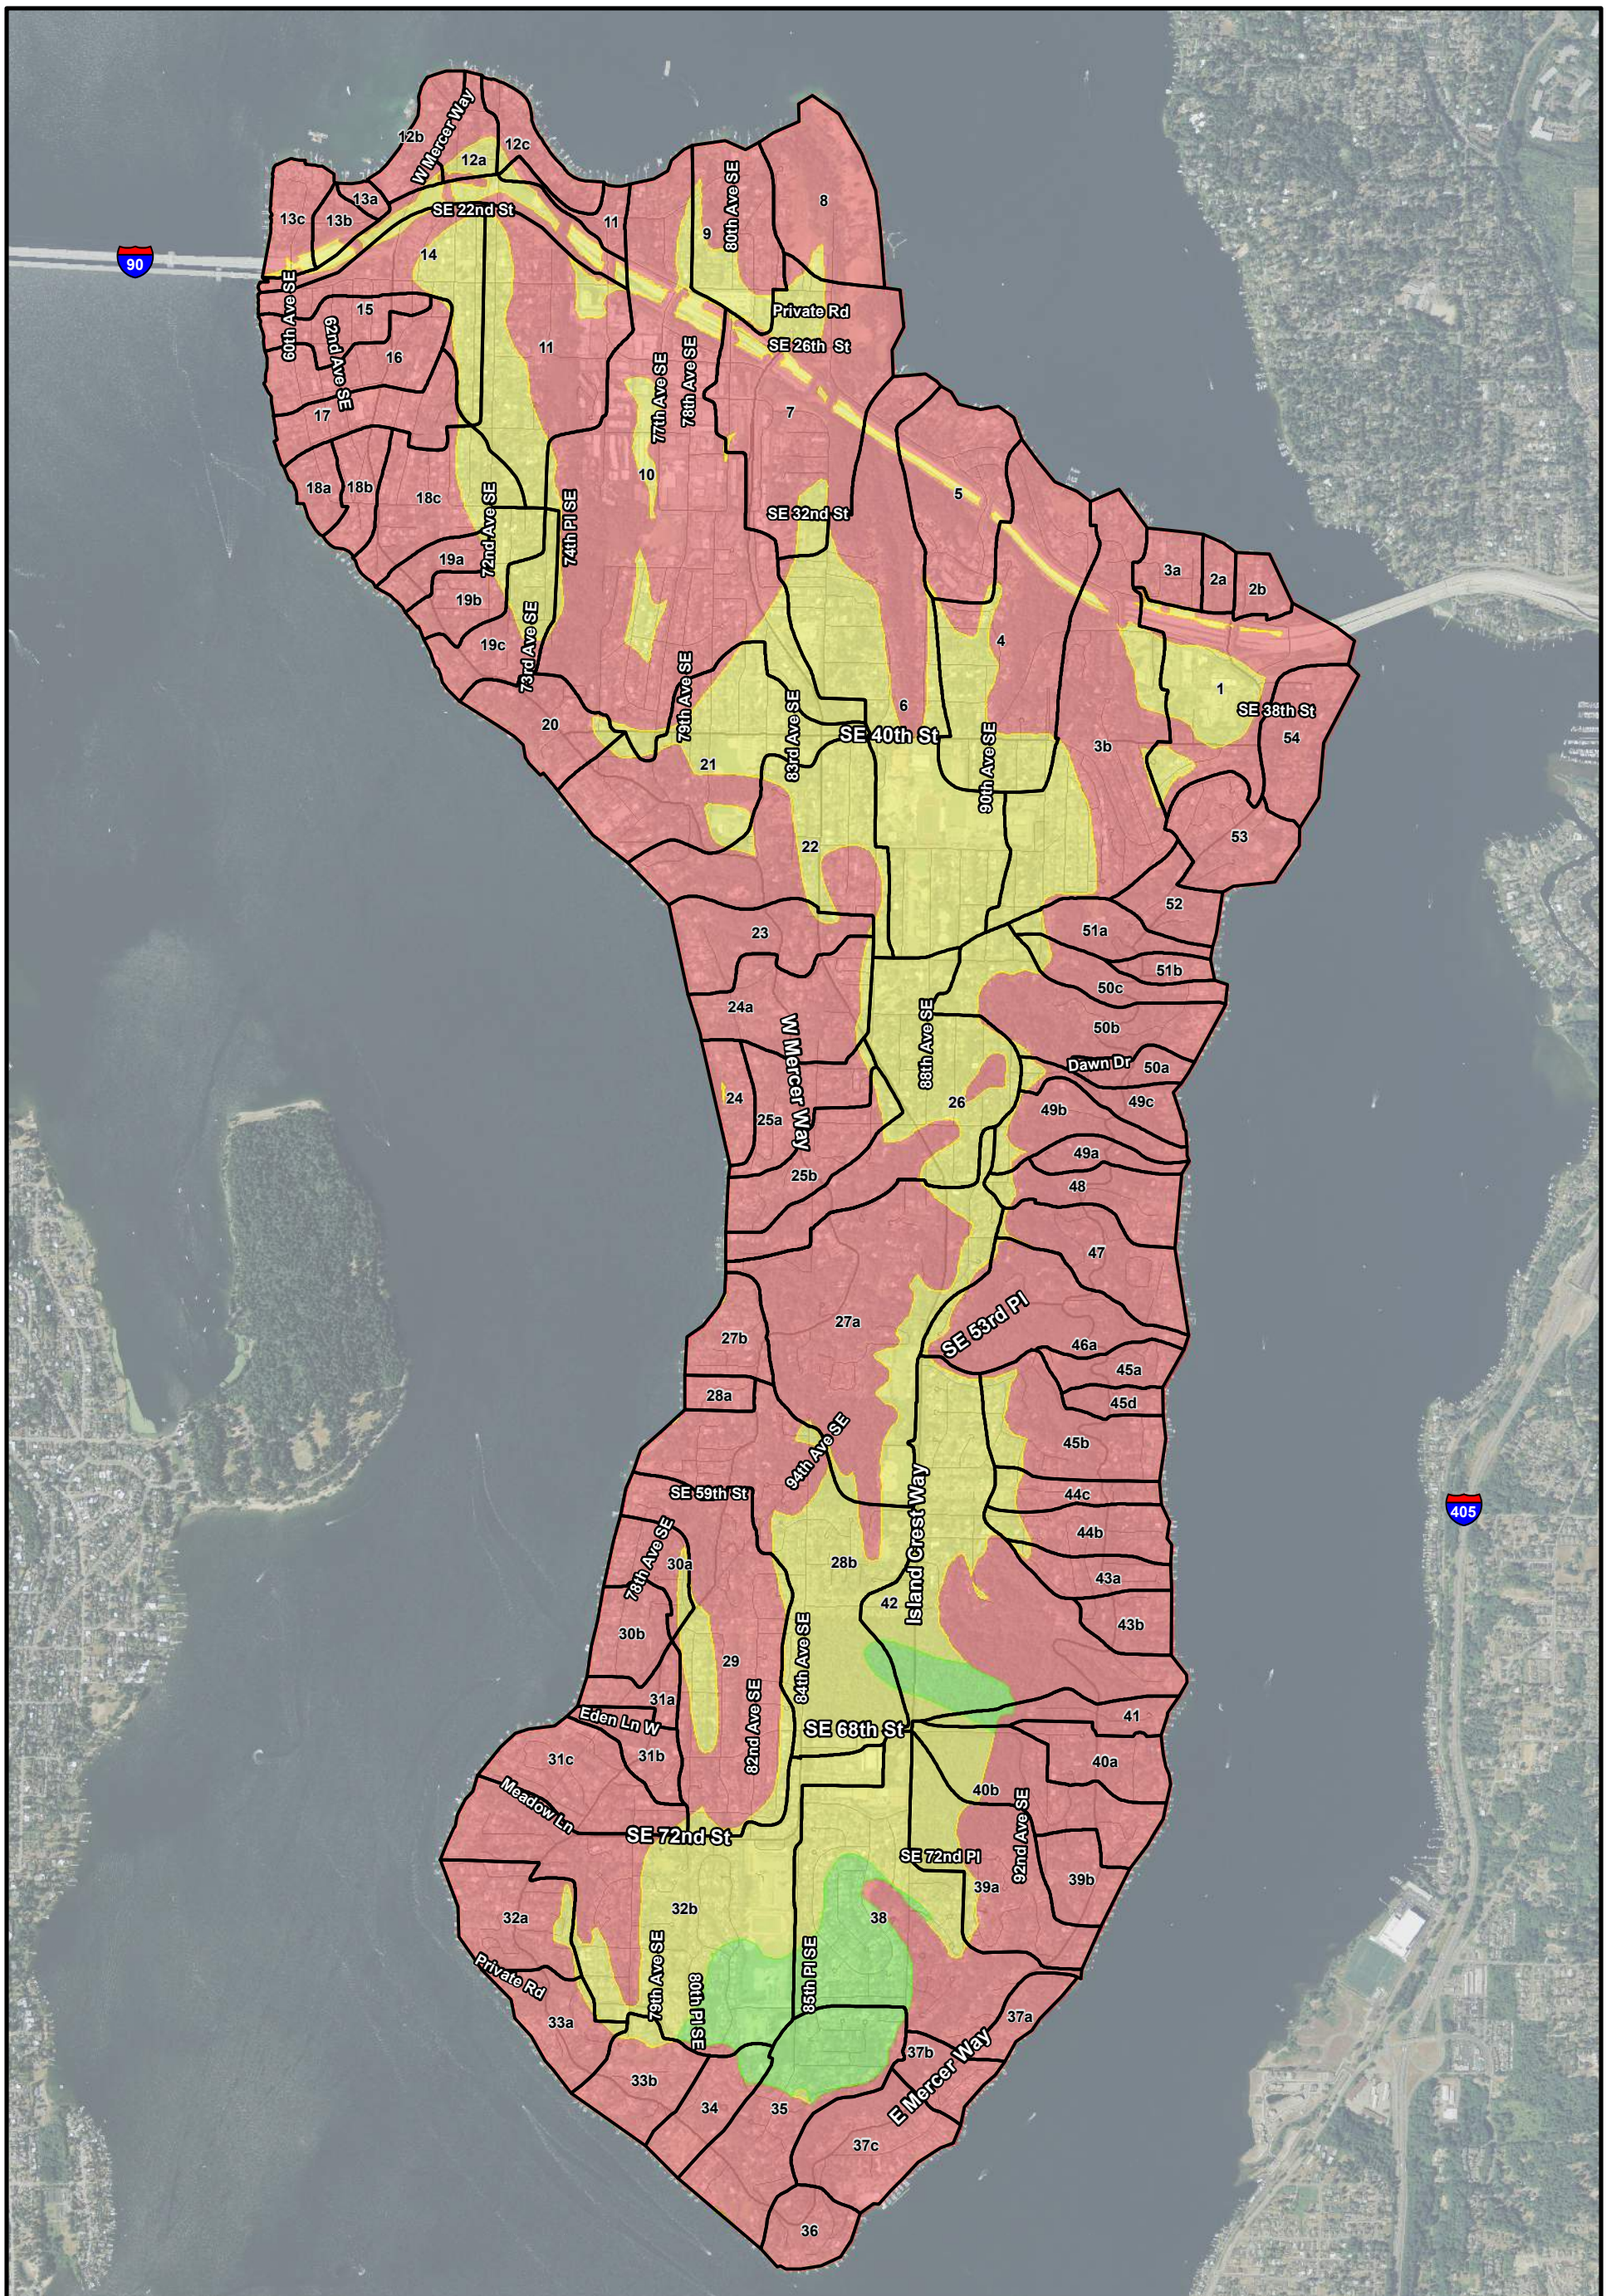
Completion Depth:	14.0ft	Remarks: Boring was drilled with a Acker portable drill rig. Standard Penetration Test (SPT) sampler driven with a 140 lb hammer using a rope and cathead dropping 30 inches per stroke.
Date Borehole Started:	5/11/17	
Date Borehole Completed:	5/11/17	
Logged By:	Bjarni Kristjansson	
Drilling Company:	CN Drilling
