Arborist Report - Note to Reviewers

Project: **7615 E Mercer Way** (Cheshire Residence)

Note to Reviewers re: Following Arborist Report

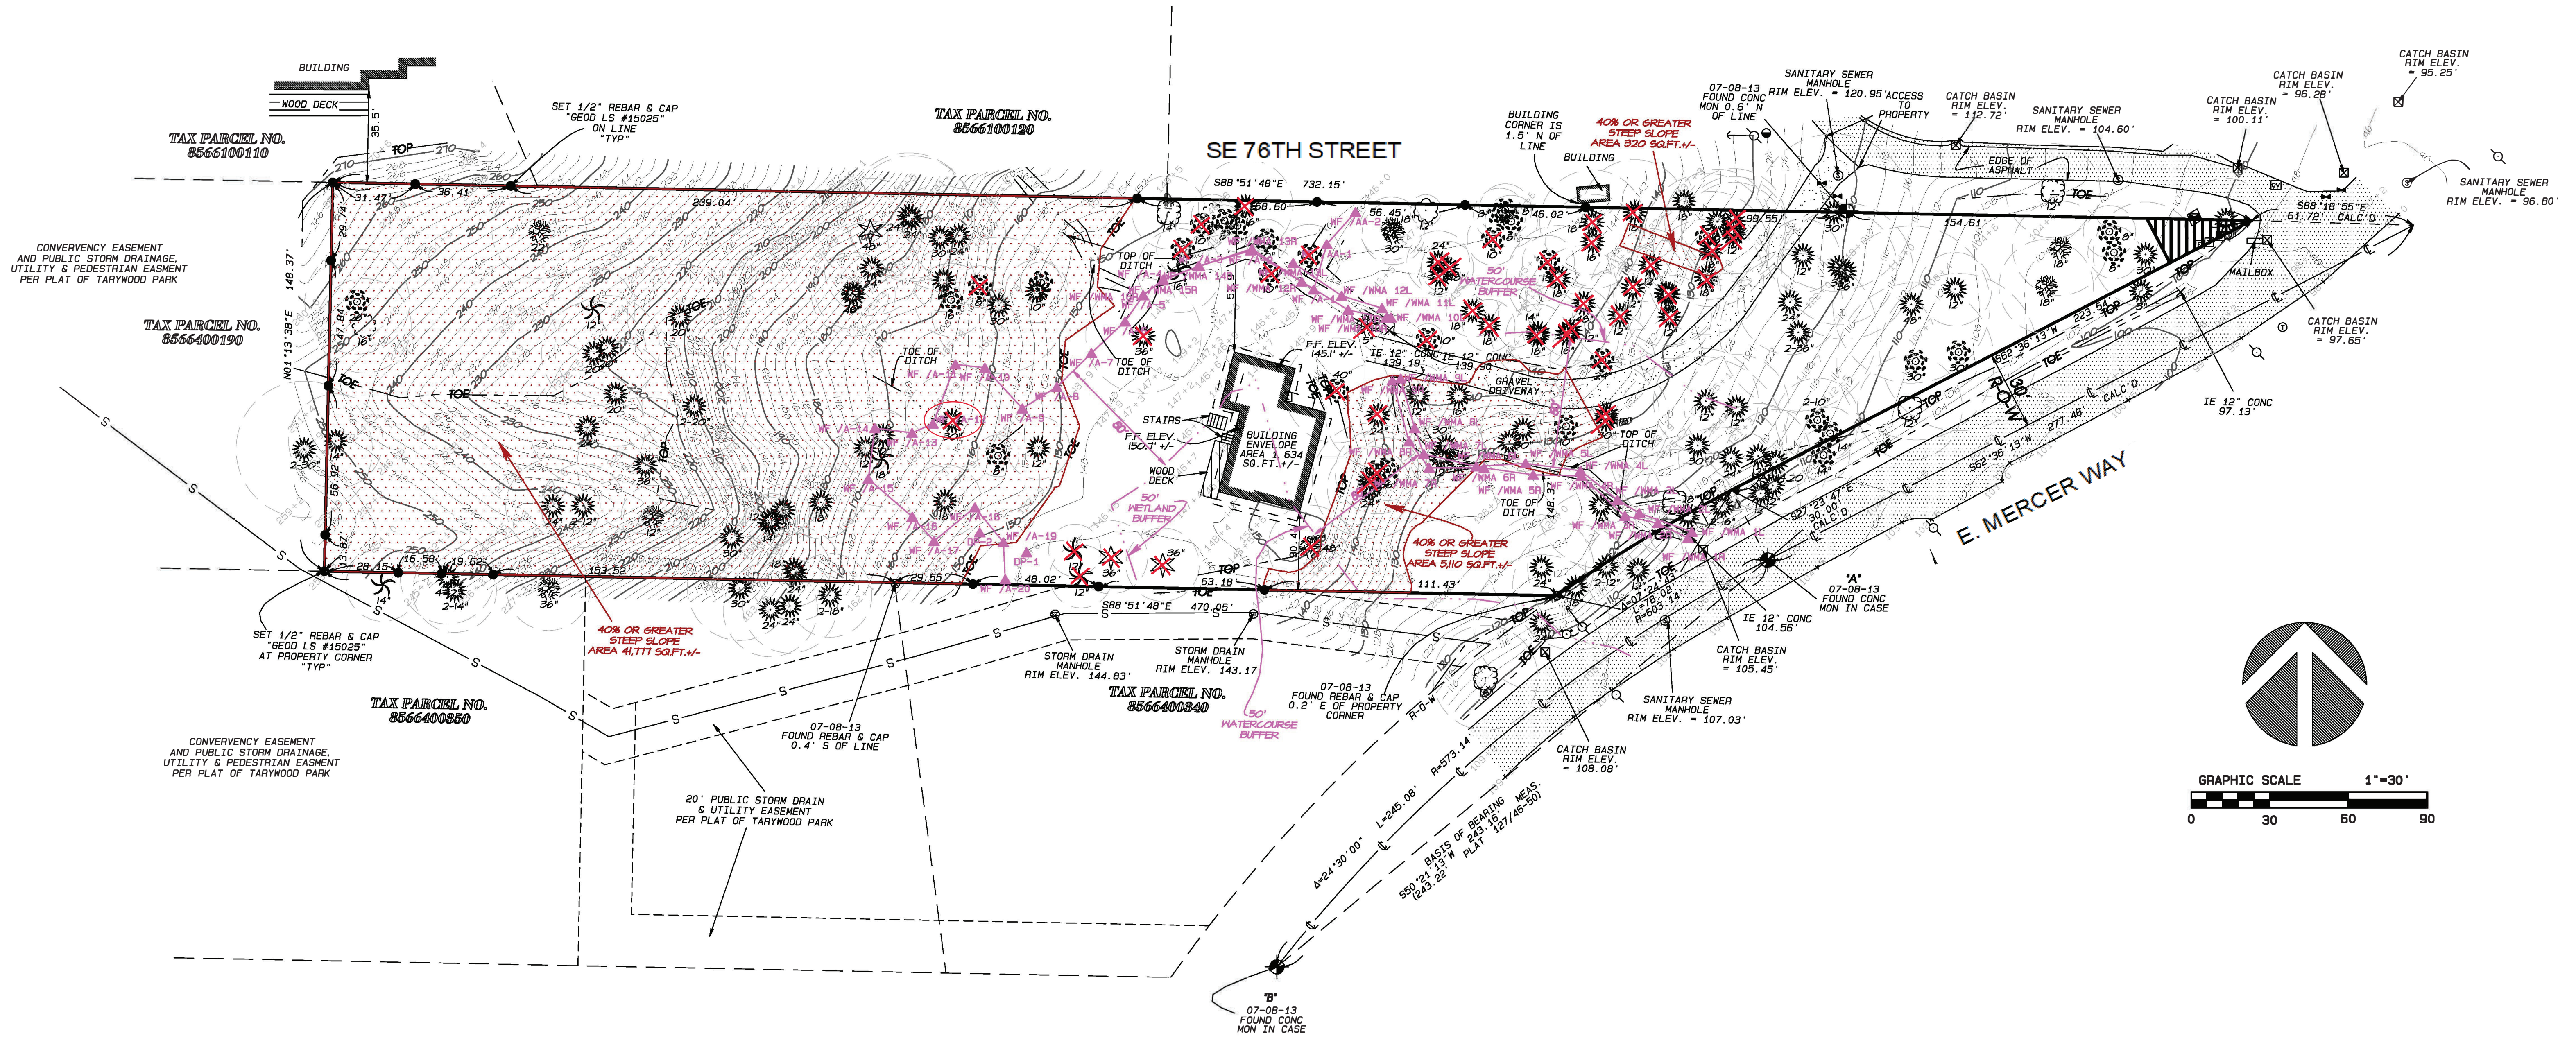
TOPOGRAPHIC & BOUNDARY SURVEY

Red 'X' marks trees removed on Subject Lot per Tree Permit 1707-320, Issued 3/27/18, Finaled 5/2/19
