Trees & Construction Memo

To: Dan Buchser
From: Bob Layton
CC:
Date: September 2, 2025
Re: 5320 Butterworth RD - Tree #33 and #35 Retention Issues

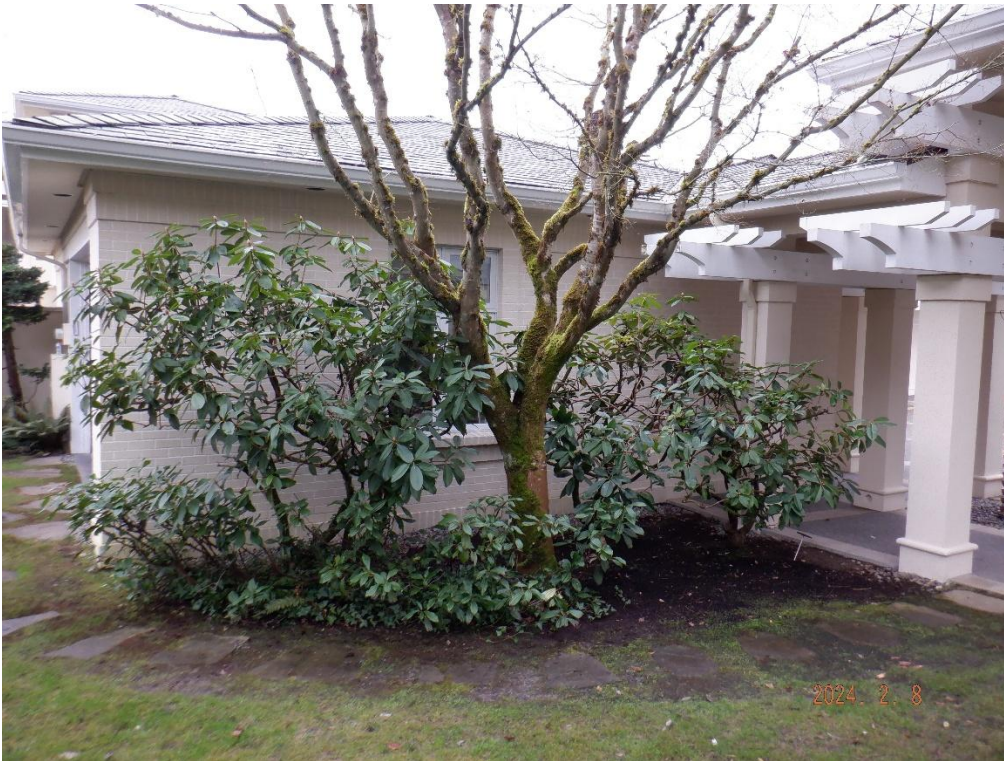
Tree #33 will be compromised by the proposed new driveway construction. The tree is located too close to the proposed grading for the new driveway subbase to be feasibly retained. The anticipated amount of root loss can be expected to trigger immediate decline and compromise structural stability.

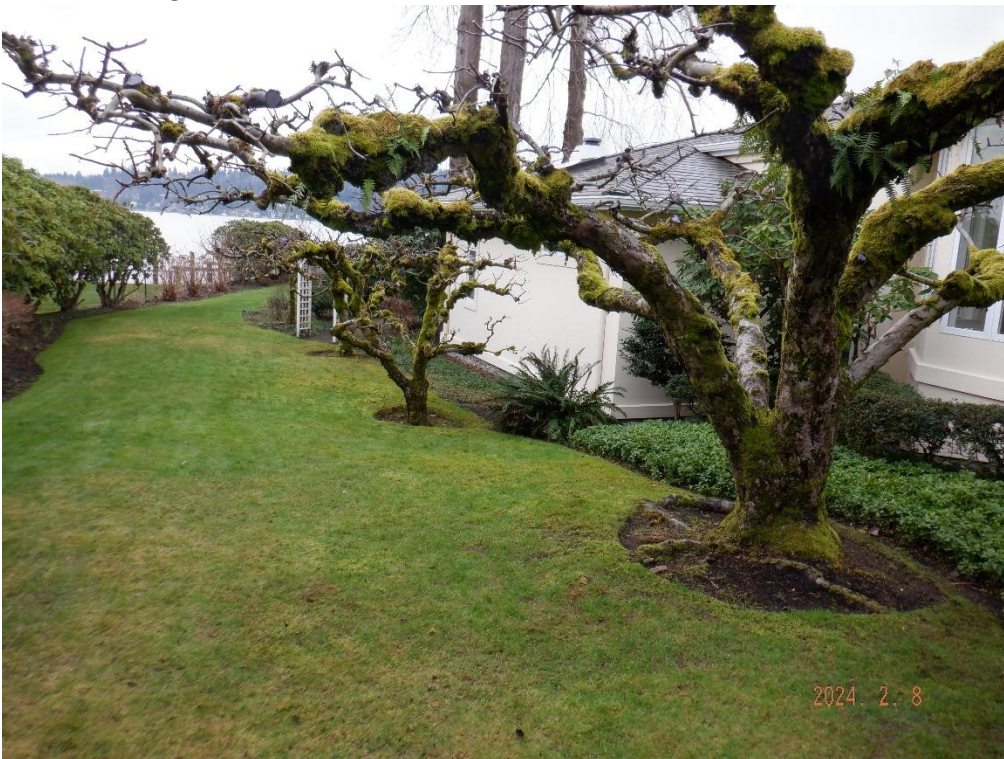
Tree #35 on right

Tree #35 will also be compromised by the proposed new driveway. It is within the new driveway footprint. This tree was measured at one-foot above ground. The calculated diameter of individual stems measured at 4 ½-feet above ground would not likely exceed 20-inches, see picture below. This tree provides very little canopy coverage, see picture below. Considering long-term tree management and increased benefits, it would be prudent to replace this with a new tree in a more appropriate location on the property.
