**Washington Tree Experts**  
**16732 Broadway Ave**  
**Snohomish, WA 98296**  
**206-362-3380**  
**wtetree@yahoo.com**

**Job Address:** 8203 Avalon Drive  
**City, Zip:** Mercer Island, WA 98040  
**Parcel numbers:** 0321100090  
**C/O:** Wishwas Mohan

**Assignment**

Tree inventory with basic visual inspection and site specific limits of disturbance a home addition project.

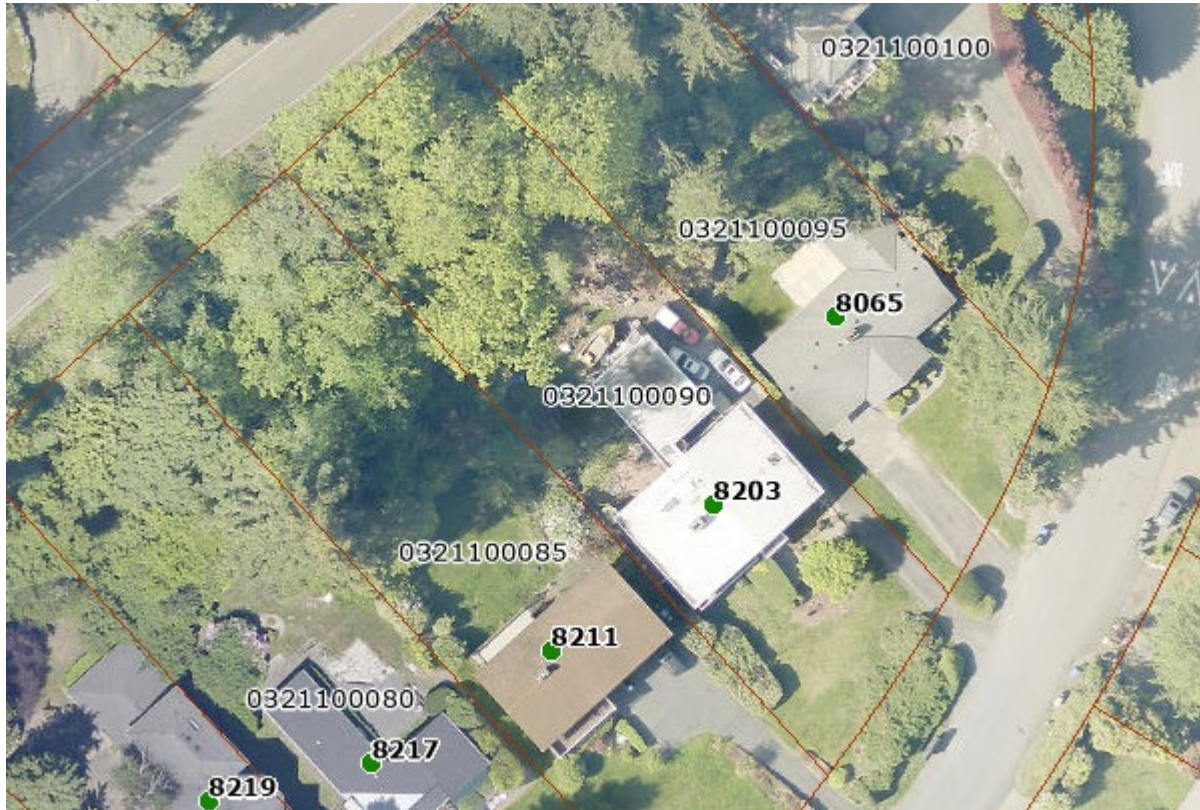
Site map (not to scale for illustration only tree locations approximate)

The 12 trees are all deciduous. 3 ornamentals in the yard proper and 9 native bigleaf maple trees on the slope. The larger diameter bigleaf maple trees have multiple trunks originating from near

the ground level which may be a result of previously removed trees allowed to sprout back in a process called vegetative reproduction. Several of these trees have large trunks attached to decayed wood where there have been failures in the past. The group of maples grow near each other which is creating narrow and tall canopies versus the more typical wide canopy spread of open grown bigleaf maple trees. These trees may need to be assessed for risk and failure potential if the use of their target areas change in frequency. The plans allow for the retention of all the trees on this lot.

Retention trees are required to be protected. The purpose of the tree protection measures outlined here is to preserve tree health by avoiding damage to roots, trunks, or live crown. A standard method of determining the critical root zone (CRZ) is to equate it to the dripline measurement. I have used this method for this project. For most trees, protection equal to the dripline is sufficient to ensure viability after construction and is a good starting point. The tree protection zone (TPZ) can be equal to the CRZ. For this plan the trees on the slope should be left undisturbed and a protection fence set up outside of the nearest trees' driplines. The ornamentals can be protected by establishing the TPZ equal to the driplines.
