Subject: Drainage Assessment, Existing Residence Remodel, 9756 S.E. 40th Street,  
Mercer Island, WA 98040 (PN: 265550-0167) (Client: Danny Tran)

Subject: GEOTECHNICAL REPORT, Existing Parcel, 9756 S.E. 40th Street, Mercer Island, WA 98040 (PN: 265550-0167) (Client: Danny Tran)

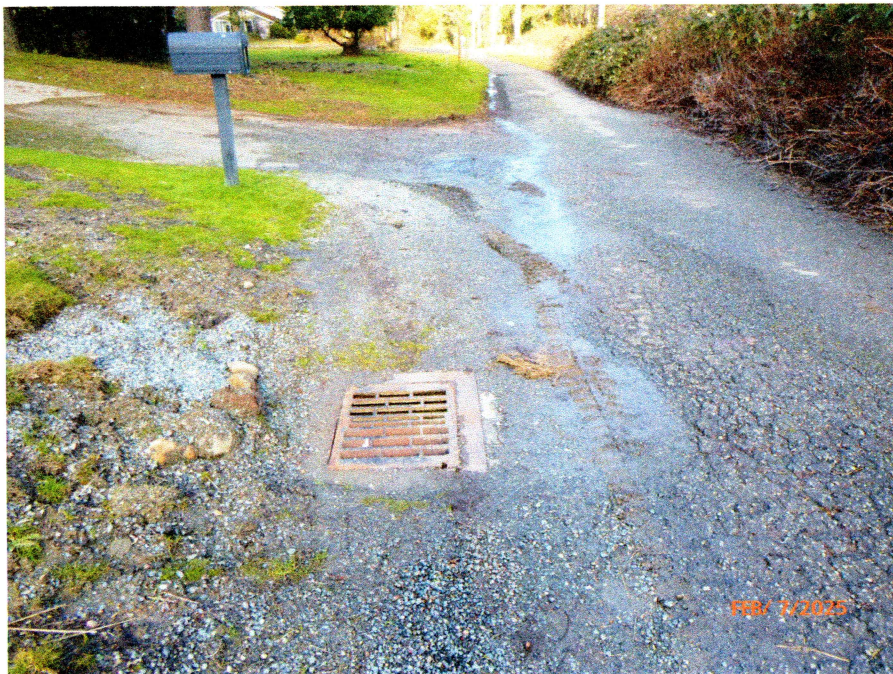
In summary, it was found that the site soils are not permeable. While the site frontage on 97th Avenue S.E. is basic two-lane pavement with gravel shoulder, it does have directly in front of the site a Type 1 catch basin. The catch basin has an existing outlet leading east under the road.

EXISTING CATCH BASIN ON 97TH AVENUE S.E.

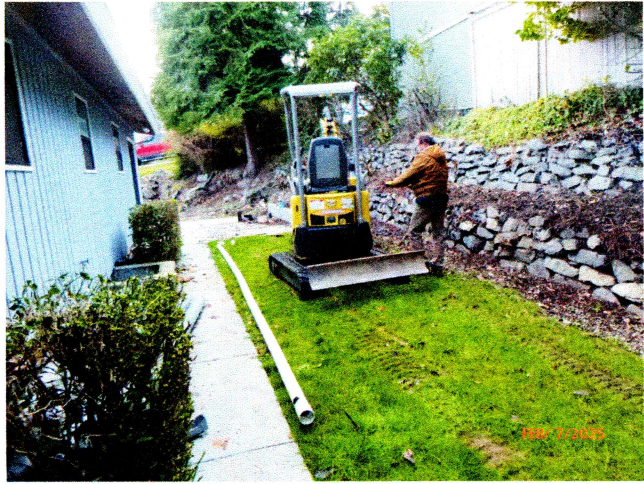
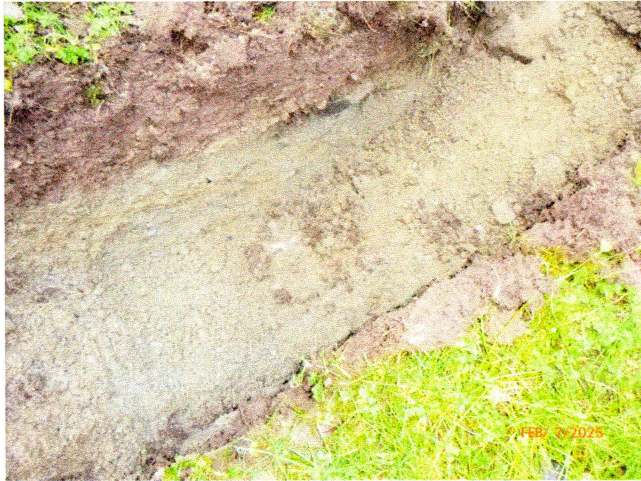
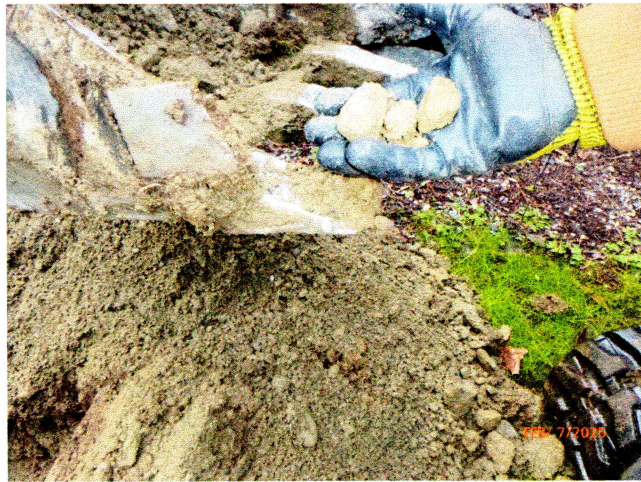
SOIL LOG 1

SL 1

0 - 36"

**CLAYEY MEDIUM SAND W/ROCKS/SLIGHT MOTTLING**

36" - 42"+

**SANDY HARDPAN DAMP/SLIGHT MOTTLING**

NO GROUNDWATER ENCOUNTERED

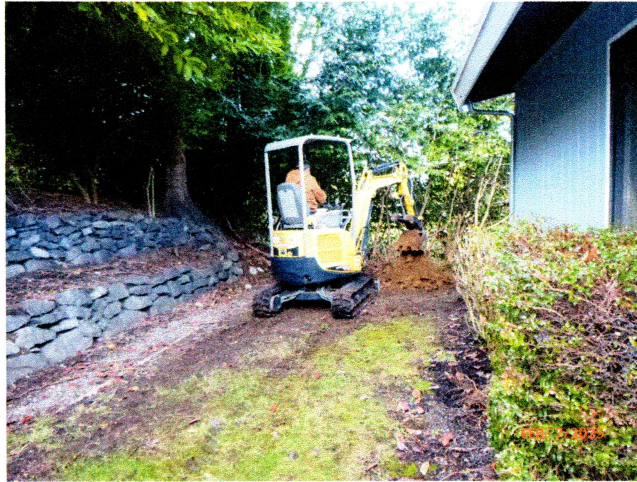
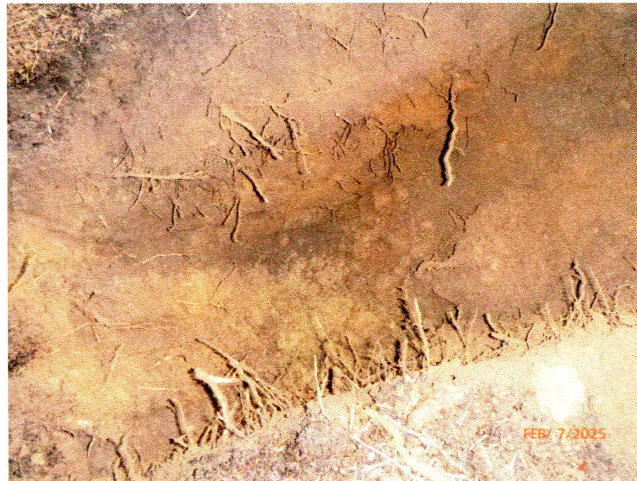
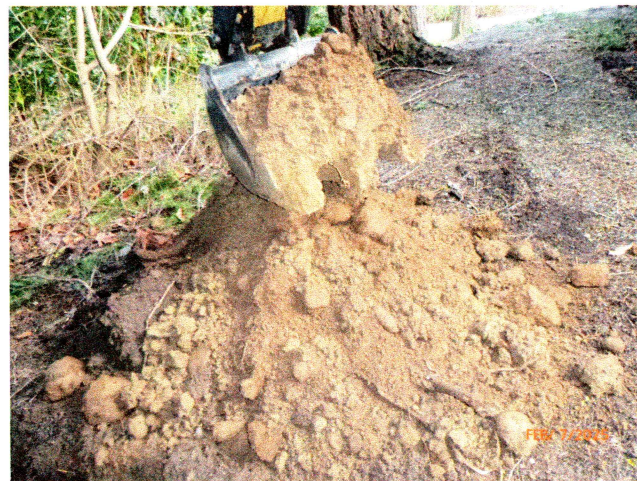
SOIL LOG 2

SL 2

0 - 36"

**CLAYEY MEDIUM SAND W/ ROCKS/SLIGHT MOTTLING**

36" - 42"+

**CLAYEY SAND/HARDPAN DAMP/SLIGHT MOTTLING**

NO GROUNDWATER ENCOUNTERED

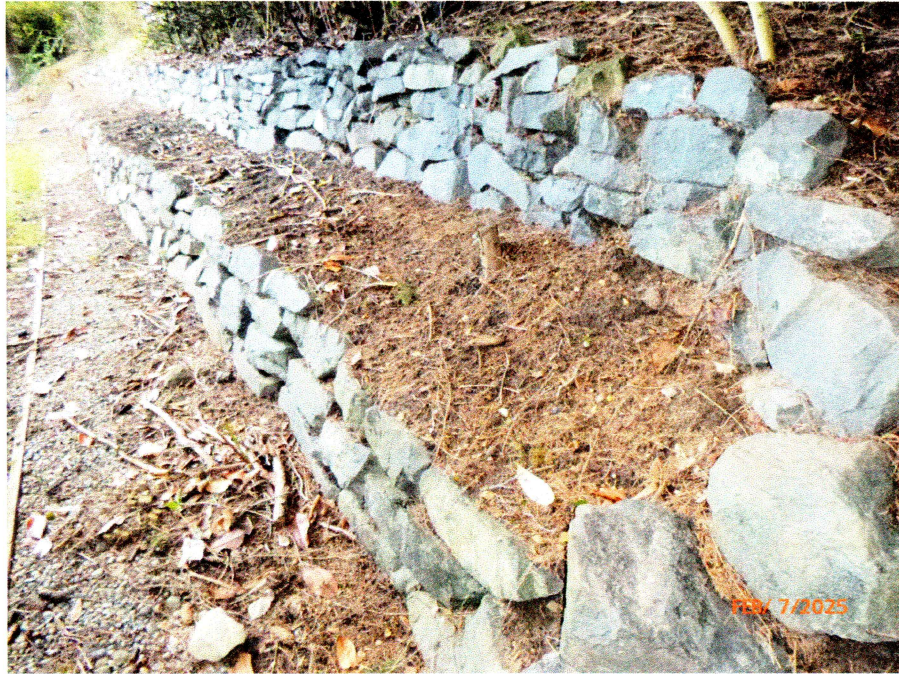
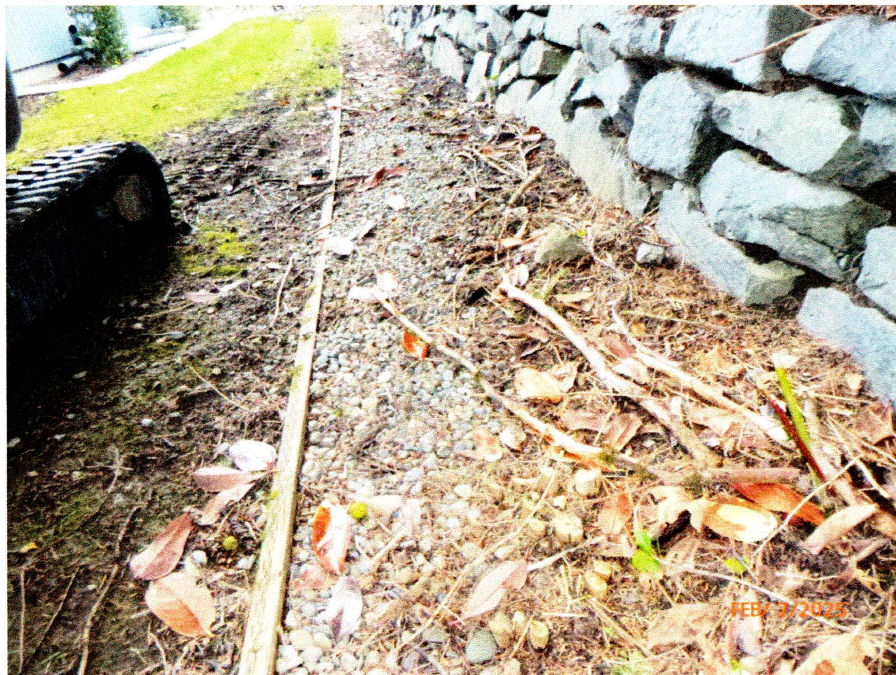
REAR YARD DOUBLE ROCKERY AND BASE "FRENCH DRAIN"

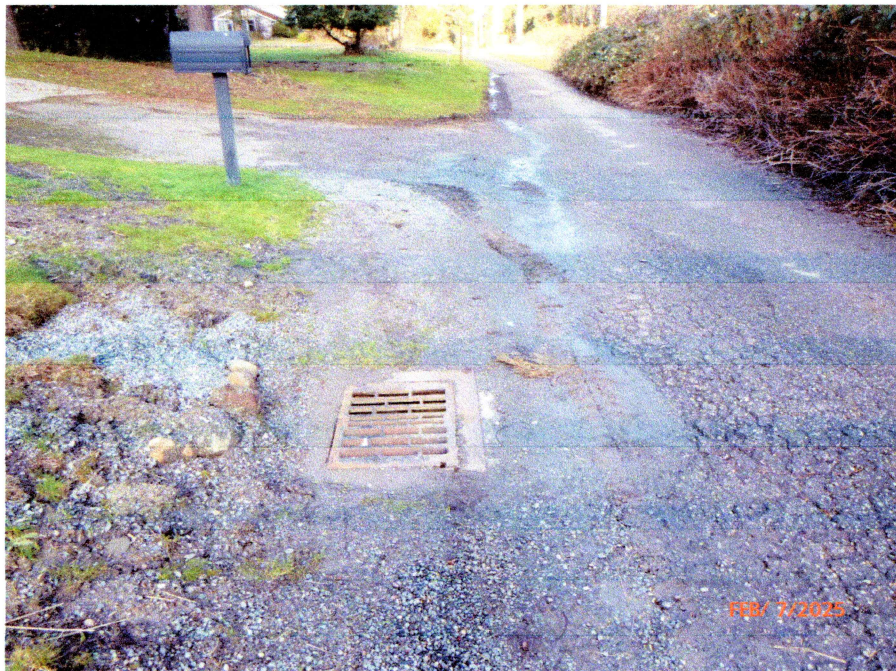
The site frontage on both streets is gravel shoulder. Noted is that at two locations along the site's frontage on 97th Avenue S.E. are catch basins. Based on site observations, the more central catch basin receives house runoff via a 4 inch pipe, with the catch basin 12 inch outlet running east, under 97th Avenue S.E.

EXISTING CATCH BASIN ON 97TH AVENUE S.E.

As an upgrade to the roof drainage system, it is recommended that in the run of line from the house to the catch basin, that a 2 foot wide by 10 foot long Perforated Pipe System is inserted in the line. The specifications for a Perforated Pipe Connection are per guidance in the King County Surface Water Manual, Appendix C, or as adopted by the City of Mercer Island.

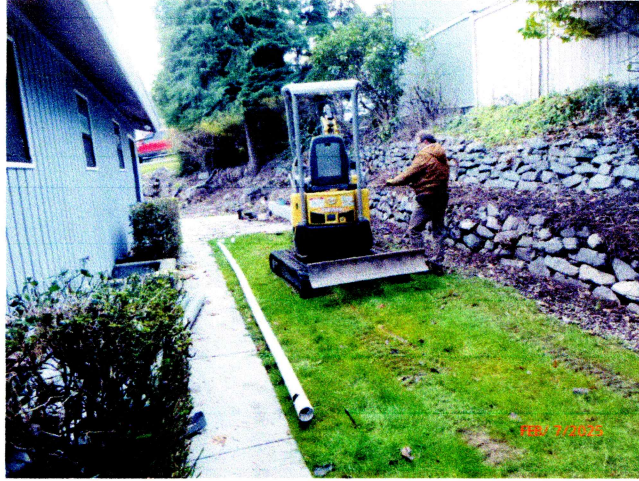
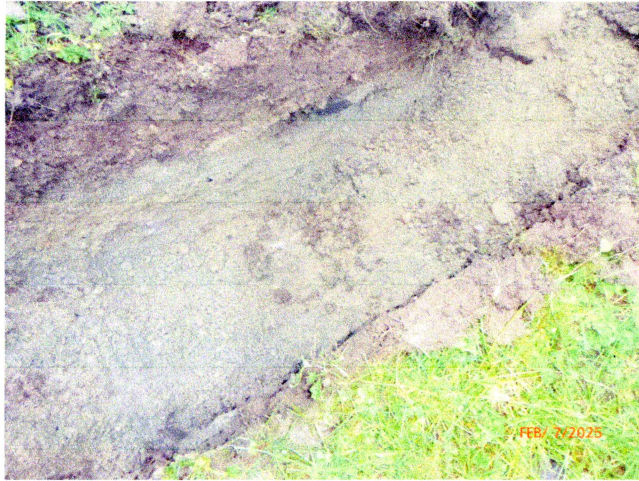
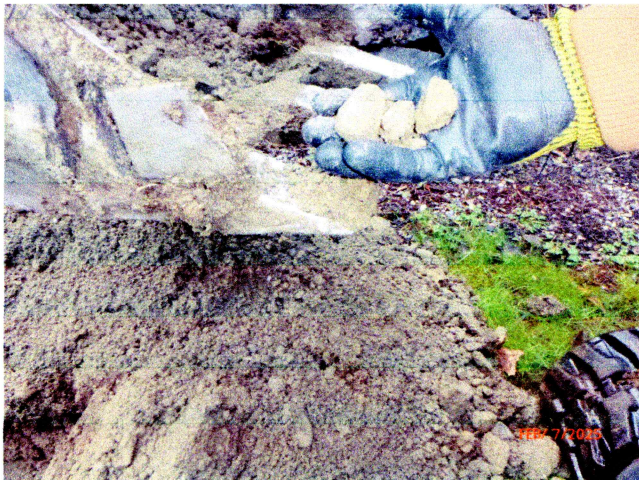
SOIL LOG 1

Both logs were excavated to a depth of 42 inches, or about 3.5 feet. Encountered in each log was an upper layer of Clayey Sand, slightly mottled, underlain to depth with a Sandy Hardpan, also slightly mottled. All soils were full-depth wet or saturated. (See attached Soil Logs). Noted is that the rear yard soils represent a cut area, the soils were dense and undisturbed. However, the logs may be assumed as reasonably representing general site soil conditions.

SL 1

0 - 36"

**CLAYEY MEDIUM SAND W/ROCKS/SLIGHT MOTTLING**

36" - 42"+

**SANDY HARDPAN DAMP/SLIGHT MOTTLING**

NO GROUNDWATER ENCOUNTERED

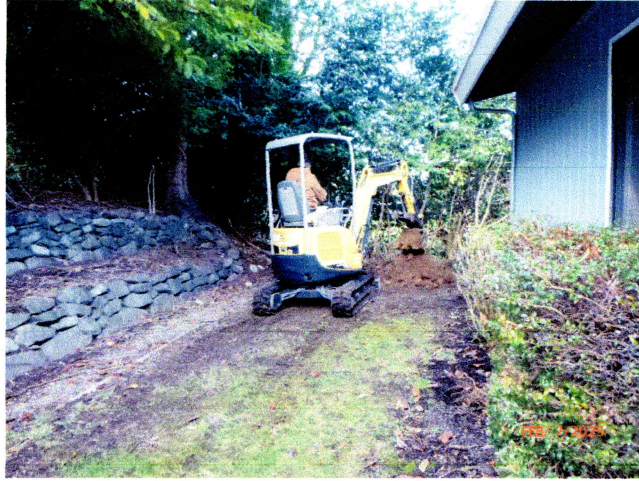
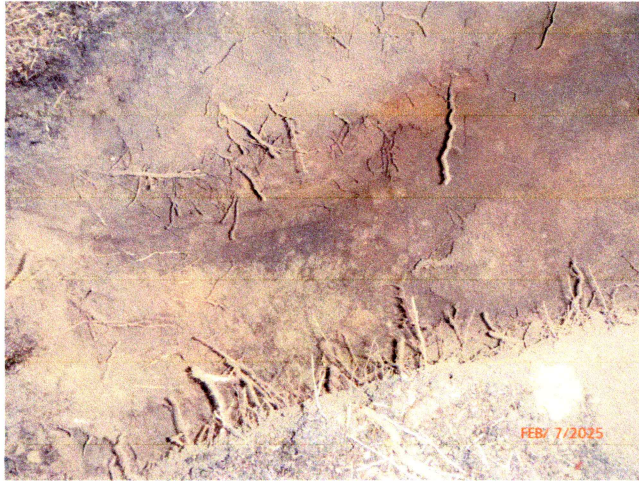
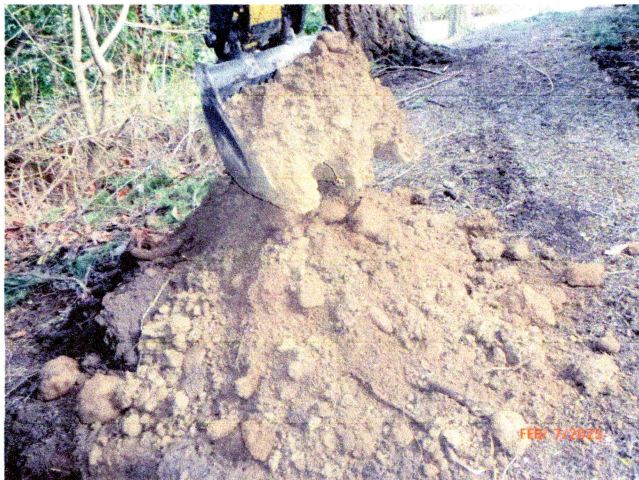
SOIL LOG 2

SL 2

0 - 36"

**CLAYEY MEDIUM SAND W/ ROCKS/SLIGHT MOTTLING**

36" - 42"+

**CLAYEY SAND/HARDPAN DAMP/SLIGHT MOTTLING**

NO GROUNDWATER ENCOUNTERED

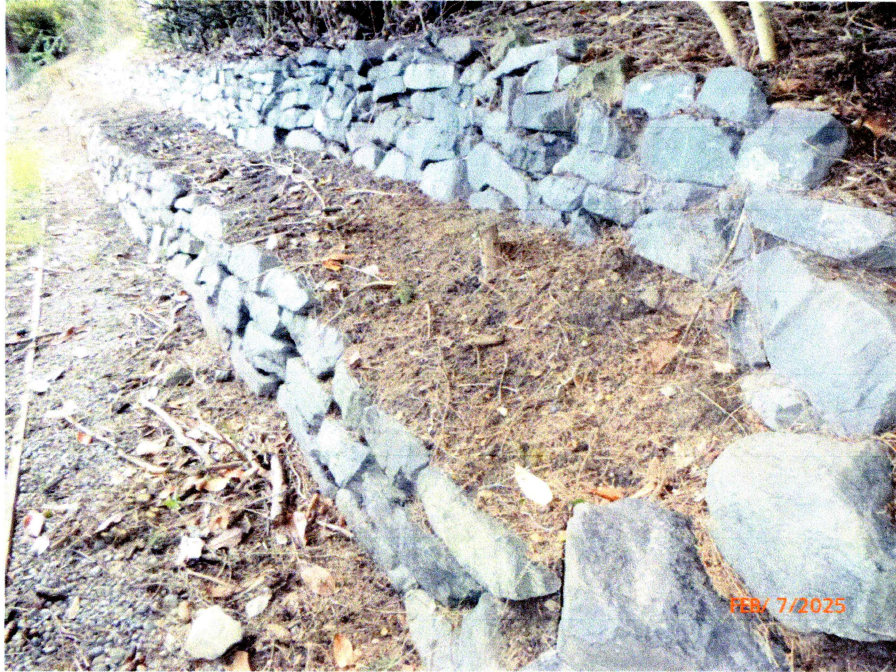
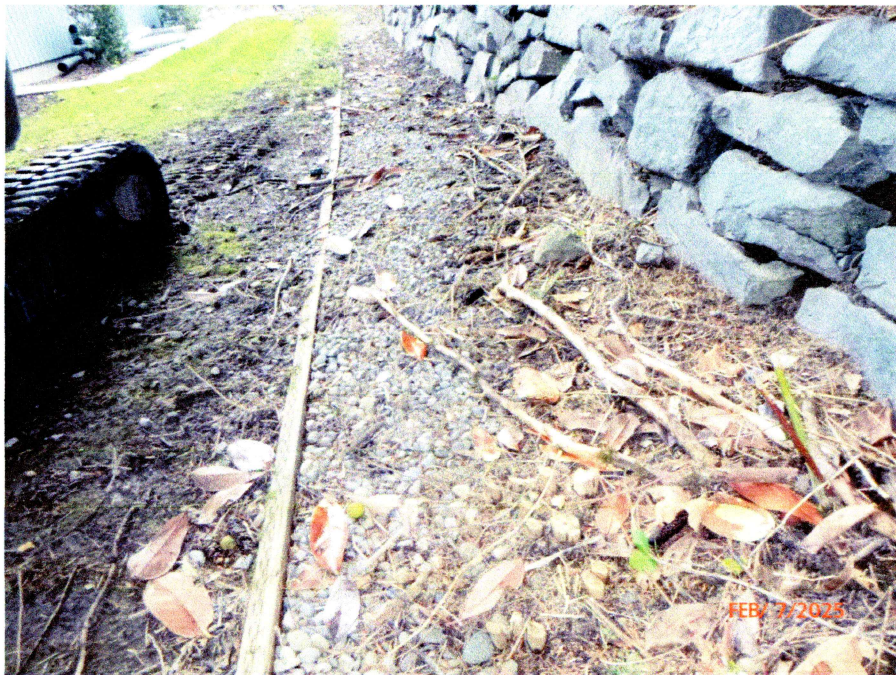
REAR YARD DOUBLE ROCKERY AND BASE "FRENCH DRAIN"
