# CASCARA TREE CONSULTING

## ARBORIST REPORT

REFERENCE: Tree Inventory & Assessment

SITE ADDRESS: 7650 Ridgecrest Lane, Mercer Island, WA

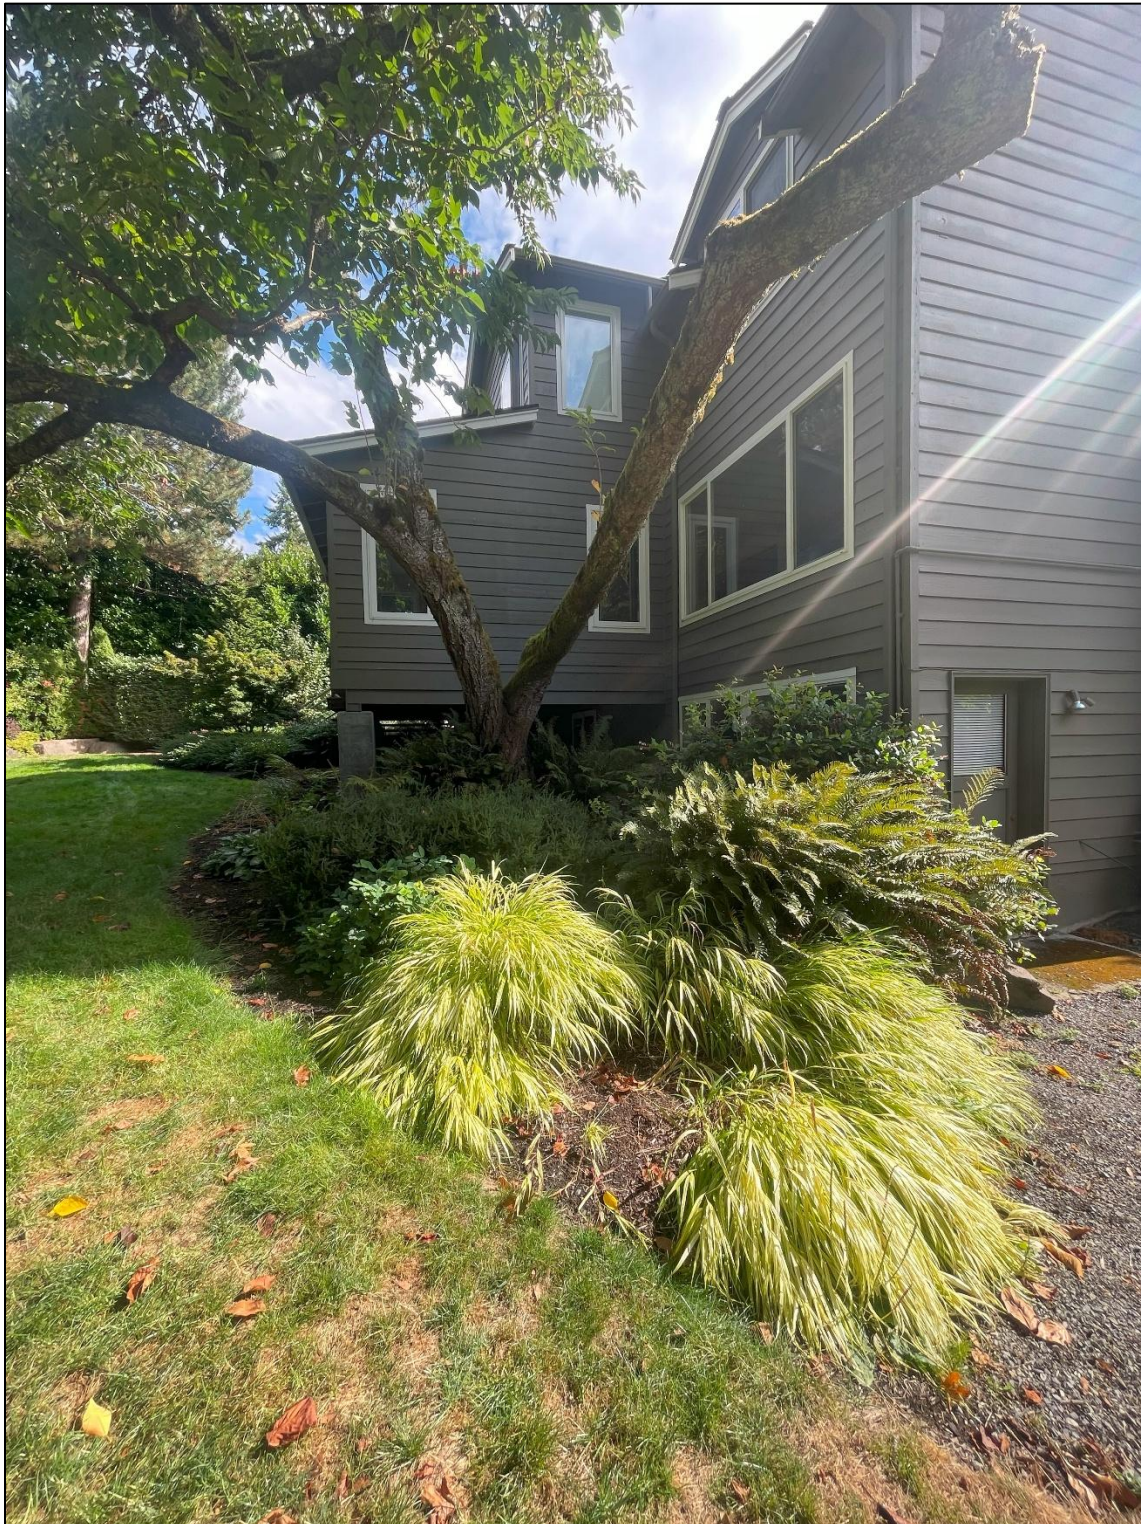
- Tree #559: A 23.5" DBH sweet cherry (*Prunus avium*) on the north side of the house with a dripline that overlaps the proposed addition. There are likely some roots occupying the space to the west where the addition is planned that may be impacted during the foundation excavation. See tree protection recommendations below.
- Tree #558: A multi-stemmed common fig (*Ficus carica*) on the south side of the house with a dripline that overlaps the proposed addition. No major impacts are anticipated to this tree; however, tree fencing is recommended to ensure machinery is not operated within the Critical Root Zone (CRZ). See additional recommendations below.

*Photo 1. Tree #559 (Prunus avium) near the excavation site for the proposed addition.*

- **Tree Fencing:** Install tree protection fencing to restrict machinery access and prevent damage to tree roots. See “Tree Protection Zone” section below.
- **Monitoring:** Consider on-site arborist monitoring for any excavation within 10-15 feet of the tree trunk.
- **Root Management:** Cleanly cut any roots 2 inches in diameter or larger with a sharp saw to promote wound closure and regeneration.

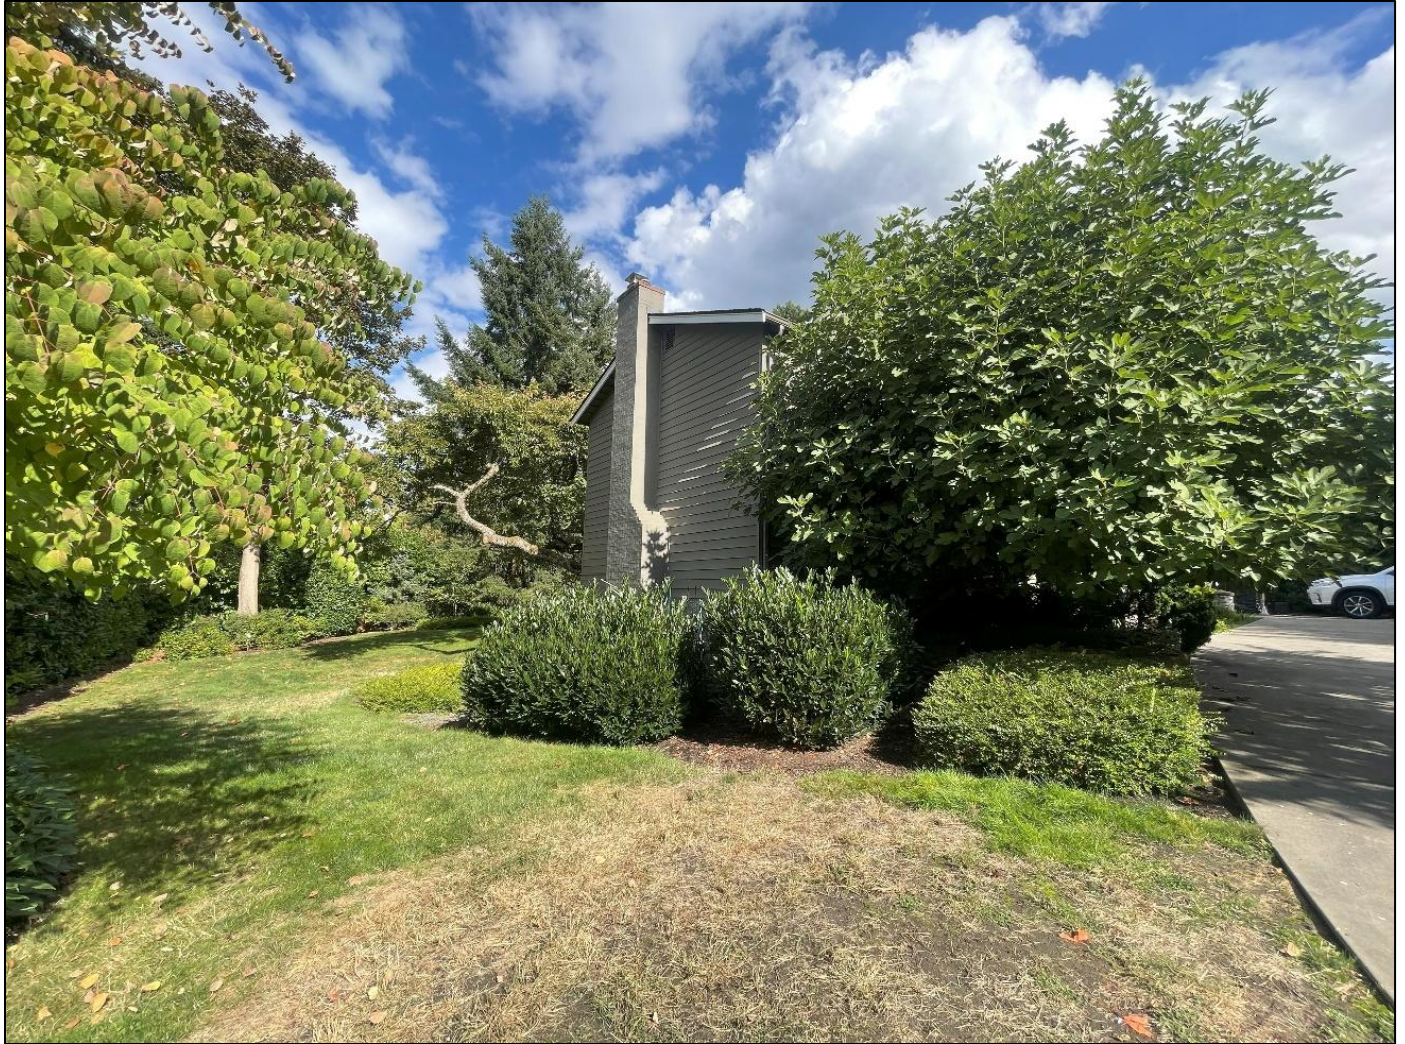
*Photo 2. Tree #558 (Ficus carica) on the south side of the house and location of the proposed addition.*

- **Tree Fencing:** Install tree protection fencing to restrict machinery access and prevent damage to tree roots. See “Tree Protection Zone” section below.
- **Root Management:** Cleanly cut any roots 2 inches in diameter or larger with a sharp saw to promote wound closure and regeneration.

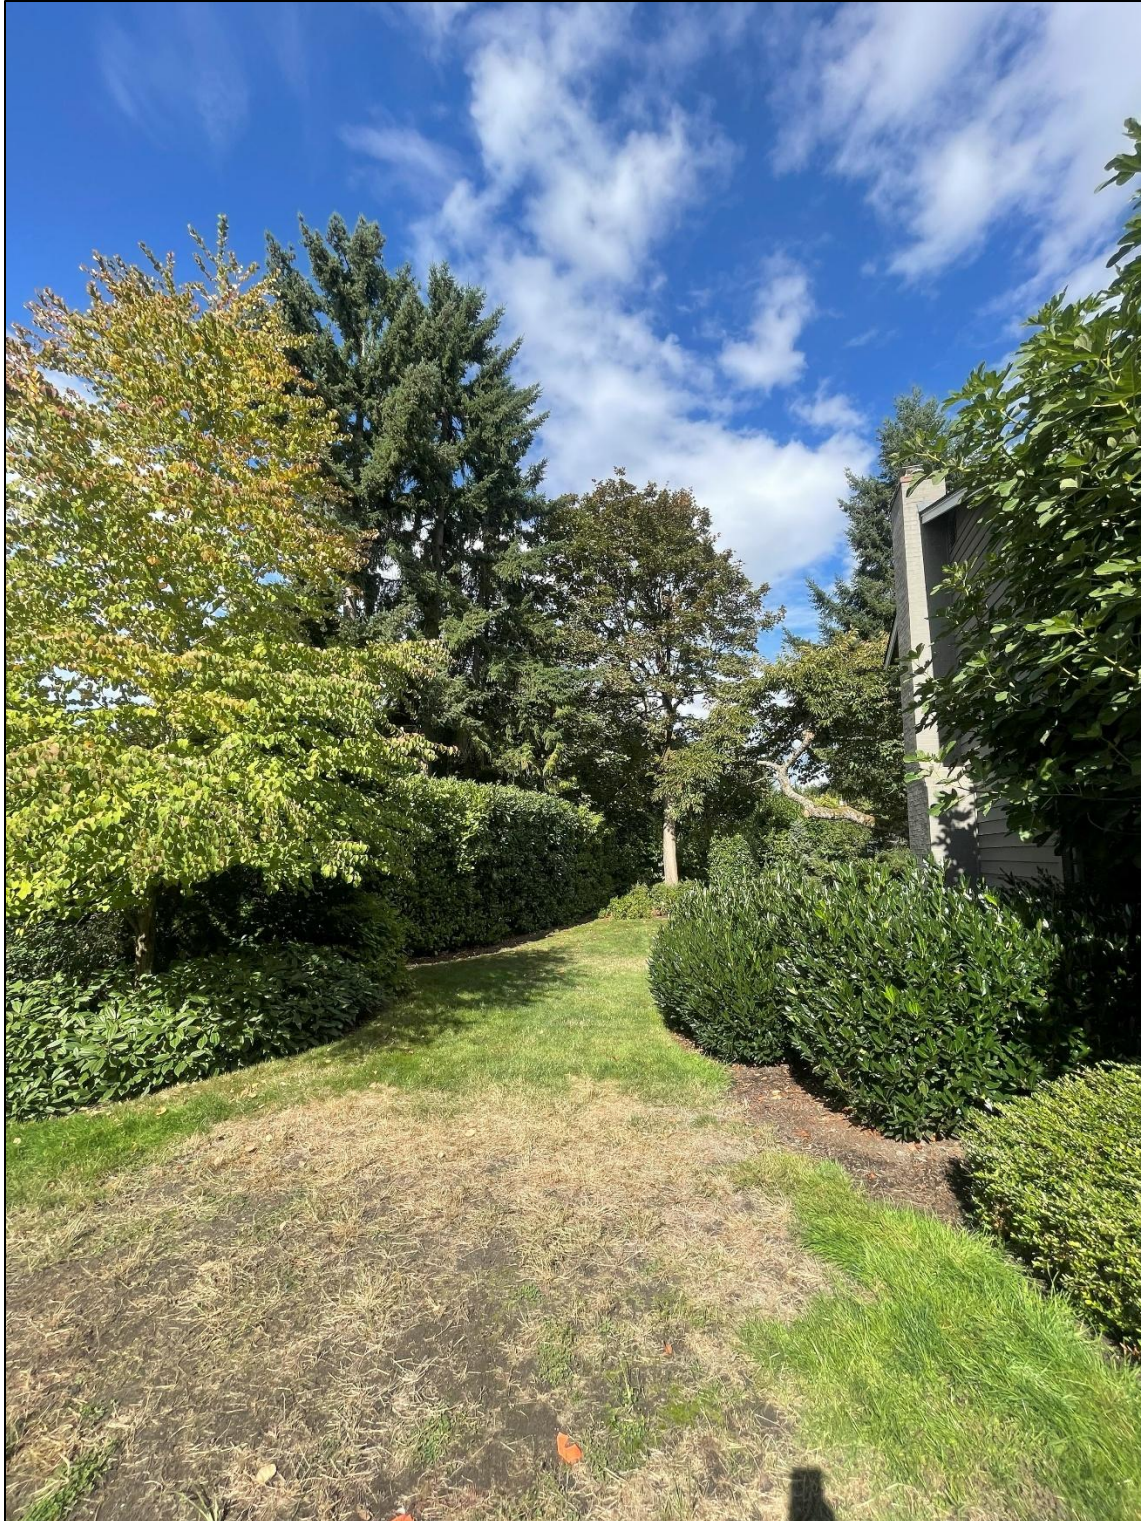
*Photo 3. Construction access on the west side of the house with exceptional Tree #560 (Acer macrophyllum) in the distance.*
