4215 Holly Lane – Drainage Issues Response

From: Alex Lupulyak, PE
To: Marlon Nerio, F & M Construction and Remodeling
Subject: 4215 Holly Lane Drainage Issues Response

January 9th, 2026

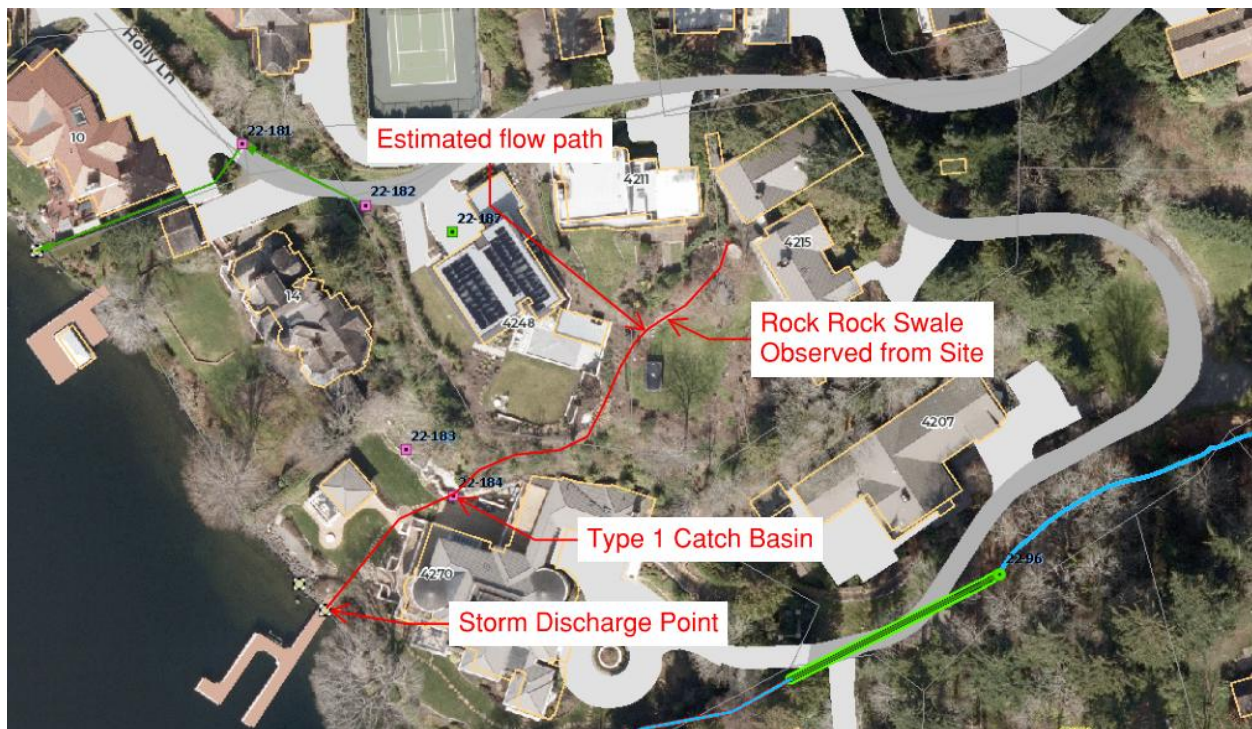
Figure 2: Approximate Drainage Path

In addition to no net increase of impervious surfaces, the approximate drainage path from the project site can be seen below in **Figure 2**. The area downstream of the project is private property and HRC does not have permission to enter, so the flow path is no guarantee, but is believed to be accurate based off of observation from the project site made by HRC in the field and City of Mercer Island GIS data.

Runoff from the project site #4215 exits the site on the western portion into a rock swale through #4211 (visibly from the project site), through #4248, and is believed to enter a Type 1 Catch Basin on site #4270, and discharged to Lake Washington where the Storm Discharge Point is visible on the GIS.

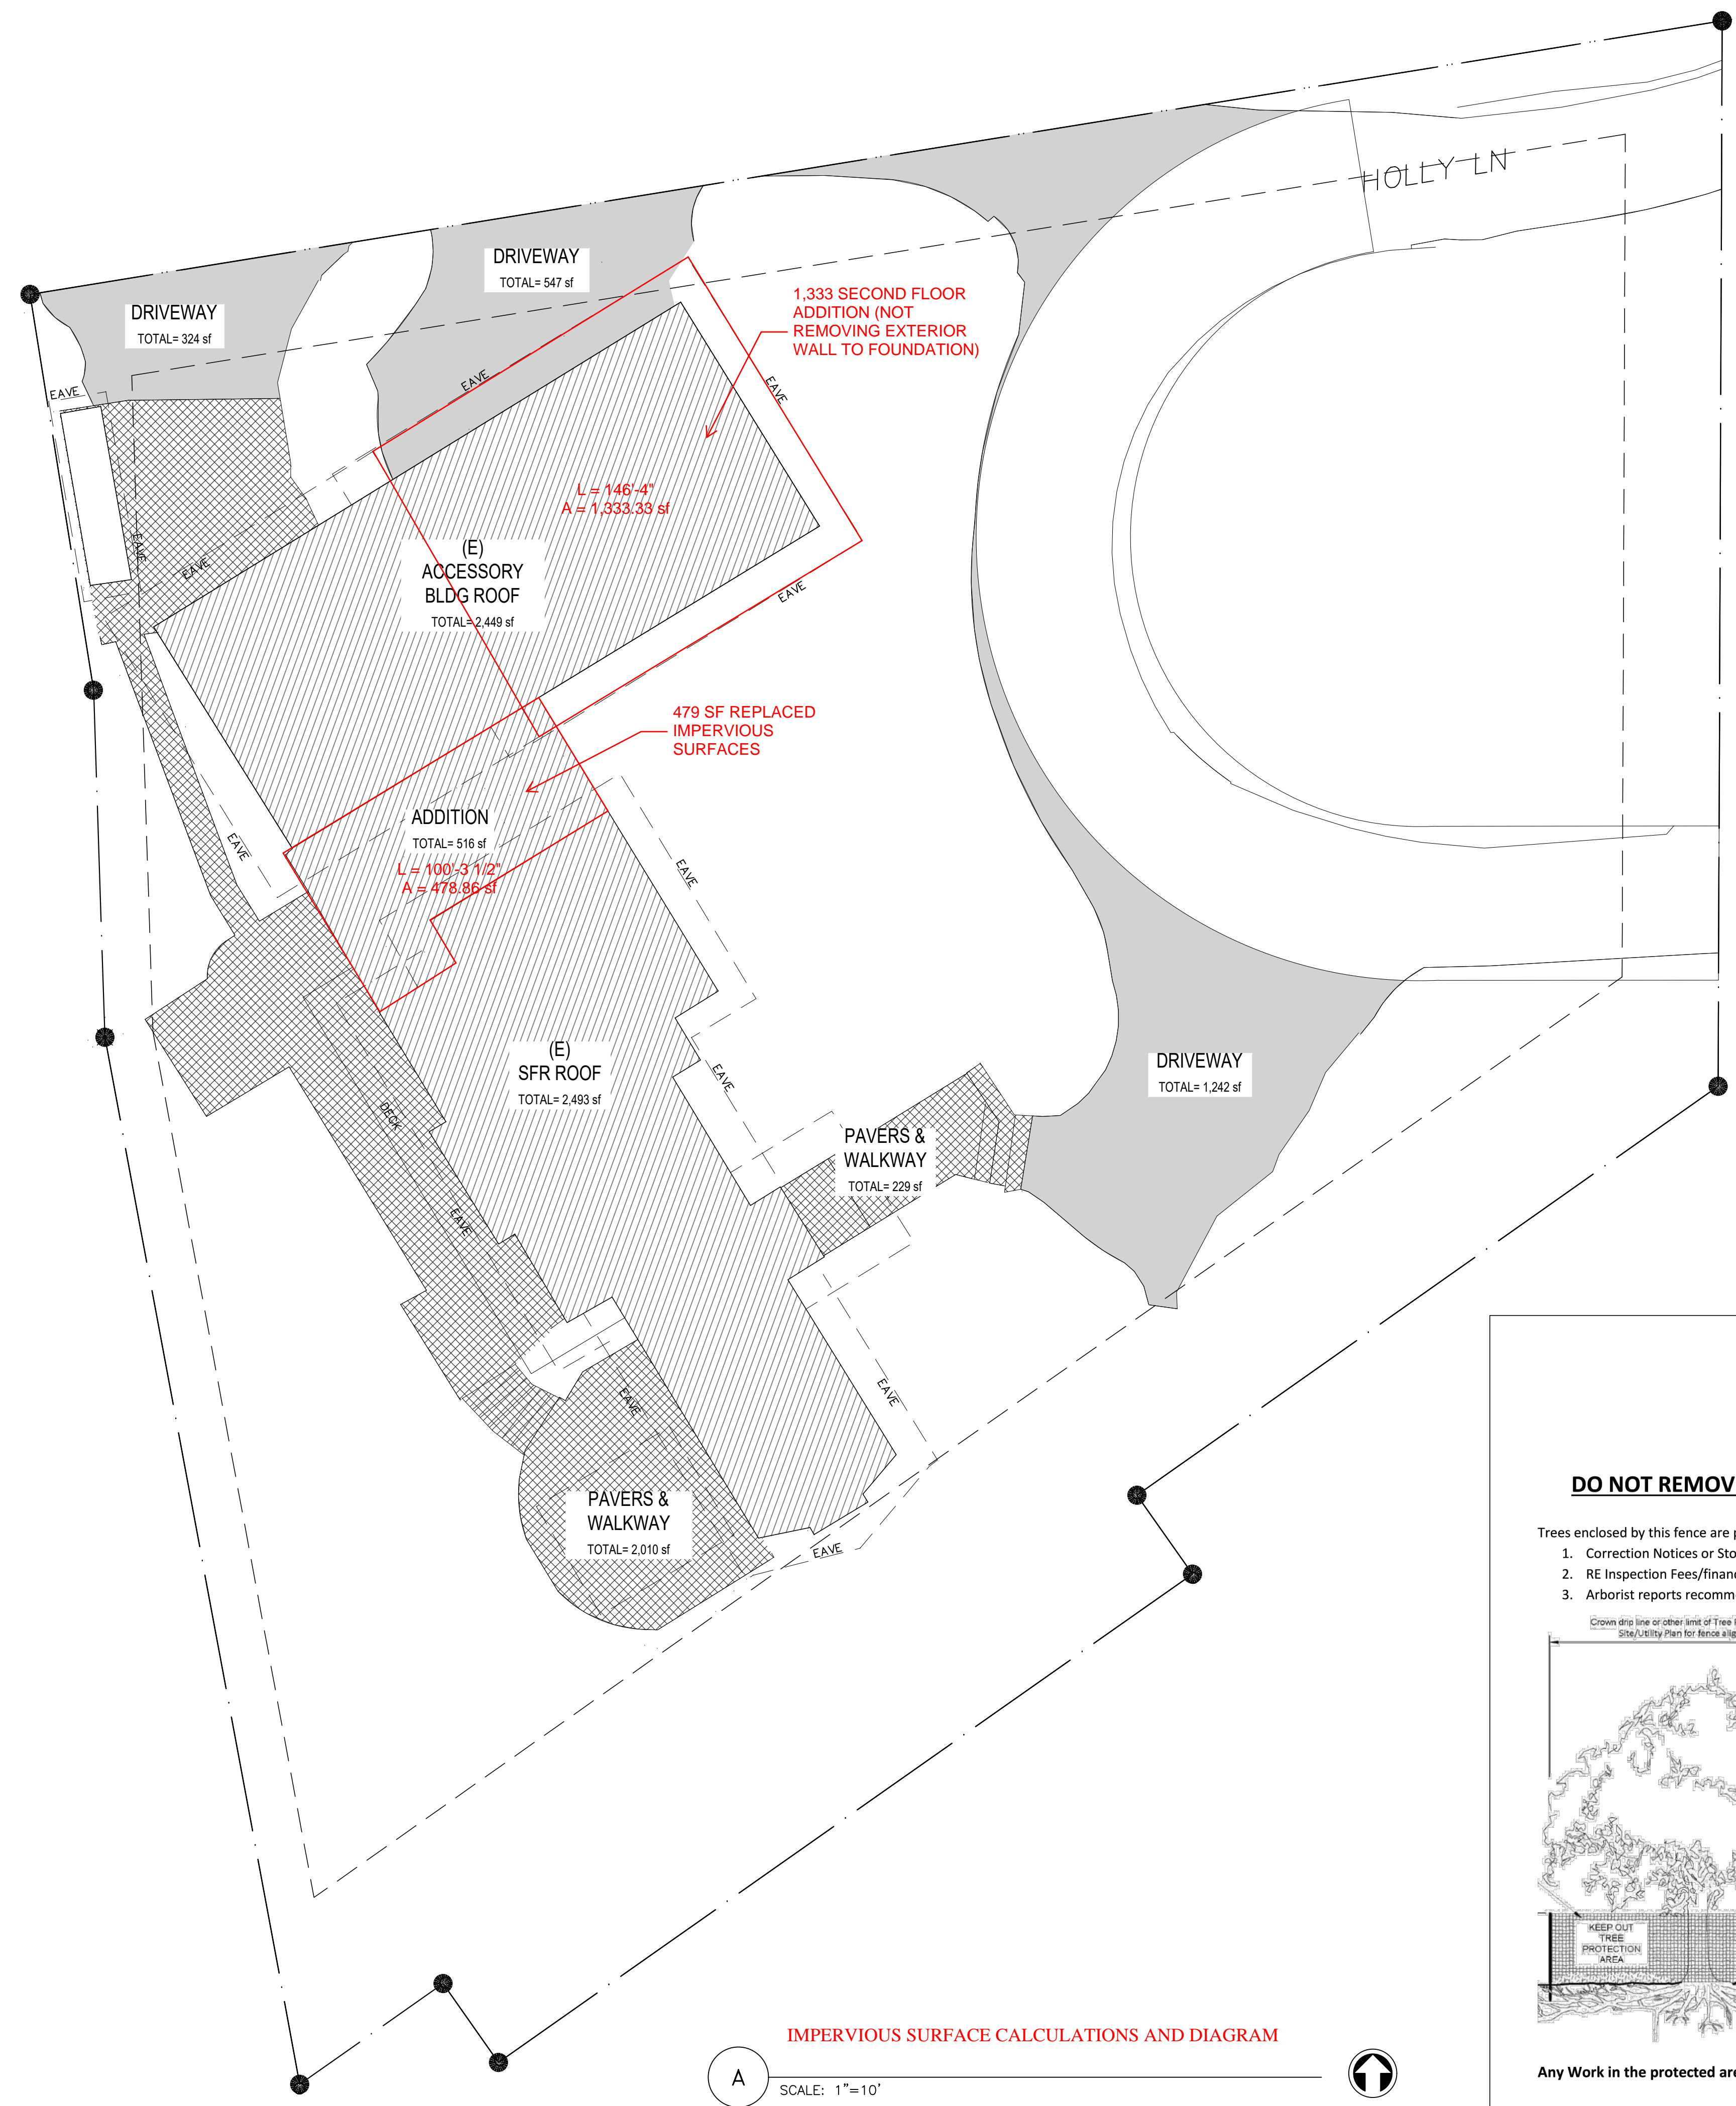
IMPERVIOUS SURFACE CALCULATIONS AND DIAGRAM

The current project, which is a remodel project, consists of no net increase of impervious surfaces per the Impervious Surface Calculations and Diagram

found in **Appendix A**. This means no additional stormwater runoff would enter the system to cause an increase of flow since only part of the existing roof will be replaced in one portion, not added to, and the other portion adds roof where there was previously concrete. This means that when it rains, the amount of water collected by the drainage system remains unchanged as a result of the project.

TOTAL LOT AREA - 25,059 SF
 EXISTING HOUSE ROOF - 2,493 SF
 EXISTING ACCESSORY BUILDING ROOF AREA - 2,449 SF
 EXISTING DRIVEWAY - 2,113 SF
 EXISTING CONCRETE WALKWAYS/PATIO - 2,010 SF
 PROPOSED ROOF ADDITION (REPLACED IMPERVIOUS) - 479 SF

TOTAL EXISTING IMPERVIOUS - 9,065 SF
 TOTAL PROPOSED REPLACED IMPERVIOUS - 479 SF
 NET INCREASE IMPERVIOUS SURFACES - 0 SF
 TOTAL IMPERVIOUS (EXISTING/PROPOSED) AFTER PROJECT COMPLETION - 9,065 SF
