January 2, 2024

Site: 7414 78th Ave SE  
Mercer Island, WA 980404  
TPN: 2524049075  
Area: 68,825 sq. ft. = 1.6 acre

Re: RFI dated November 27th, 2023, changes itemized below, on the report and on the city response matrix highlighted in yellow.

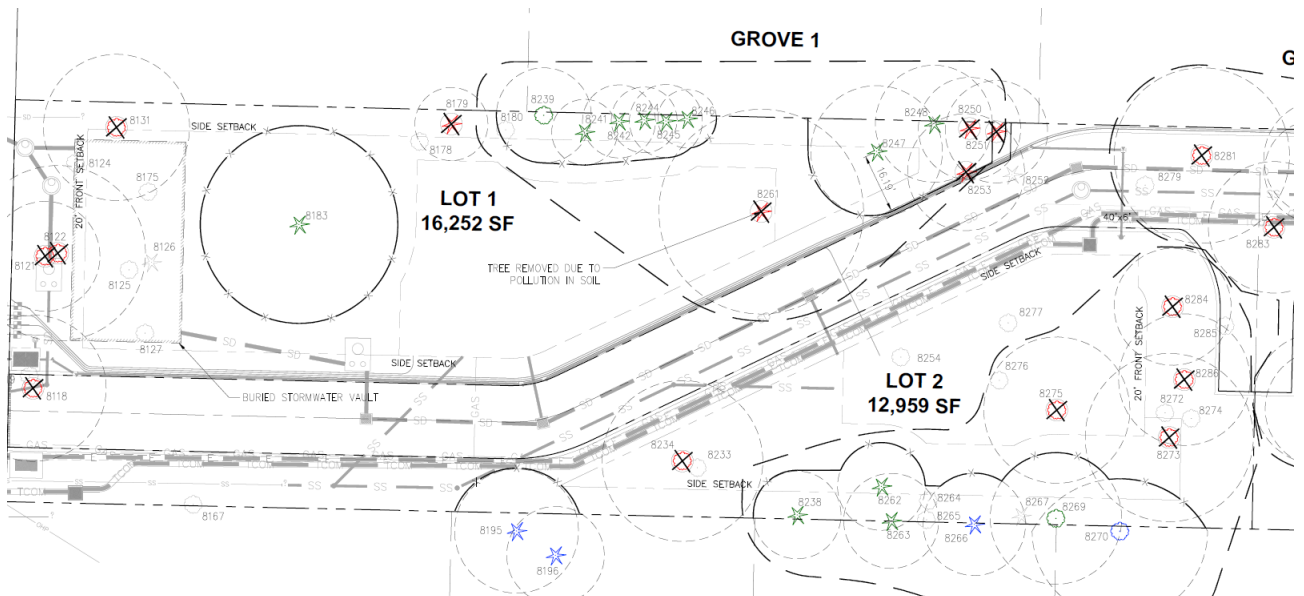
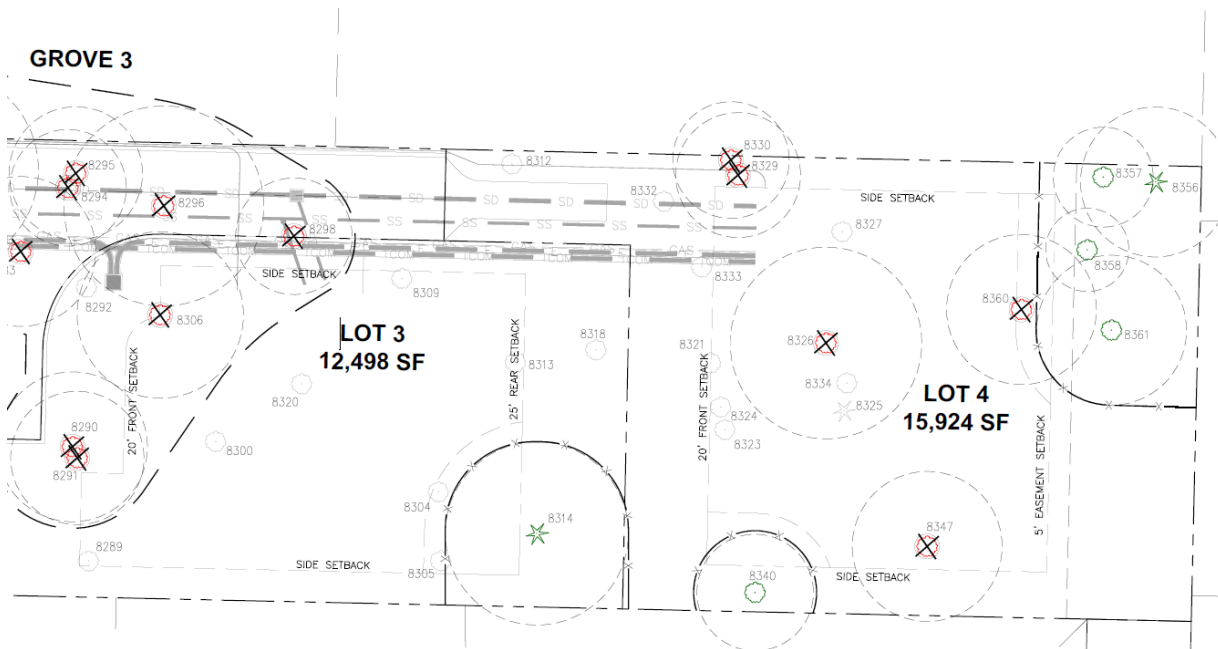
**Proposed site Improvements: (for reference only, see civil plans for details)**

1. The tree protection shown on the site plan is right on the building pad, which would be unrealistic in the field. The building pads will need at least five feet of clearance for walking and machine access. The tree protection and limits of allowable disturbance will need to be adjusted to account for the five-foot clearance. (Building pads were reduced to allow for a 5' buffer, completed by Navix; site plan is copied and pasted onto page 21)
