David Yusen  
Mercer Island project

## Pre-construction Arborist Report

Address: 3246 72nd Pl SE, Mercer Island, WA

Site visit date: 7/2/25

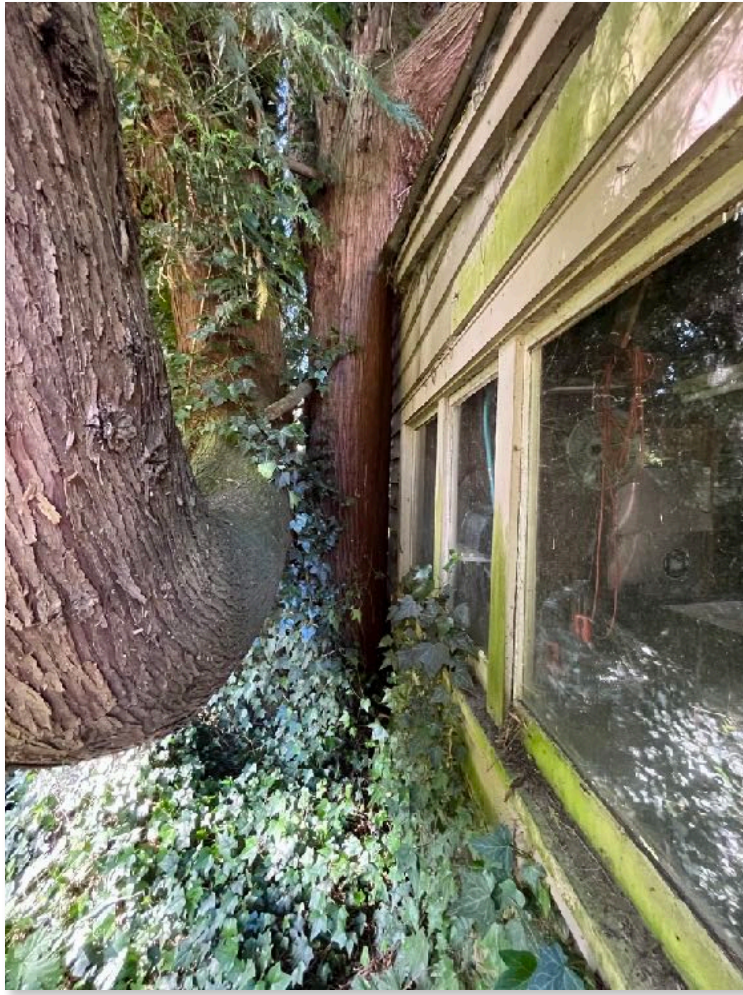
Right: Lilac (in front of garage) is not regulated and can be removed. Below: Cedar 5067 seen behind the garage could be designated a hazard tree due to the fact that it touches the structure of the garage. Remove.

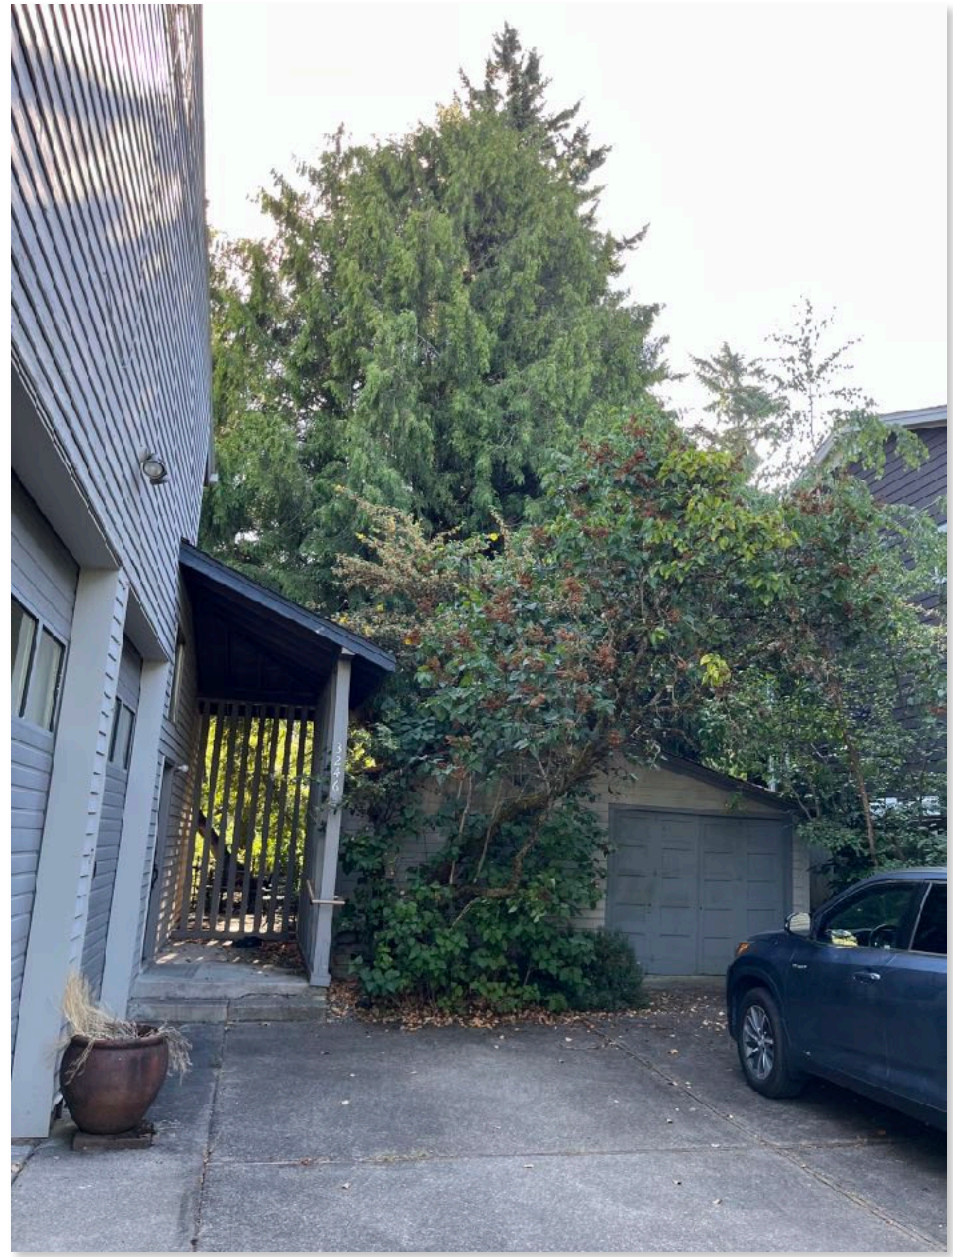
- **Tree #5067** – Western Red Cedar (landmark): This tree is located behind and in contact with the garage. It was previously topped and has large, sweeping branches resembling a pitchfork form. If removal is preferred, it can be considered a hazard tree due to proximity to the existing garage. A tree risk assessment will be required and we can provide that for you.

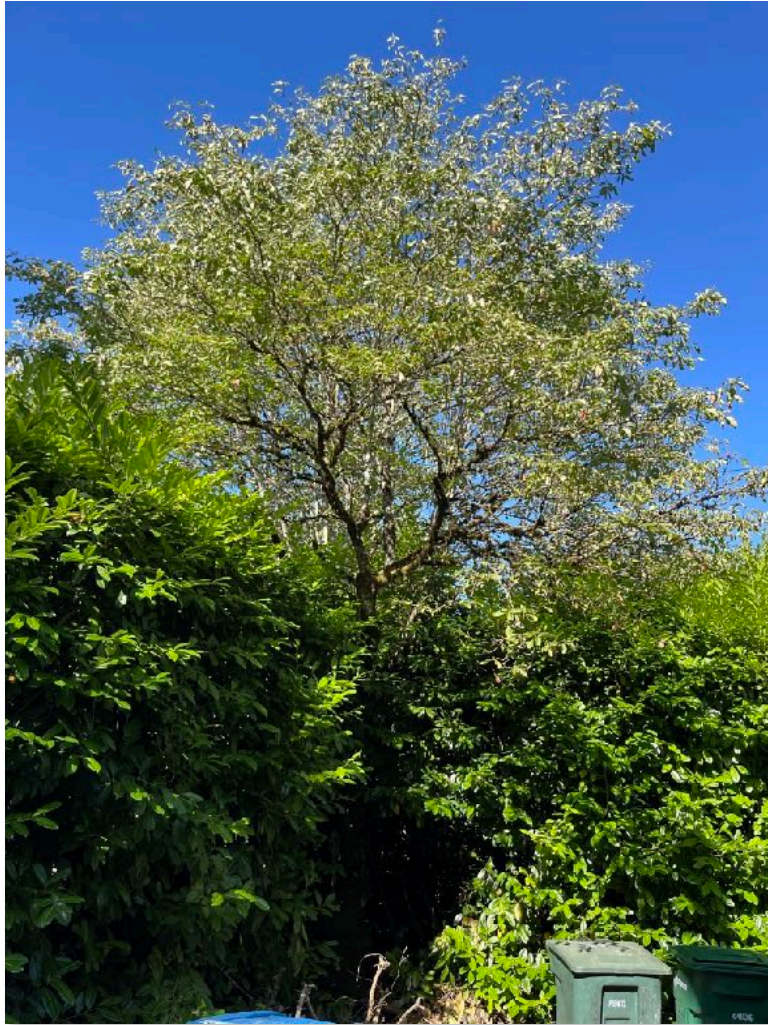
- Tree #5066 – Black Hawthorn (right side of driveway): In good condition. This native species should be retained if possible. While this tree is 6-10"

Right: Hawthorn 5066. Retain.

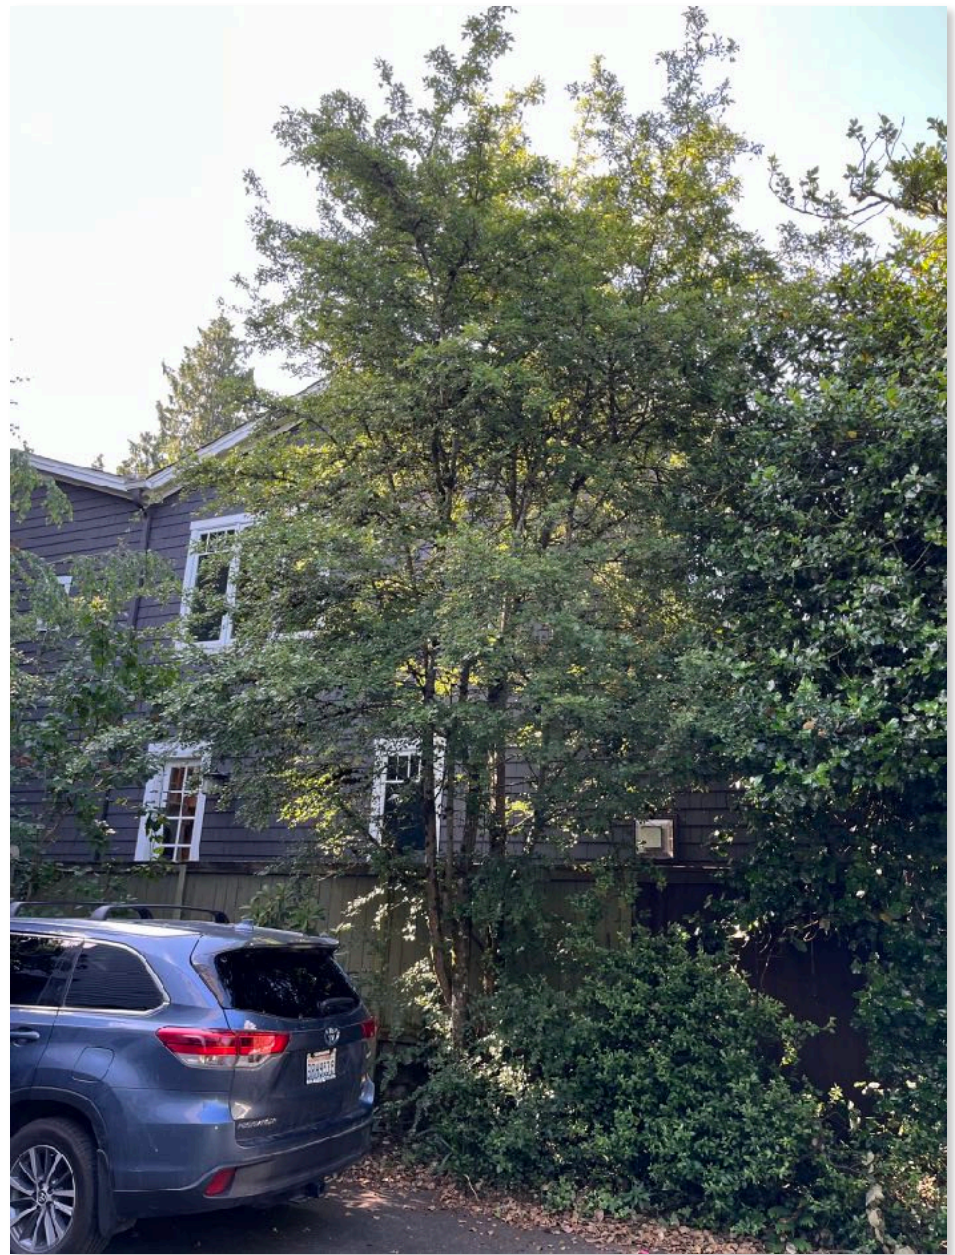
Below: Dogwood 5085 surrounded by laurel hedge. Remove.

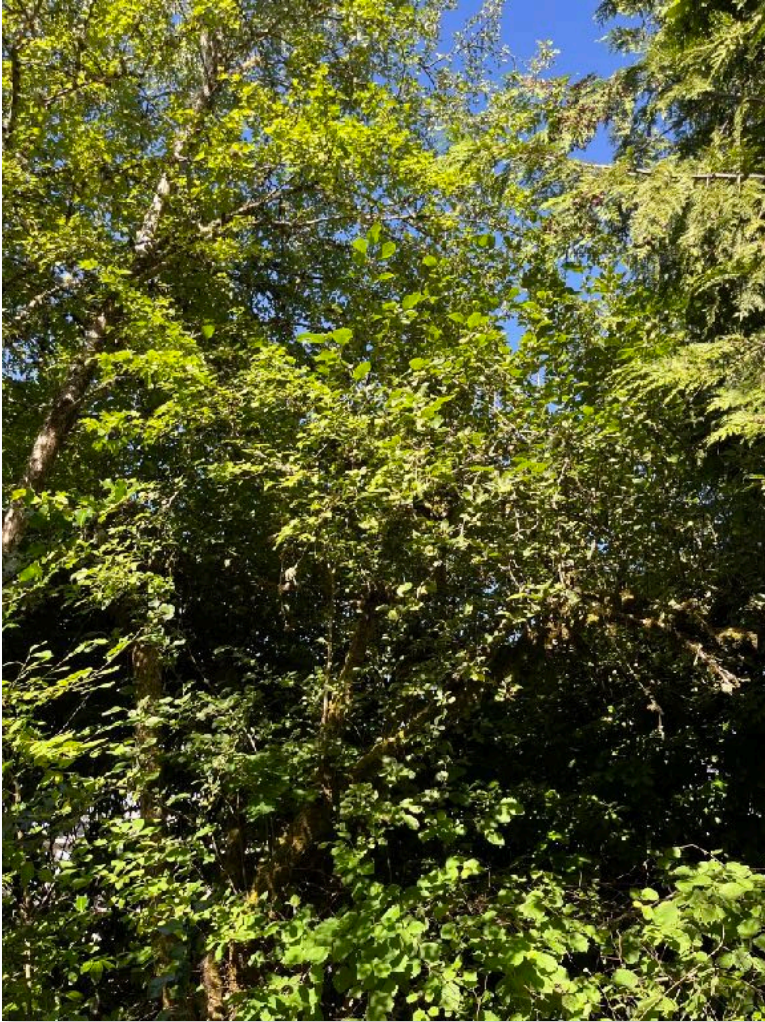
Right: Hawthorn 5084. Retain.  
Below: Crabapple 5083. Retain.

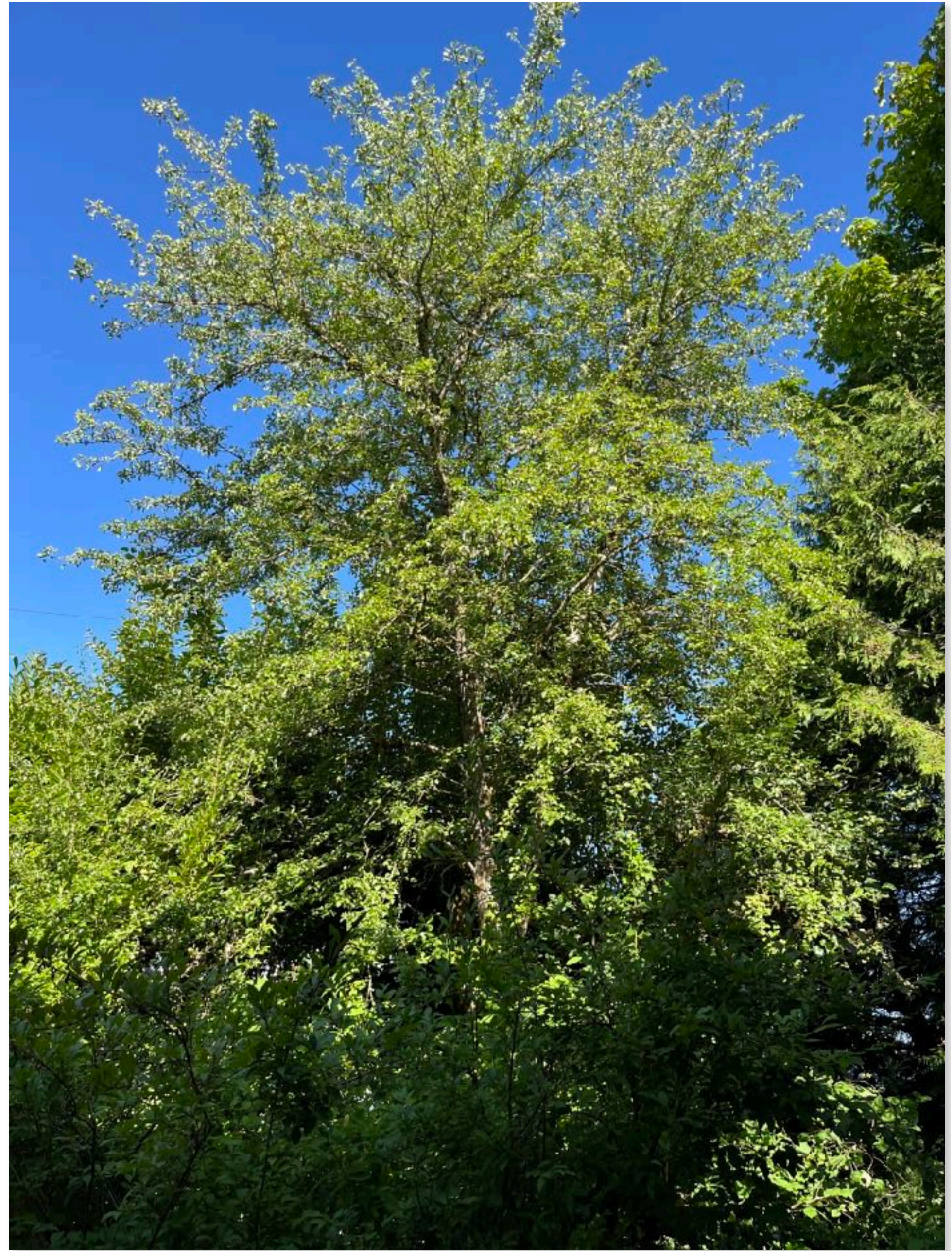
- Tree #5078 – Douglas Fir (landmark): In good condition and adjacent to an off-site Douglas fir. No visible health or structural concerns.
- Tree #5083 – ROW. Crabapple: In fair condition and would benefit from structural pruning.
- Tree #5084 – Black Hawthorn: In good condition and should be considered for retention.
- Tree #5085 – Western Dogwood: Exhibits signs of chlorosis, wilt, and water sprouting, yet the canopy remains full. Leaf and soil assessment are recommended to diagnose disease or nutrient deficiency.
- Tree #5086 (previously tree C) – Willow was initially thought to be offsite but determined to be an onsite tree during the survey. This tree was not tagged.

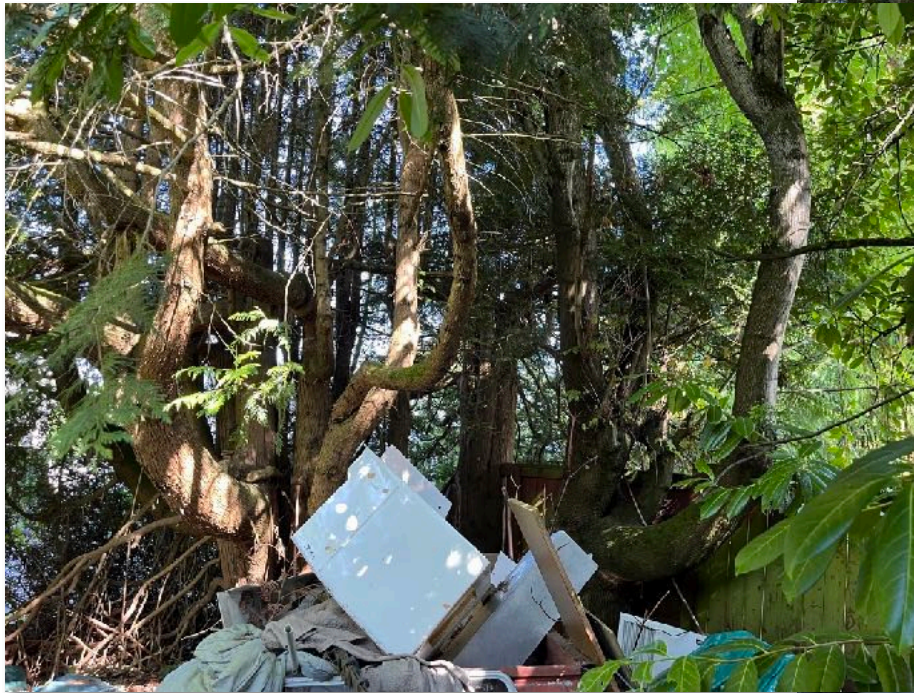
Right: Cedar 5082 has been topped. Retain  
Below: Cedar and maple group in NW corner 5079-5082 Retain.

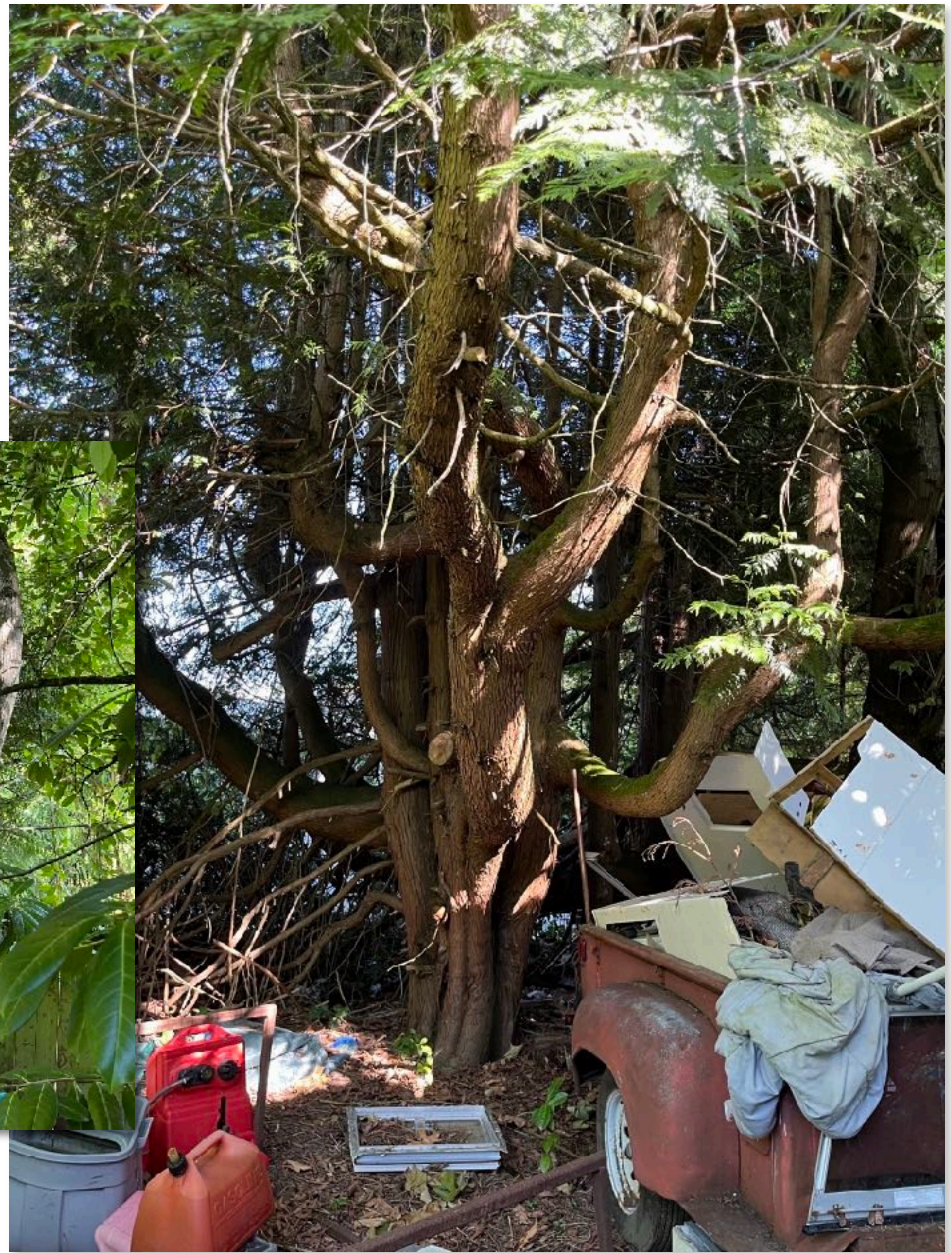
Northwest Corner trees (adjacent to the street): This area contains **four trees 5079-5082**, three of which are western red cedars with poor structure, and one is a big leaf maple with fair structure.

- Tree #5081 – Big leaf Maple: Appears healthy with a single trunk but unusual lower branching that should be monitored.
- **Trees #5079, 80, 82** – Western Red Cedar (multi-stemmed): Forms a pitchfork structure at ~4-7 feet and appear to have been topped multiple times. The trees have **poor structure** and are impacted by **overhead utility lines** at ~15 feet. **All trees in this corner have been topped**, except the maple.

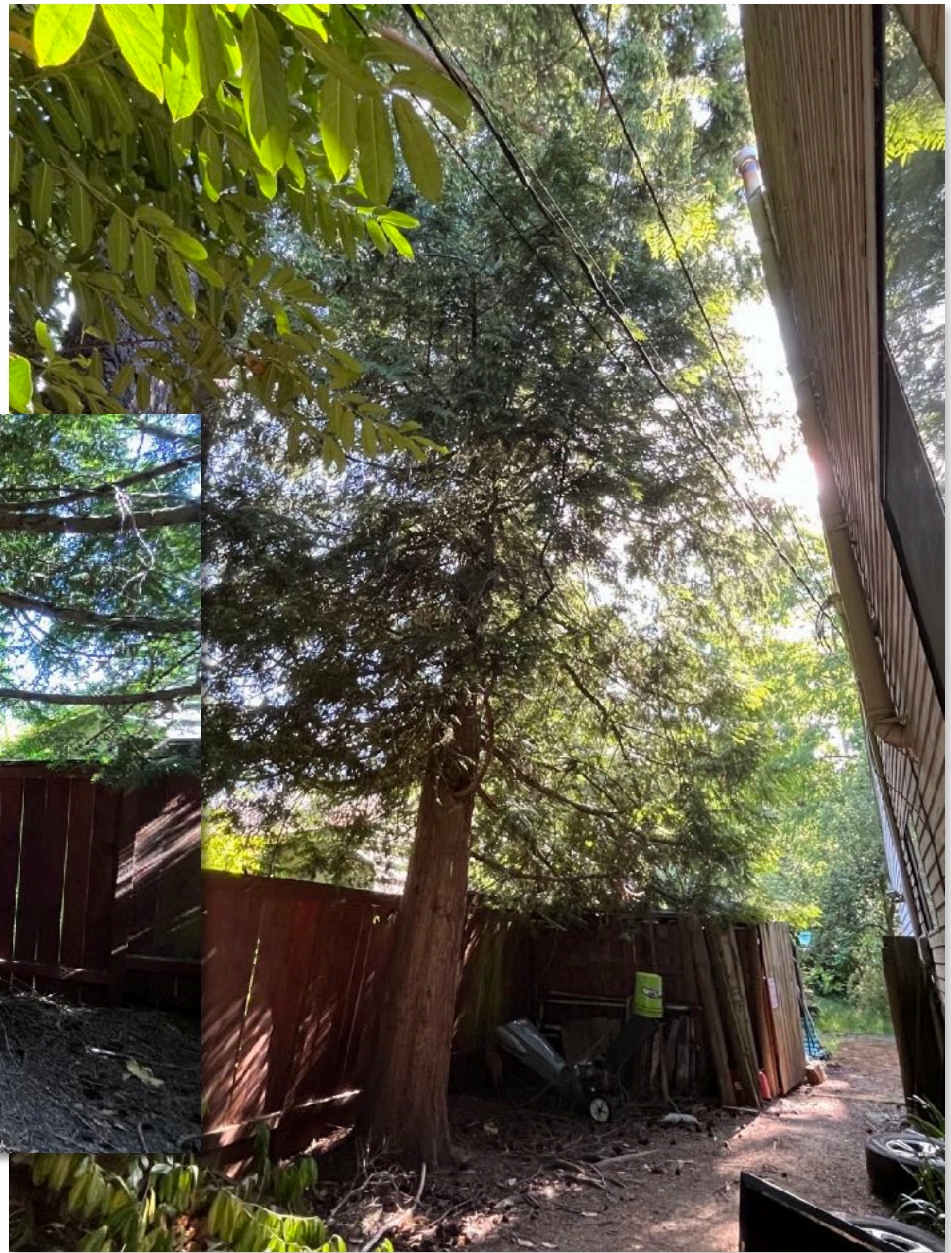
- Tree #5077 – Western Red Cedar: In good condition and located near the fence line, close to two Douglas fir trees.

Right: Cedar 5077. Retain.  
Below: Douglas fir 5078 and cedar 5077 trunks. Adjacent tree A is behind the fence. Retain.

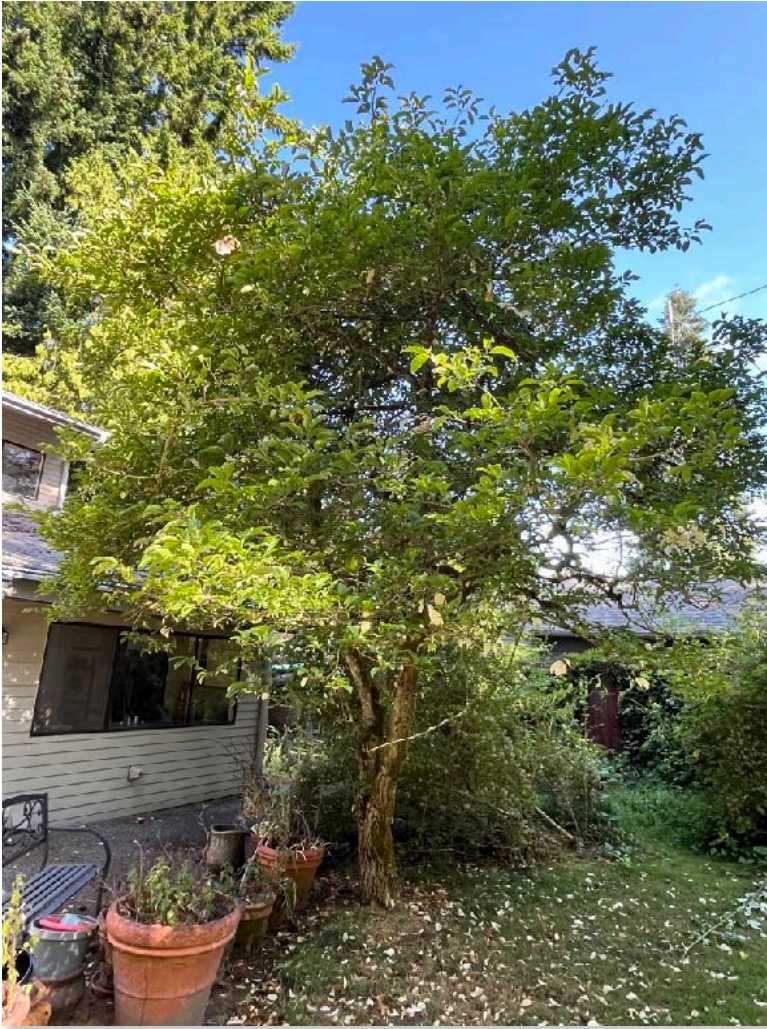
Right: Pear tree 5076. Remove

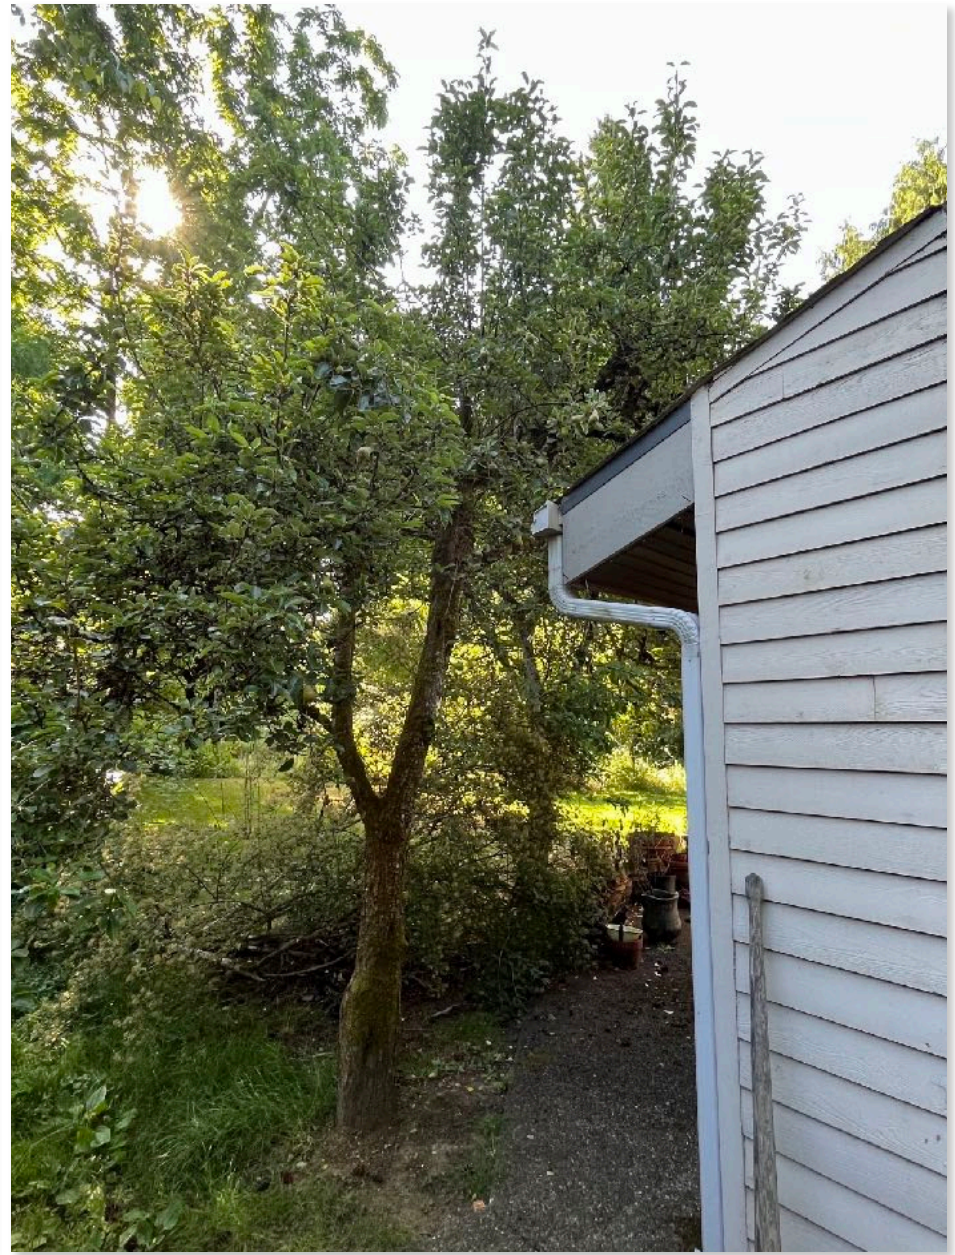
Below: Euonymus 5075 has a tree form. Remove

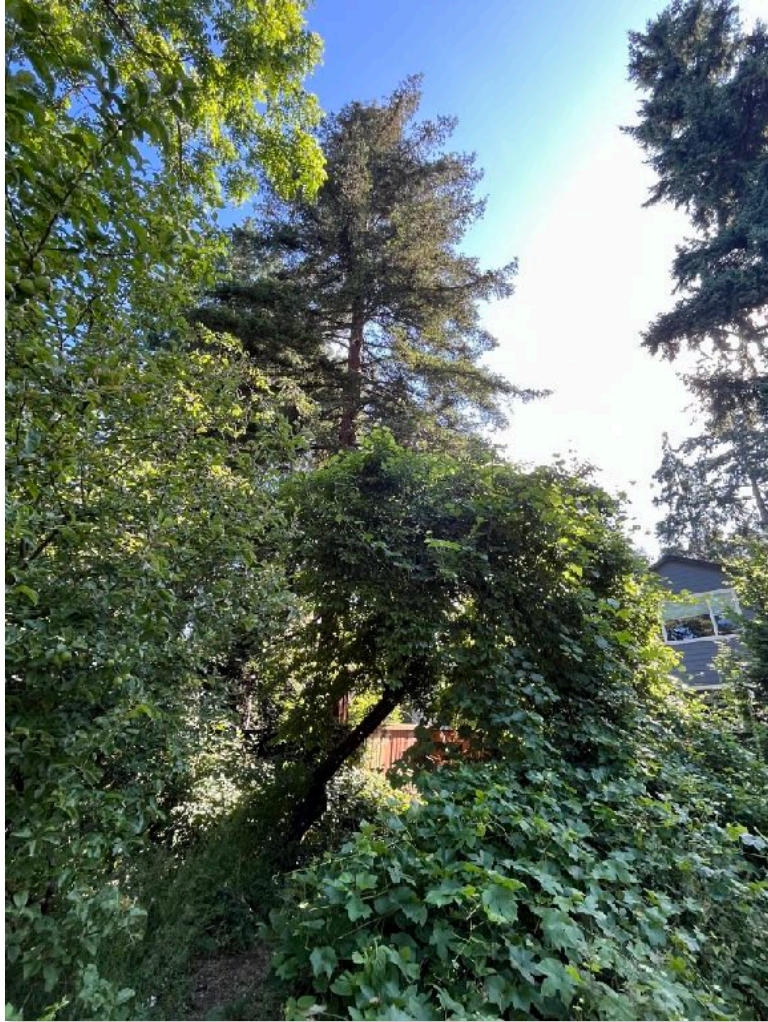
- Tree #5074 – Walnut: In good health with generally sound structure. However, at ~20 feet there is a co-dominant stem junction with stems diverging in two directions. Cabling may be needed in the future; arborist inspection recommended in 5 years if retained.

Right: Walnut 5074

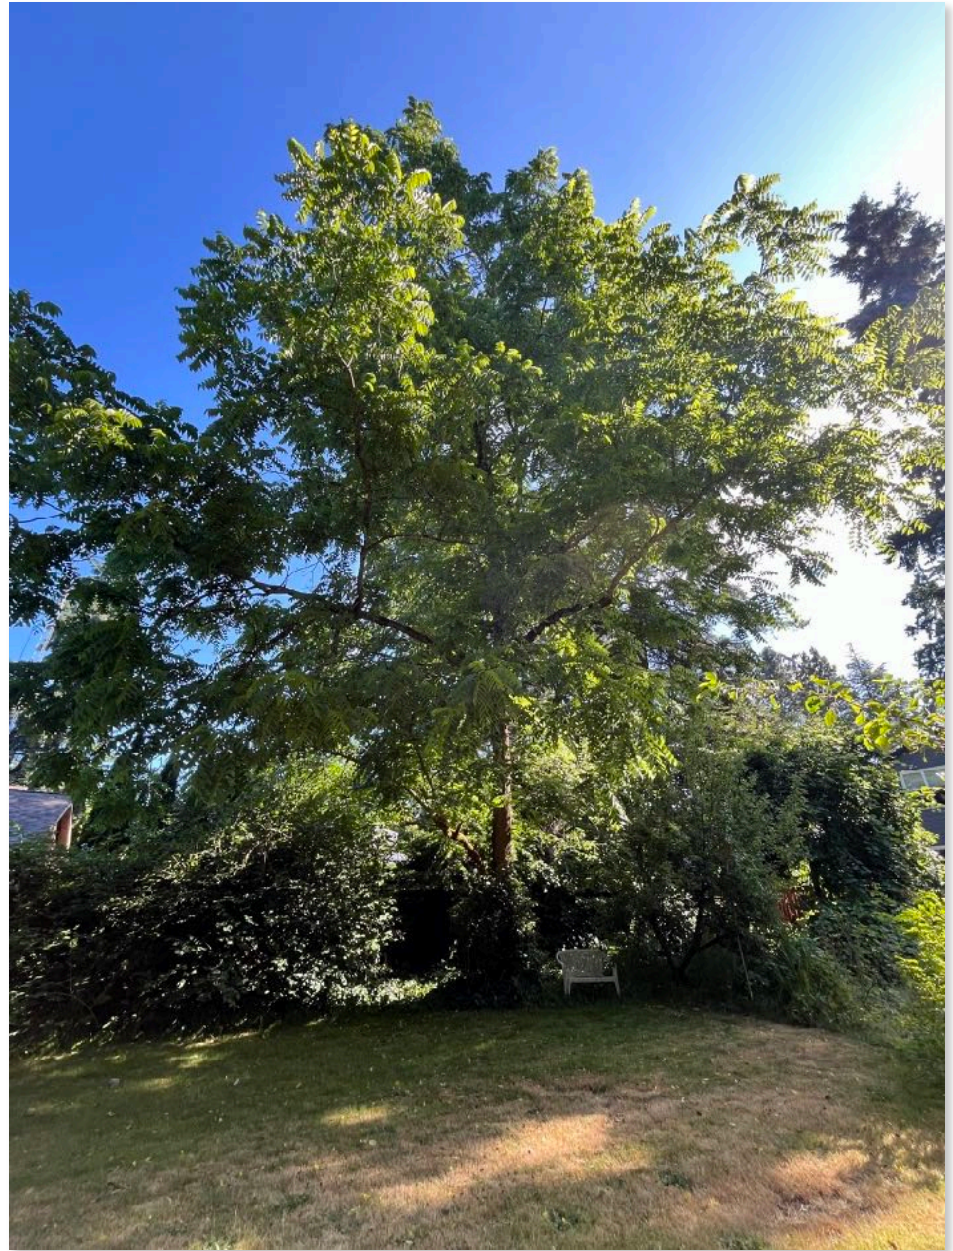
- Tree #5072 – Cherry: In good condition, though canopy is one-sided due to suppression from an adjacent Sequoia on a neighboring property.
- Tree #5073 – Plum Tree: Has a leaning trunk with a full canopy. No signs of structural instability at this time.
- Tree #5075 – Hamilton's Spindle: An unusual species that some consider a shrub, but can grow up to 30' which makes it a tree in most municipalities. It has a low primary junction at ~2 feet that may pose structural concerns in the future, but it is currently healthy. Inspect in 5 years if retained.
- Tree #5076 – Pear Tree: Appears healthy and is fruiting well.
- Tree #5079 – Western red cedar in NW corner. Suppressed by nearby larger trees.

Below: Plum 5073 and cherry 5072 (behind). Adjacent redwood tree B is seen above and behind the plum.

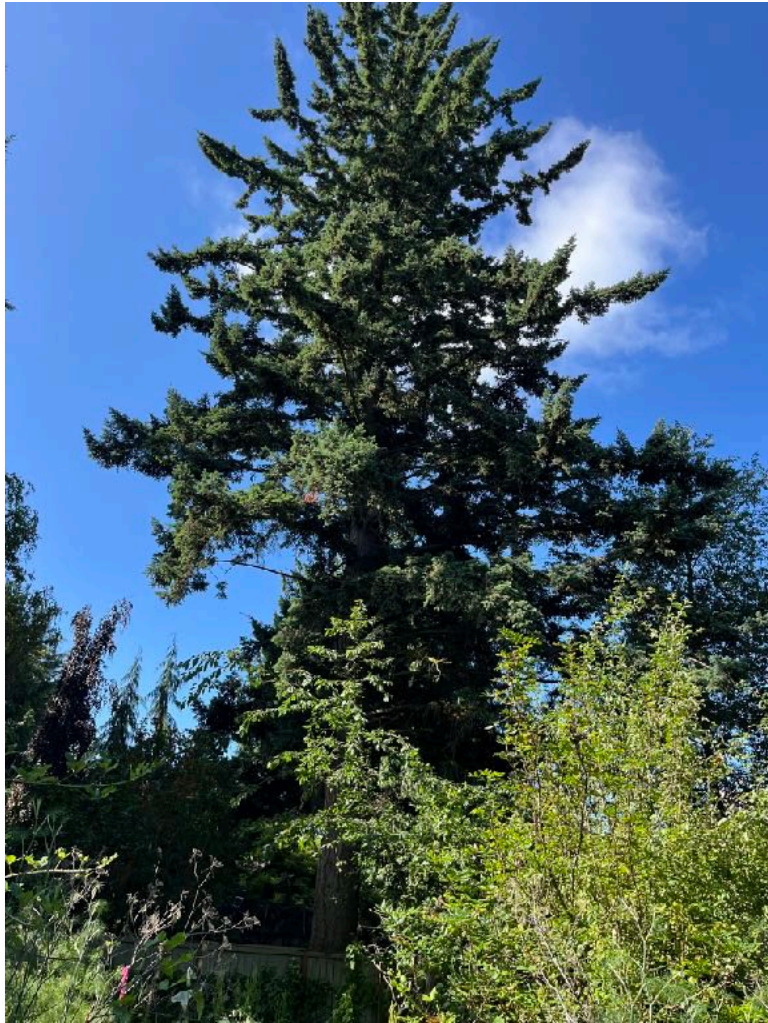
Right: Adjacent tree C willow is right against the fence.  
Below: Adjacent tree D is a large Douglas fir close to the fence.

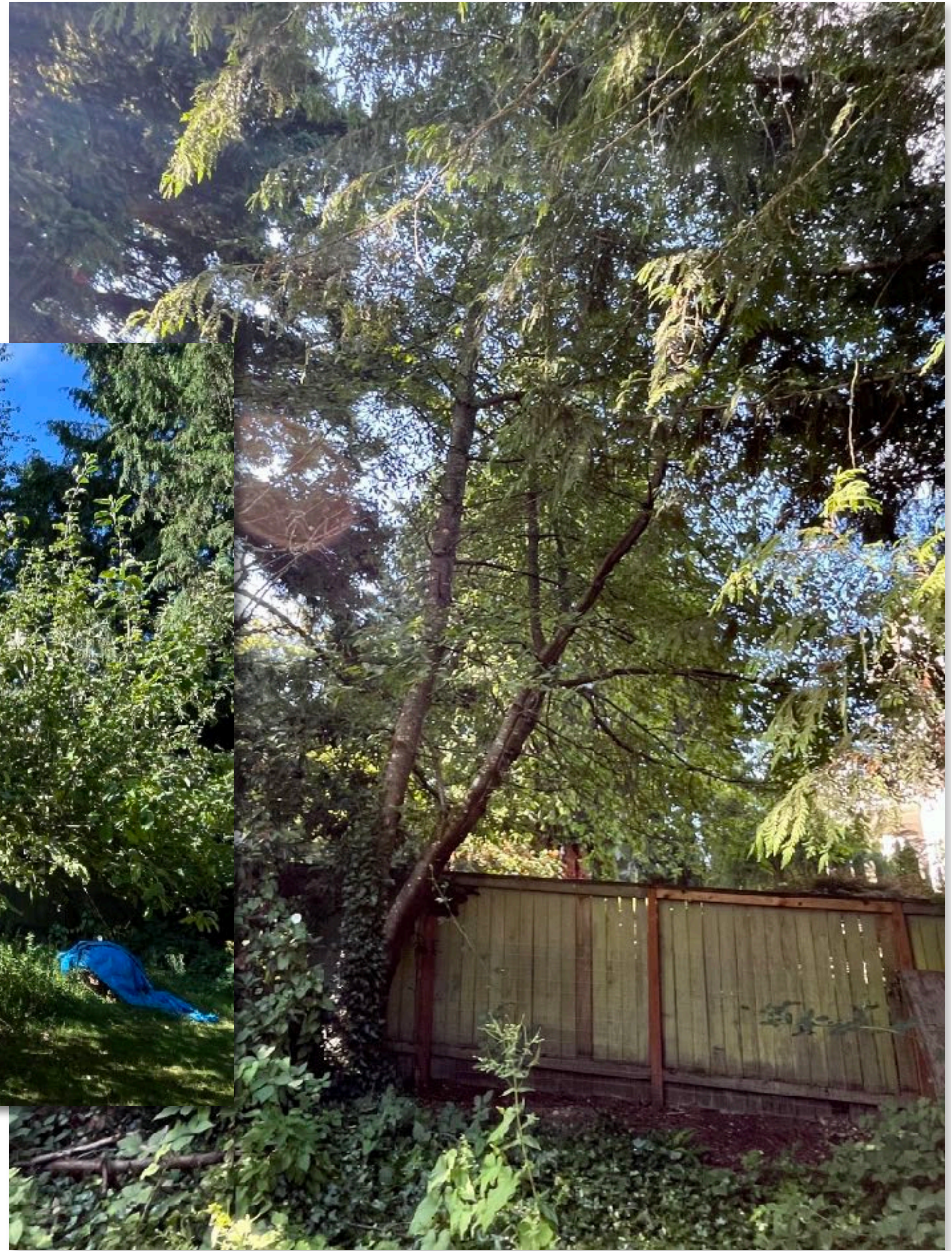
- Tree #5069 – Bitter Cherry: Multi-stemmed at ~4 feet with three stems forming a steep-angled junction. This structure can become unstable over time, but there is no current sign of weakness. One or more secondary stems could be removed or cabled in the future.

Right: Bitter cherry 5069  
Below: Apple 5071

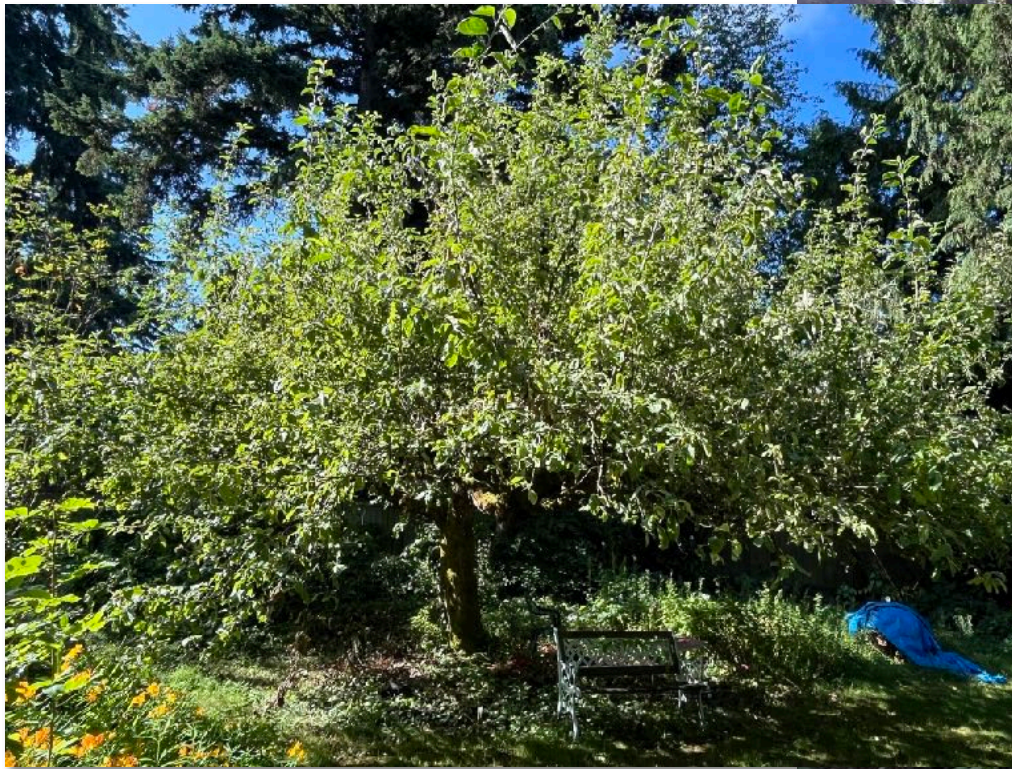
- **Tree #5070** – Cherry: Completely dead, with no visible foliage. Reduction to wildlife snag or removal is recommended.
- **Tree #5071** – Apple Tree: Very mature with a hollow trunk, but otherwise appears healthy and structurally stable at this time. Monitor every 2-3 years for decline.

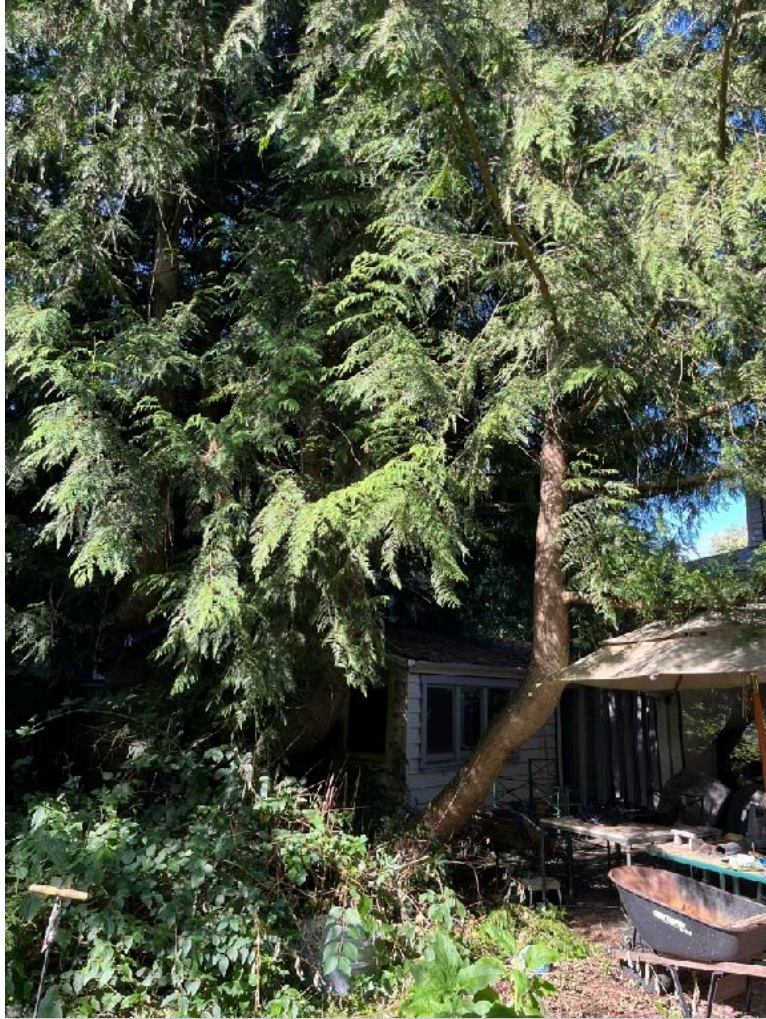
- **Tree #5068** – Western Red Cedar: Nearby cedar with a sweeping lower stem that becomes vertical at about 7 feet. Its canopy is mostly one-sided due to suppression by Tree 5067.

Right: Cedar 5068 and 5067 (far right)

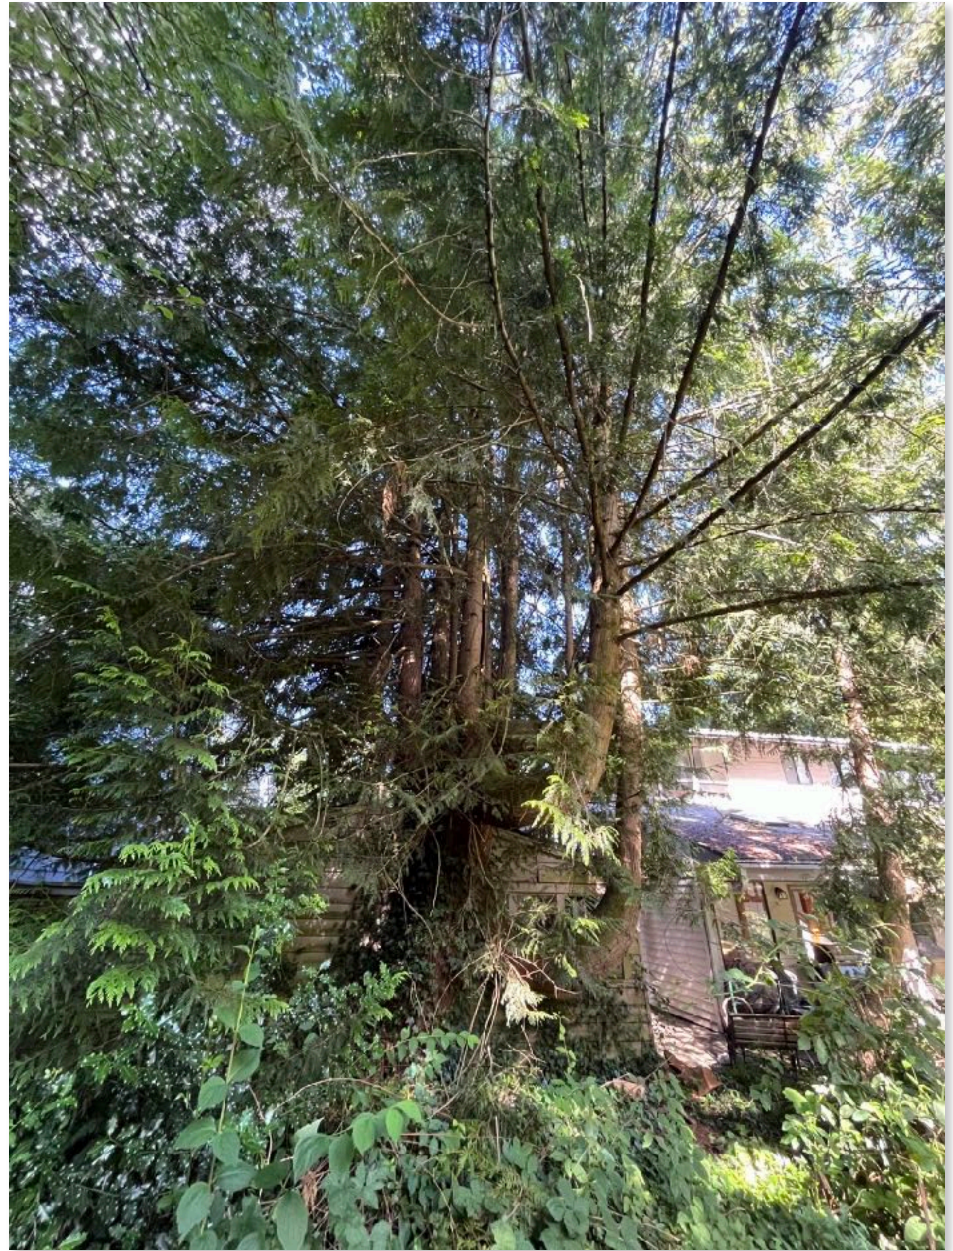
Below: Cedar 5067
