GEOTECHNICAL ENGINEERING INVESTIGATION

Proposed Single Family House
5425 96th Ave SE
Mercer Island, Washington
Parcel#: 1438700145

November 19, 2024
Project No. 2DF0422984

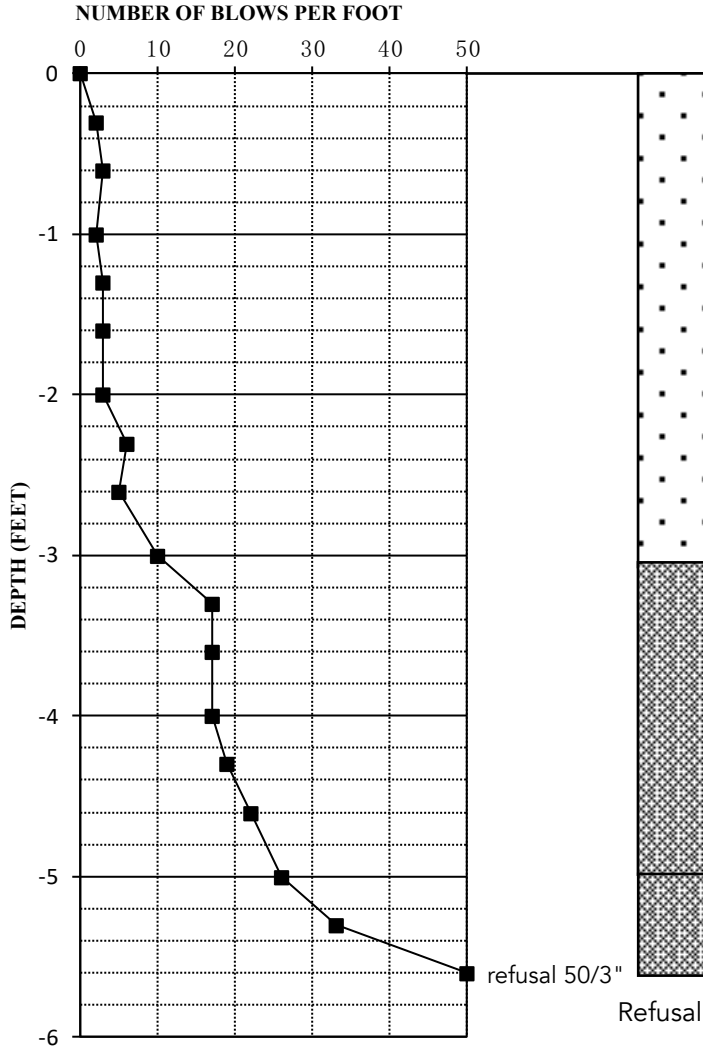
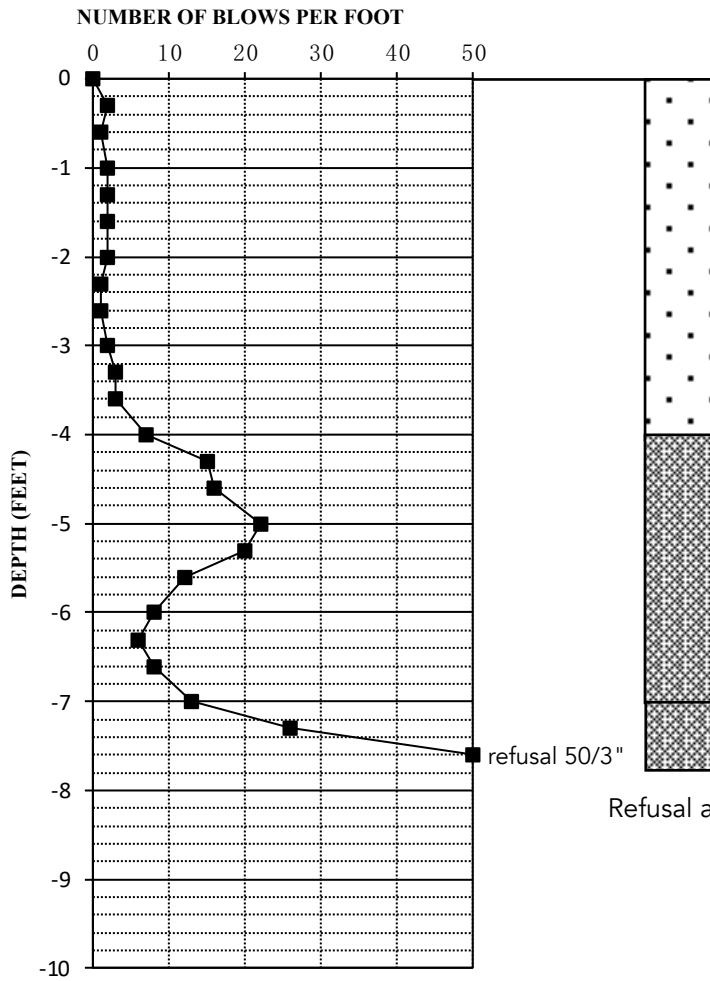
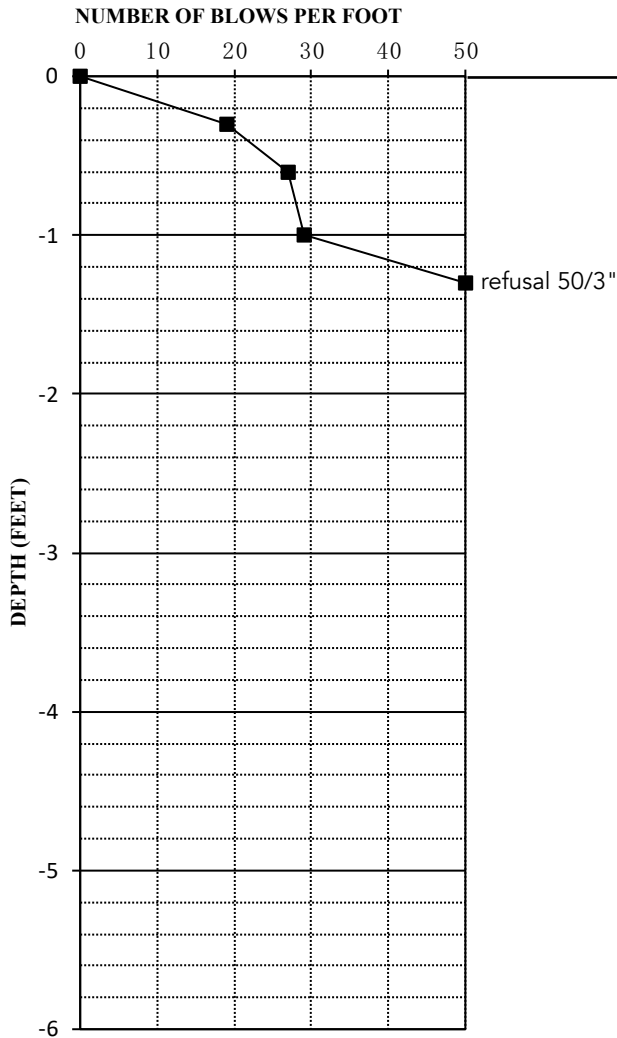
Subsurface soil and ground water conditions were investigated by conducting three (3) DCP tests to maximum 7.6' depth on June 29, 2022. Test locations are shown on the site plan (Figure 2). Test logs are presented in the Appendix of this report as Figures 4 through 6.

A layer of loose silty which varies in thickness from 0” - 4’ generally blankets the slope. The more closer to the top of slope, the shallower of this loose silty sand is. The soil was damp, crumbly when disturbed, and loose in situ.

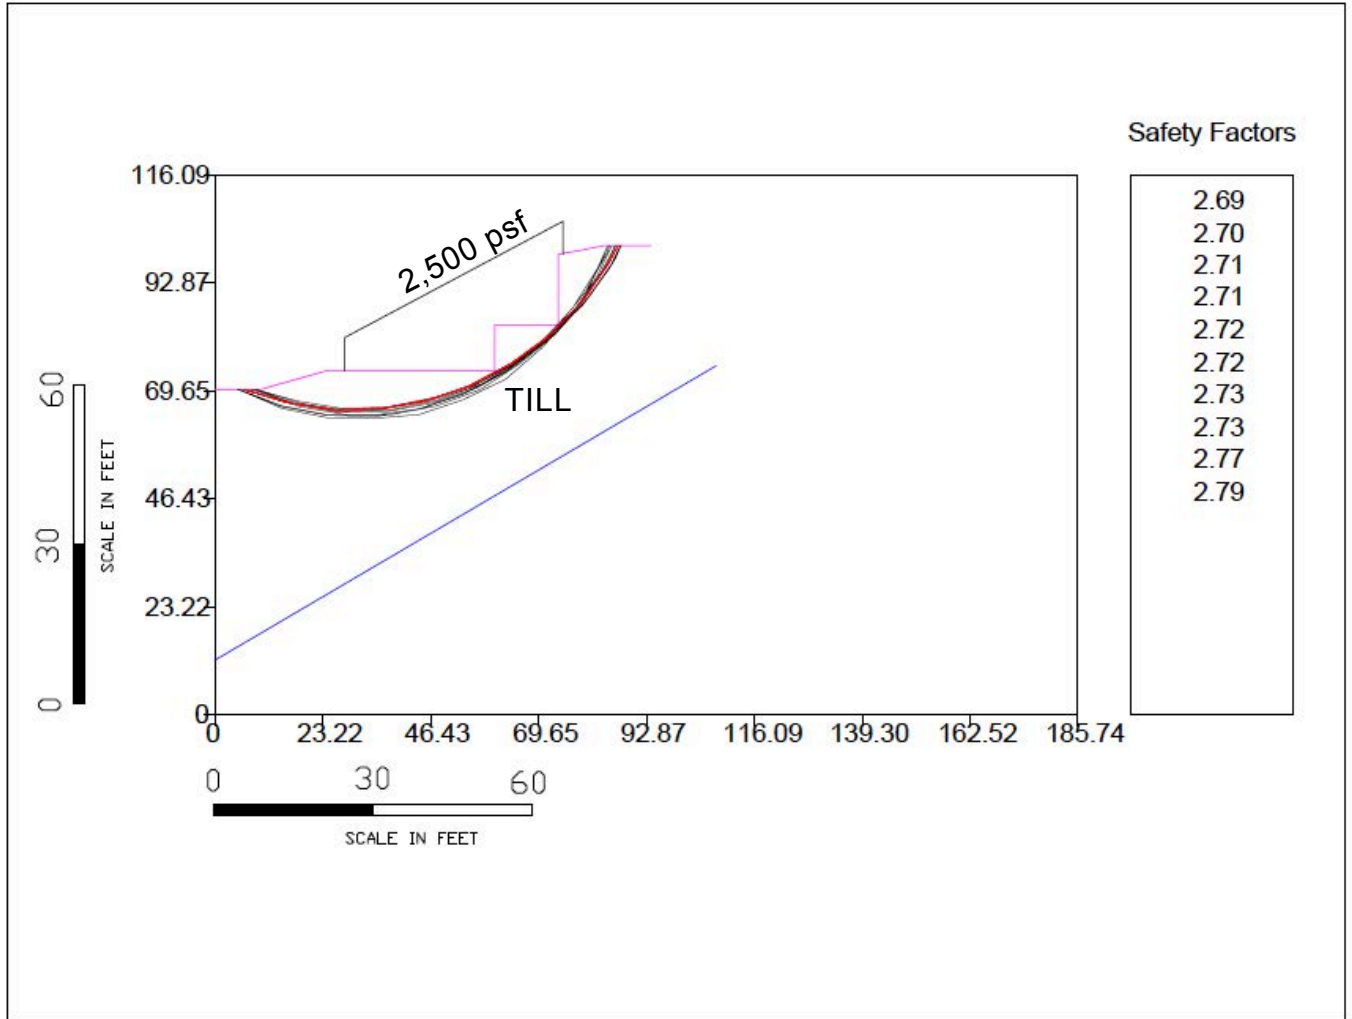
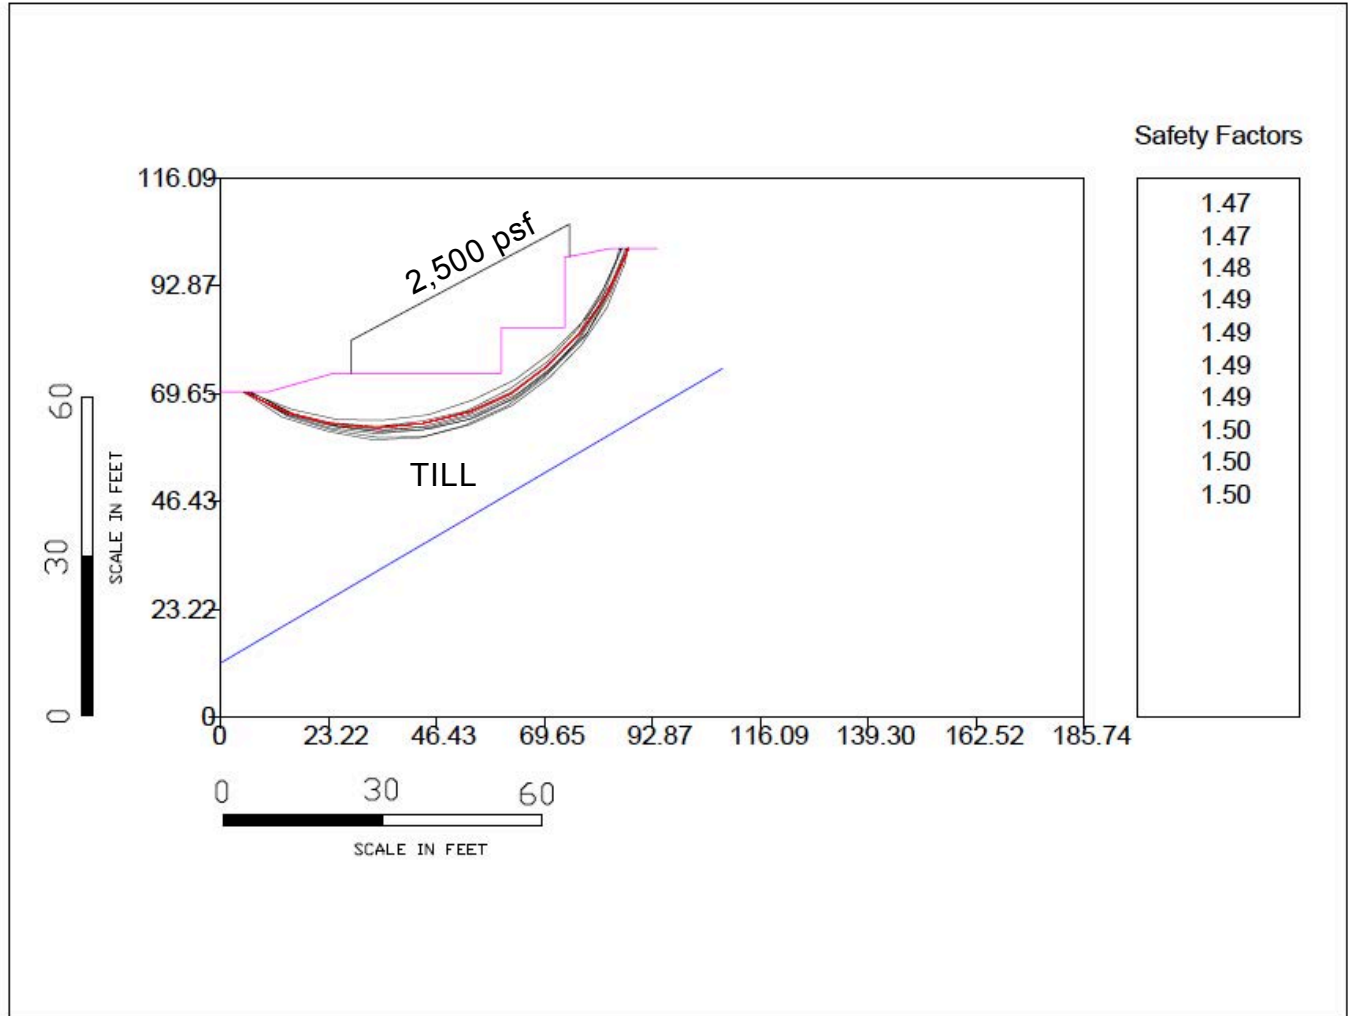
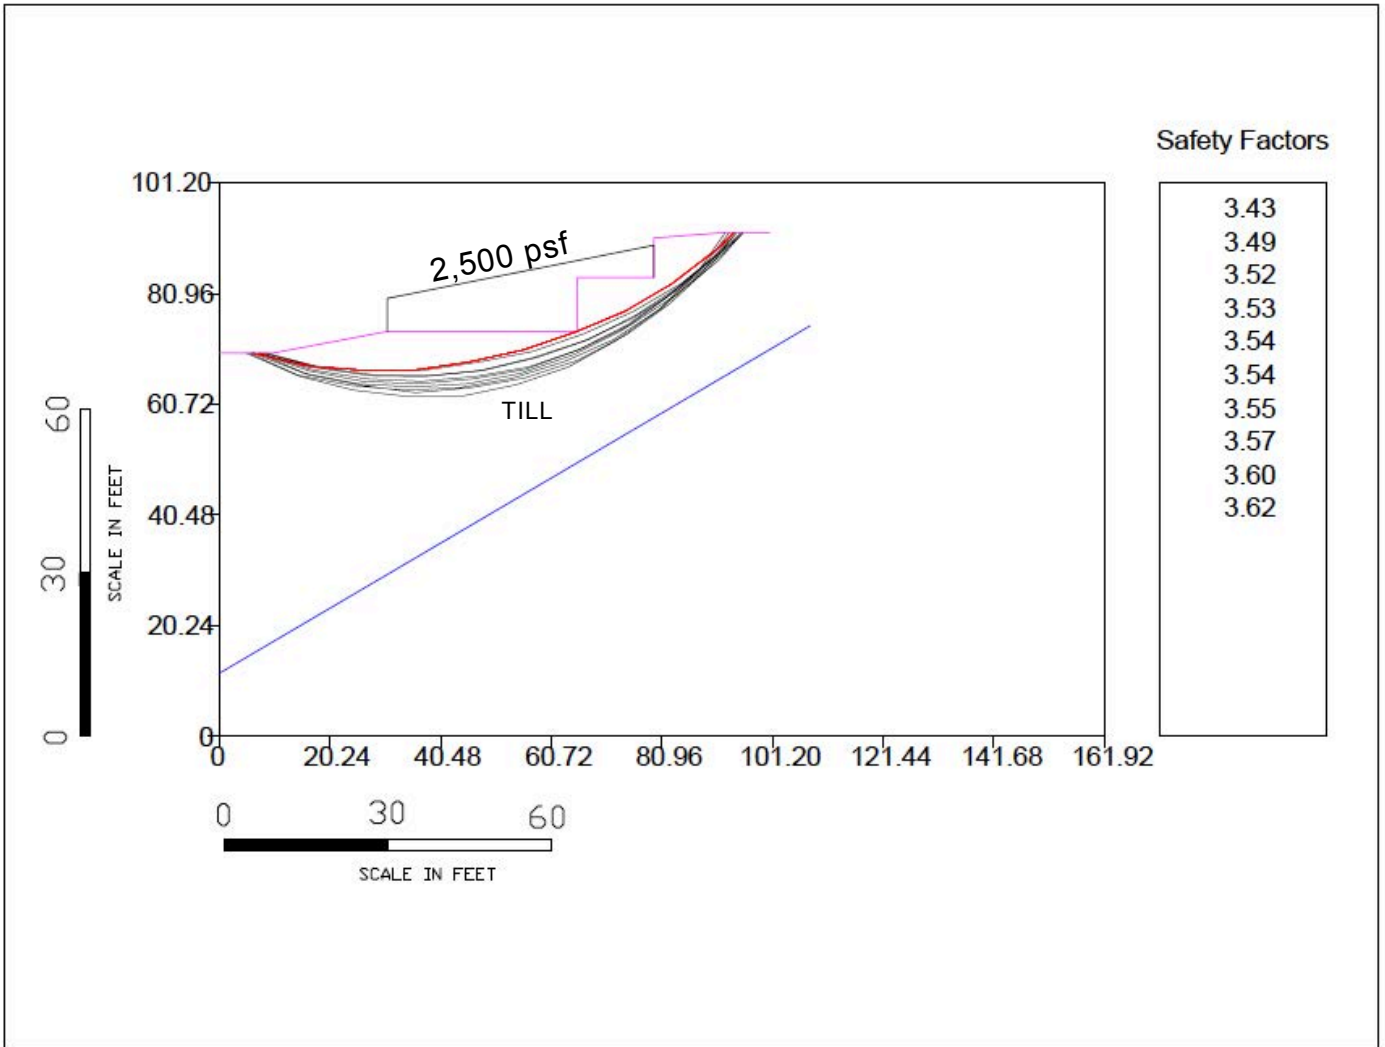
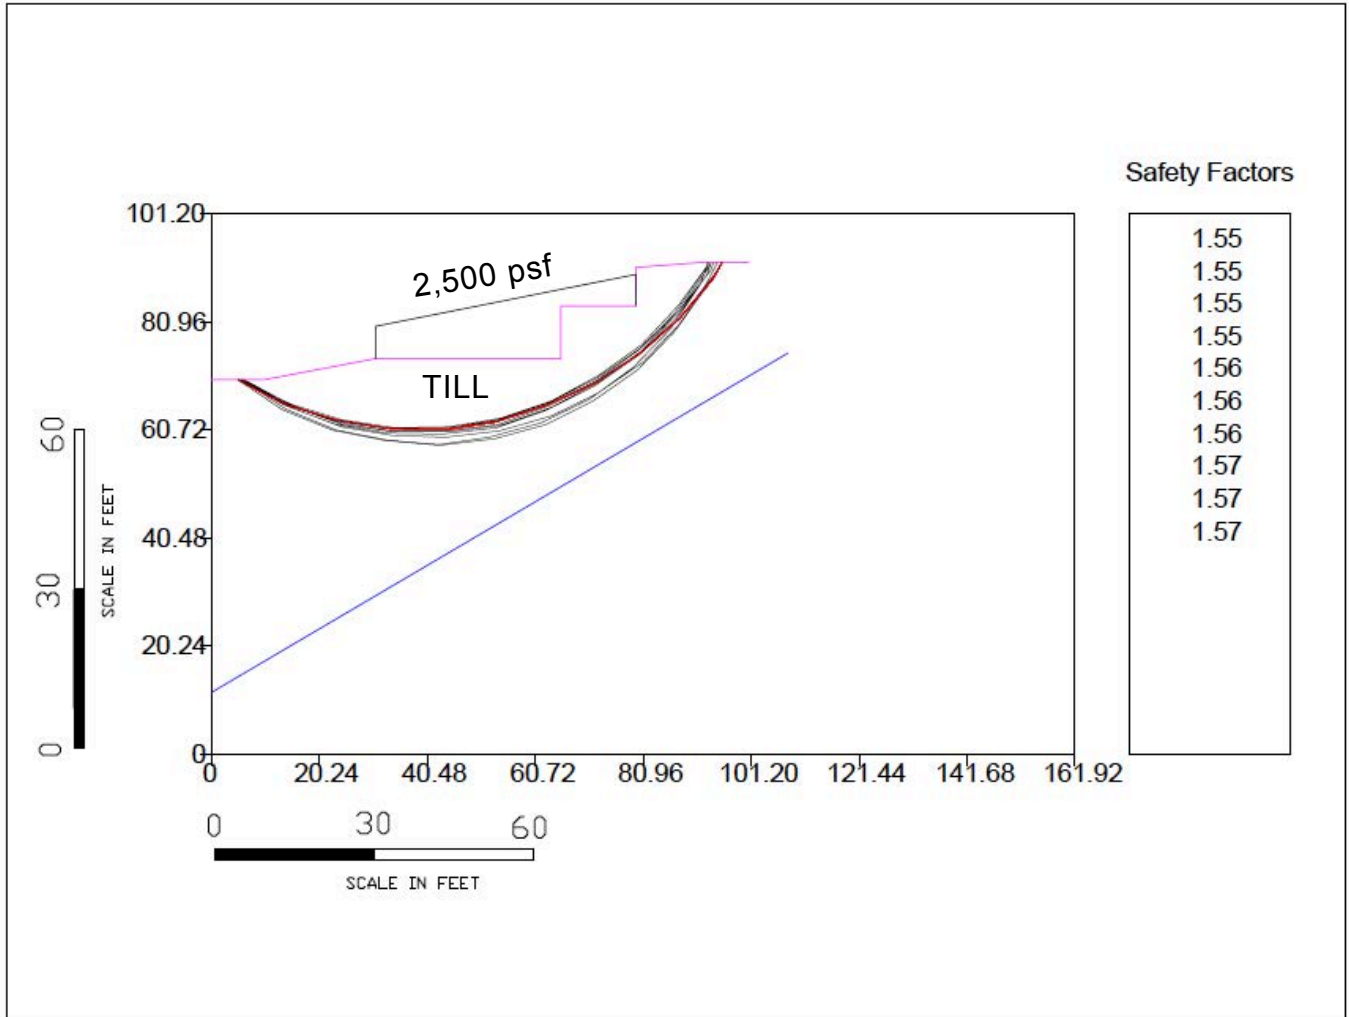
Results of analysis incorporating the full-scale slope condition are shown in Figure 7 through Figure 10. For curves originating past the base of the slope and extending to the top of slope, Factor of Safety values are well above target values. Recorded static values are FS = 2.69; seismic values are FS =1.47. The high FS values despite the slope size are attributed to the presence of the resistance upper soil unit of hardpan glacial deposits.

Analysis showed that cross-sections B-B' and C-C', Figure 8 and Figure 10, do meet the minimum FS of 1.125 for seismic conditions for a horizontal earthquake coefficient of 0.73g.

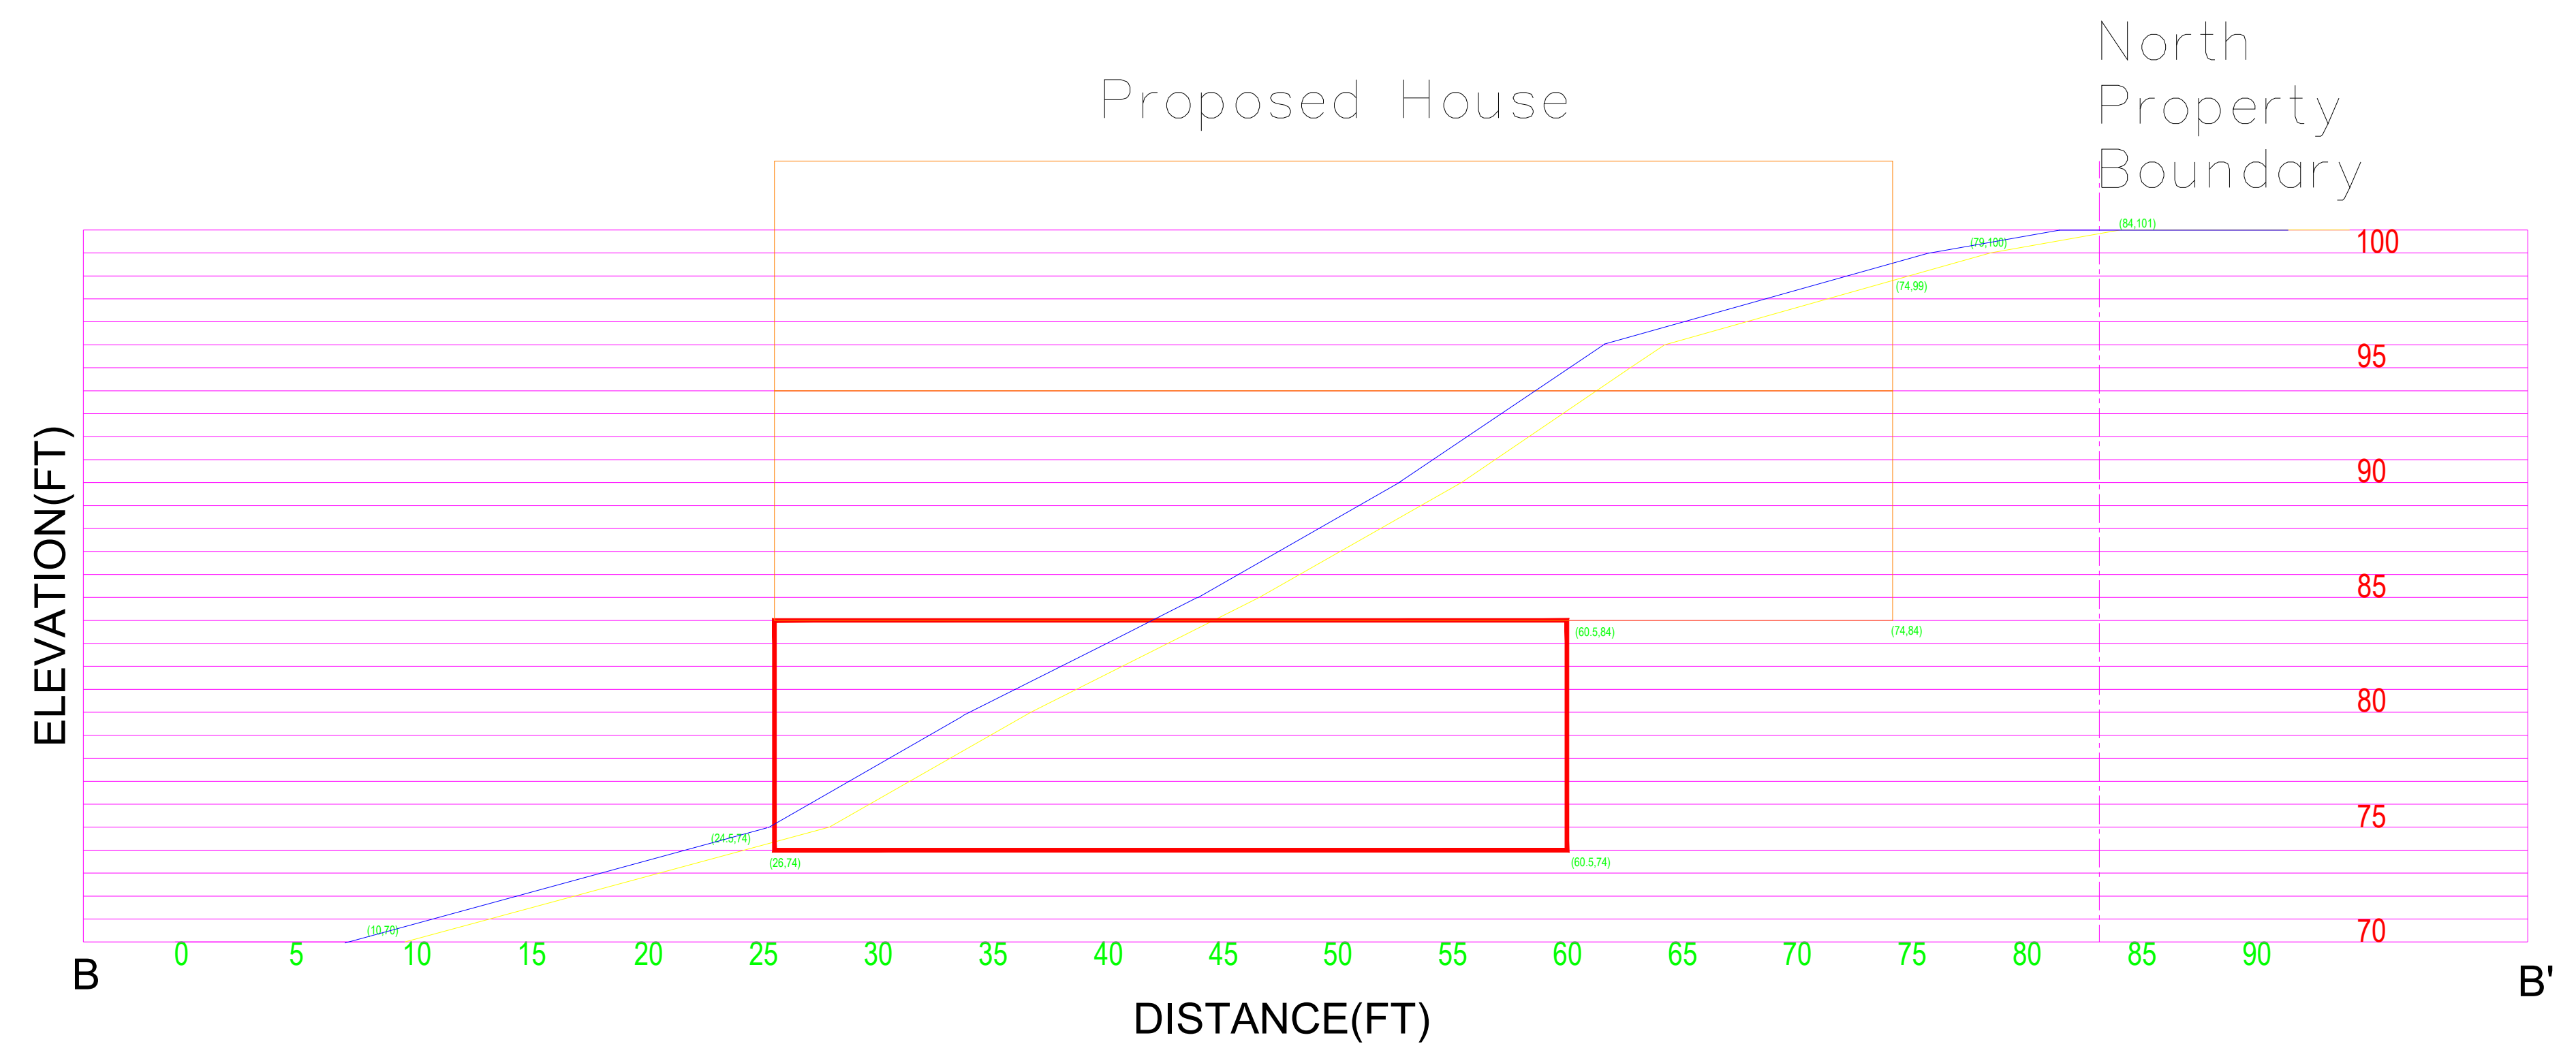
SOUTHWEST FACING SLOPE CROSS SECTION B-B'

The steep slope to the north generally faces southeast and southwest. For southwest facing steep slope, the upper portion has a steep slope approximately 1.4H:1V (~70%) with local elevation loss ~14ft, roughly 35° following up with approximately 2H:1V (~51%) steep slope with local elevation loss ~9ft, roughly 27°. The lower portion has a gentle slope approximately 5.1H:1V (~20%) to the 96th Ave SE at east.

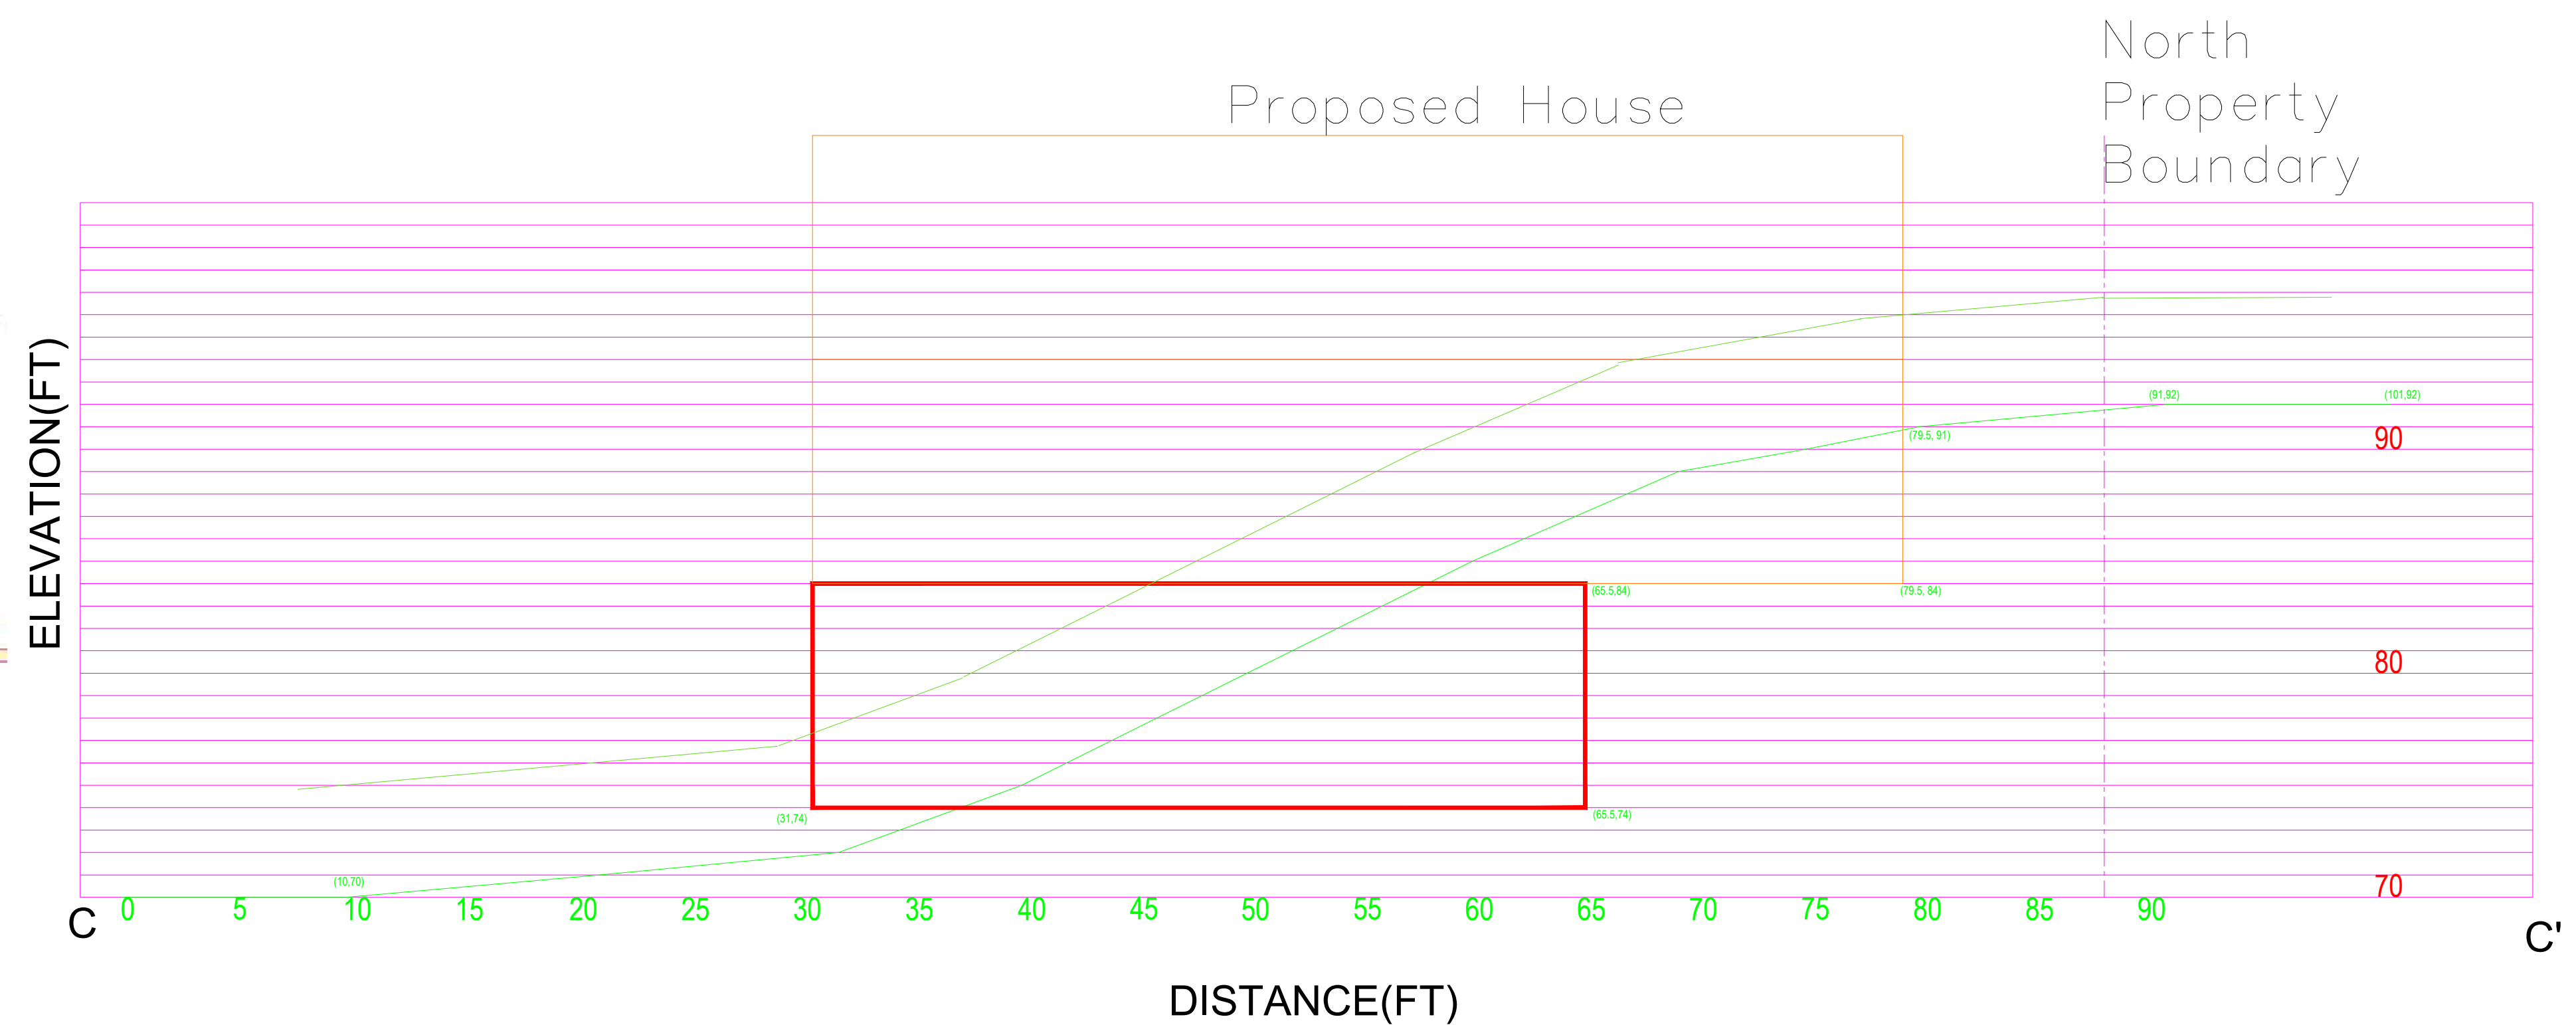
SOUTHEAST FACING SLOPE CROSS SECTION C-C'

For southeast facing steep slope, the upper portion has a mild slope approximately 5.5H:1V (18%) with local elevation loss ~12ft, roughly 10° following up with approximately 1.7H:1V (~59%) steep slope with local elevation loss ~18ft, roughly 31°. Both slopes ultimately reach to the Lake of Washington.
