Tree Inventory Report

Bauman Residence

Facet Number: 2402.0436.01

September 2024

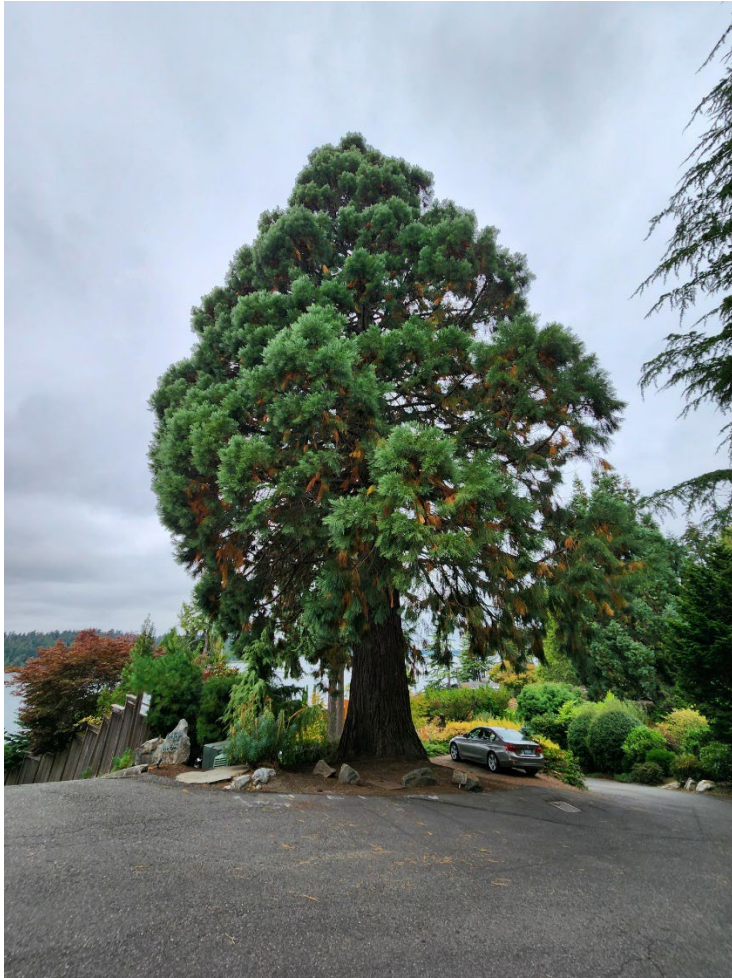
Exceptional Trees. Three on-site trees meet the criteria for an Exceptional Tree (Tree #100, a 72.9-inch giant sequoia, Tree #101, a 33.5-inch deodar cedar, and Tree #112, a 42-inch western red cedar).

Photo 1. Tree #100, facing northwest.

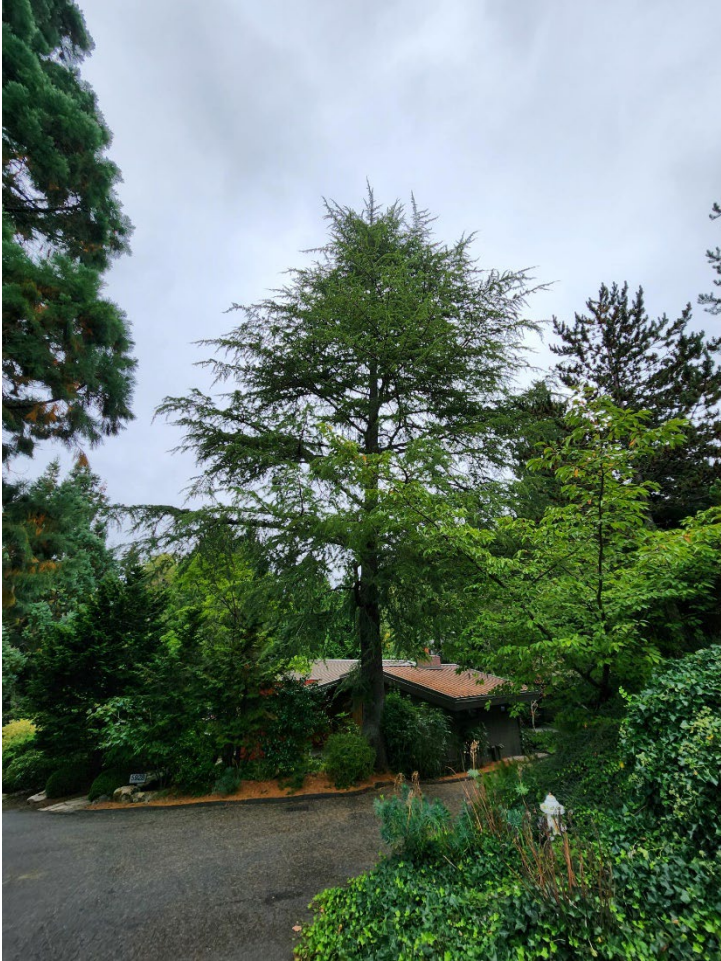
The project proposes to demolish the existing residence and construct a new residence with a larger footprint, as shown in the enclosed site plan. One regulated tree, Tree #101, is proposed for removal. Tree #101 is a large deodar cedar with a 33.5-inch DBH that is located adjacent to the existing residence and driveway. According to the Project Team, this tree will need to be limbed approximately 25 feet up the north side of the trunk in order to construct the proposed residence. The removal of that many limbs combined with the proposed impacts to the CRZ, (discussed below),

may impact the tree such that its long-term viability may be compromised. Given that the tree is considered exceptional, the project design should accommodate its retention.

Photo 2. Tree #101, facing north.

Tree #101: Should the tree be retained, demolition of the existing residence and excavation for the foundation of the new residence would encroach a portion of the outer critical root zone (CRZ). We recommend exploratory root investigations to guide project design, protection measures during construction, and future maintenance and monitoring needs:

- Exploratory excavation via air spading or hydro spading should be performed by a qualified professional to confirm the presence or absence of structural roots in the location of the proposed foundation prior to excavation activities.
- If structural roots are encountered, the Project Arborist will consult with the project team on whether the proposed excavations will impact the long-term viability of the tree and if alternative designs should be pursued.
- Before construction, tree protection fencing should be installed at the TPZ boundary determined from the exploratory root excavations and approximately four inches of mulch or arborist chips should be placed on the remaining CRZ located outside the fence.

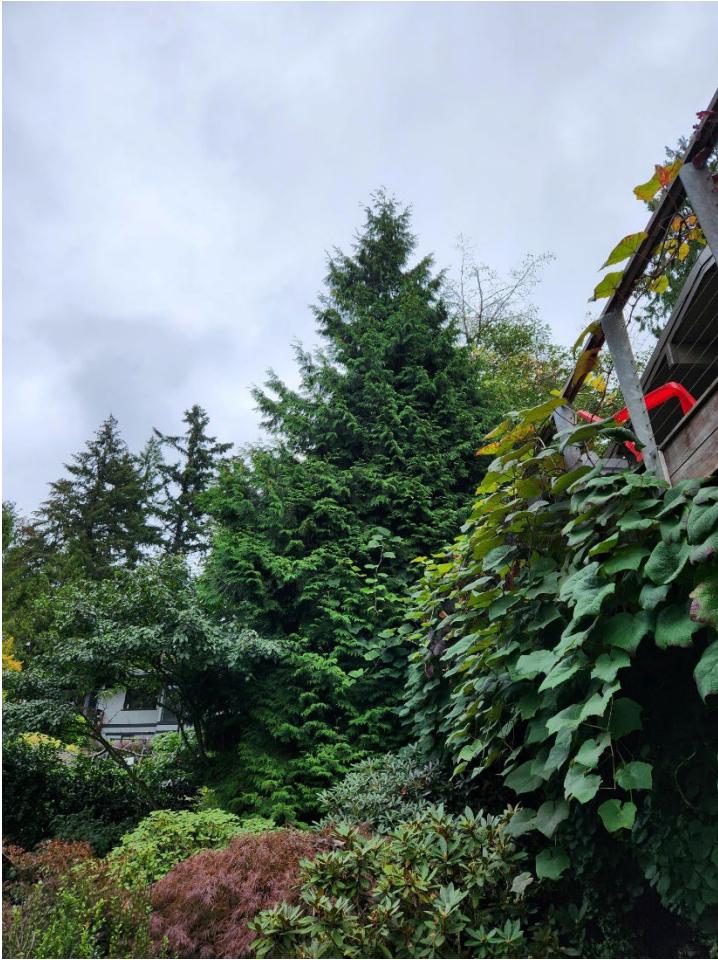
Tree #109: Structural roots associated with Tree #109 were observed near the concrete walkway adjacent to the northeast corner of the existing residence. These roots may extend beneath the walkway. As such, the following practices should be observed:

Photo 3. Tree #109, facing east.

- Removal of the walkway should be done by hand and no heavy machinery should be used.
- Tree protection fencing shall be installed at a distance of 8 feet from the face of the trunk to the north, south, and west.
- The Project Arborist should be on-site to supervise and consult should roots extend beneath the walkway toward the foundation of the existing residence.

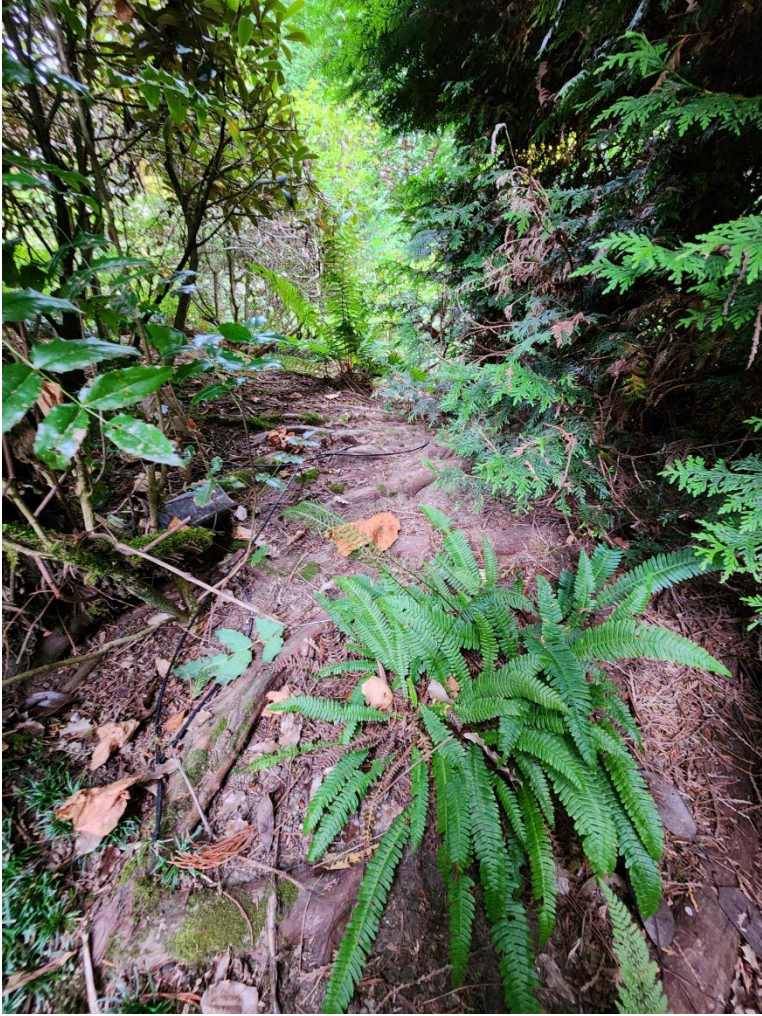
Photo 4. Roots of Tree #109.

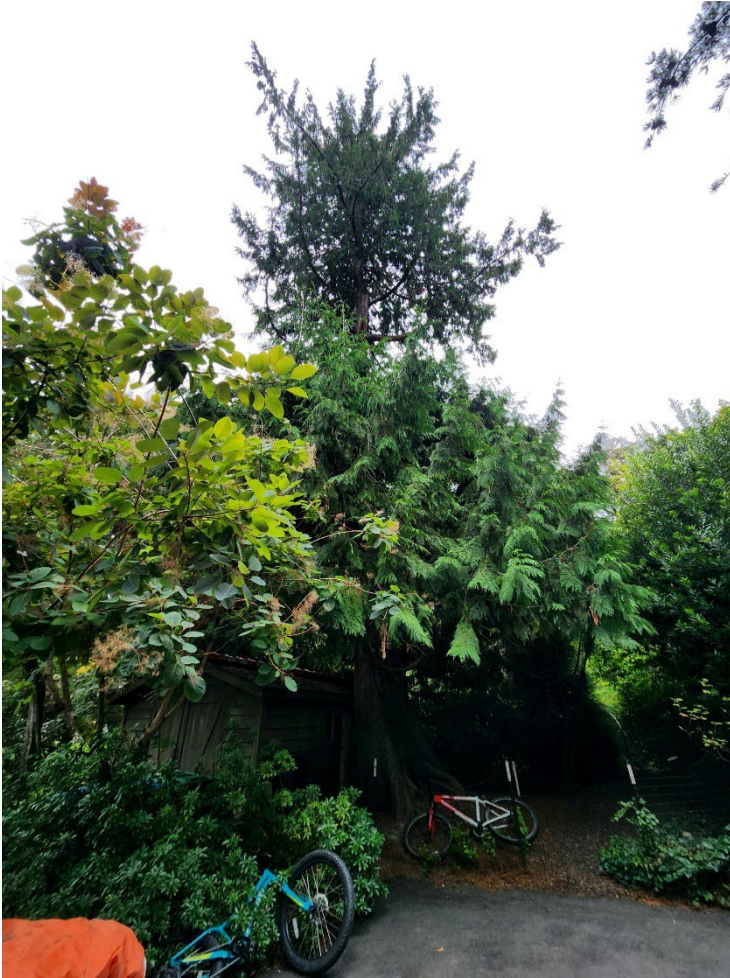
Condition. Of the six regulated on-site trees, all but one were found to be in Good condition with normal vigor, well-developed structure, and no significant damage, defects, or disease. One tree, Tree

#112, was in Fair condition, showing signs of reduced vigor, twig dieback, defoliation, or significant damage or defects.

Tree #112: The existing shed located immediately next to Tree #112, an exceptional size western red cedar, is planned to be demolished. Given the proximity of the shed to Tree #112 and the current condition of the tree, protection measures should include the following:

Photo 5. Tree #112, facing east, with existing shed below.

- Prior to construction activities, the remaining CRZ should be protected with tree protection fencing and an application of approximately four inches of mulch or arborist chips.
- A trunk wrap using untreated 2"x4" wood slats should be erected around the trunk of the tree before demolition activities.
- Once the shed is demolished, tree protection fencing shall be installed at a distance of 11 feet from the northwest face of the trunk and 16.5 feet from the west face of the trunk for the remainder of construction.
- The Project Arborist should be on-site for foundation excavations proposed in the outer critical root zone. If structural roots are encountered, the Project Arborist will consult with the

project team on whether the proposed excavations will impact the long-term viability of the tree and if alternative designs should be pursued.
