September 12, 2025

2262 78th Ave SE Critical Area Study Peer Review

Facet Project No: 2410.0634.04

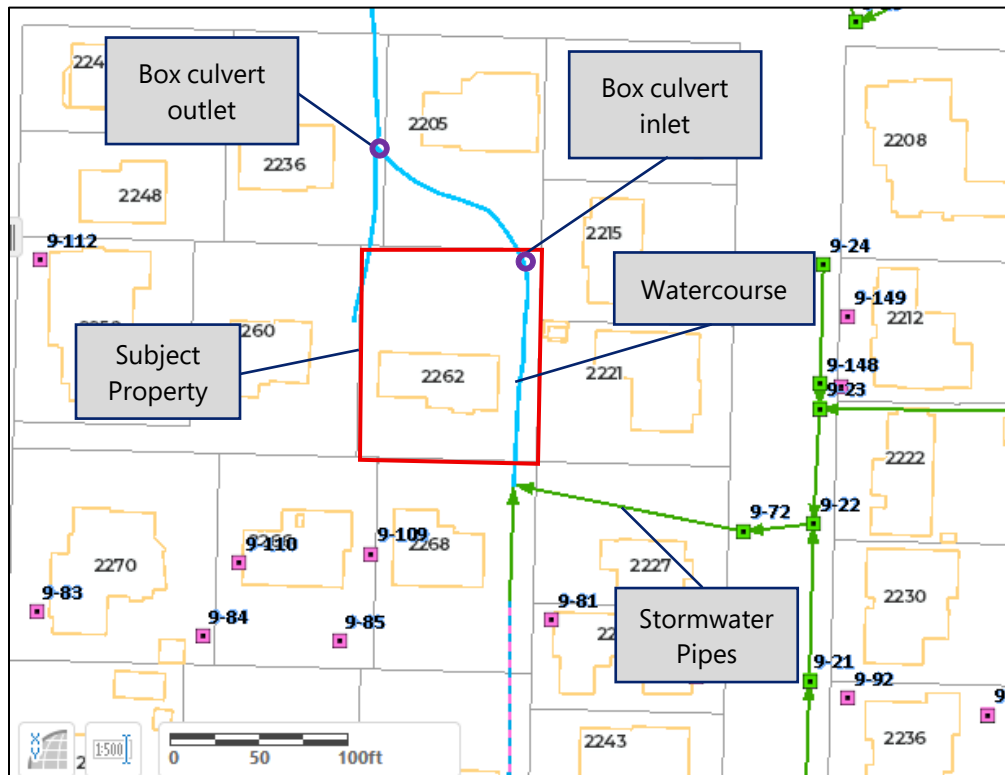
City GIS-based mapping inventories are somewhat ambiguous as to whether the on-site ditch is a watercourse or a stormwater conveyance feature. The available mapping shows the transition from a piped storm main to an open watercourse near the subject parcel's southern property boundary (Figure 1). However, based on field observations, there is no discernable distinction between the characteristics of the feature at this location (Figure 3). The ditched feature is situated on a relatively flat terrace flowing north before entering a vertical concrete box culvert at the northern property boundary (Figure 4). The culvert's mapped discharge location is near the top of a natural ravine, the point at which the CAS identified the start of the regulated watercourse.

Figure 1. Mapped stormwater conveyance and open watercourse (source: Mercer Island GIS Portal)

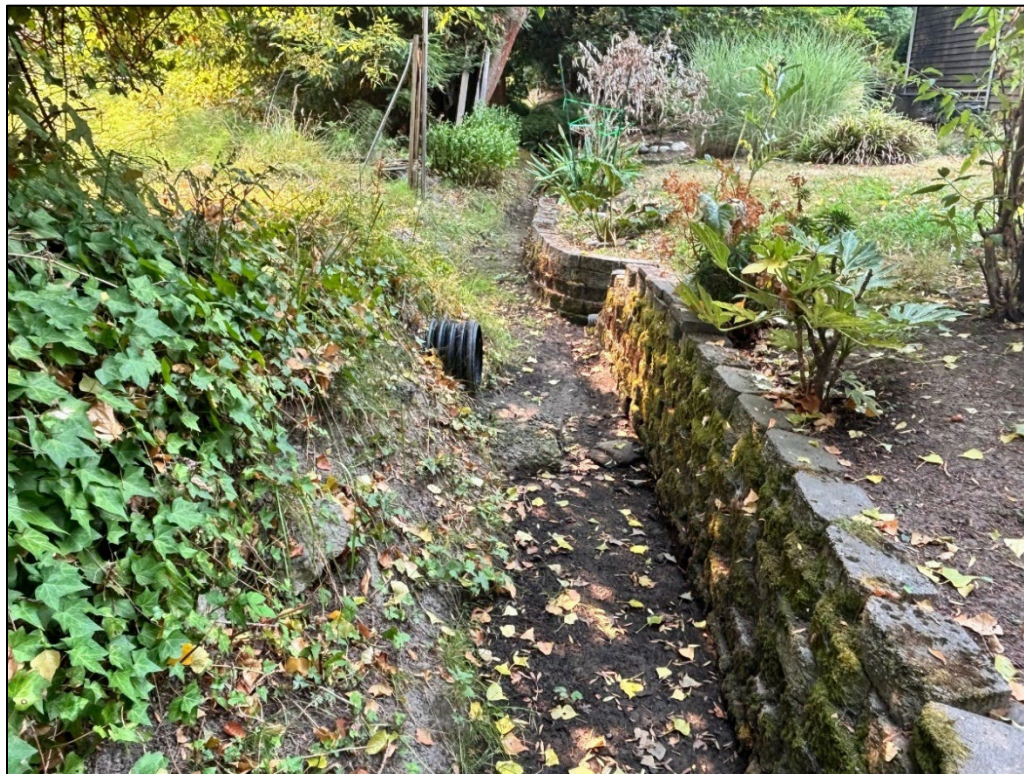
Figure 2. Location of the mapped transition point from stormwater ditch to open watercourse, viewed from southeast corner of subject property, facing south.

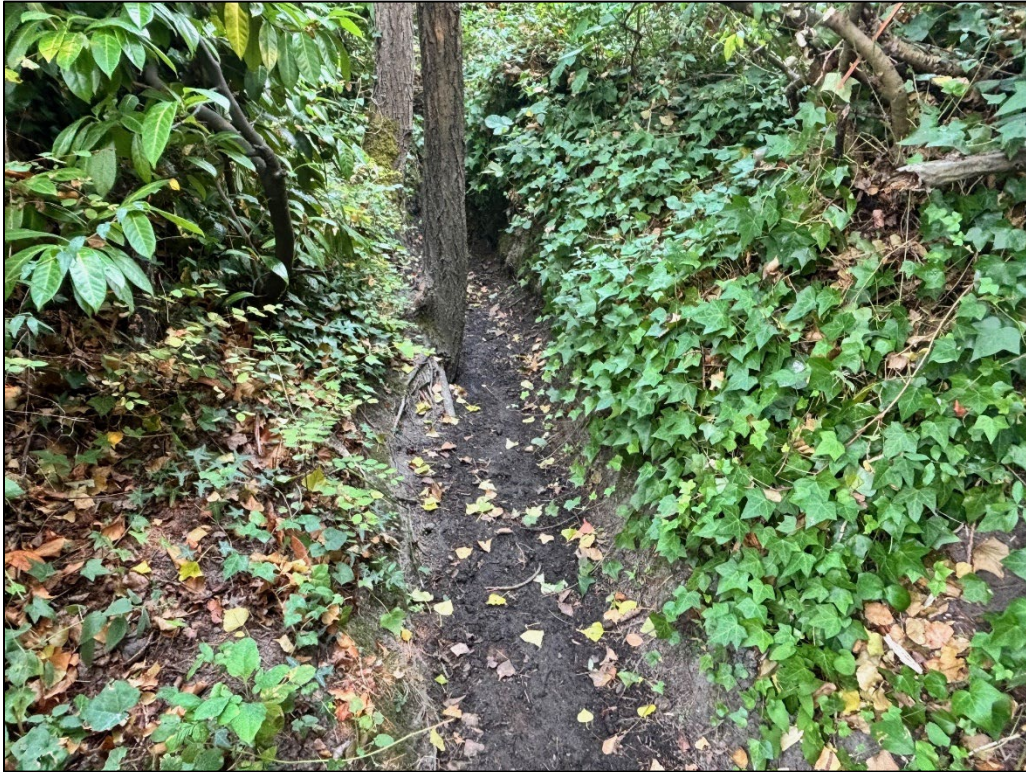
Figure 3. Open channel watercourse/ditch on subject property, facing north

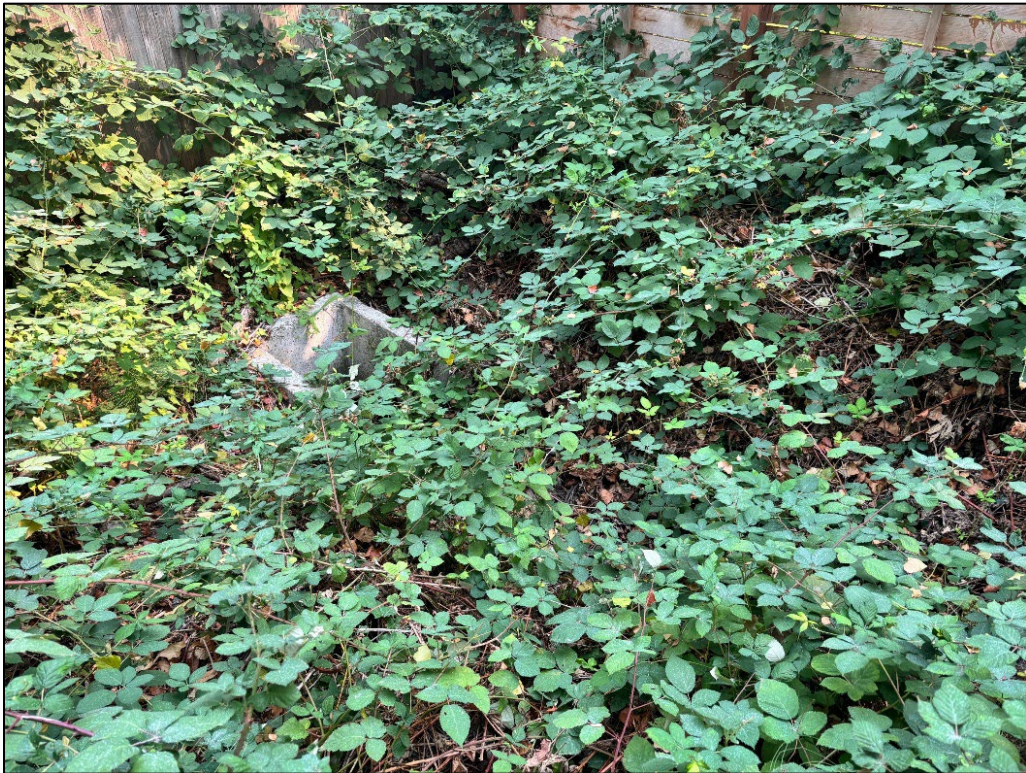
Figure 4. Vertical box culvert at end of open ditch in northeast corner of subject property

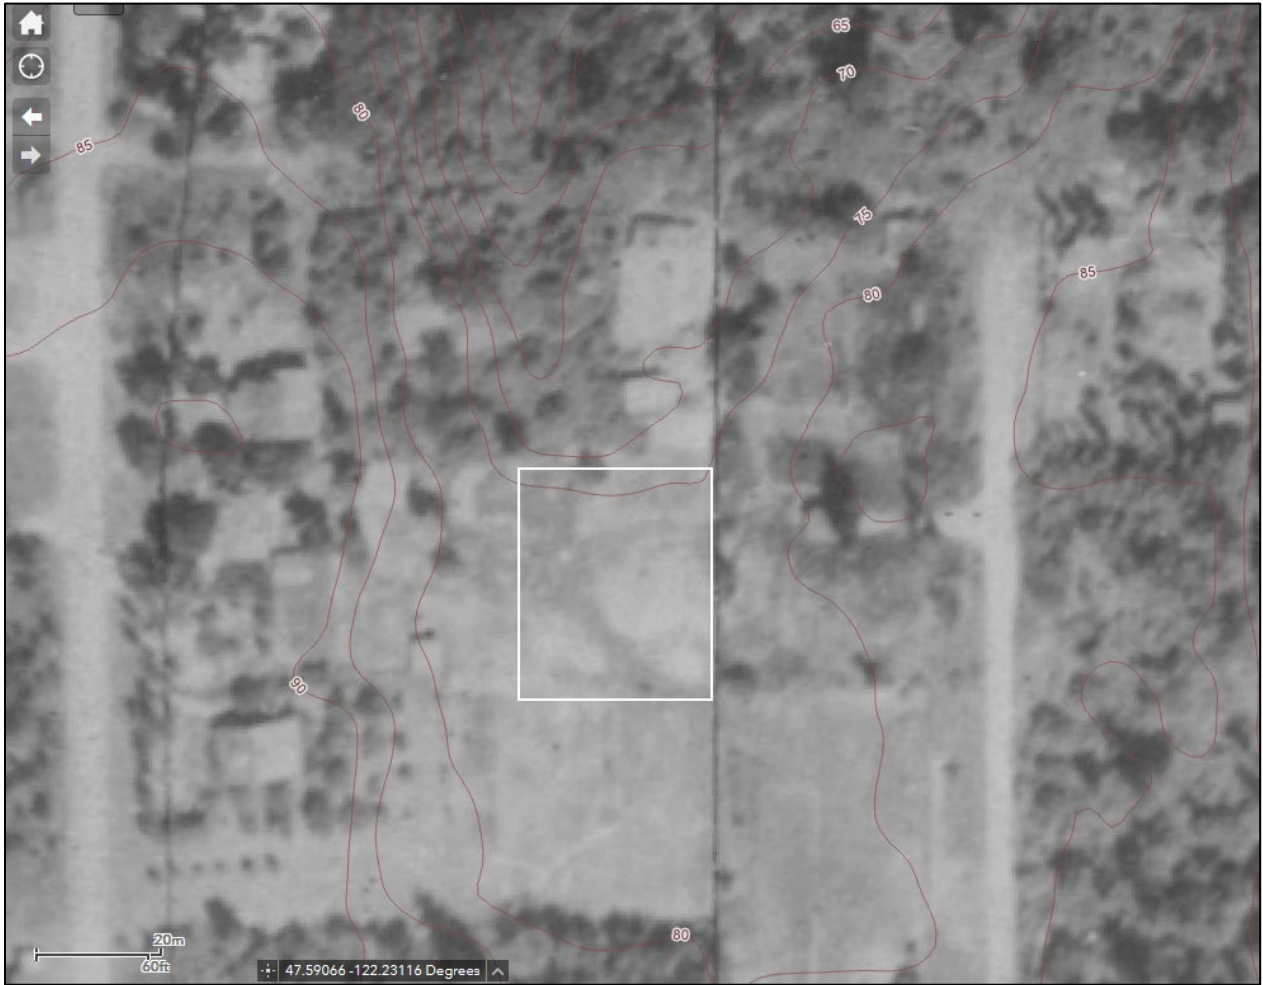
To determine if the on-site portions of the open channel are part of a modified, natural stream channel or an entirely artificial stormwater conveyance system, I reviewed historic aerial imagery, all available public inventories, and LIDAR-based topographic imagery and mapping. A review of historic aerial photographs, particularly from 1936 (when vegetative cover was absent), suggests that there was no stream channel present in this location at that time (Figure 5). Mercer Island GIS mapping (Figure 1), visual observations (Figures 2 and 3), and LIDAR-based topographic images (Figure 6) suggest that the on-site channel is an excavated feature (steep, vertical sides and linear orientation). The landscape position of the subject property, situated atop a relatively flat terrace unassociated with known wetlands or seeps, is not a typical landscape position in which the headwaters of a small stream would be located. Rather, the steep ravine just north of the subject property is more indicative of a topographic feature that would channelize surface flows or groundwater seeps into a defined stream channel. A pronounced change in gradient and channel incision is visible beginning at the location where the concrete box culvert discharges into the ravine (Figure 5). Bed, bank, sorted sediments, and erosion indicators are not present in the short section of the ravine above the discharge. Such characteristics were observed through binoculars beginning at the discharge point. Therefore, based on the preponderance of available data, it is my conclusion that the on-site channel segment is an artificially created stormwater conveyance feature and not a historic watercourse channel that is regulated as a critical area under MICC 19.07.

Figure 5. 1936 aerial photograph. Note absence of an open channel on the subject property (source: King County iMap)

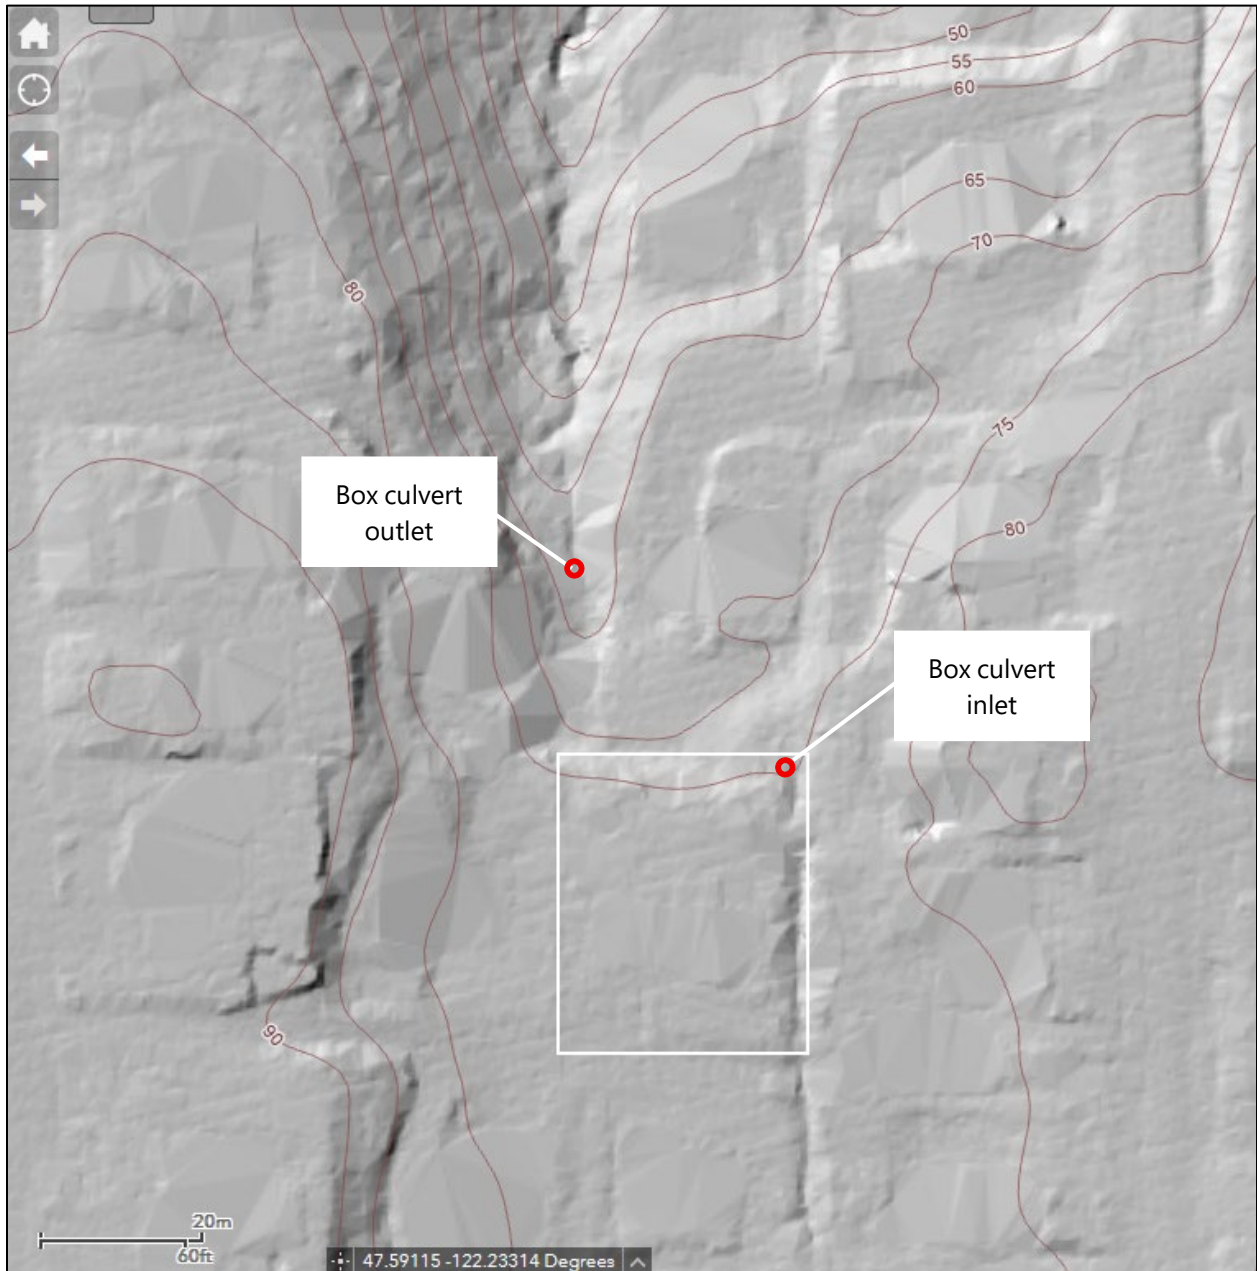
Figure 6. LIDAR-based topographic image, subject property in white (source: King County iMap)
