Arborist Report(DRAFT)

Client: Andrea Becker, Gerald Yuen
Address: 4624 East Mercer Way, Mercer Island, WA 98040
Date Prepared: 1/21/2026
Documenting Arborist: Alec Johnston
ISA Certified TRAQ Arborist IN-3591AU

Introduction

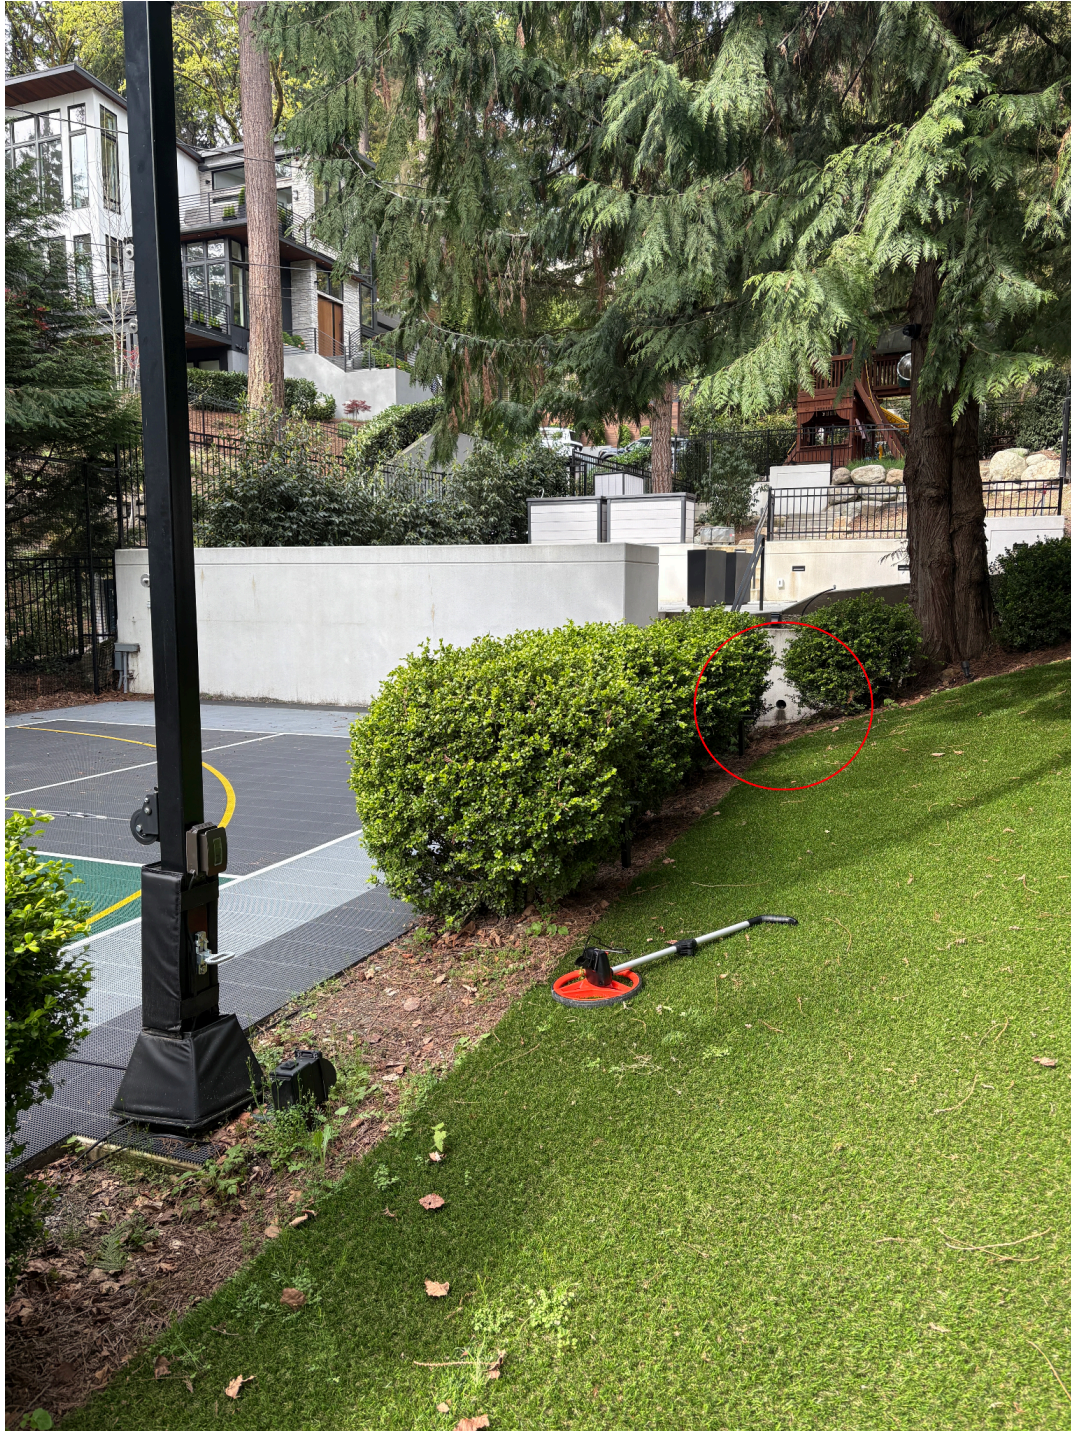
A 4-inch PVC drainage pipe is proposed for installation on the south side of Tree #40, as shown in the Tree Plan. The pipe will connect to an existing drain line located within the retaining wall at the northeast corner of the adjacent sport court.

Photo 1: Existing Drainage Pipe Connection Near Tree #40

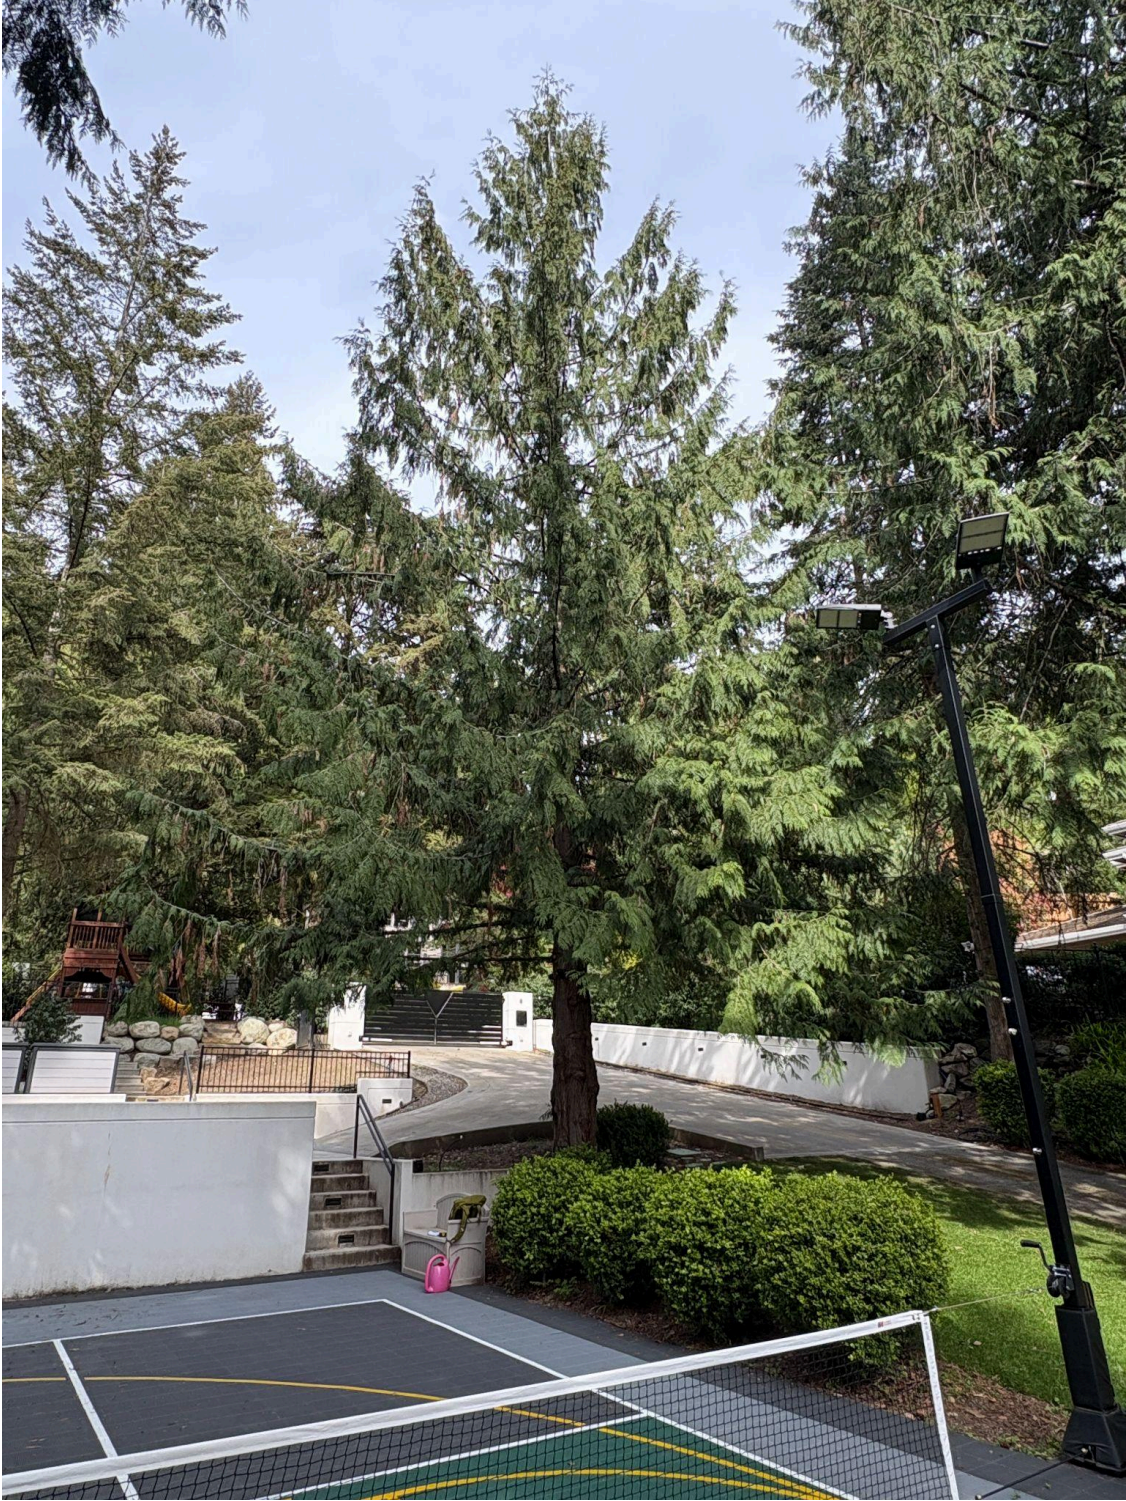
The proposed pipe will be installed approximately 4 feet south of the trunk of Tree #40. Excavation within this area will be performed using hand digging or air spading to minimize root disturbance and to identify any significant structural roots.

Given the shallow installation depth (4 to 6 inches), impacts to the root system are expected to be minimal. Upon exposure of roots, minor adjustments to the pipe alignment or depth may be made to avoid cutting or damaging major roots.

Photo 2: Tree #40 Viewed Facing Northwest

Tree protection fencing will be installed at the dripline, extending to a radial distance of approximately 16 feet from the trunk.

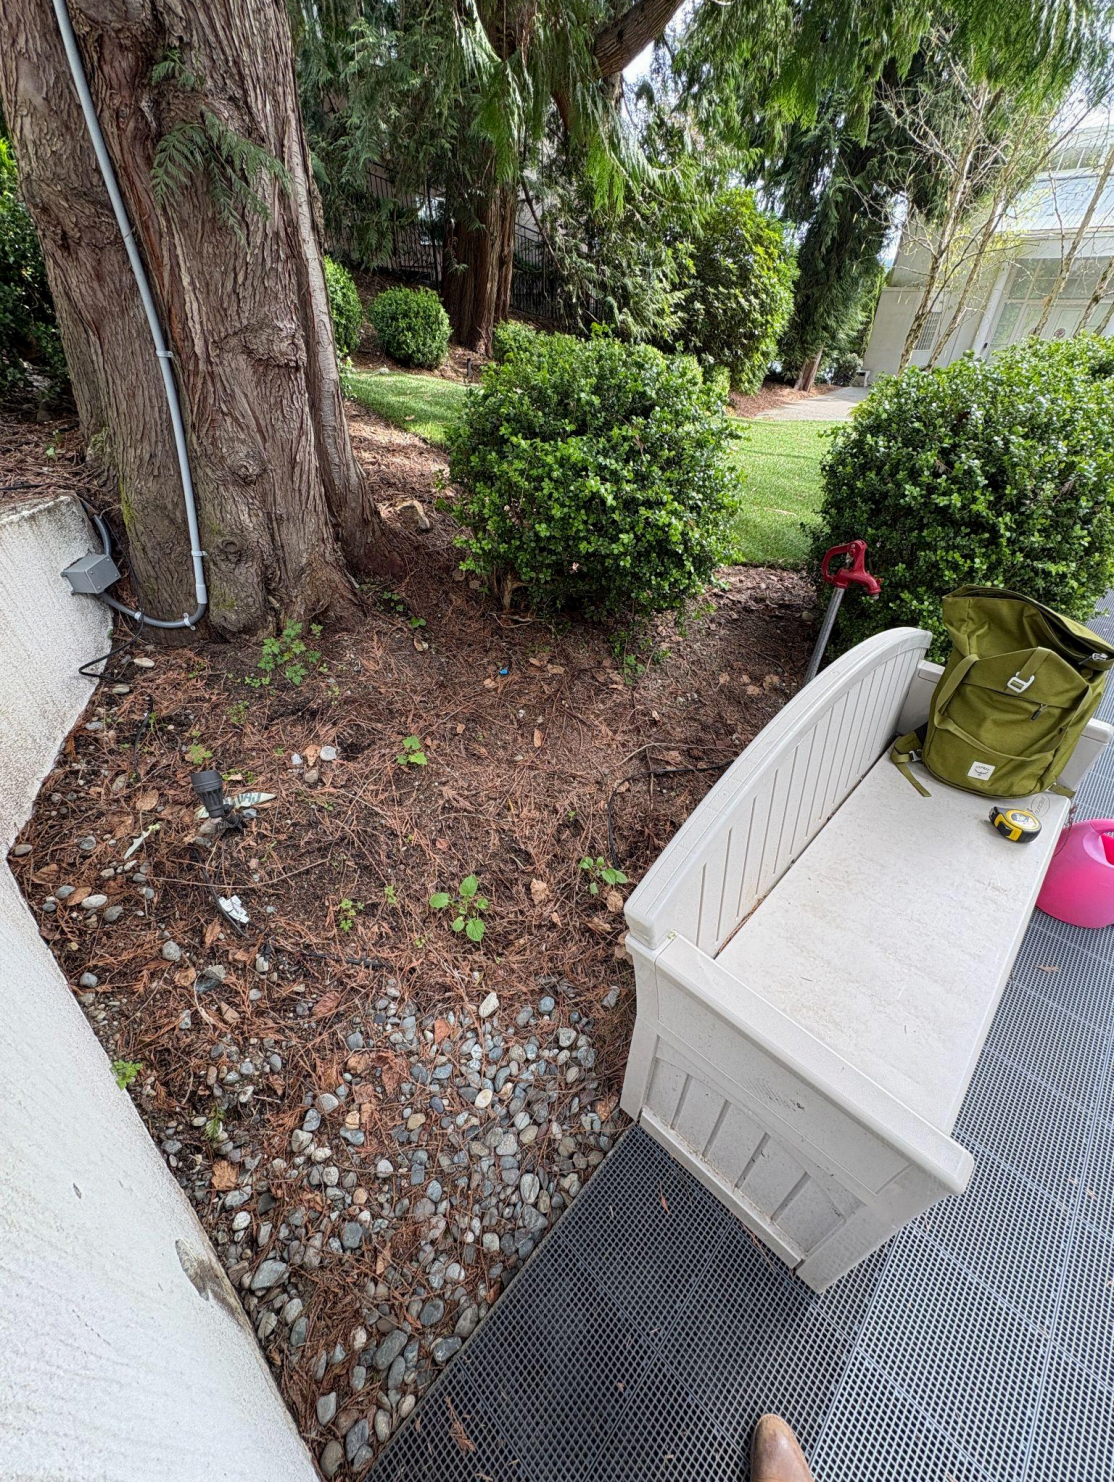
Photo 3: South Side of Tree #40, Location of Pipe Installation Beginning Point

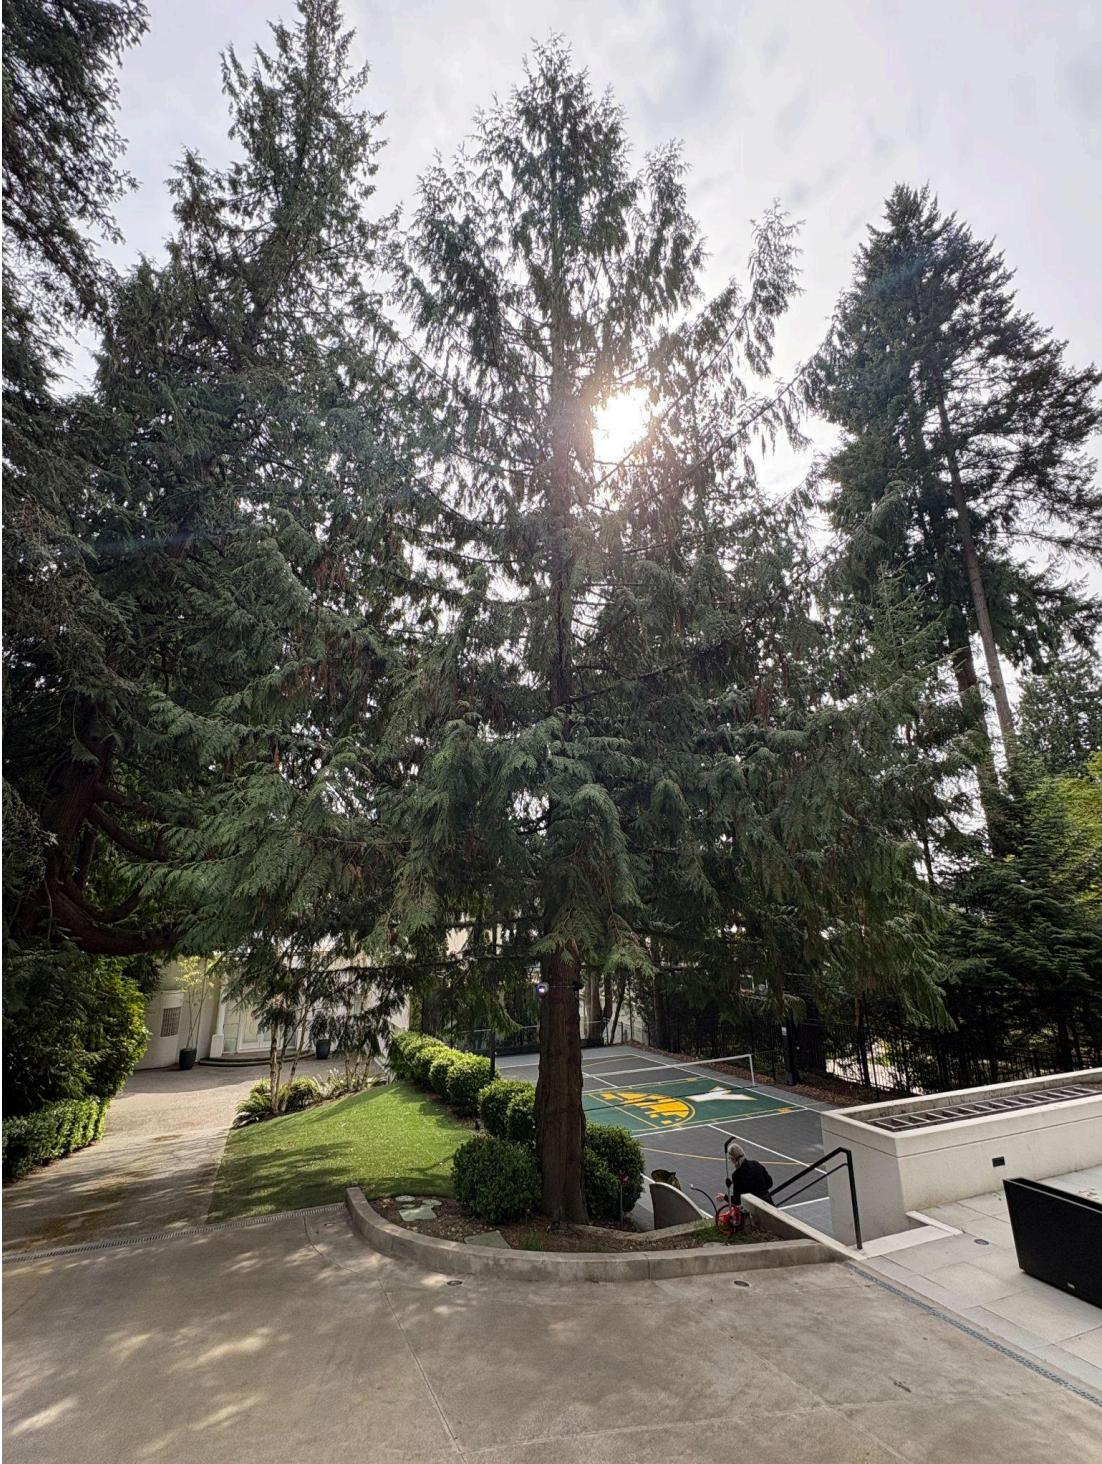
Photo 4: Tree #40 Viewed Facing Southeast

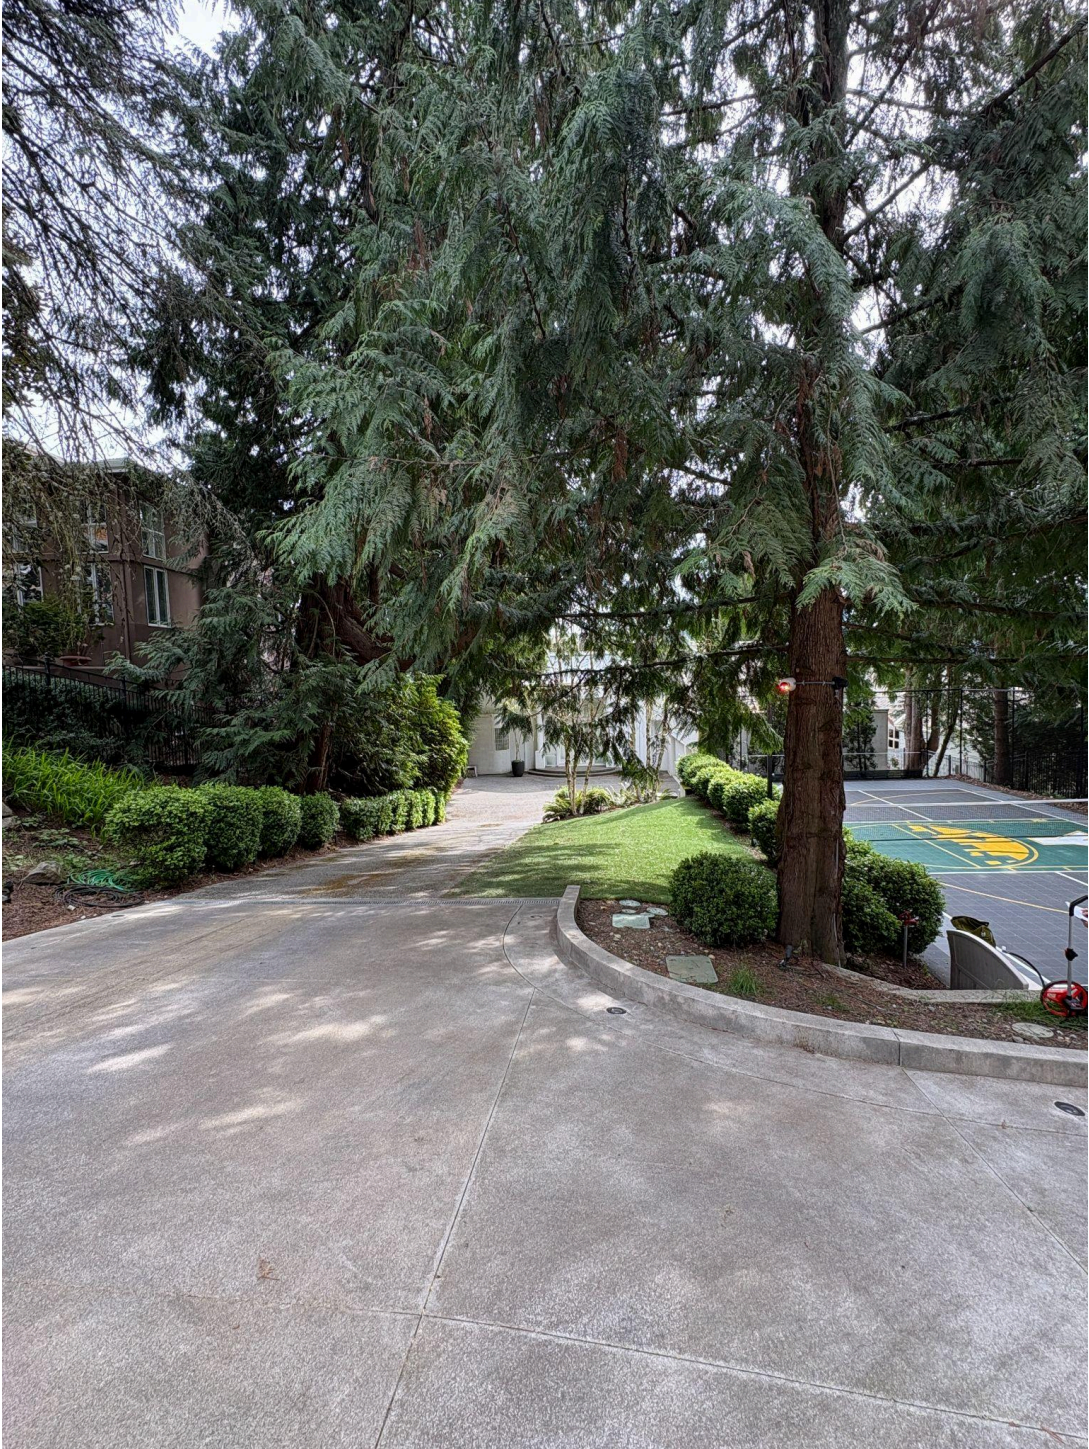
The lawn area east of Tree #40 is currently covered with artificial turf over a gravel base. The existing gravel layer beneath the turf, approximately 4 inches deep, will be removed and replaced with topsoil of similar depth.

Within the lawn area, removal of the existing gravel base and replacement with topsoil is not anticipated to adversely affect the root system. The new soil will be installed following best management practices, avoiding excessive compaction to maintain adequate soil aeration and water infiltration.

Photo 5: Yard Space East of Tree #40

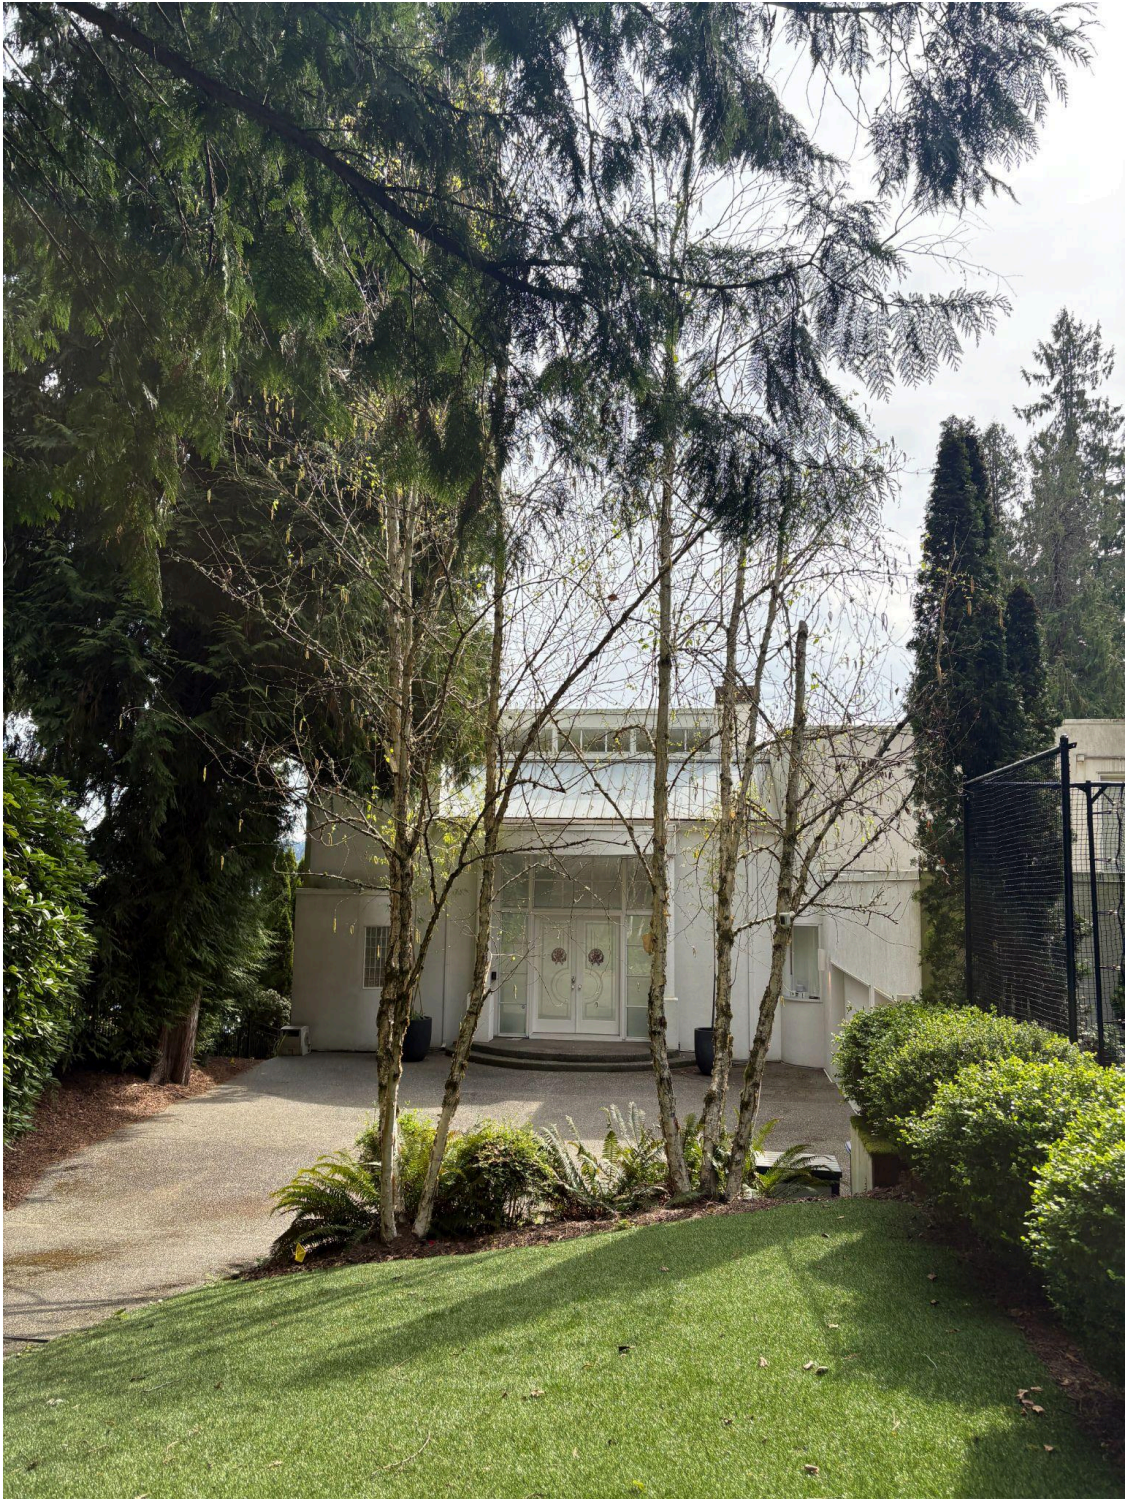
Both trees are located along the eastern boundary of the lawn area. Trenching in the vicinity of Trees #41 and #42 will also be conducted using hand digging or air spading, consistent with the mitigation approach for Tree #40 to minimize impact. The proposed pipe installation is expected to minimally impact the root system specifically of Tree #42.

Photo 6: Tree #41(Left) and Tree #42(Right) Shown at Eastern Edge of Lawn Space

Tree protection fencing will be installed at each tree's dripline, with an approximate radial distance of 8 feet from each trunk.

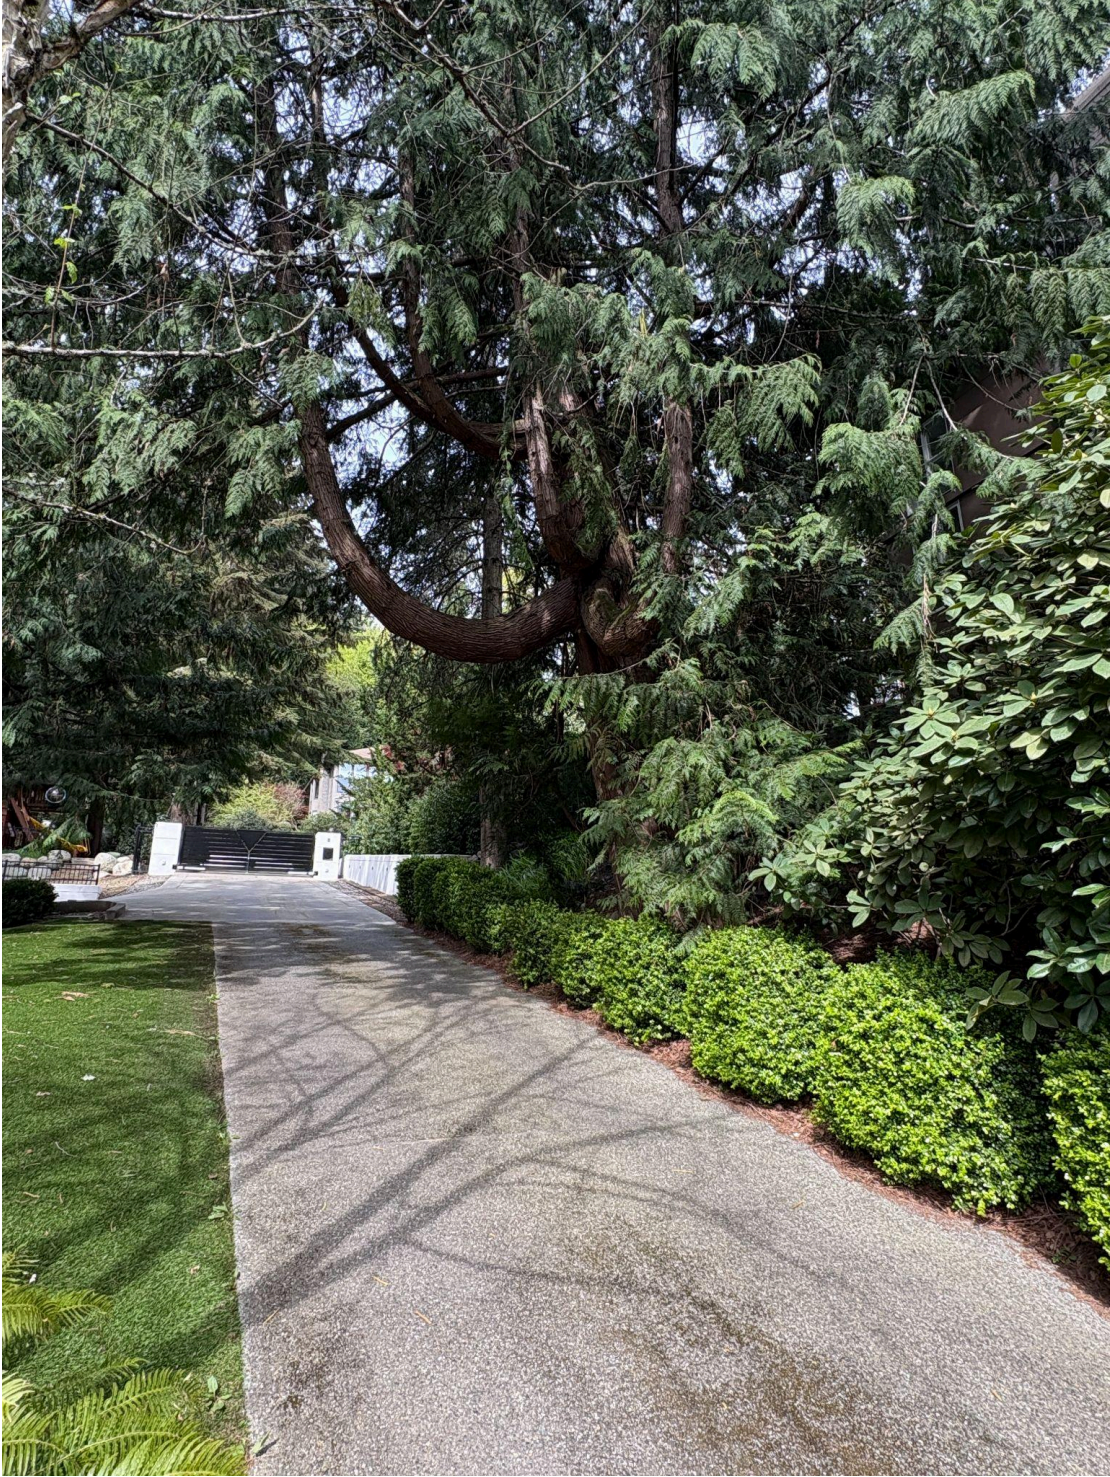
Trees #38 and #39 are not expected to be impacted by the proposed construction activities. They likely share the root space with Tree #40 within the lawn area. The root systems of Tree #38 and Tree #39 should not be impacted by the gravel replacement previously described should the best management practices be followed.

Photo 7: Tree #38 and Tree #39 Viewed Facing Northwest
