Subbasin 46.3 Watercourse Stabilization

Design Report

Northwest Hydraulic Consultants Inc.

August 27, 2025
Draft Report, Rev. 0

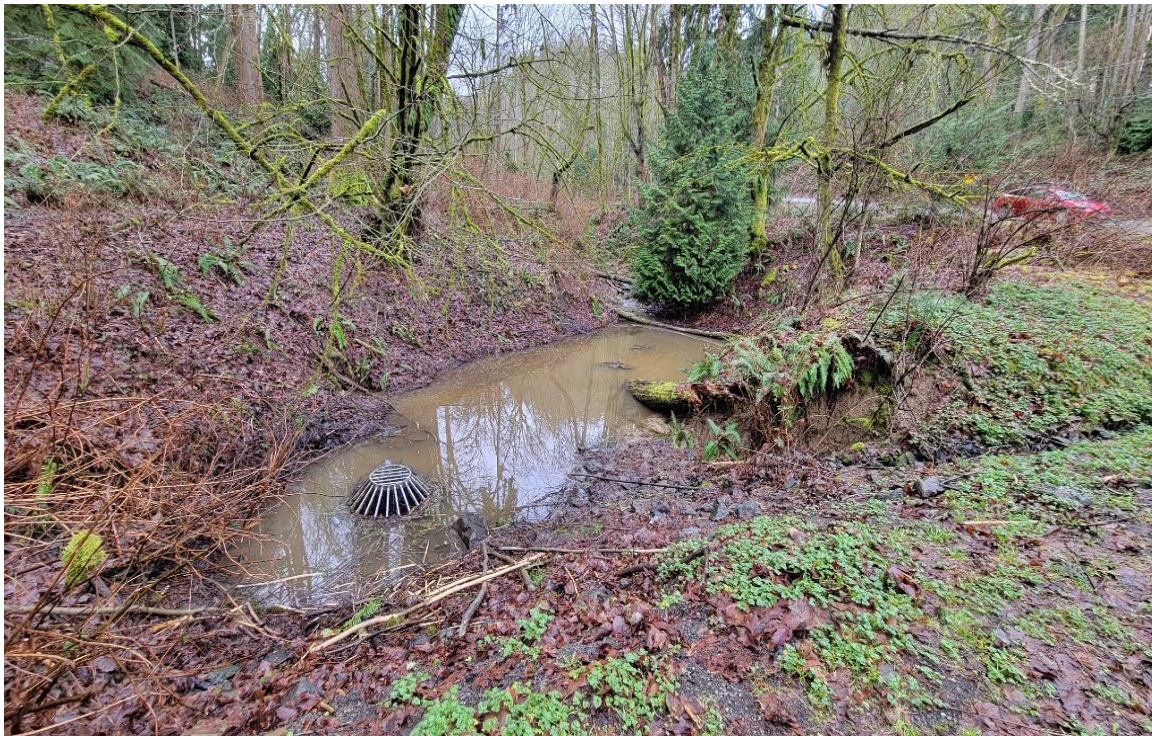
The project is located within a forested ravine surrounded by light residential development and paralleled by the SE 53rd Place roadway to the north. Three culverts along SE 53rd Place contribute flows from tributaries to the north (Figure 1.1). The stream channel is relatively steep and incised into the surrounding terrain. The East Mercer Way (EMW) structure is City-owned and consists of two 1.5-foot diameter, 240-foot long corrugated stainless steel (CST) pipe culverts., with an estimated average slope of 5.7%, based on surveyed invert elevations and available LiDAR. The inlet to the EMW culvert is an approximately 5-foot tall standpipe with trash rack surrounded by a sediment pond (Photo 1.1). The Washington Department of Fish and Wildlife (WDFW) currently lists the crossing (Site ID: 920822) as a total barrier to fish passage, due to an excessive drop in water level across the structure (WDFW, 2021).

Photo 1.1 Upstream view of East Mercer Way crossing and upstream sediment pond.

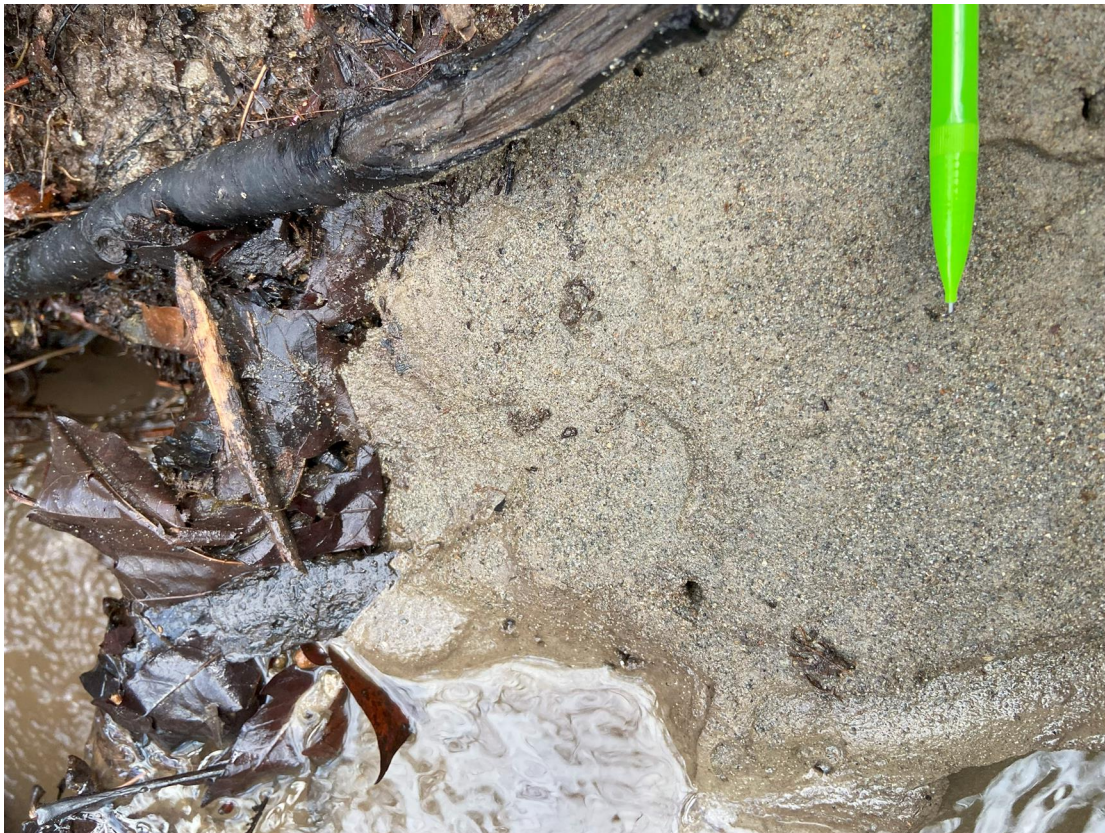
City maintenance staff accounts indicate regular (i.e., annual) removal of sediment and debris from the EMW crossing and upstream sediment pond, with the most recent removals in 2023 being the highest in history (Grueber, E., Public Works, personal comm., 2024). Average annual sediment removals from the facility are estimated at about 29 cy/yr and primarily composed of fine sands and silt (Photo 1.2). Sediment removal volumes have remained relatively unchanged, despite prior mitigation efforts described above (Grueber, E., Public Works, personal comm., 2024).

Photo 1.2 Photo of fine sediments (sands and silts) observed within sediment pond.
Note, 0.9 mm pencil lead shown for scale.

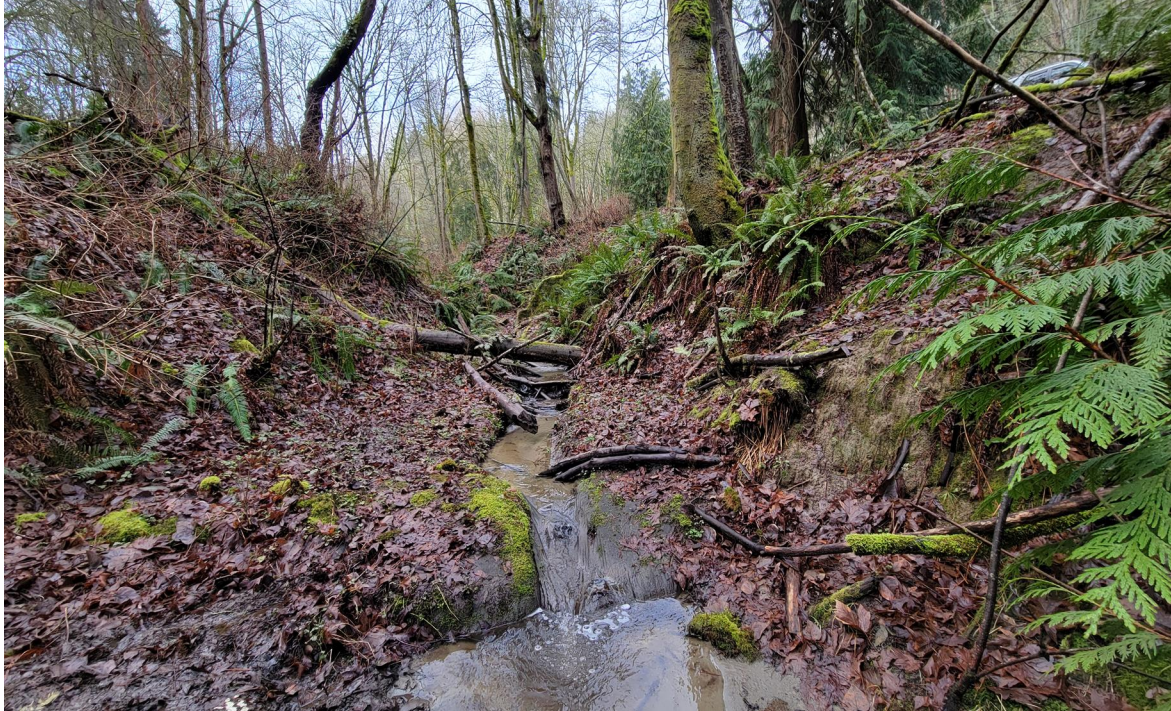
Figure 2.1 provides a longitudinal profile of the existing stream channel alignment from recent 2025 NHC channel survey and available 2021 LiDAR. From its headwaters to the EMW crossing, the stream channel is incised into the adjacent hillslopes (Photo 2.1). Channel depths range from

1 to 3 feet, with deeper sections observed within the middle of the project reach from about 500 to 1,000 feet upstream of EMW. Ravine top widths range from 30 to 150 feet. Banks are vegetated by shrubs and some trees (Photo 2.1).

Photo 2.1 Upstream view of stream channel, about 140 feet upstream of EMW.

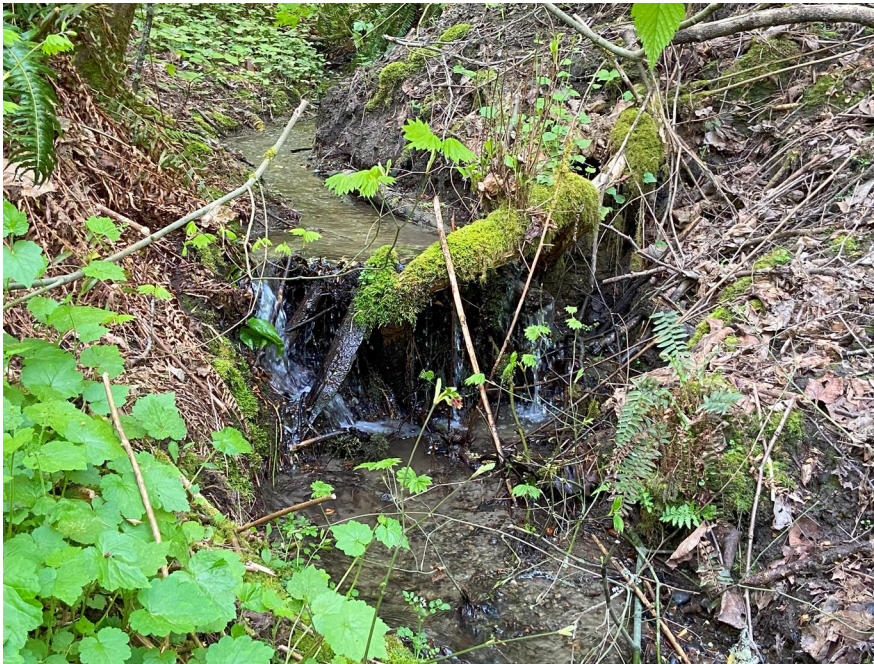
Photo 2.2 Upstream view of stream channel, about 560 feet upstream of EMW. Note, existing debris in channel providing limited grade control and some upstream sediment retention and flanking with erosion along channel banks.

Existing log weir stabilization is intended to enhance the structural integrity of existing natural weir features, where near term failure and loss of existing grade control expected, such as that shown above in Photo 2.2. The streambed stabilization mixture is comprised of 50% Streambed Sediment, 45% 8-inch Cobble, and 5% Type 1 Stream Boulder. This mixture follows the Bathurst stable bed sizing methodology and WDFW natural bed gradation ratios presented in Barnard et al (2013). The design mixture is intended to be stable at the 100-year flood discharge, therefore significantly coarser than the existing bed material. Stabilization materials will be placed immediately downstream of the existing structure and tie into the channel banks to buttress it and limit the potential for outflanking. Materials will be placed at varying depths across the section to provide hydraulic diversity and suitable flow conditions for fish passage (Figure 3.6). Stabilization of three existing structures is proposed (Figure 3.1).

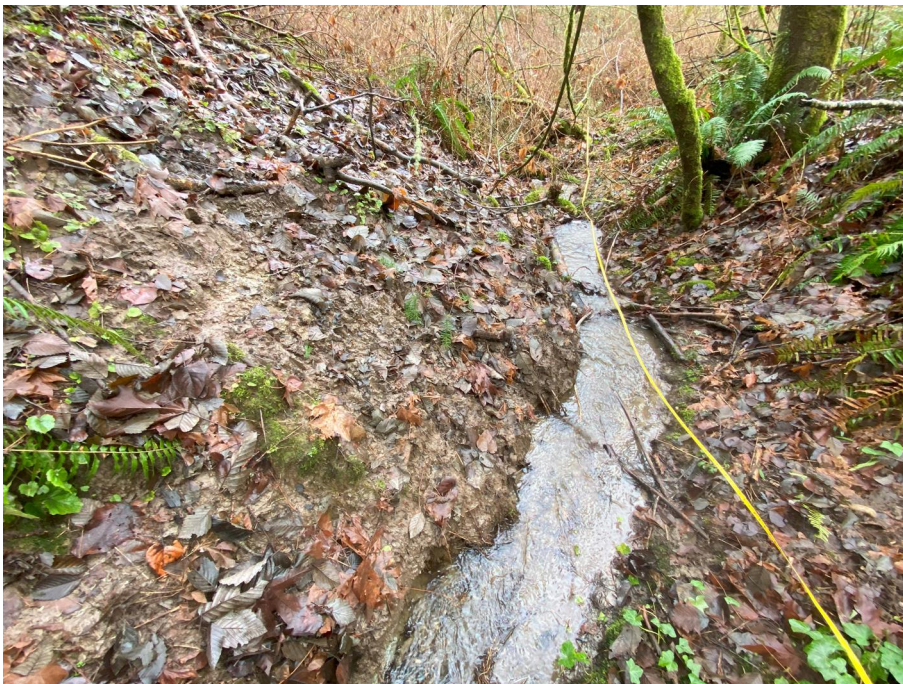
Photo 2.3 Downstream view of stream channel, about 680 feet upstream of EMW. Note, erosion into exposed landslide deposit.

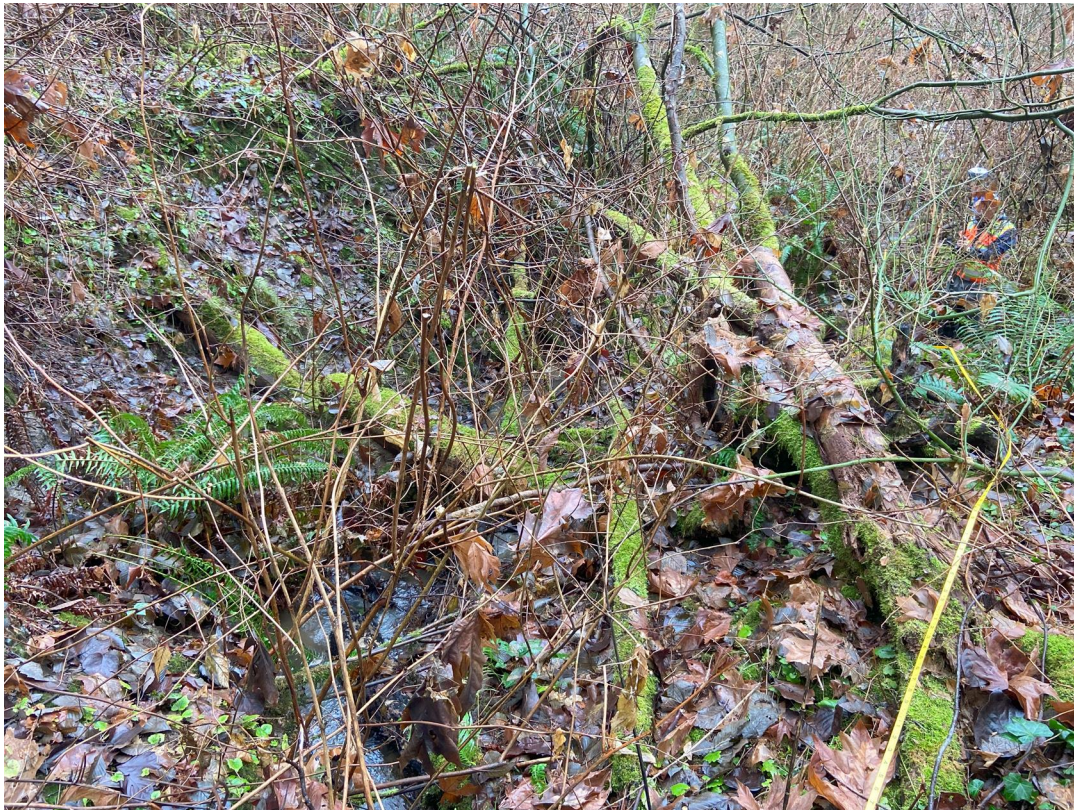
Upstream of station 5+00 (i.e. 500 feet upstream of EMW), constructed mitigation measures were varied in condition, with damage, including flanking and erosion of the channel banks observed in some locations. Near about 600 feet upstream of EMW the channel has incised, leaving previously placed LWM suspended above the channel (Photo 2.4). The channel profile from about 560 to 960 feet upstream of EMW is convex, interpreted as a geologically young channel segment, still incising through a more recent historical landslide deposit. Loss of grade control within this section of the stream channel is expected to result in continued incision and a relatively high supply of fine sediment to the sediment pond.

Photo 2.4 Downstream view of stream channel, about 600 feet upstream of EMW. Note, channel incision and LWM suspended above channel.

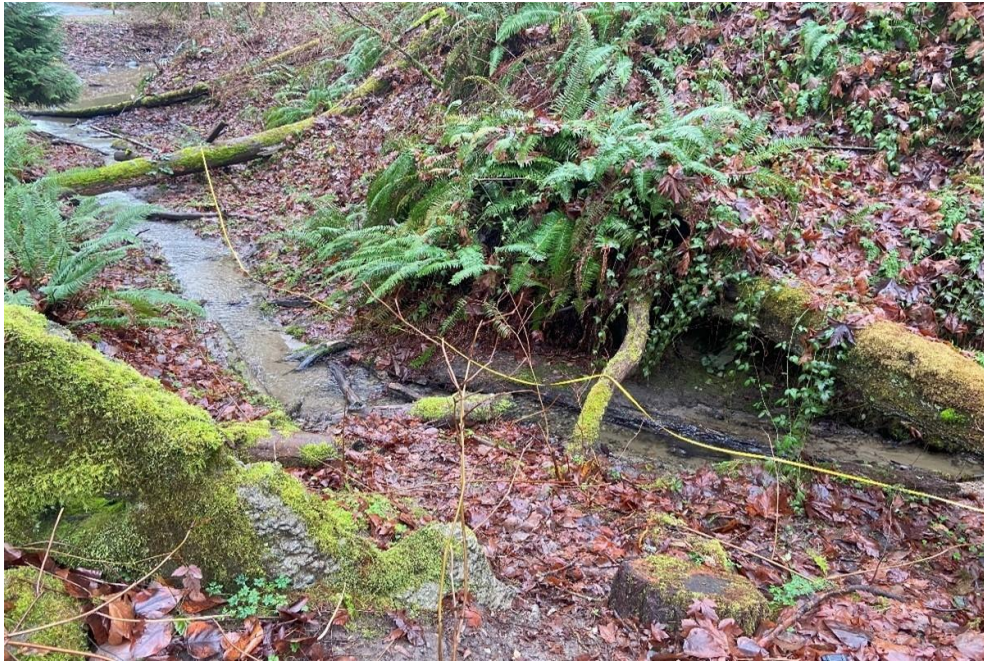
Photo 3.1 Downstream view of stream channel, about 160 feet upstream of EMW. Note, existing toe log providing stability to bank.
