February 5, 2024
PanGEO Project No. 23-386

Mercer Island Beach Club
8326 Avalon Drive
Mercer Island, WA 98040
Attn: Gardner Morelli

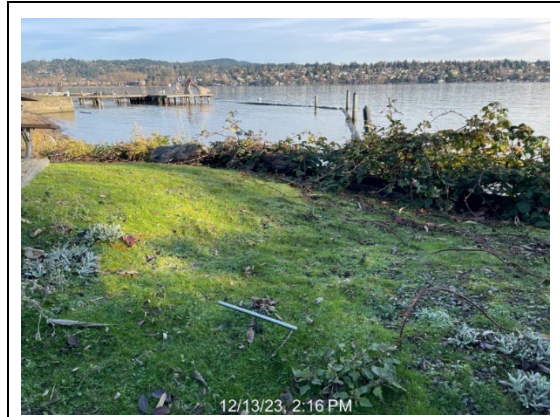
Plate 3. Note 3-foot-long steel hand probe pushed to full depth through loose fill soils.

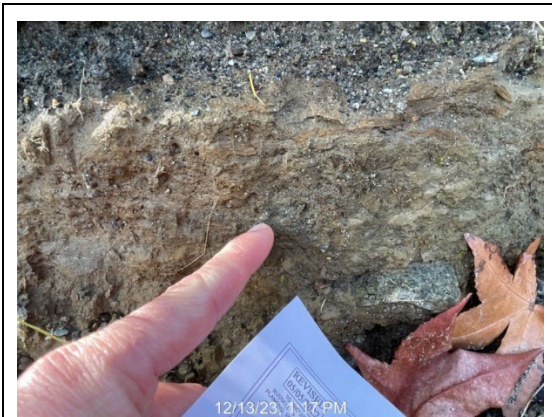
Plate 4. Exposed soils at the base of the failing bulkhead consisted of dense silty fine sand and very stiff sandy silt.

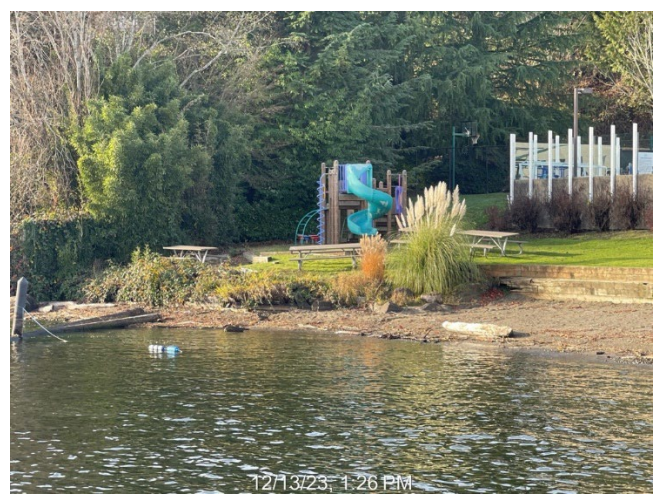
Plate 5. Looking southwest at area of proposed bulkhead removal. Bulkhead is located below the picnic tables, but is obscured by vegetation growth.

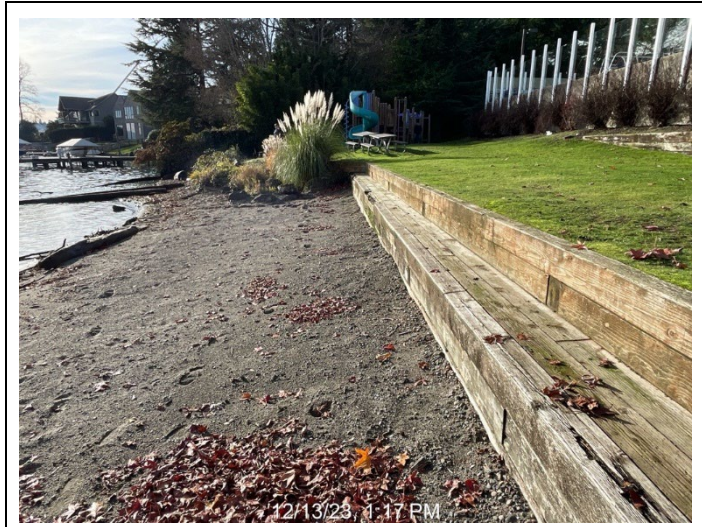
Plate 6. Looking south along existing beach area. Proposed bulkhead removal area in the distance. Proposed beach reconstruction will generally match the existing beach condition shown in photo.
