## TECHNICAL INFORMATION REPORT CITY OF MERCER ISLAND

**Adams Mercer Island SFR  
3508 96<sup>th</sup> Ave SE  
Mercer Island, WA 98040**

**November 30, 2023  
Updated JUNE 11, 2025**

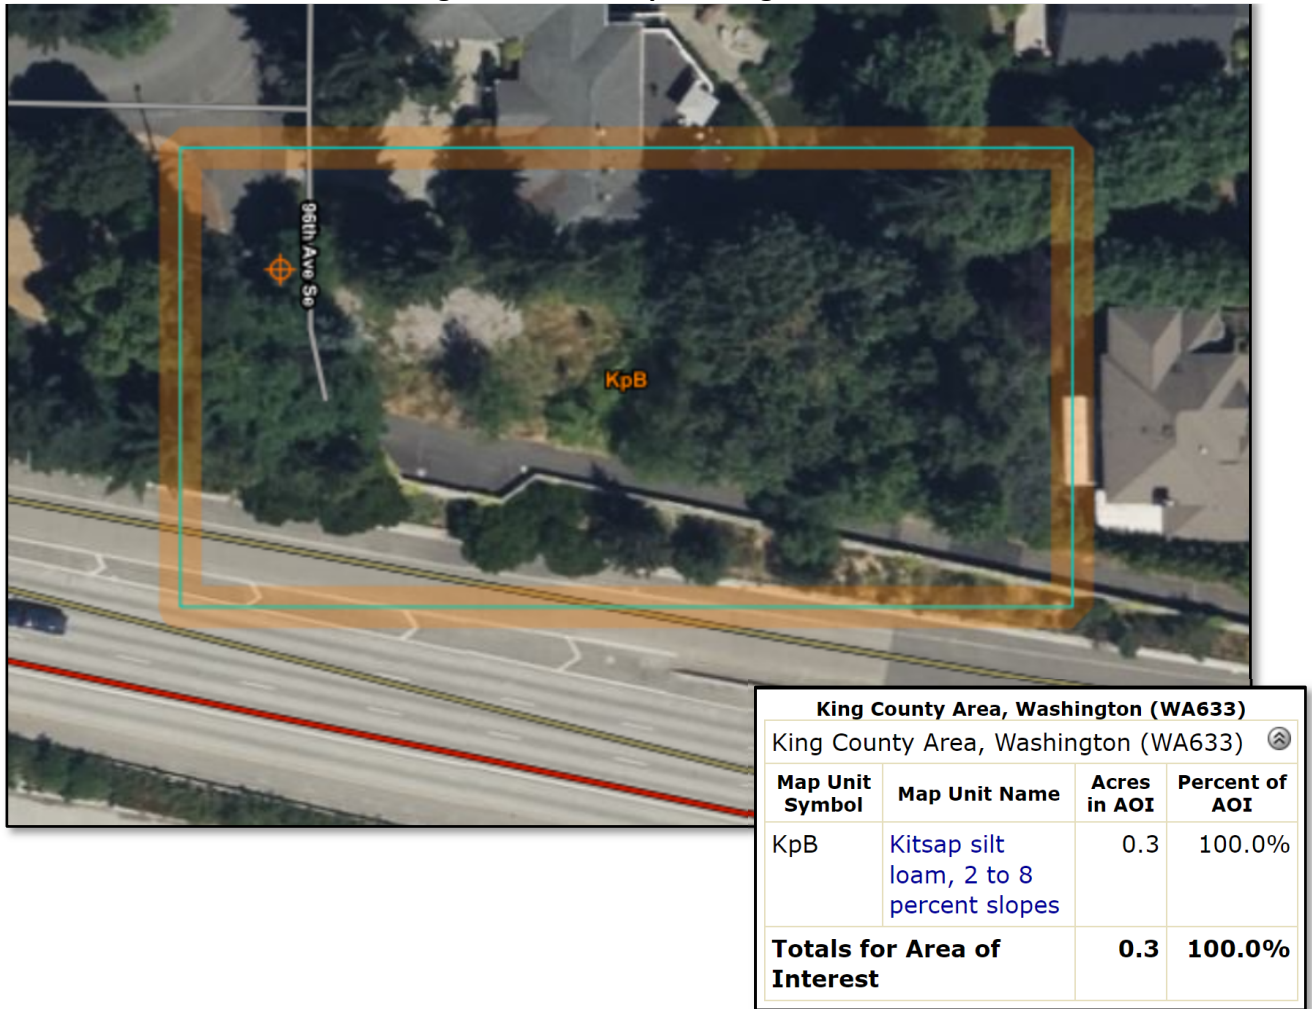
Figure 2: Soils Map and Legend

The onsite soils are mapped as Kitsap silt Loam (KpB) by the US Department of Agriculture (USDA), Natural Resources Conservation Service (NCRS) Web Soil Survey information. Further field exploration and testing were performed by Cobalt Geosciences revealed that the site is underlain with Vashon Recessional Lacustrine Deposits which include silt and clay. Refer to Appendix B for the full geotechnical report.

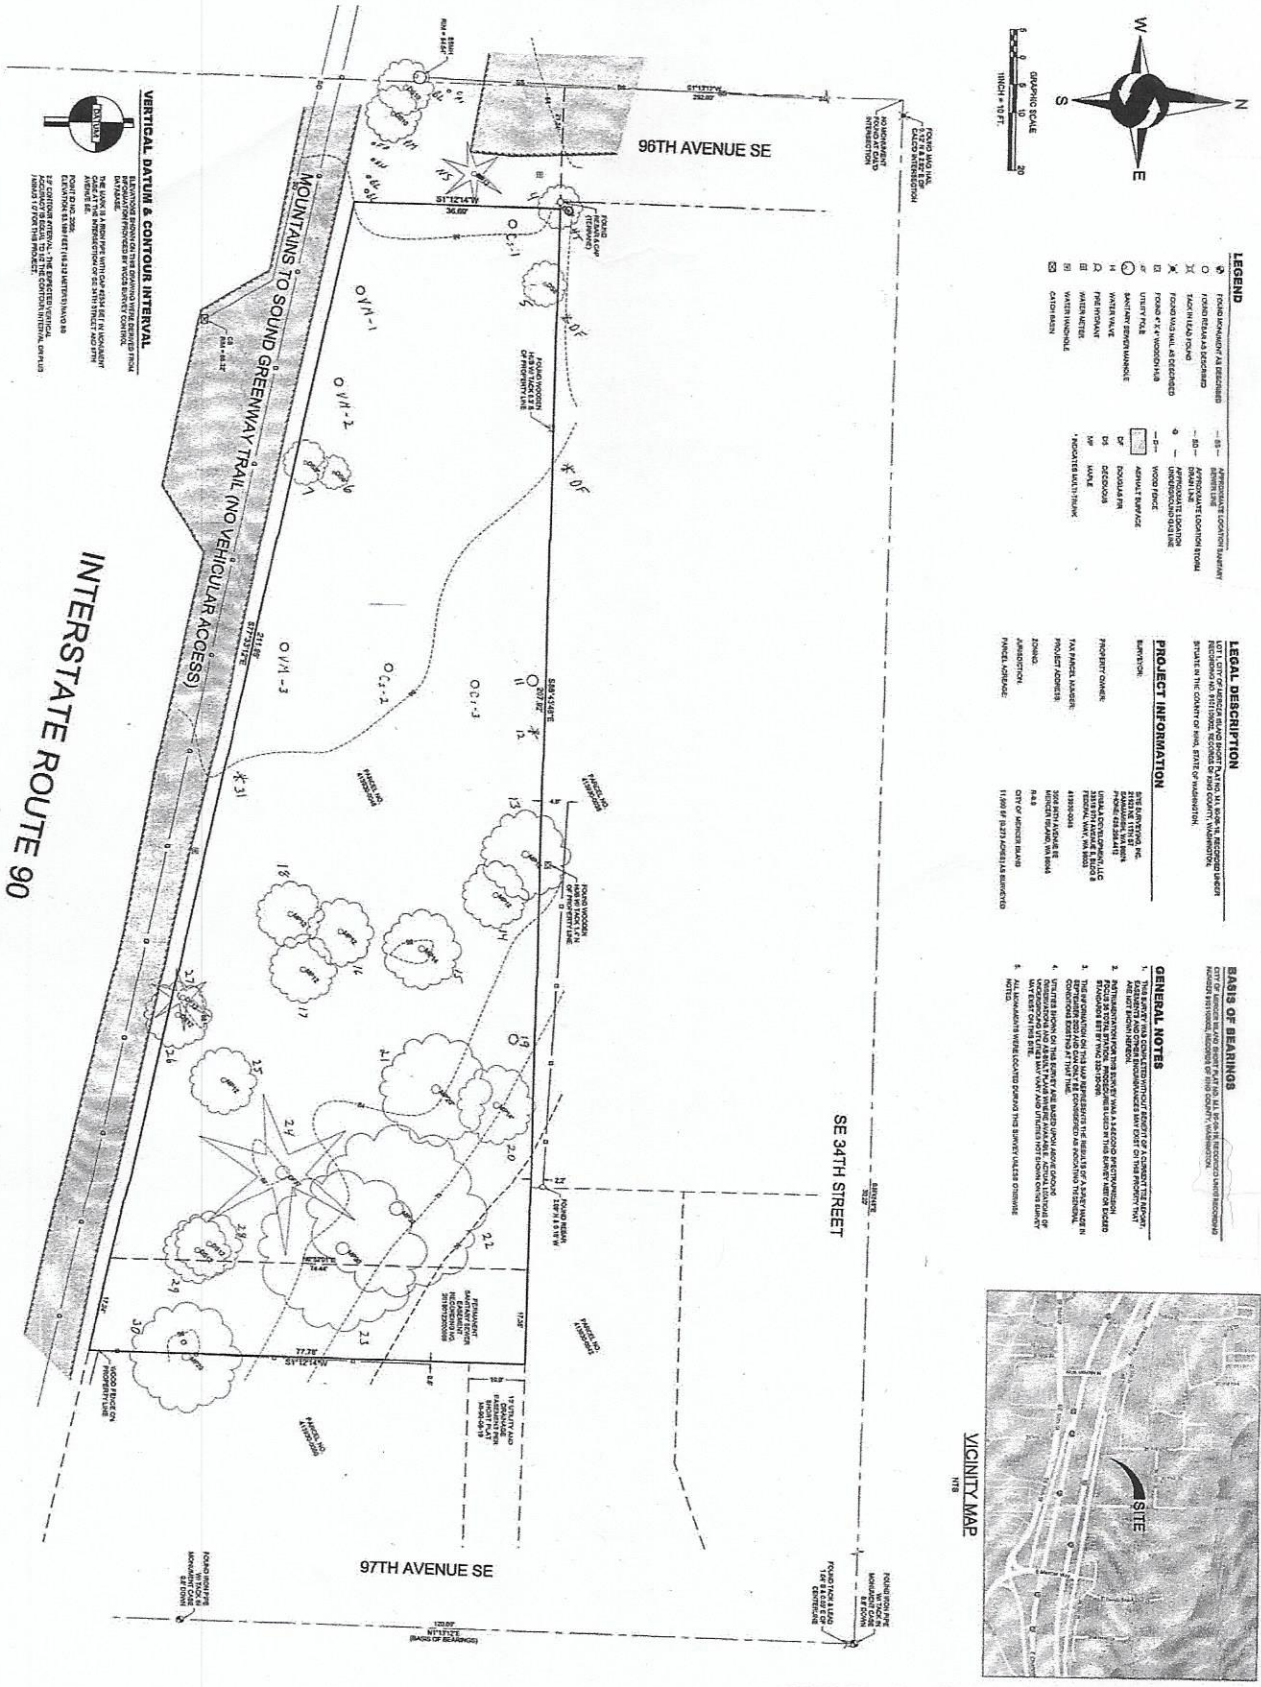
# Appendix C: Tree Map

TOPOGRAPHIC SURVEY  
URBALA DEVELOPMENT LLC  
3508 96TH AVENUE SE  
MERCER ISLAND, WA 98040

I tagged the trees with aluminum tags and numbered them according to the tree numbers shown on the Topographic Survey. Some trees in the western cleared area were already tagged. Trees that I found that were not shown on the plan, I numbered as well. Some trees that were in the numerical tree sequence were not on the Topographic Survey (1, 2, 3, 8, 9 and 10) were no longer present on the site. I came to this conclusion based on the sequence of the numbered trees that were present. I included these missing trees in the report, thinking that there may be a record of them associated with the demolition permit of the house. I also noted six newly planted trees on the site. My assumption was that they were replacement trees that were planted as mitigation for trees that had been removed at the same time as the house was removed.

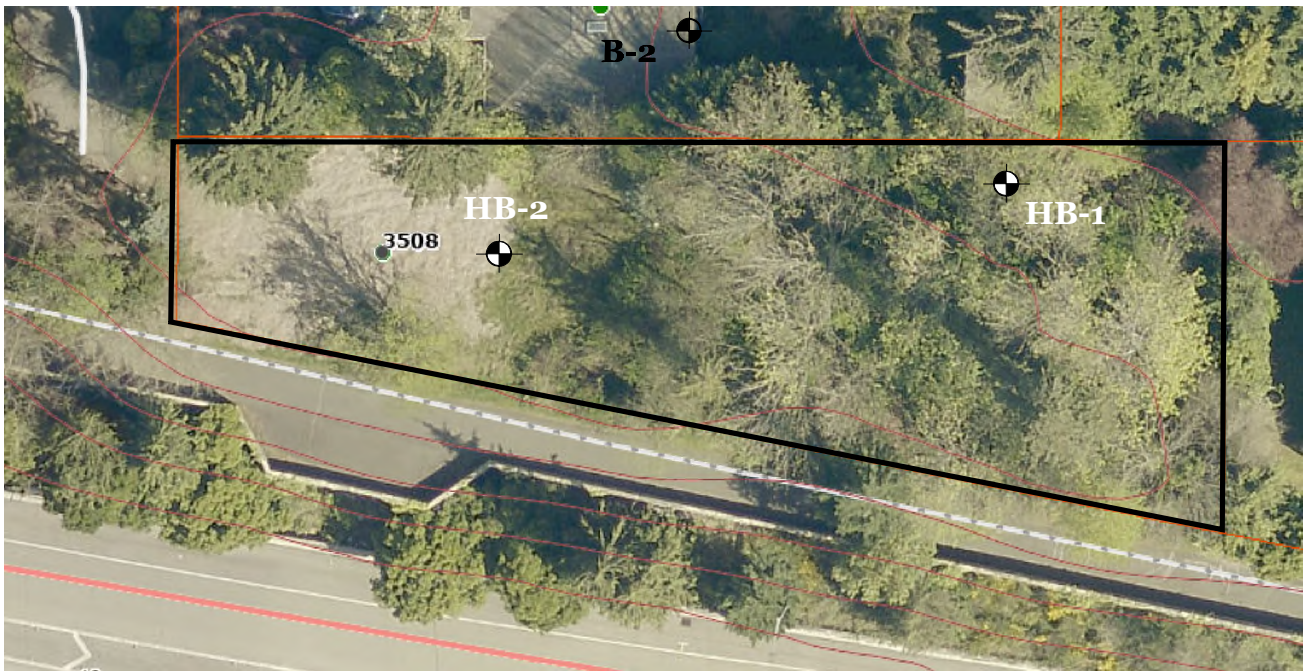
HB-1    **Approximate  
Hand Boring Location**

As part of our evaluation, we advanced two hand borings where accessible to determine if soils consistent with seismic hazard areas are present at the site.

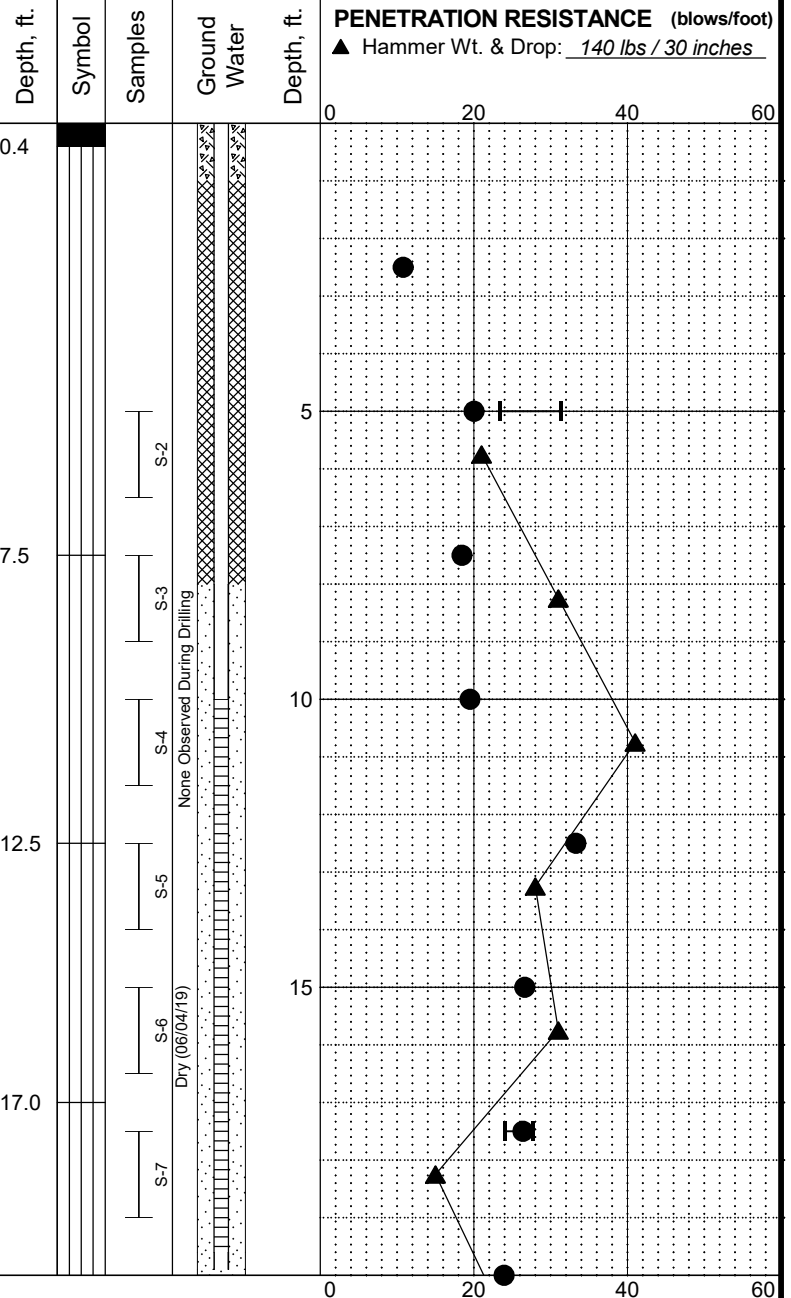
Medium dense, brown *Silt (ML)*; moist; less than 10% fine sand; nonplastic to low plasticity fines; trace partings with iron-oxide staining. (Qvgl)

Medium dense, gray *Silt with Sand (ML)*; moist; fine sand; nonplastic fines. (Qvgl)

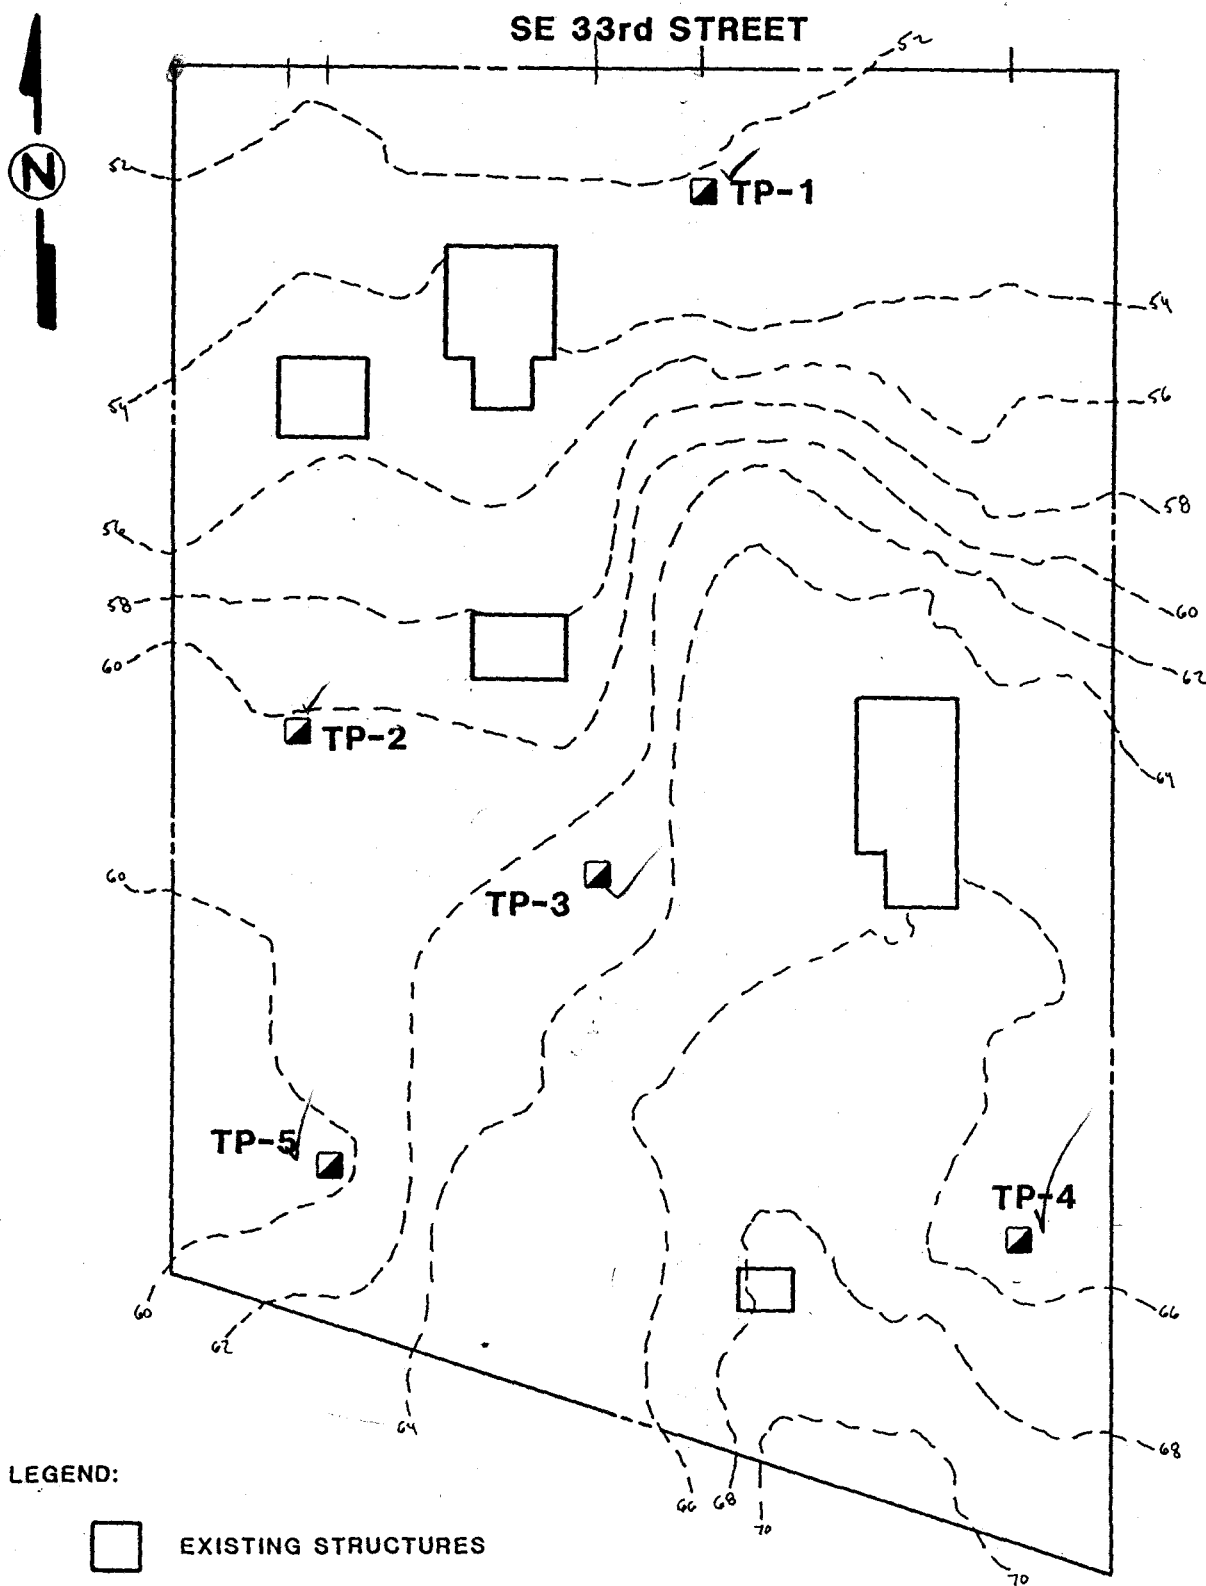
SITE EXPLORATION PLAN

APPROXIMATE TEST PIT LOCATIONS

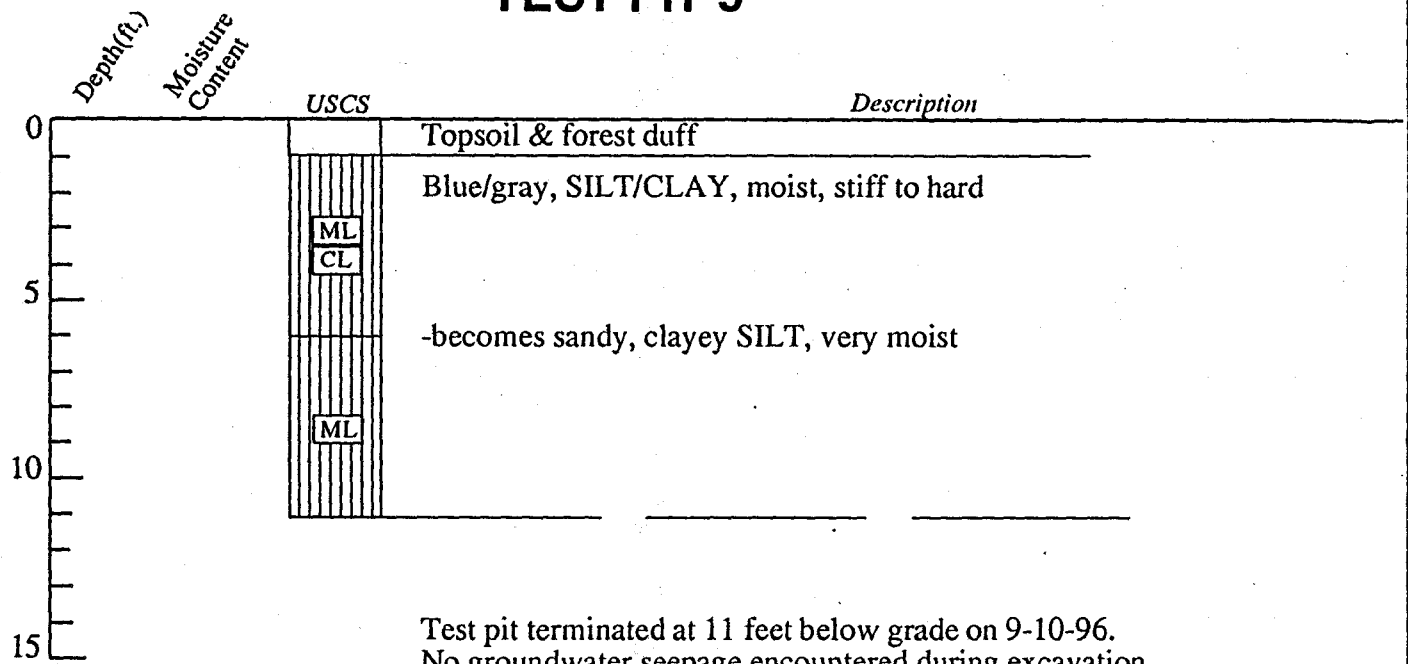
# TEST PIT 5

Test pit terminated at 11 feet below grade on 9-10-96.  
No groundwater seepage encountered during excavation.  
No caving.

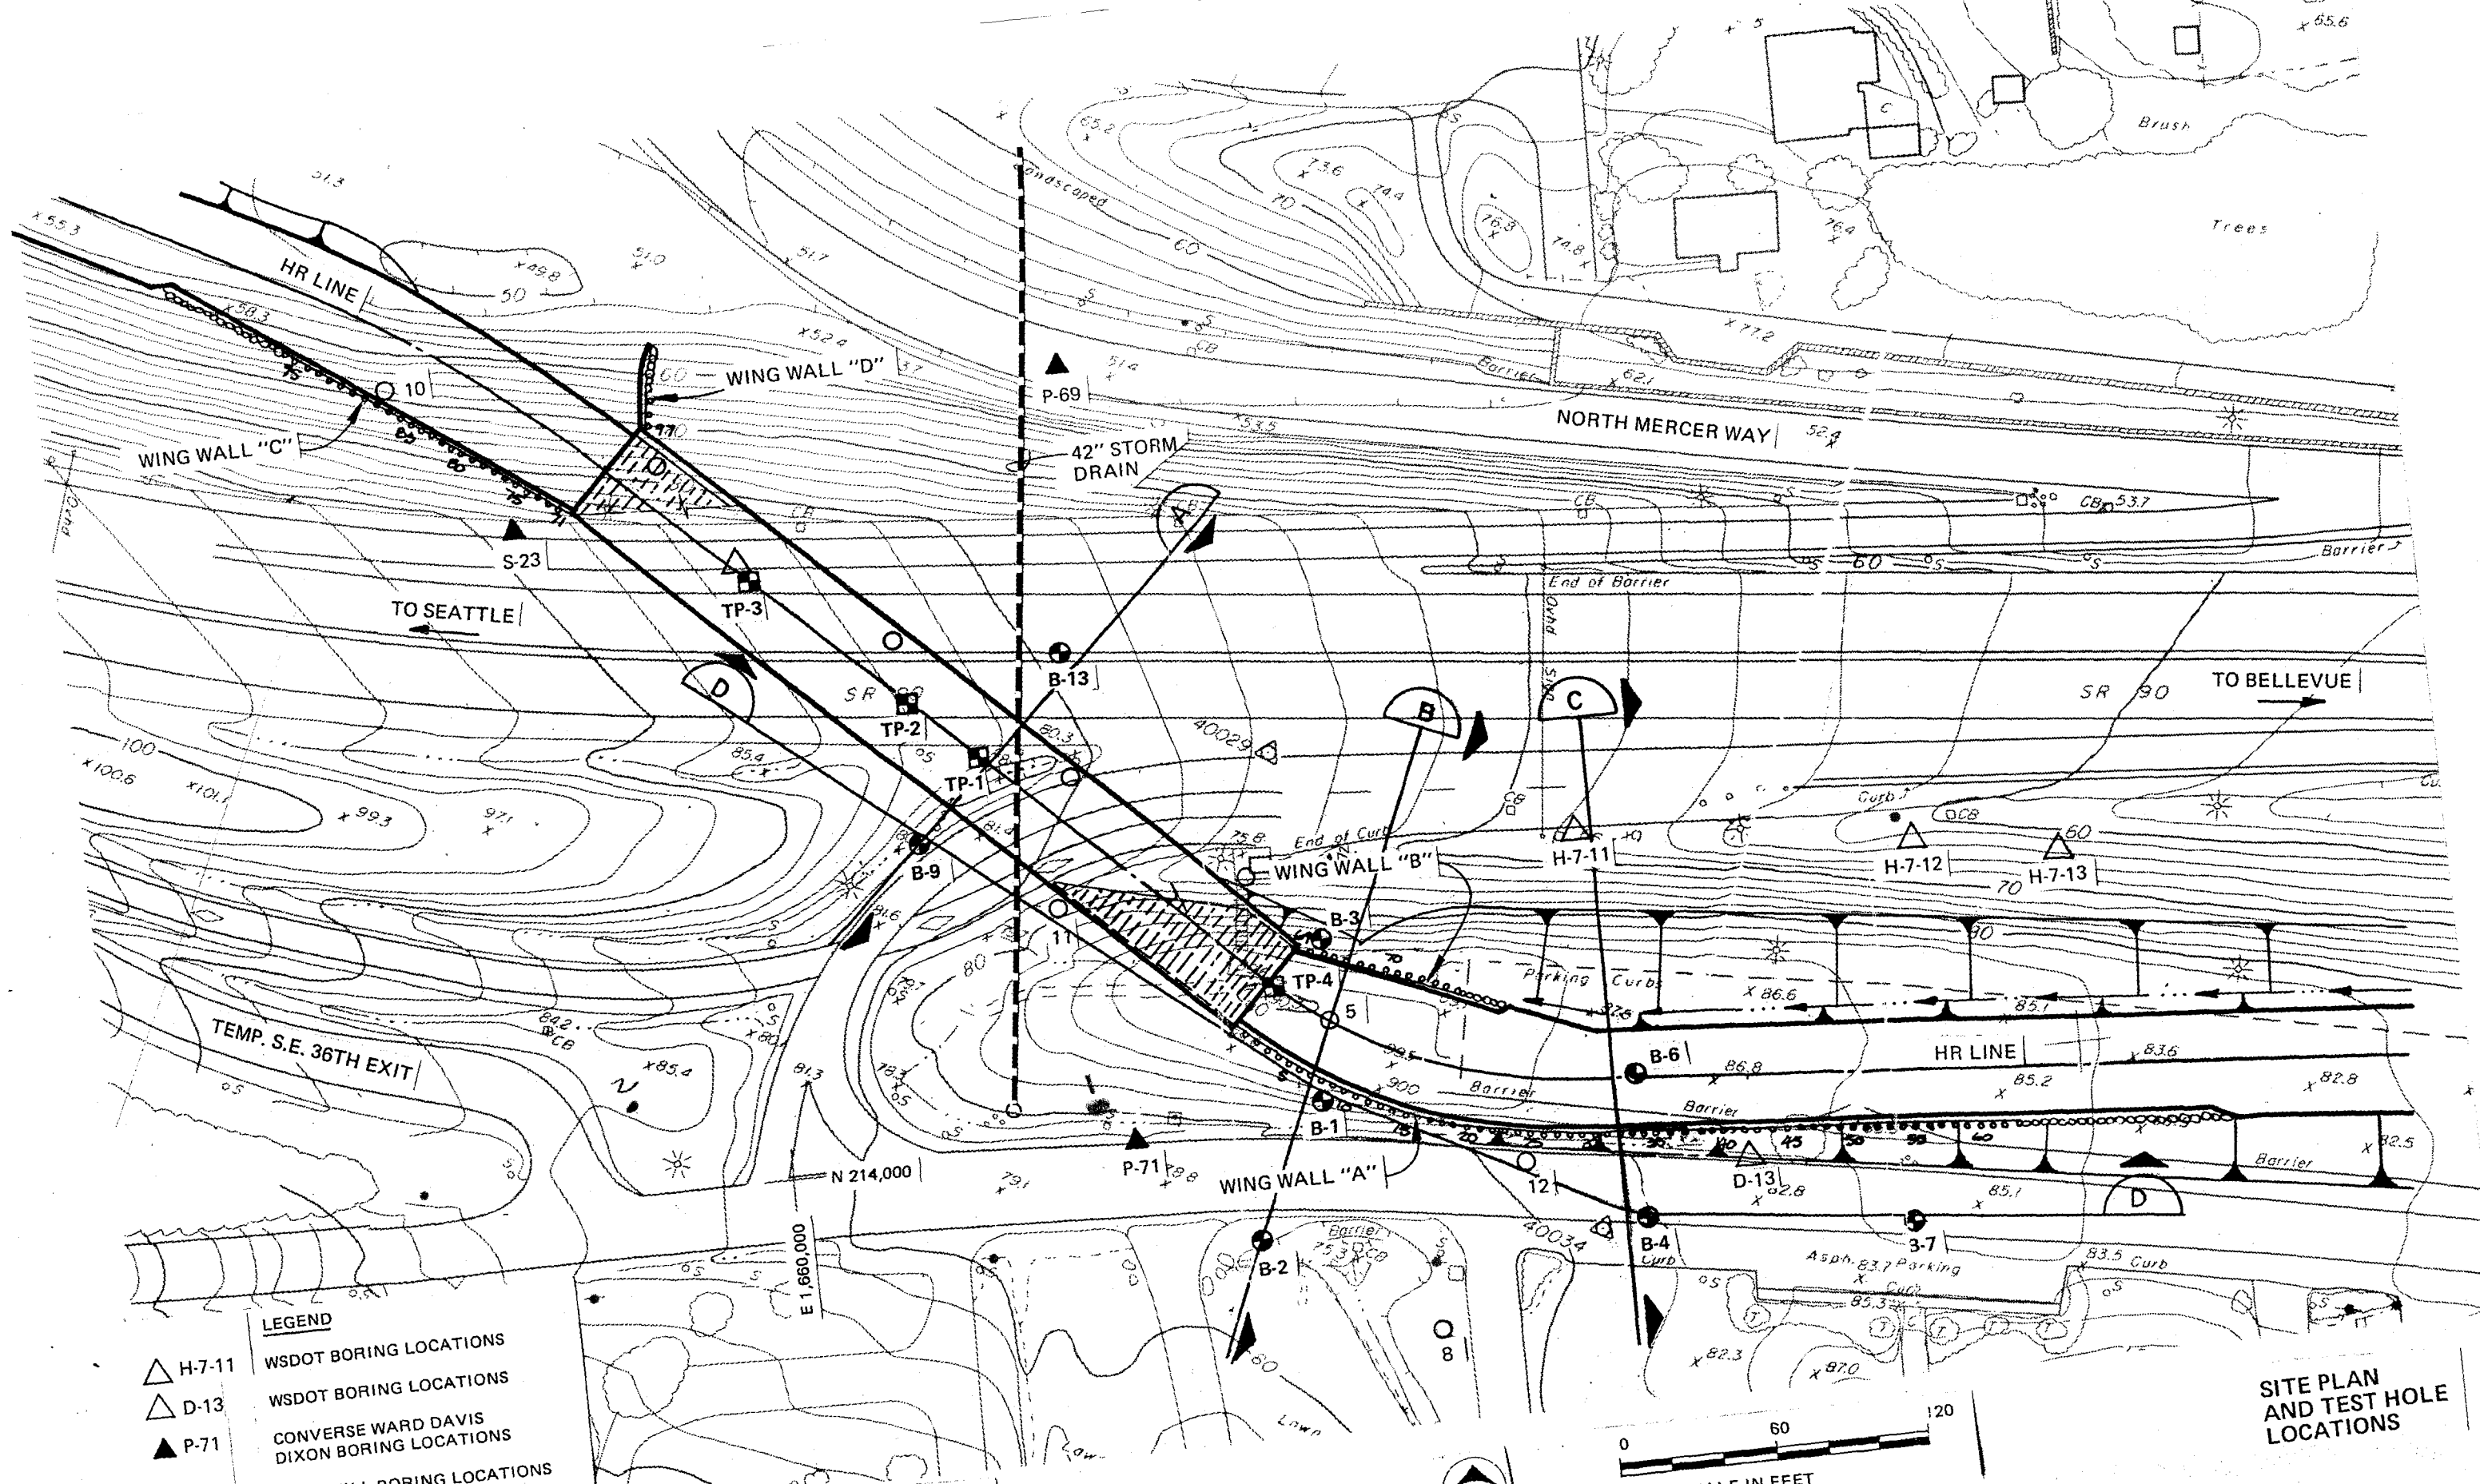
SITE PLAN  
AND TEST HOLE  
LOCATIONS

1. BASE MAP TAKEN FROM WSDOT PHOTOGRAMMETRIC MAP, FLOWN 12/17/83.

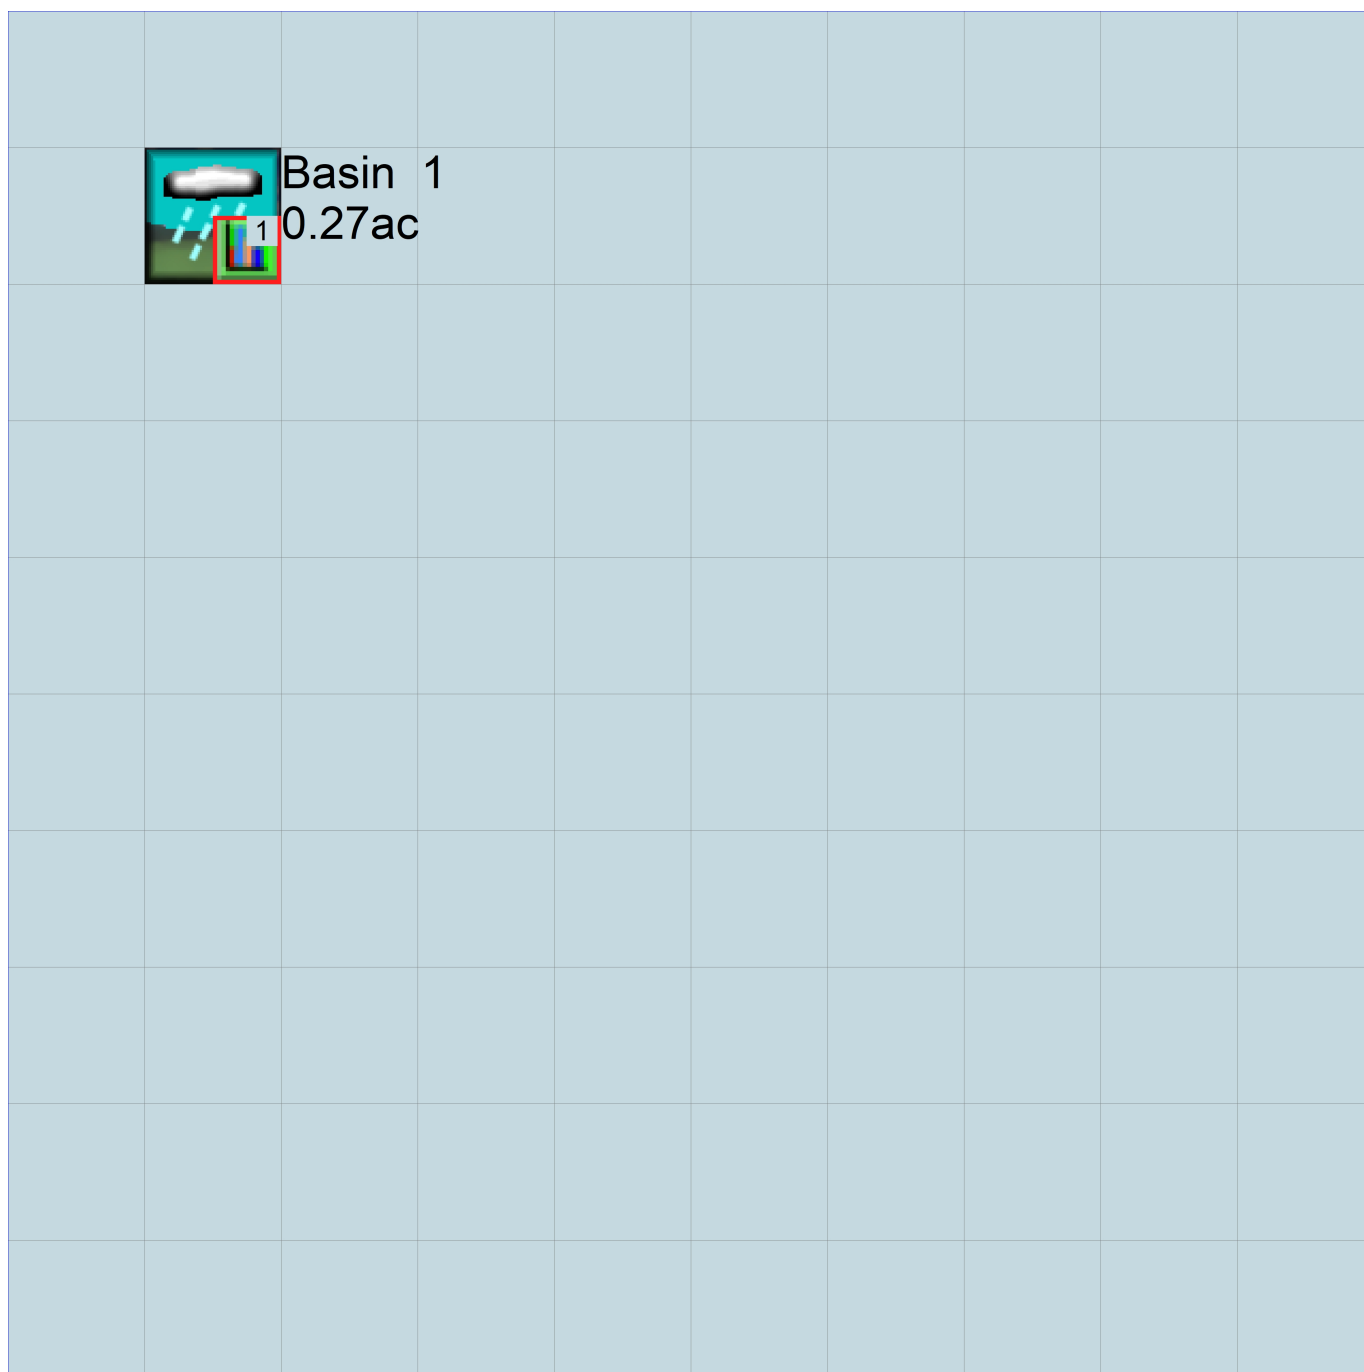
## Mitigated Schematic

Basin 1  
0.27ac
