# DRAINAGE MEMORANDUM

TO: City of Mercer Island  
 FROM: Ben Iddins, P.E.  
 DATE: February 13, 2024  
 RE: 6520 82<sup>nd</sup> Ave SE, Mercer Island, WA  
 On-site Drainage System Design Summary

**TEKIELA RESIDENCE**  
6520 82ND AVE SE  
MERCER ISLAND, WA 98040  
2311.0333.00

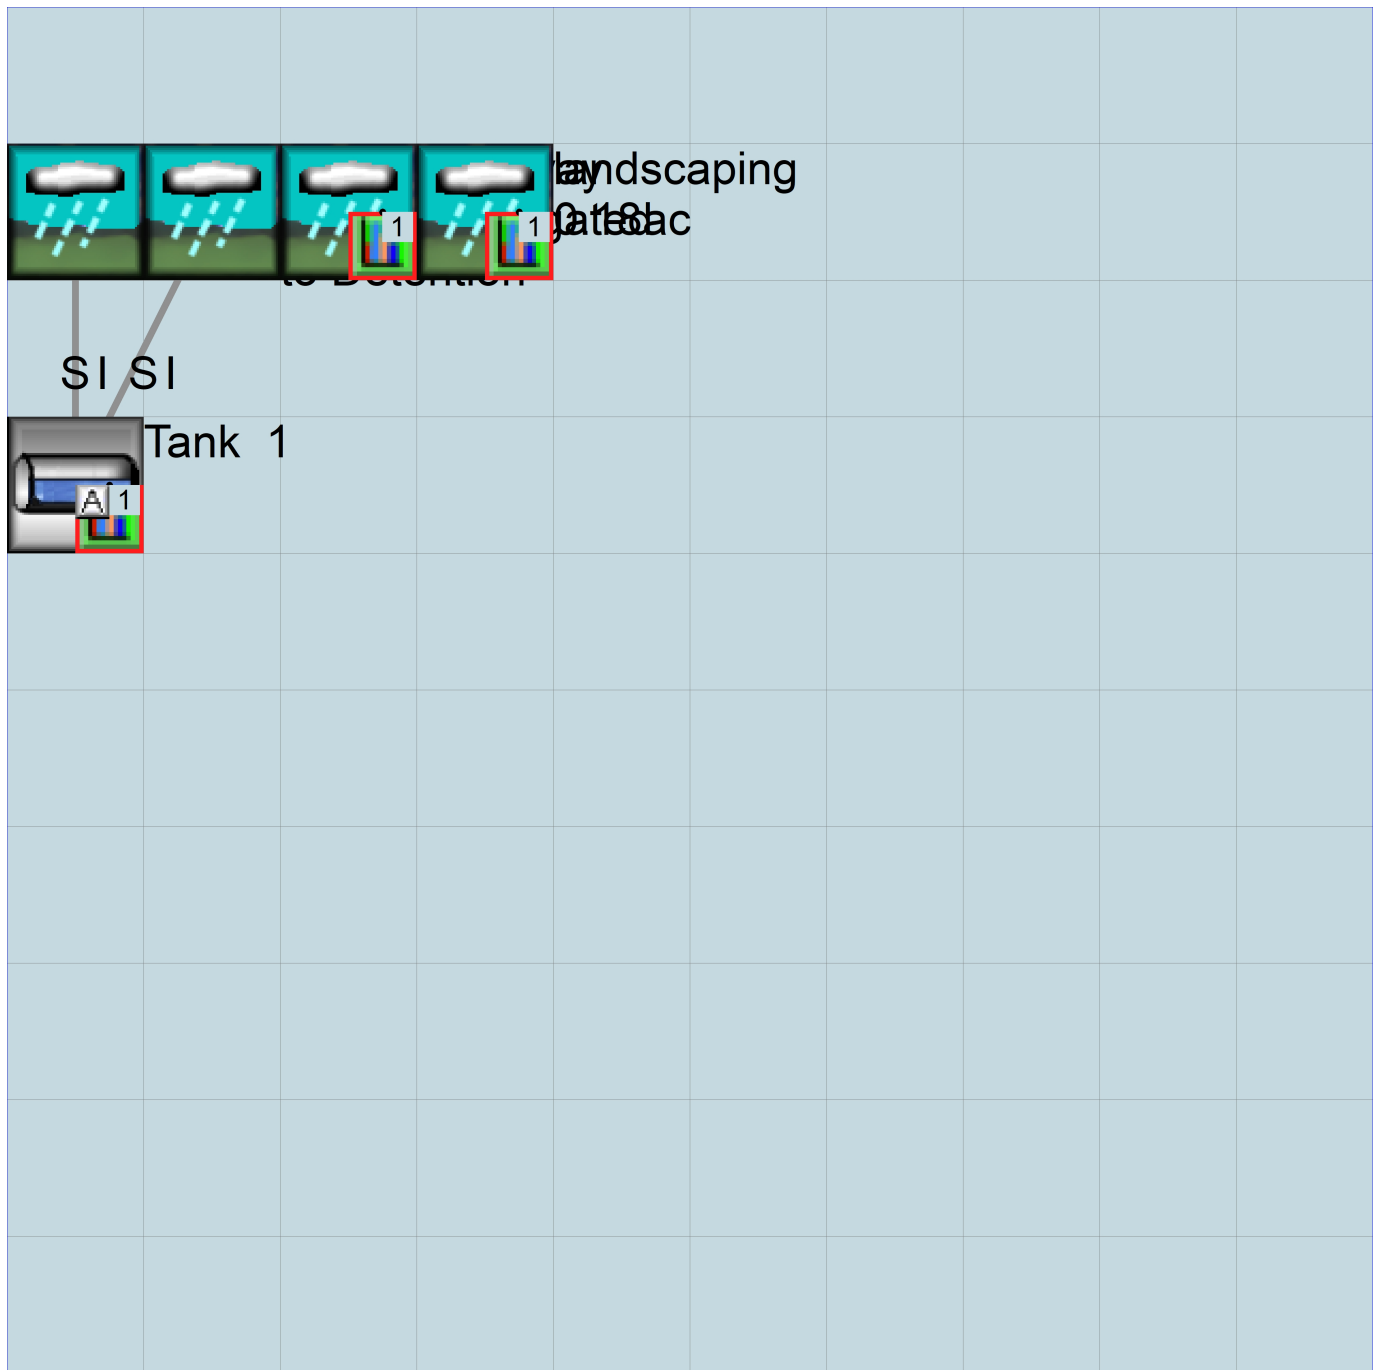
Mitigated Schematic

Basin 1  
0.35ac
