**Stormwater Drainage Report
4104 83rd Avenue SE
Mercer Island, Washington
KC Tax Parcel #362650-0040
Permit #: 2402-144**

July 26, 2024

**Offe Engineers, PLLC
Darrell Offe, P.E.
13932 SE 159th Place
Renton, Washington 98058
425-260-3412
Darrell.Offe@comcast.net**

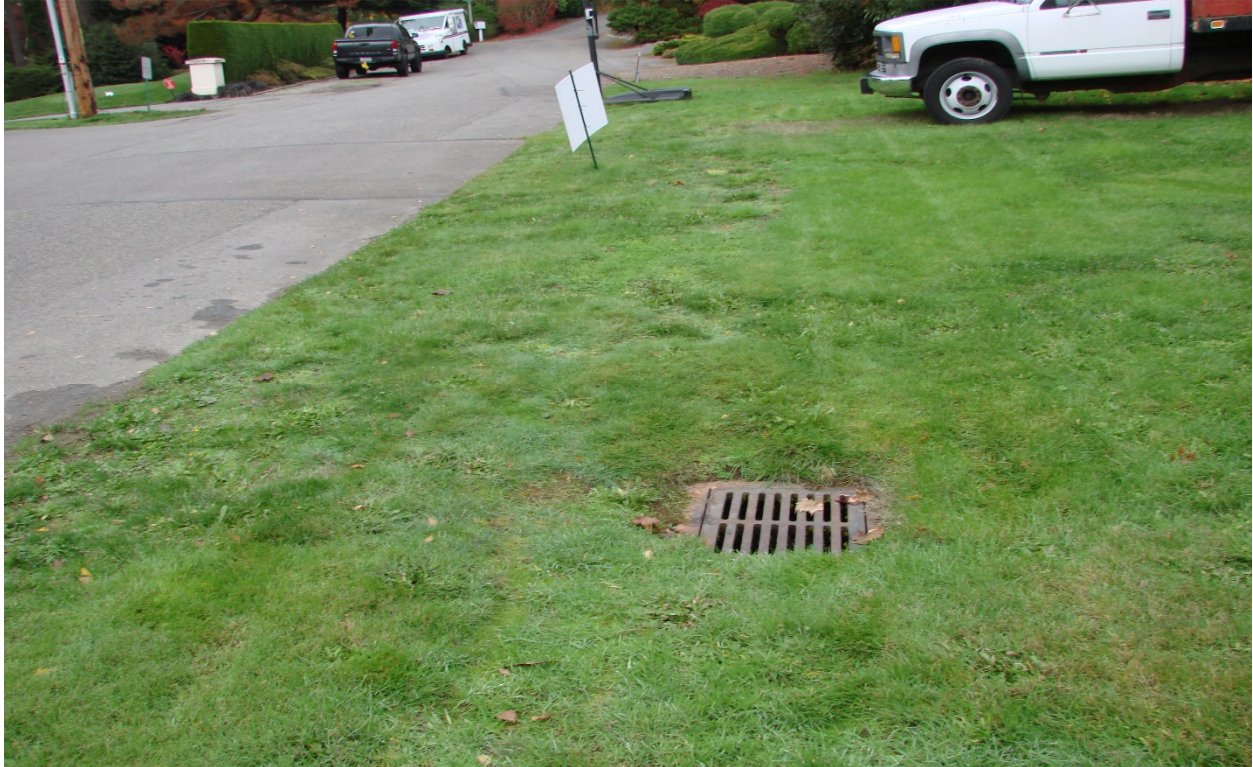
Photo #5 – Viewing north on 83rd at CB#22-112

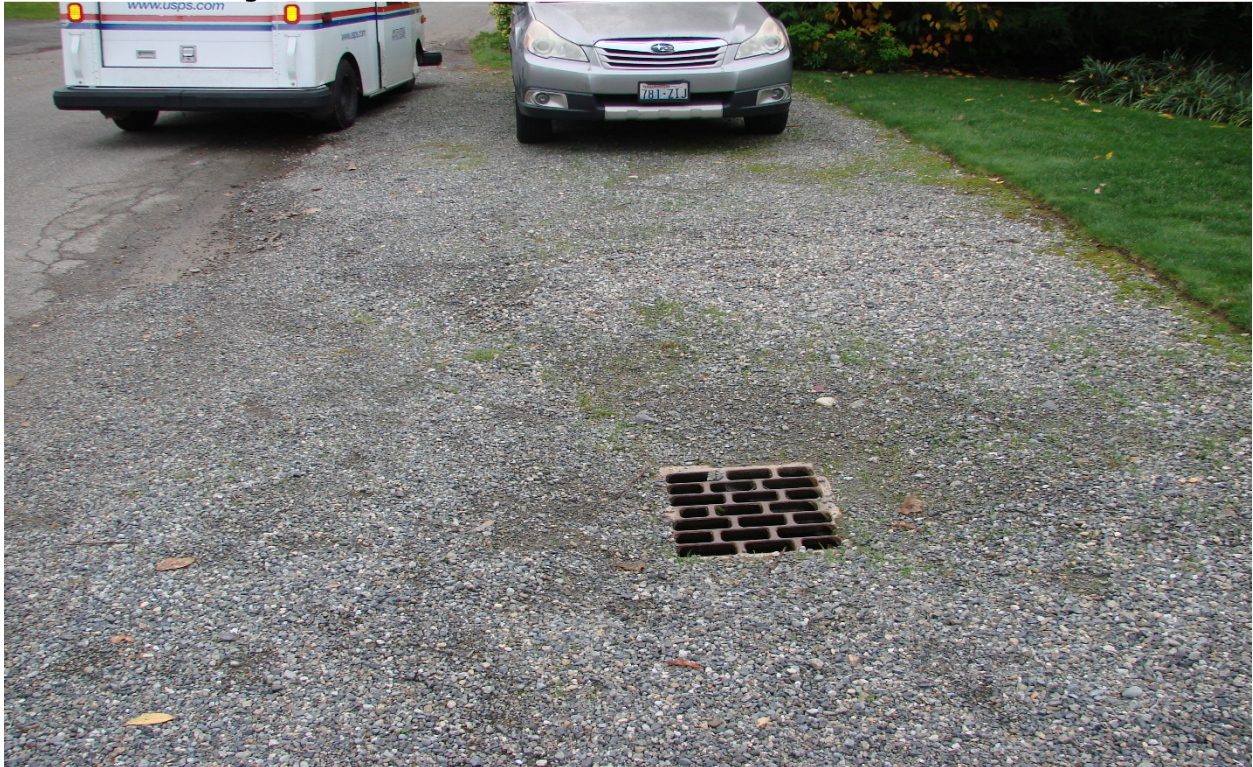
Photo #6 – Viewing south on 83rd at CB#22-55

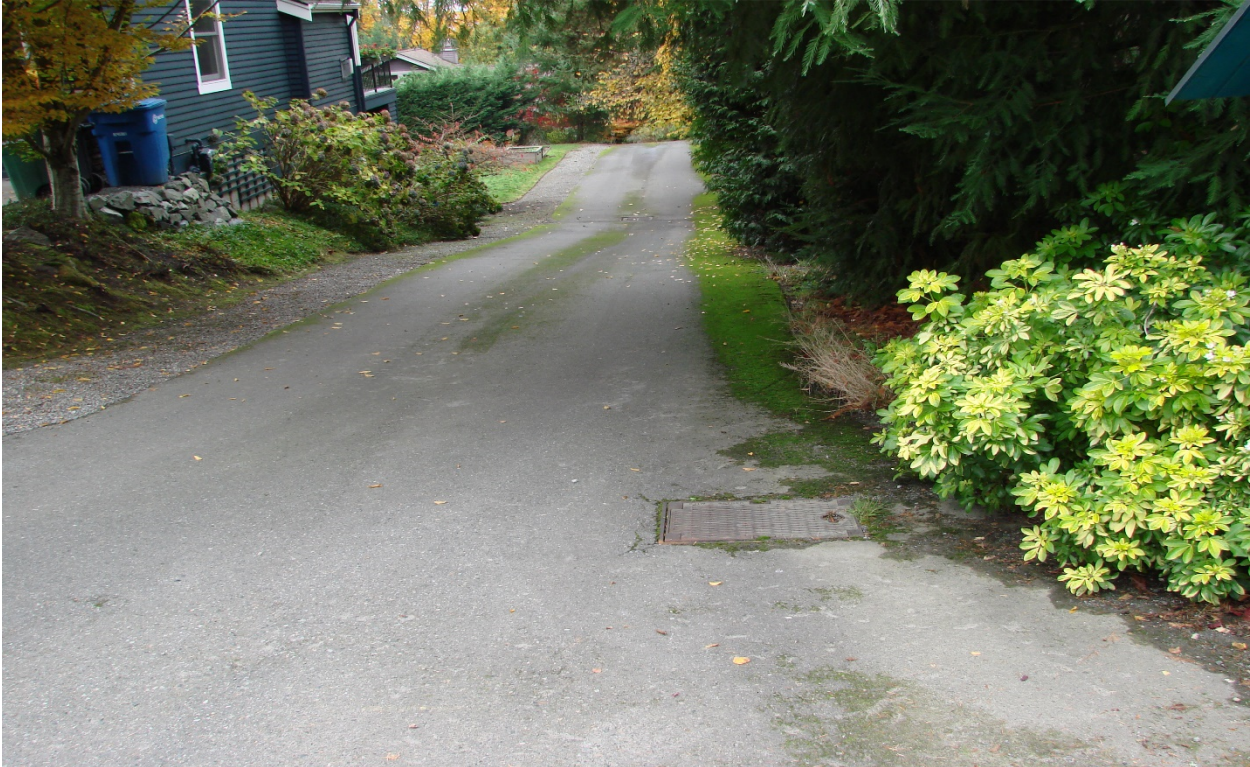
Photo #7 – Viewing west down shared access between 4131 & 4111 83rd Avenue SE – CB#22-130

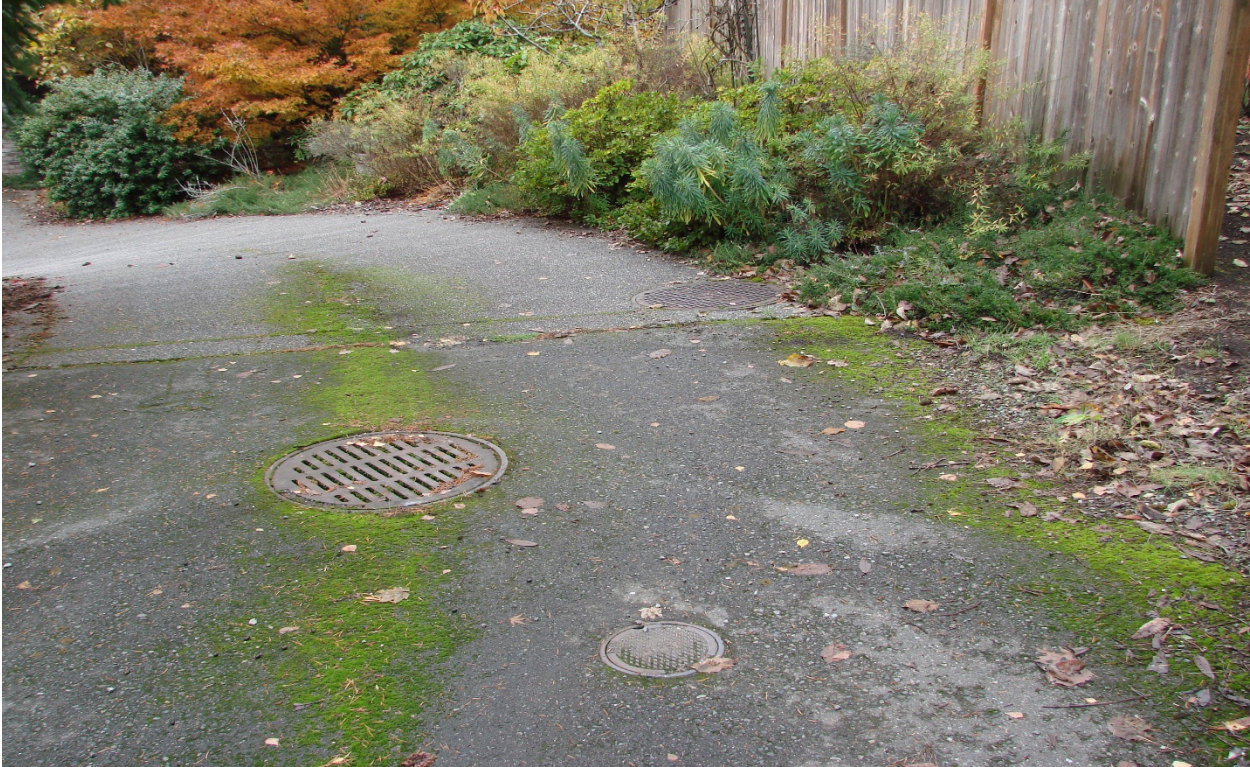
Photo #8 – West end of shared access – CB#22-168 (with solid round lid)

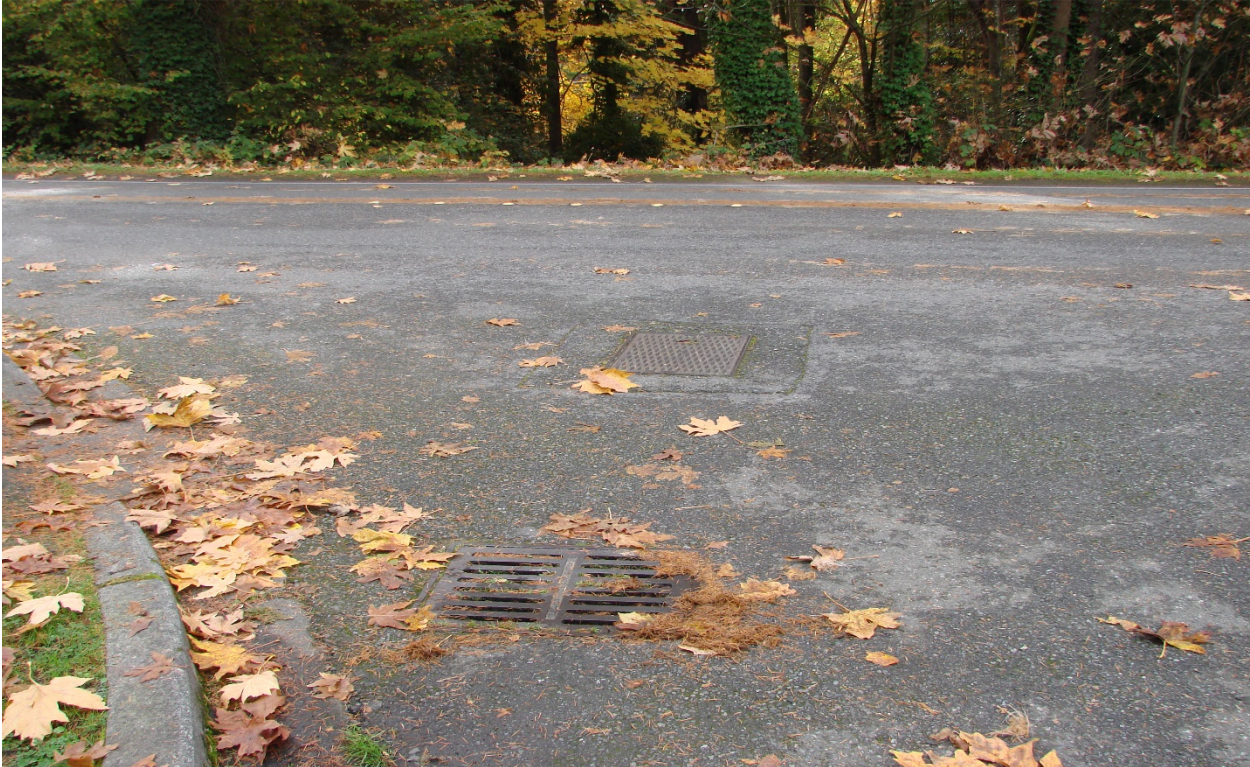
Photo #9 – View from school access towards West Mercer Way – CB#22-16

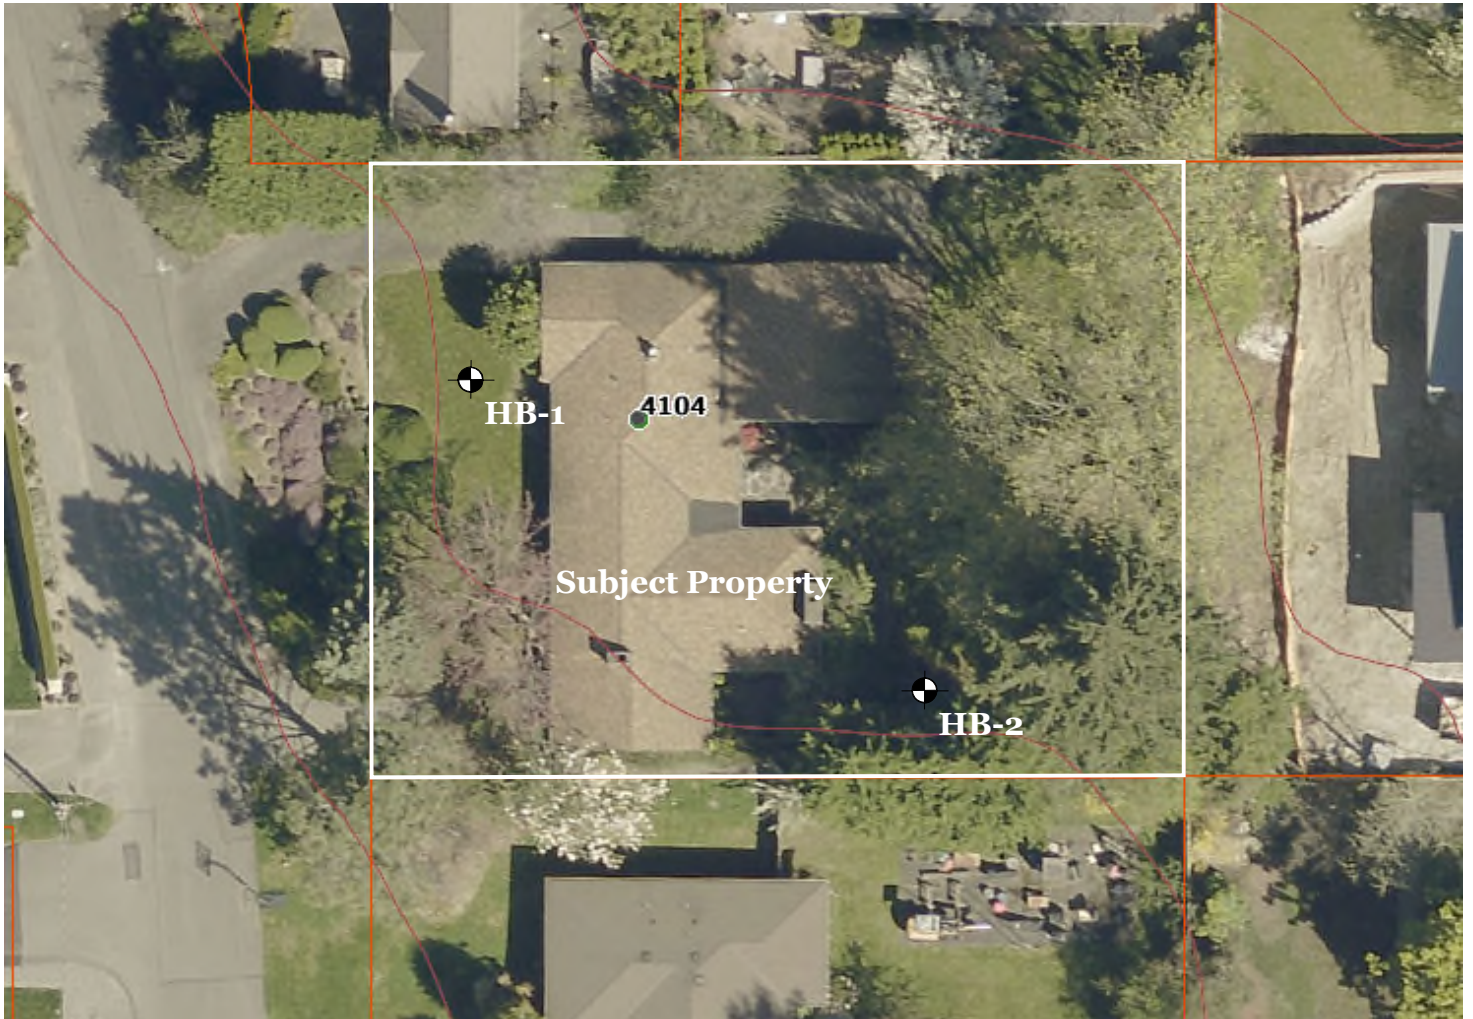
Site Image
Figure 1

**Approximate Hand
HB-1 Boring Location**

As part of our evaluation, we excavated two hand borings where accessible. The explorations encountered approximately 6 inches of grass and topsoil underlain by approximately 3.25 to 4.25 feet of loose to medium dense, silty-fine to medium grained sand with gravel (Weathered Glacial
