## GEOTECHNICAL REPORT

### Scharhon Residence

9150 – SE 54<sup>th</sup> Street

Project No. A-1709

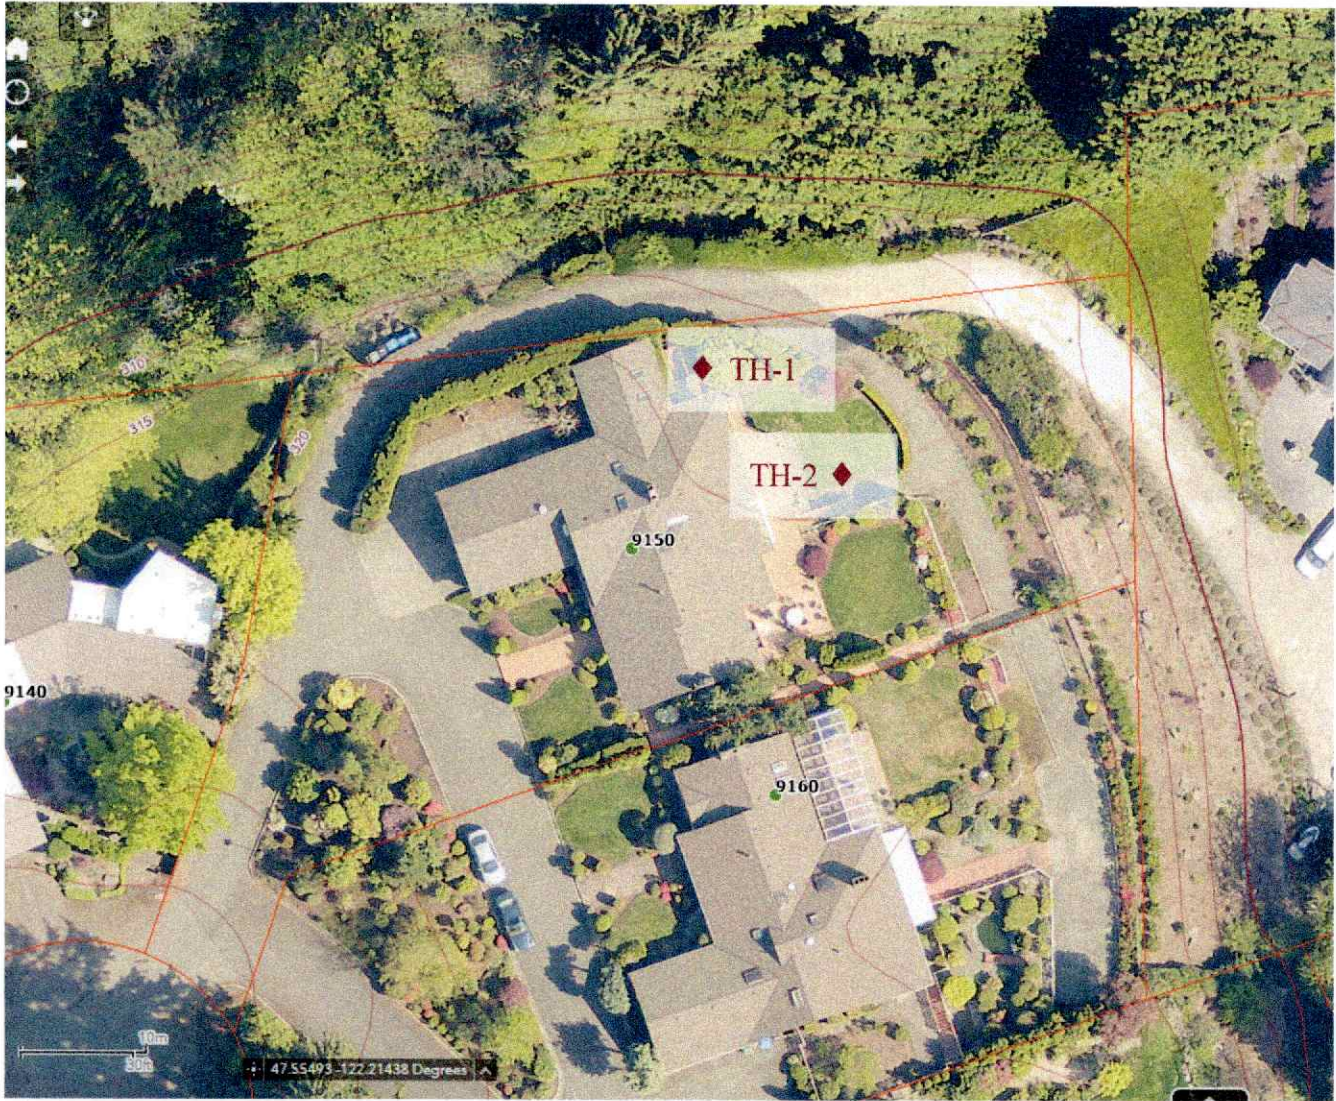
**Figure 2**

**KEY:**  
 APPROXIMATE LOCATION OF TEST HOLE      TH-1 ◆

The subject site area is a rectangular-shaped, 0.58-acre, residential parcel located at 9150 SE 54<sup>th</sup> Street in Mercer Island, Washington. The subject site is currently occupied with a single-family residence located in the approximate center of the site. The site is bordered by single-family residential lots to the south, east and west, and by the SE 53<sup>rd</sup> Open Space to the north. Access to SE 54<sup>th</sup> Street is at the SW site corner. The location of the site is shown on the Site Vicinity Map provided in Figure 1. The current site layout is shown on the Exploration Location Plan provided in Figure 2.

Figures A-1 through A-2 present more detailed descriptions of the subsurface conditions encountered in the test holes. The approximate test hole locations are shown on the Exploration Location Plan provided in Figure 2.

On September 18, 2024, we explored subsurface conditions at the site by excavating two hand-augured test holes to a maximum depth of 5.0 feet below surface grades. The approximate location of the site is shown on the Site Vicinity map provided in Figure 1. The approximate test hole locations are shown on the Exploration Location Plan provided in Figure 2.

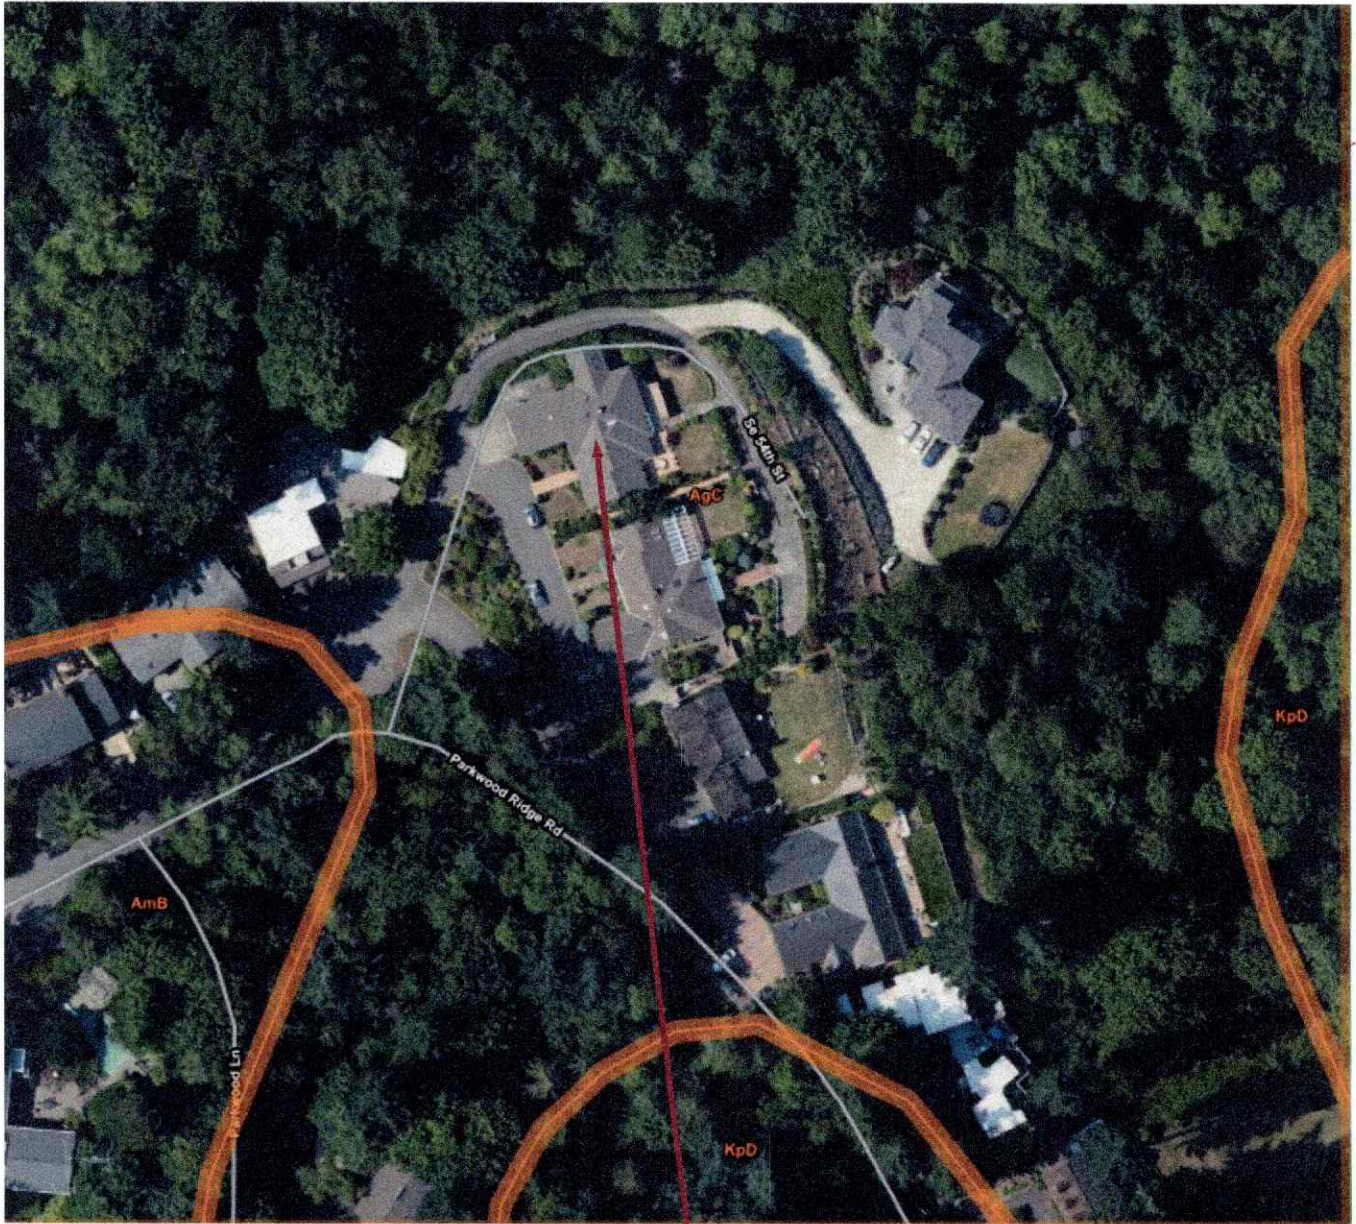
Approximate Site Location

The United States Department of Agriculture (USDA) Natural Resource Conservation Service (NRCS) maps the soils in the vicinity of the site as Alderwood Gravelly Sandy Loam (AgC) soils that form on 8 to 15 percent slopes. According to the USDA NRCS, the site soil will have a “moderate” potential erosion when exposed. A copy of the USDA NRCS Map for the subject site is provided in Figure 4.
