**SUBJECT: Stream Buffer Reduction and Enhancement for Forest Creek Lot 1
5222 Forest Ave SE, Parcel 141030-0057, Mercer Island, WA**

FIGURE 1: EXISTING CONDITIONS
 SEASCOPE HOMES
 FOREST AVE - BUFFER MITIGATION PLAN
 MERCER ISLAND, WASHINGTON
 PARCELS 1410300057 & -0059

FIGURE 2: SITE PLAN
SEASCAPE HOMES
FOREST AVE - BUFFER MITIGATION PLAN
MERCER ISLAND, WASHINGTON
PARCELS 1410300057 & -0059

FIGURE 5: PLANTING DETAILS & SPECIFICATIONS
 SEASCAPE HOMES
 FOREST AVE - BUFFER MITIGATION PLAN
 MERCER ISLAND, WASHINGTON
 PARCELS 1410300057 & -0059

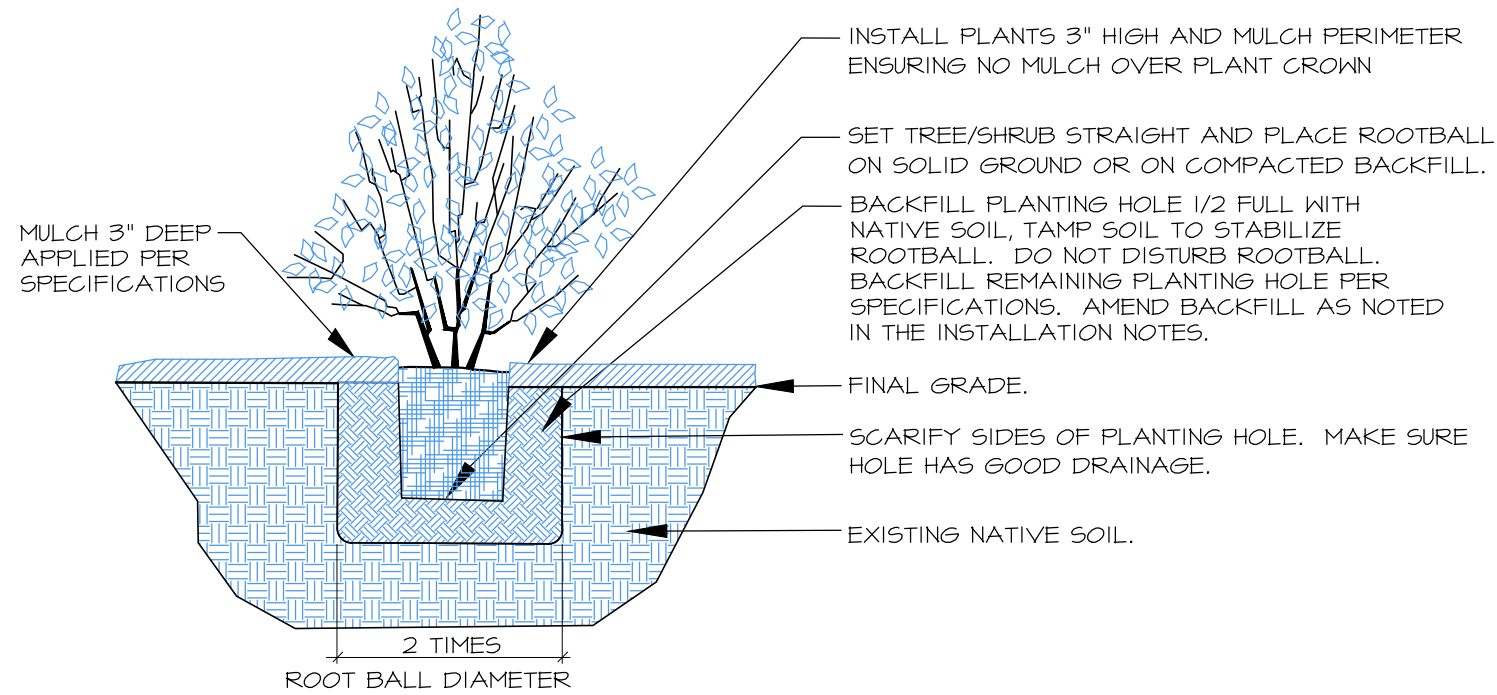
1 CONTAINER TREE/SHRUB PLANTING (TYP.)

INSTALL PLANTS 3" HIGH AND MULCH PERIMETER ENSURING NO MULCH OVER PLANT CROWN

SET TREE/SHRUB STRAIGHT AND PLACE ROOTBALL ON SOLID GROUND OR ON COMPACTED BACKFILL.

BACKFILL PLANTING HOLE 1/2 FULL WITH NATIVE SOIL, TAMP SOIL TO STABILIZE ROOTBALL. DO NOT DISTURB ROOTBALL. BACKFILL REMAINING PLANTING HOLE PER SPECIFICATIONS. AMEND BACKFILL AS NOTED IN THE INSTALLATION NOTES.

SCARIFY SIDES OF PLANTING HOLE. MAKE SURE HOLE HAS GOOD DRAINAGE.

EXISTING NATIVE SOIL.

3. ALL PLANTS SHOULD BE INSTALLED BETWEEN DECEMBER 1ST AND MARCH 15TH.
4. ALL PLANTS SHALL BE PIT-PLANTED IN PLANTING PITS EXCAVATED 2X THE DIAMETER OF THE PLANT. PITS SHALL BE BACKFILLED WITH A 30/70 MIX OF STEERCO TO NATIVE SOIL. PLANTS SHALL BE INSTALLED 2" HIGH AND SURFACED MULCHED TO A DEPTH OF 3" WITH HOG-FUEL PLACED CONTINUOUSLY THROUGHOUT THE PLANTING BED.

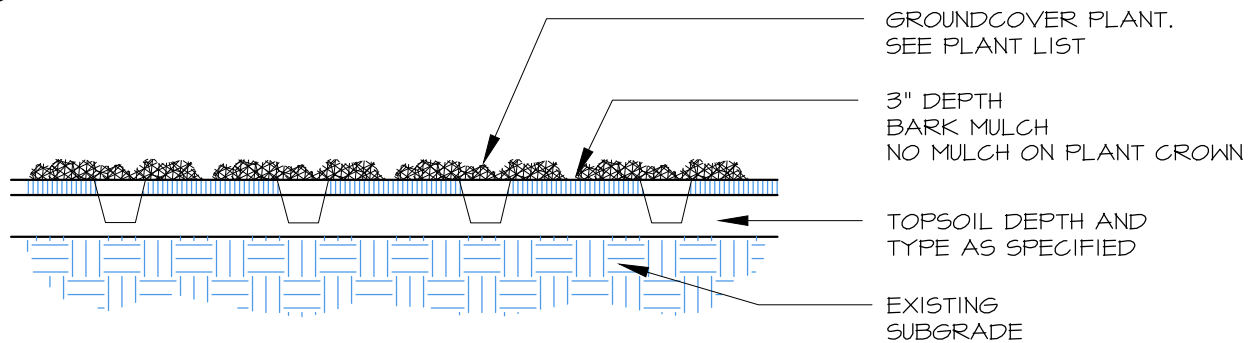
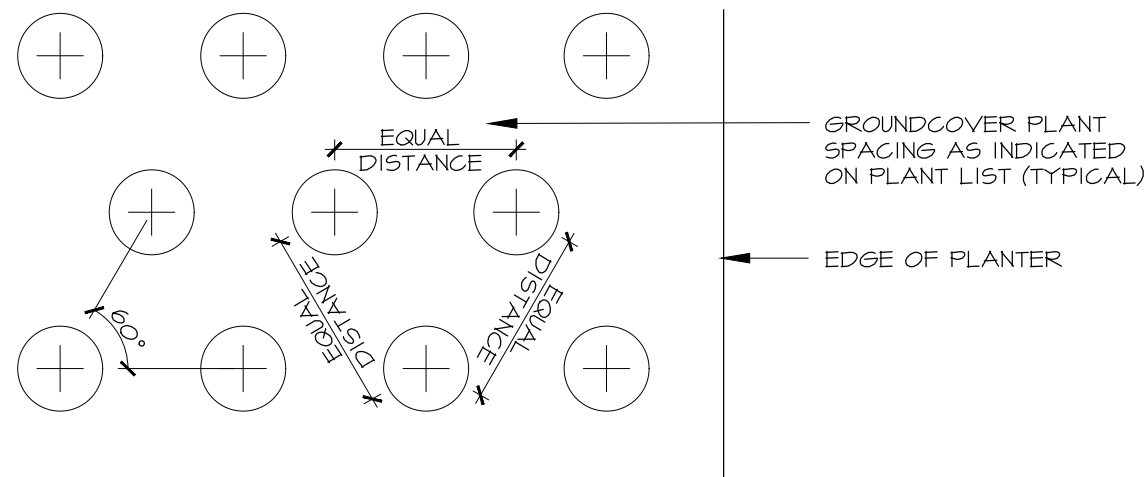
2 GROUNDCOVER PLANTING (TYP.)

GROUNDCOVER PLANT. SEE PLANT LIST

3" DEPTH BARK MULCH NO MULCH ON PLANT CROWN

TOPSOIL DEPTH AND TYPE AS SPECIFIED

EXISTING SUBGRADE

GROUNDCOVER PLANT SPACING AS INDICATED ON PLANT LIST (TYPICAL)
